ADS Emerald Park Landfill Audit Summary

TO: ADS Emerald Park Landfill Standing Committee, City of Muskego
FROM: Faith Spear.
COPIES: File
DATE: 12/12/14
PROJECT NUMBER: 1012.10030

**ADVANCED DISPOSAL SERVICES
EMERALD PARK LANDFILL / CITY OF MUSKEGO
AUDIT PHOTOS**

PROJECT NO. 1012.10030

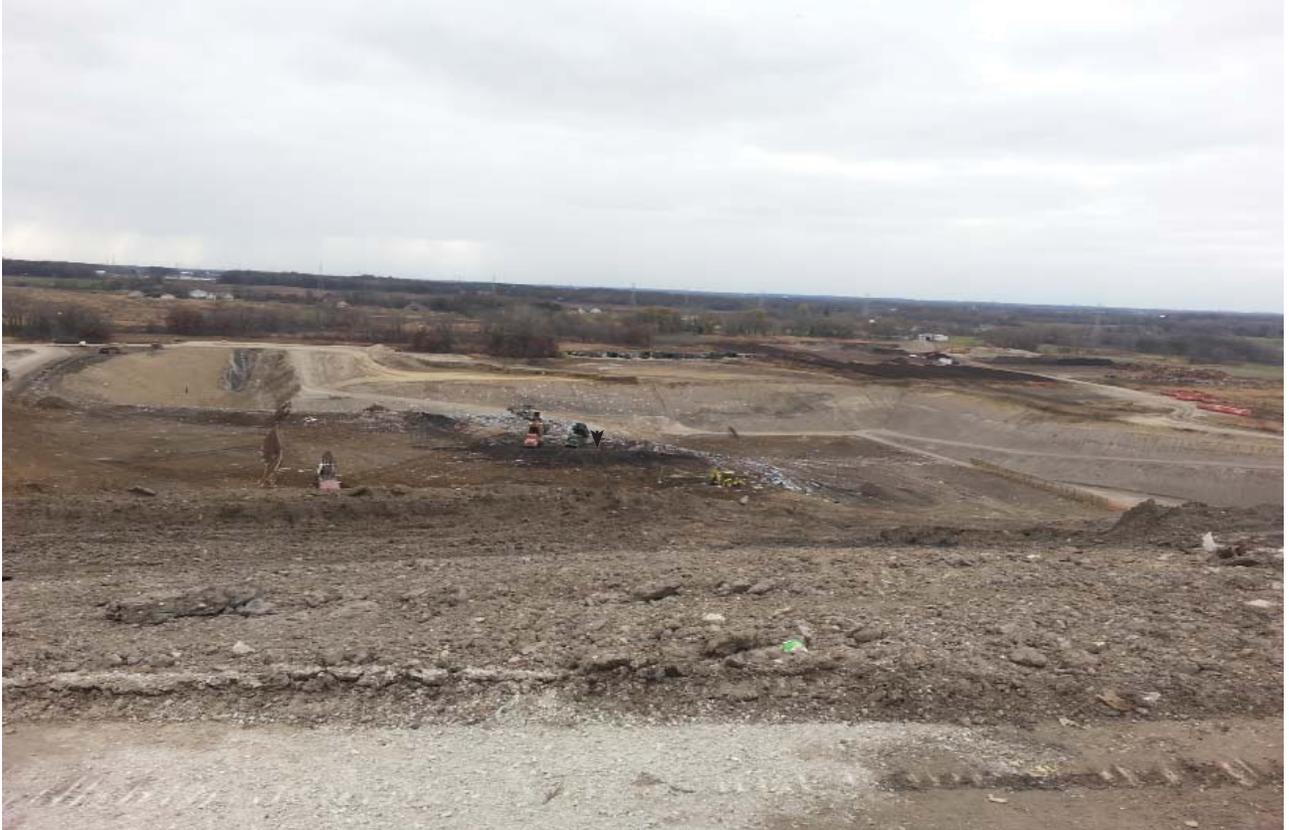
- Working face in middle of Phase 7B
 - Receiving MSW and liquid loads
- Intermediate cover on surrounding faces has been Back-dragged
- One compactor & one dozer and one excavator in use on site
 - One dozer in for repair
- Soils and foundry sand used for daily cover

Active area, Phase 7B

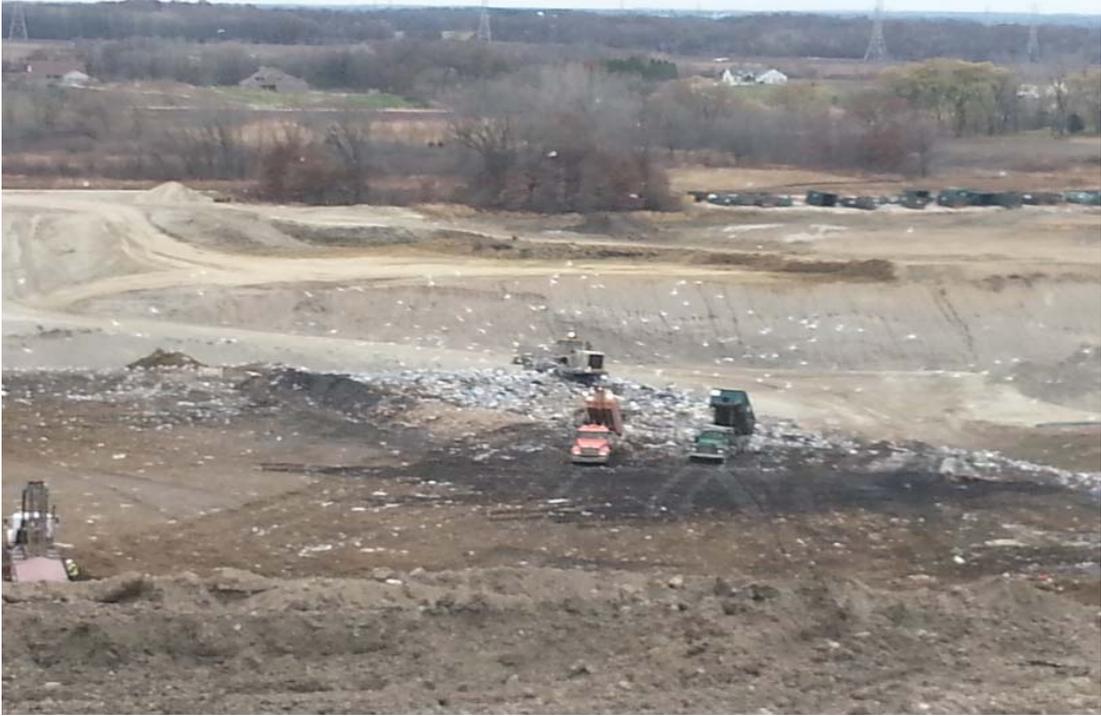
Working face viewed from the North

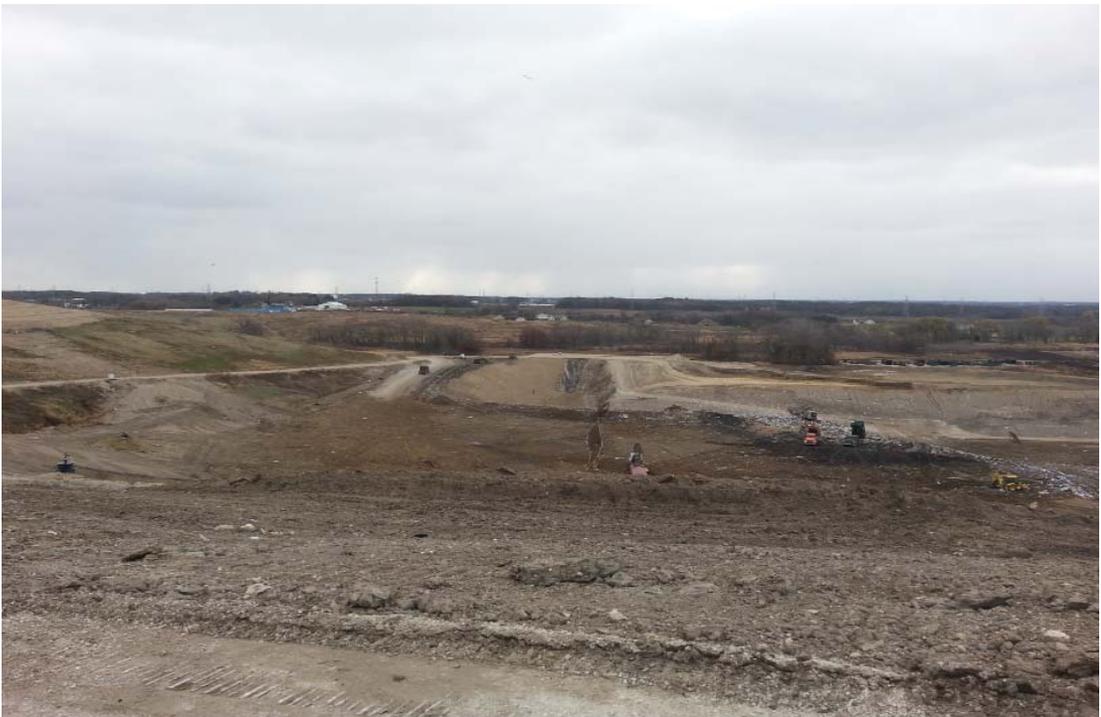
Windy day, litter about active area

Active area

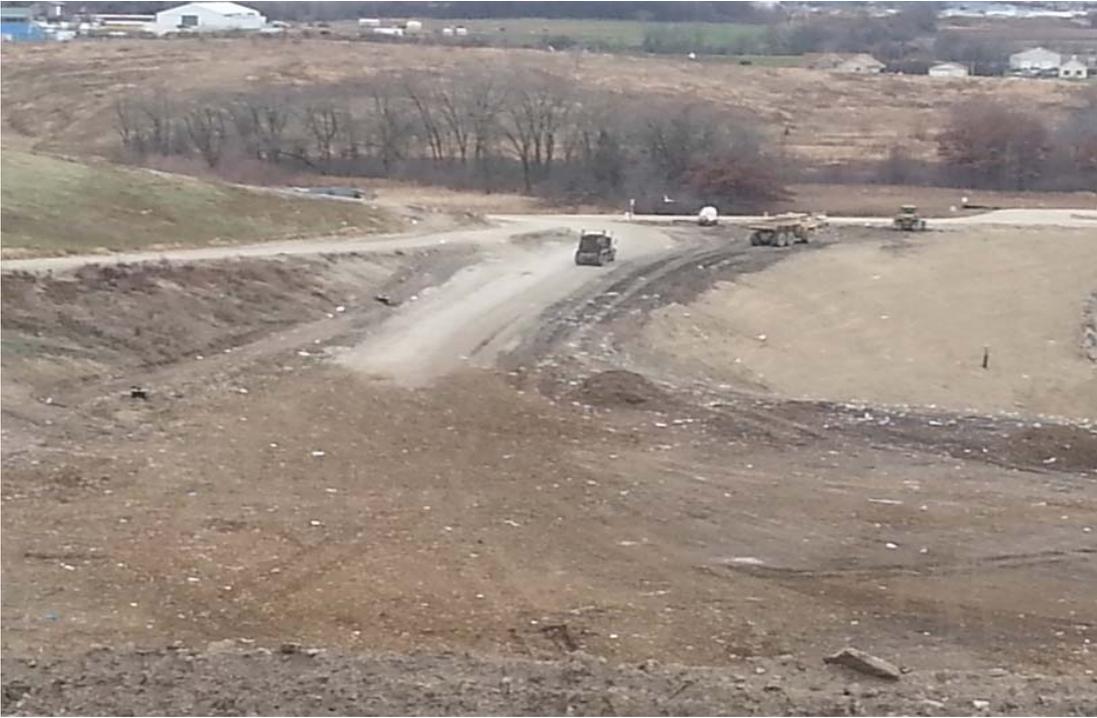
Phase 7B access ramp

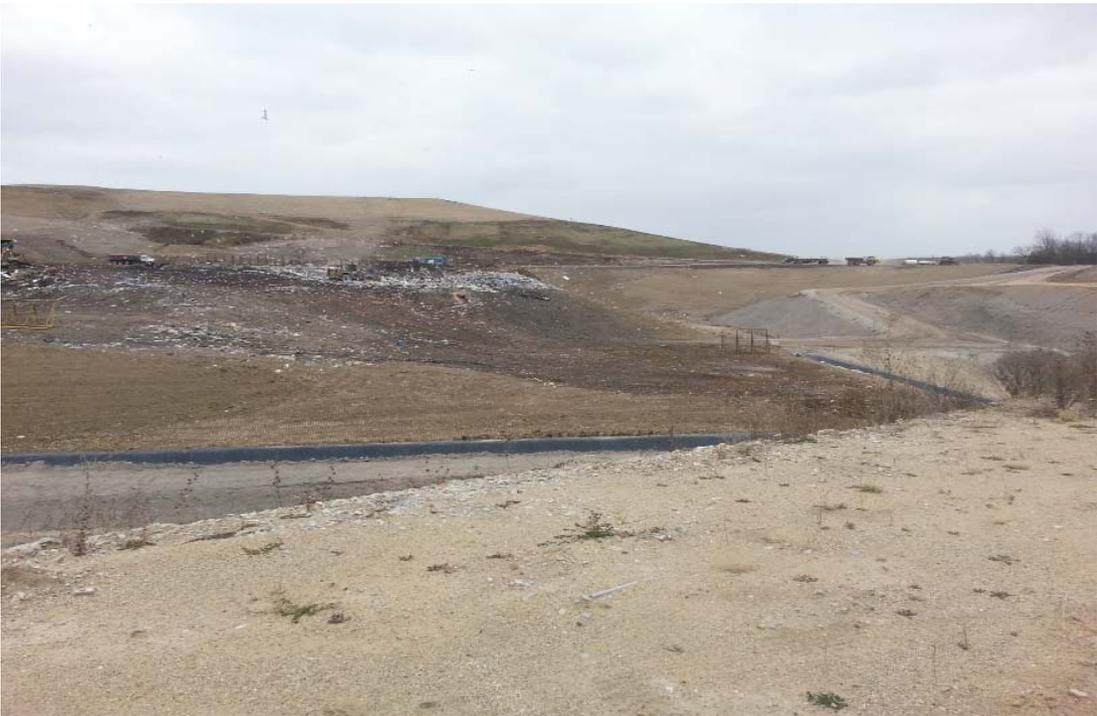
Area of repaired rain flap, with intermediate cover placed after repair

- Rain flap in Phase 7B repaired
 - Waste covered with soil
- Small Seeps on North and South slopes of Phase 7B have been repaired

* Rain flap in Phase 7B West repaired
and waste covered with soil

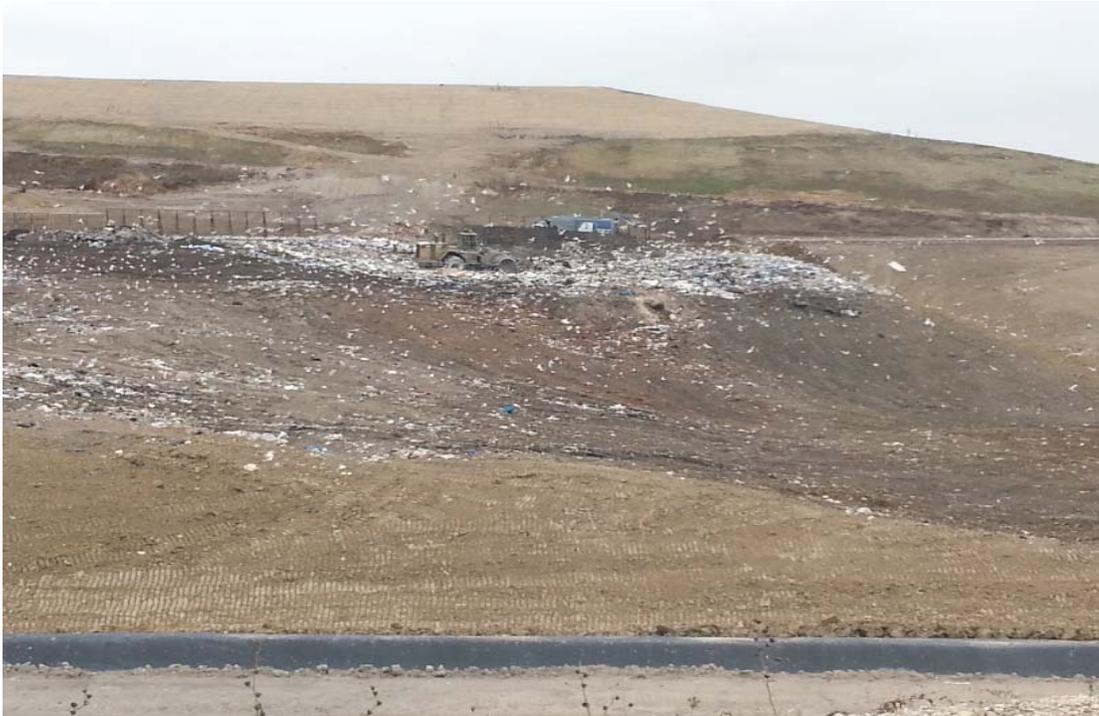
Working face viewed from West

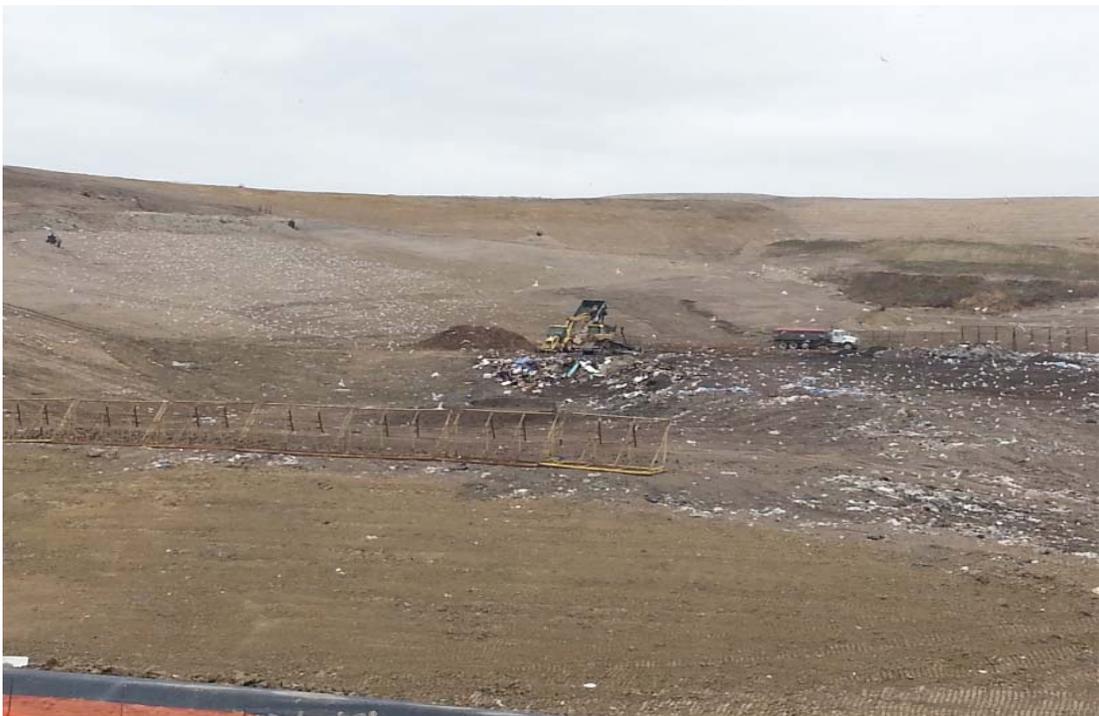
Active area viewed from the West
