ADS Emerald Park Landfill Audit Summary

To: ADS Emerald Park Landfill Standing Committee, City of Muskego
FROM: Faith Spear.
COPIES: File
DATE: 12/29/14
PROJECT NUMBER: 1012.10030

Attached is the audit report for activities at the ADS Emerald Park Landfill for the week of November 24, 2014. The audit was performed at 1:05 PM on **November 26, 2014** by Jo Spear, Jr. in the presence of David Geier, Operations Manager.

**ADVANCED DISPOSAL SERVICES
EMERALD PARK LANDFILL / CITY OF MUSKEGO
AUDIT PHOTOS**

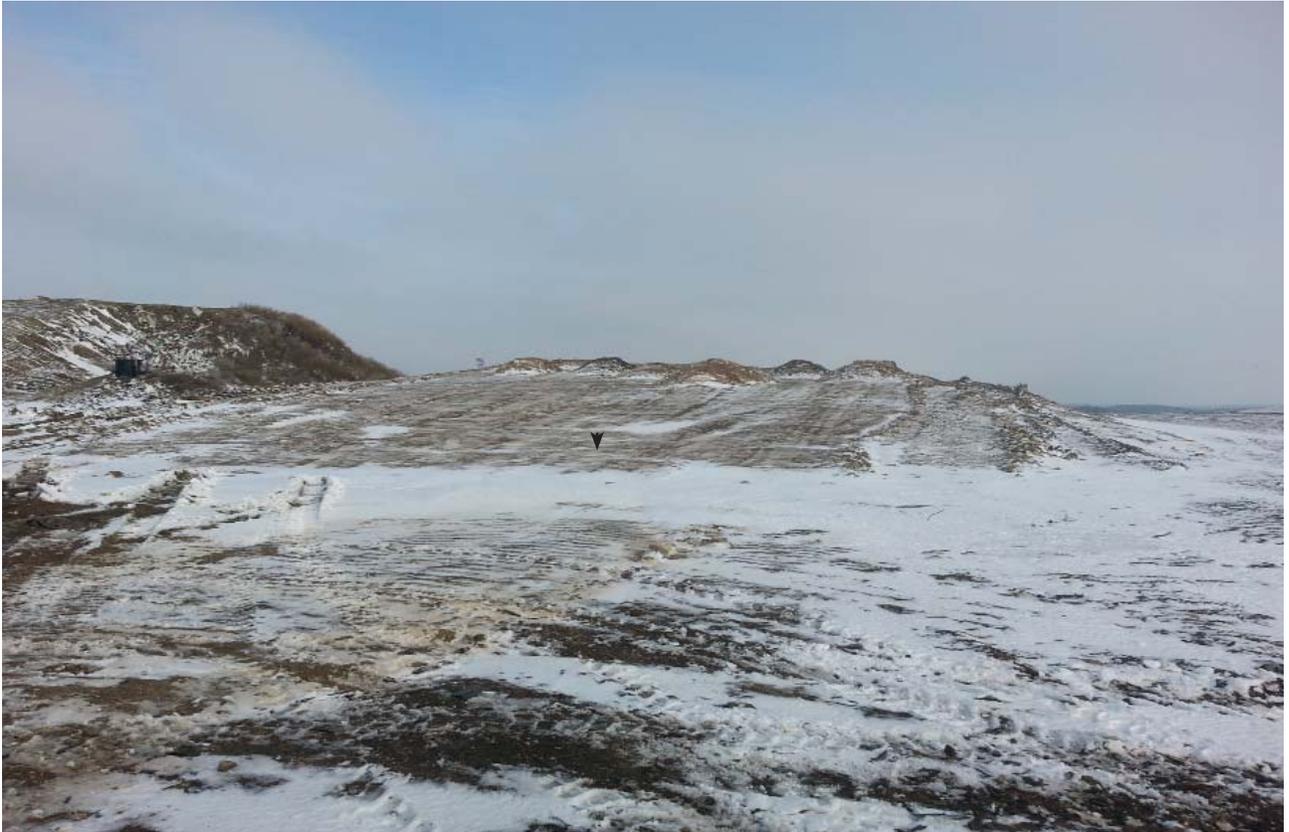
Soils tipping in Phase 4/5/6 viewed from the West

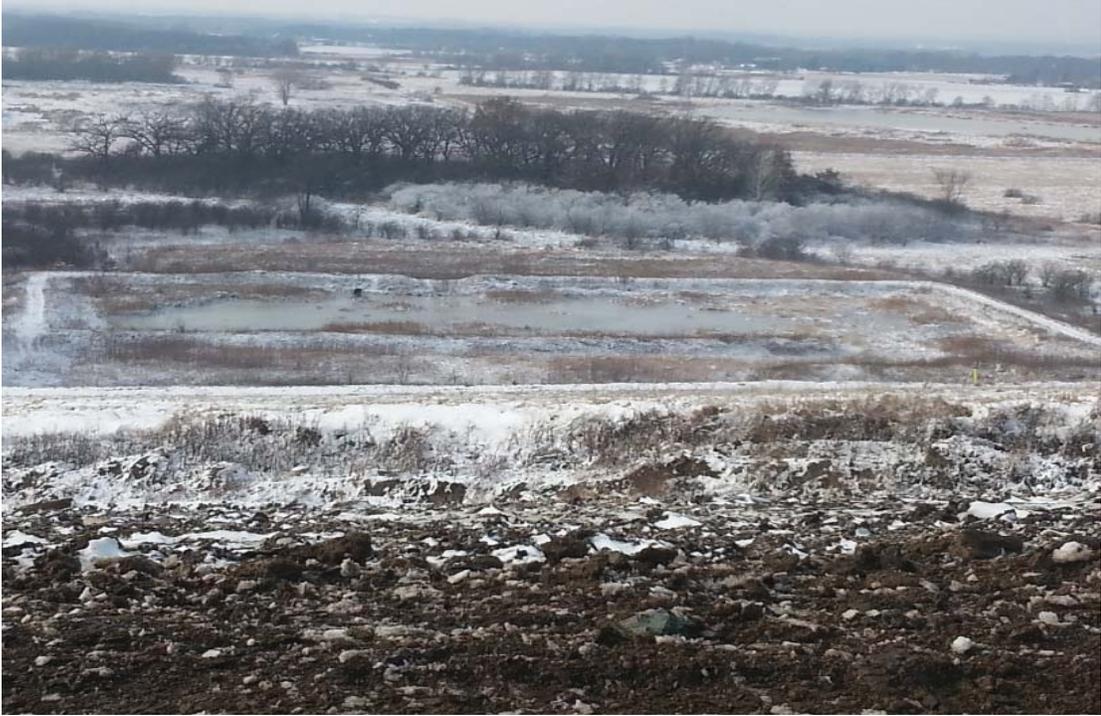
Basin #1, frozen

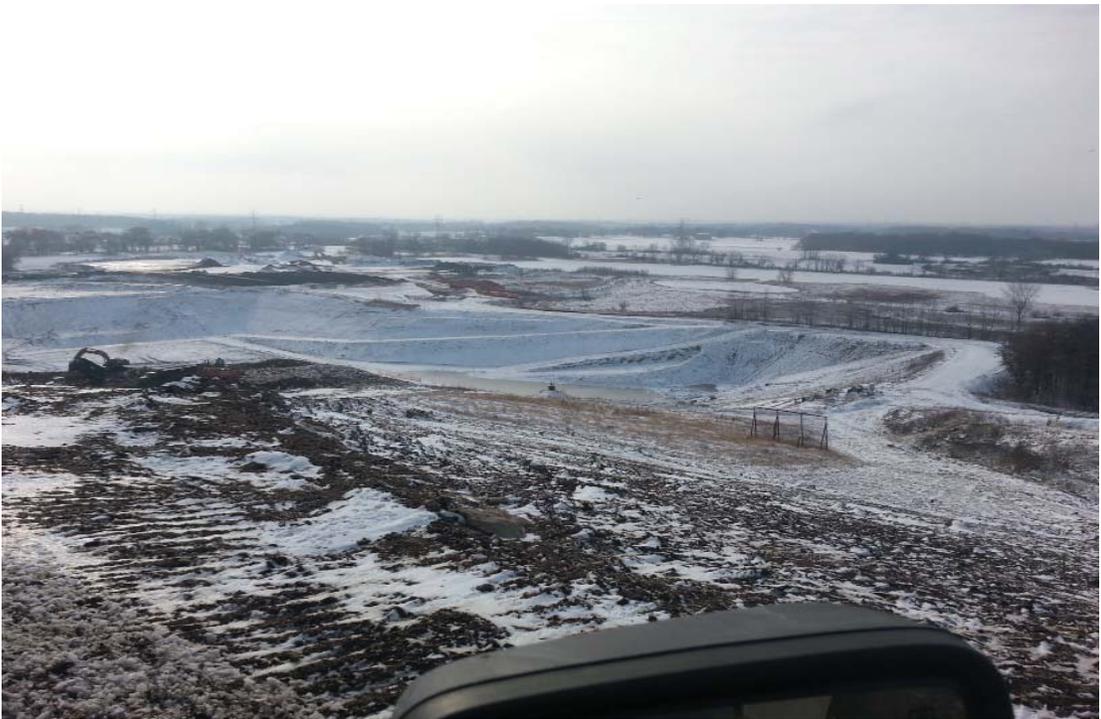
Frozen temp sed basin, viewed from Phase 2

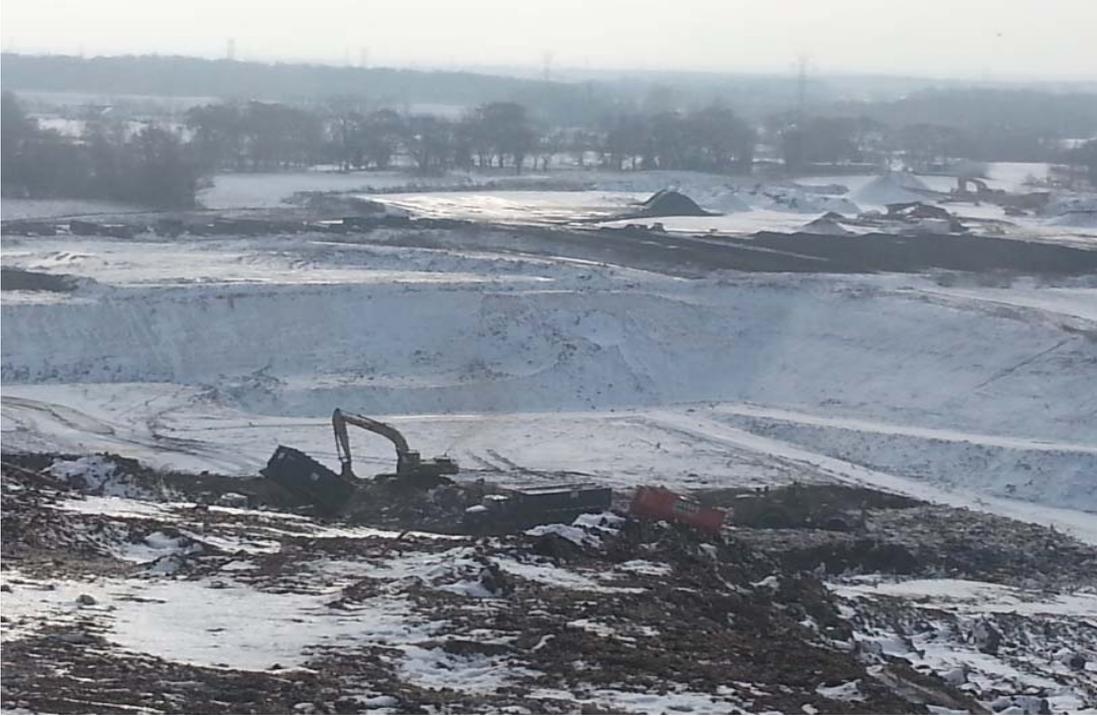
Working face

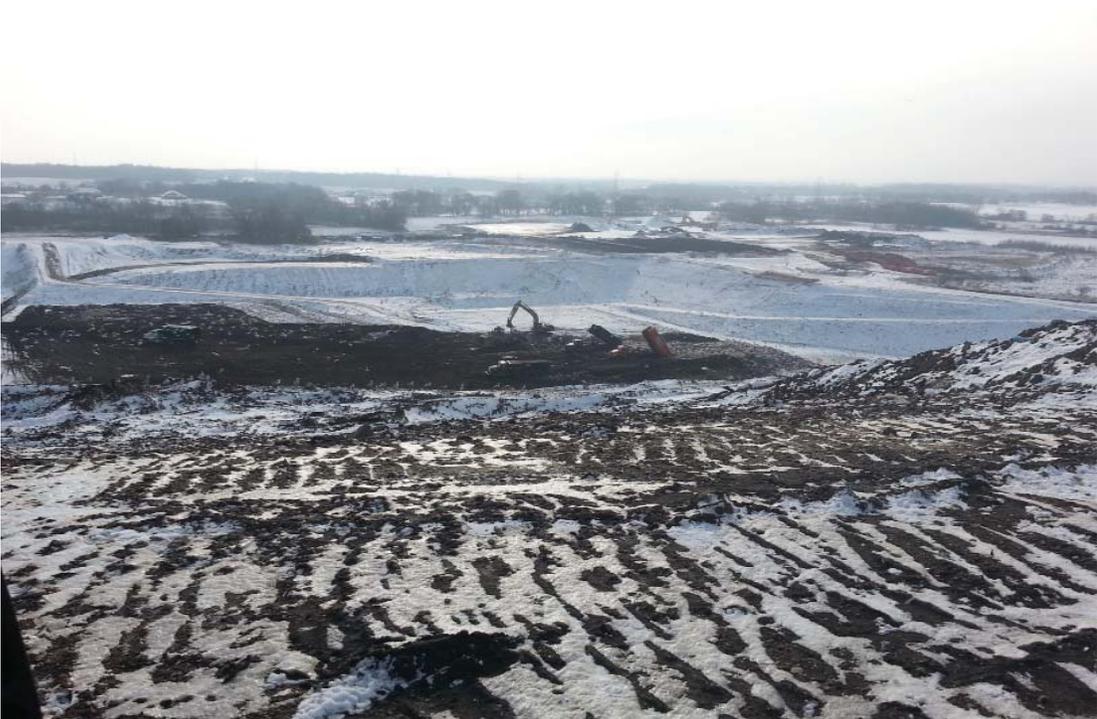
Working face in Phase 7B West, viewed from the North
