ADS Emerald Park Landfill Audit Summary

TO: ADS Emerald Park Landfill Standing Committee, City of Muskego
FROM: Faith Spear.
COPIES: File
DATE: 01/08/14
PROJECT NUMBER: 1012.10030

Attached is the audit report for activities at the ADS Emerald Park Landfill for the week of December 1, 2014. The audit was performed at 11:20 AM on **December 5, 2014** by Jo Spear, Jr. in the presence of Mike Hackney, General Manager.

**ADVANCED DISPOSAL SERVICES
EMERALD PARK LANDFILL / CITY OF MUSKEGO
AUDIT PHOTOS**

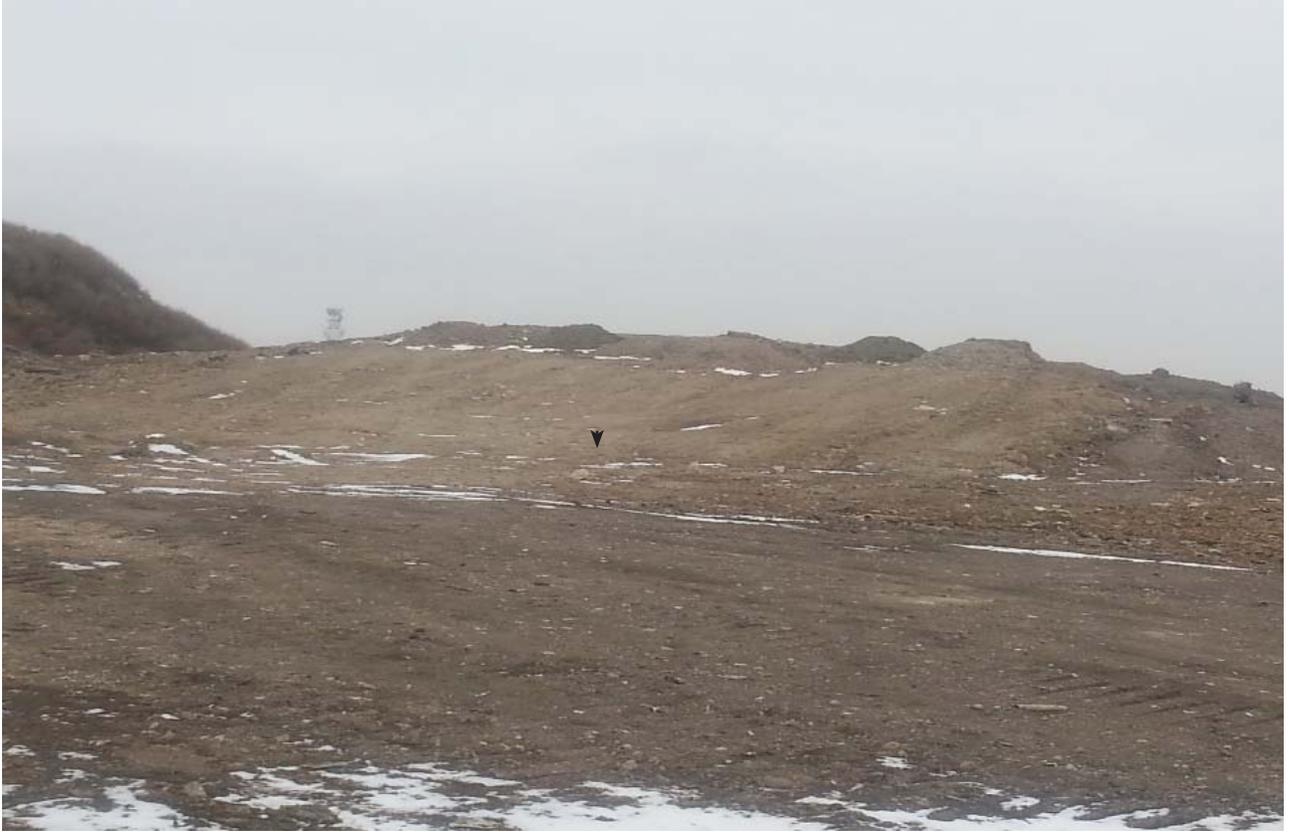
Soils tipping in Phase 4/5/6 viewed from the West

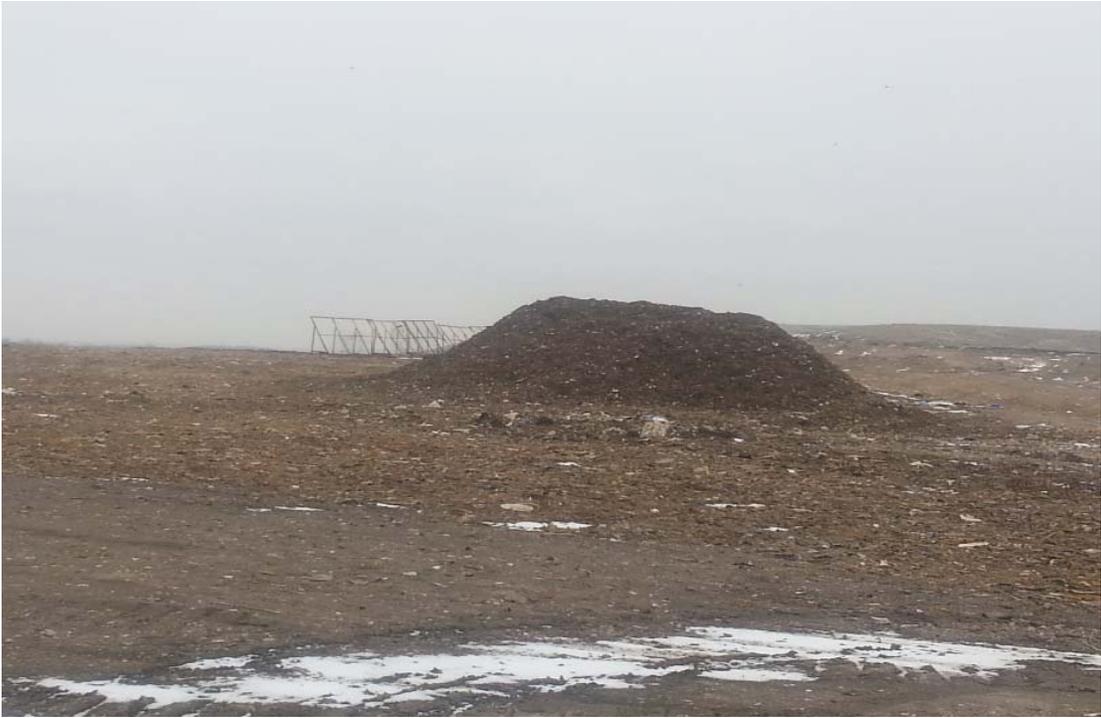
Autofluff stockpile in Phase 6 for refilling liquid load trenches

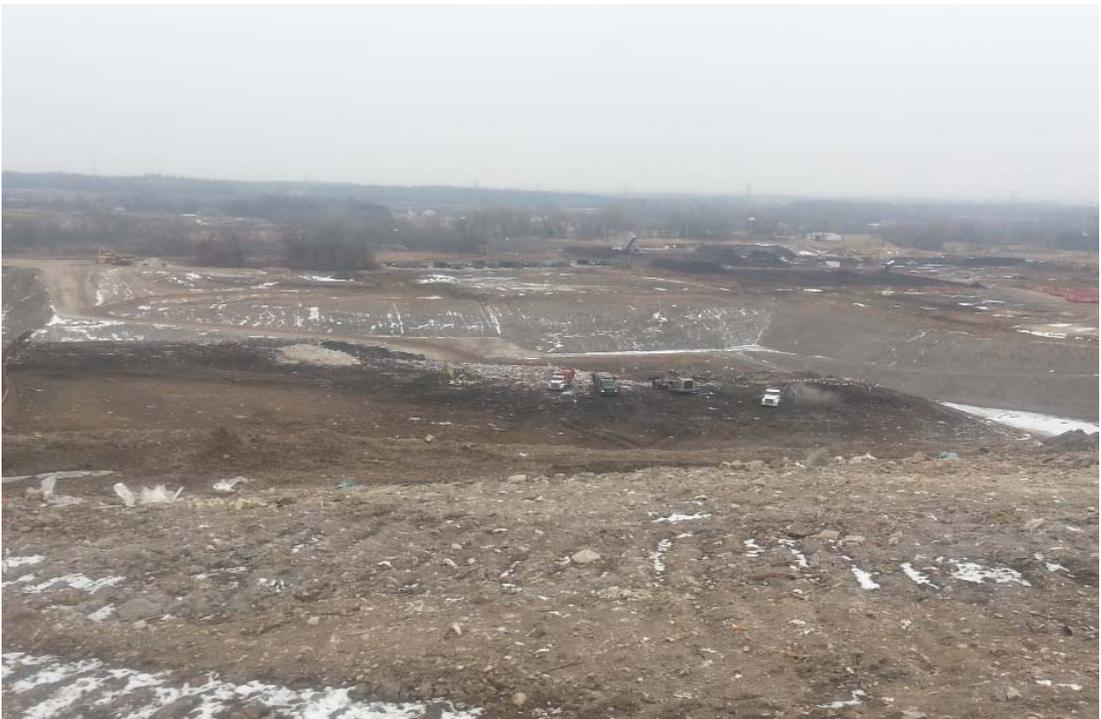
Working face, roughly middle of Phase 7B, viewed from the North

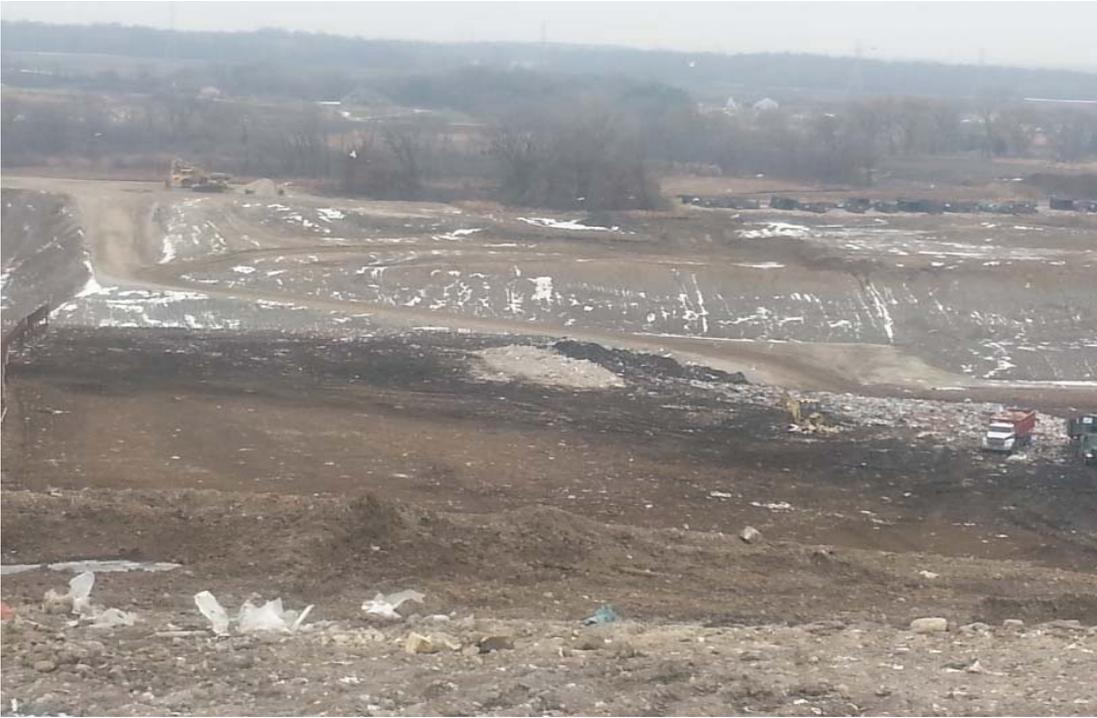
Phase 7B overview

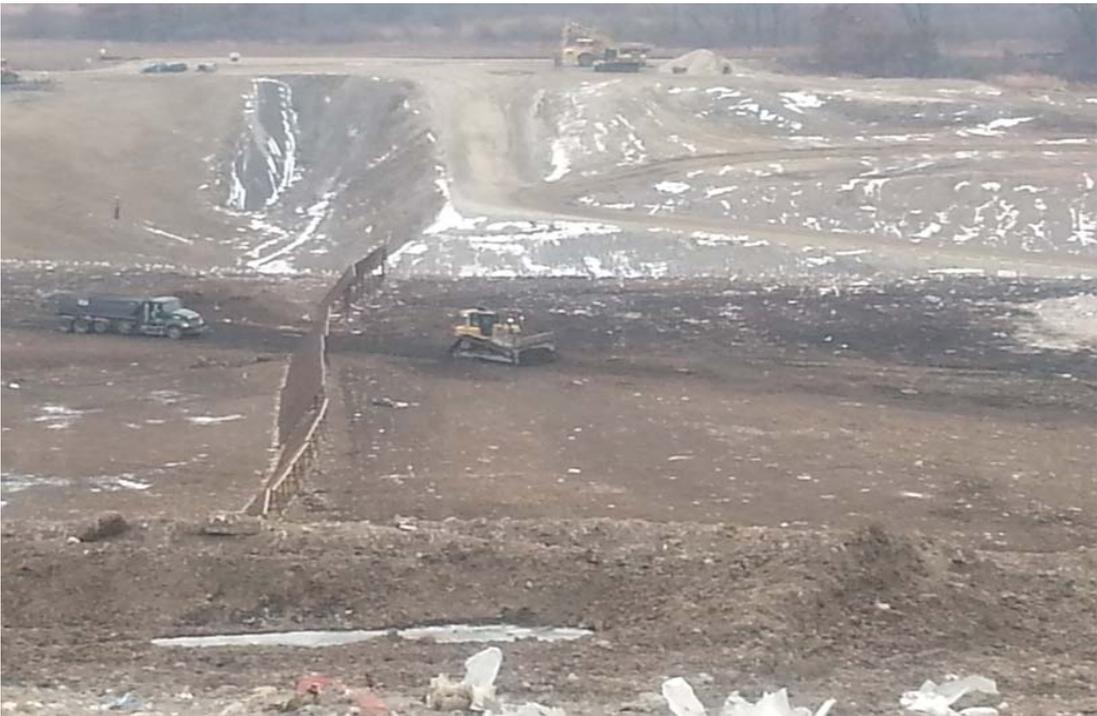
Dozer dressing site access in Phase 7B

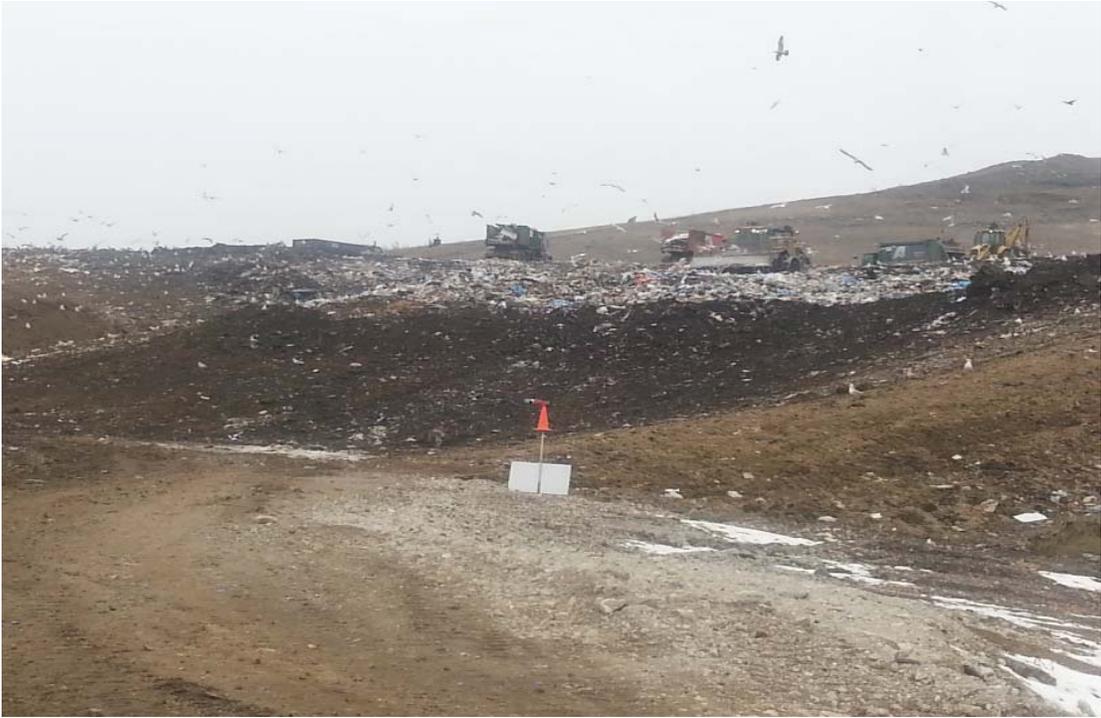
Working face viewed at grade

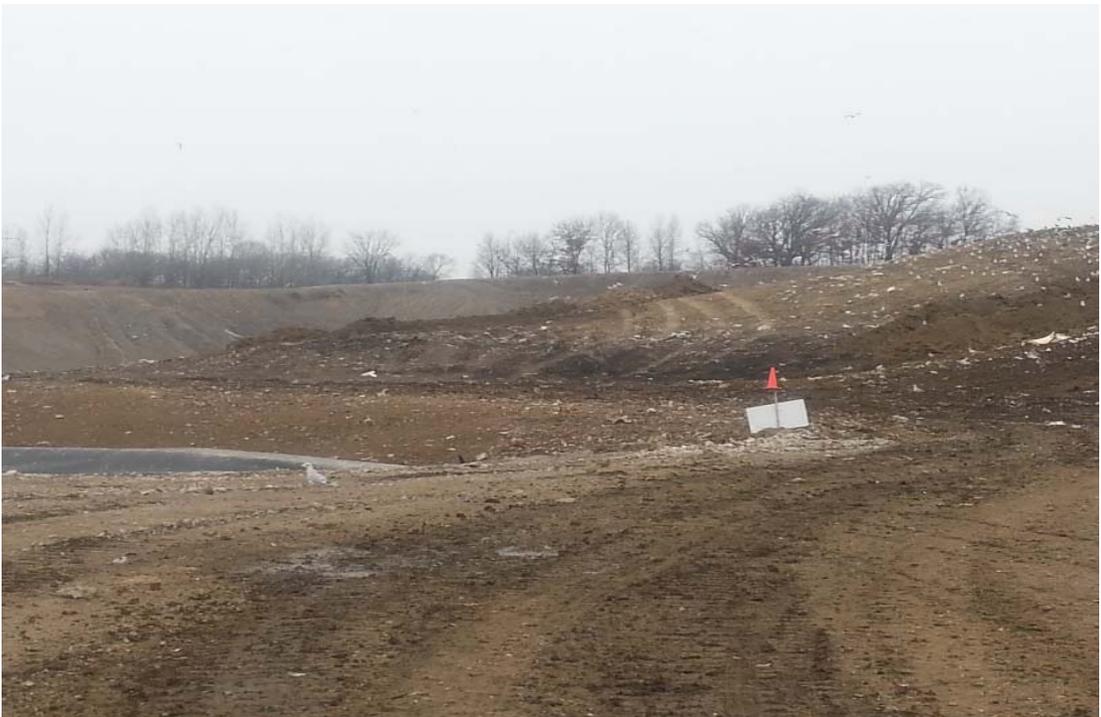
Intermediate cover on Southwest corner of Phase 7B West

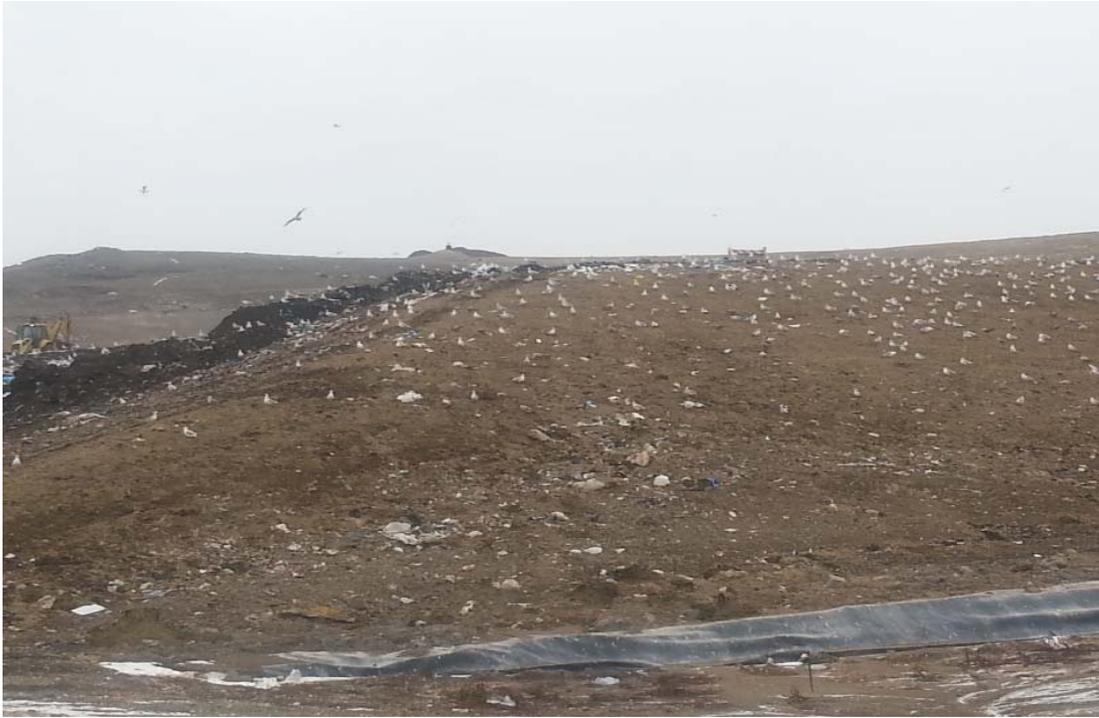
Previous working face, South slope of Phase 7B with intermediate cover

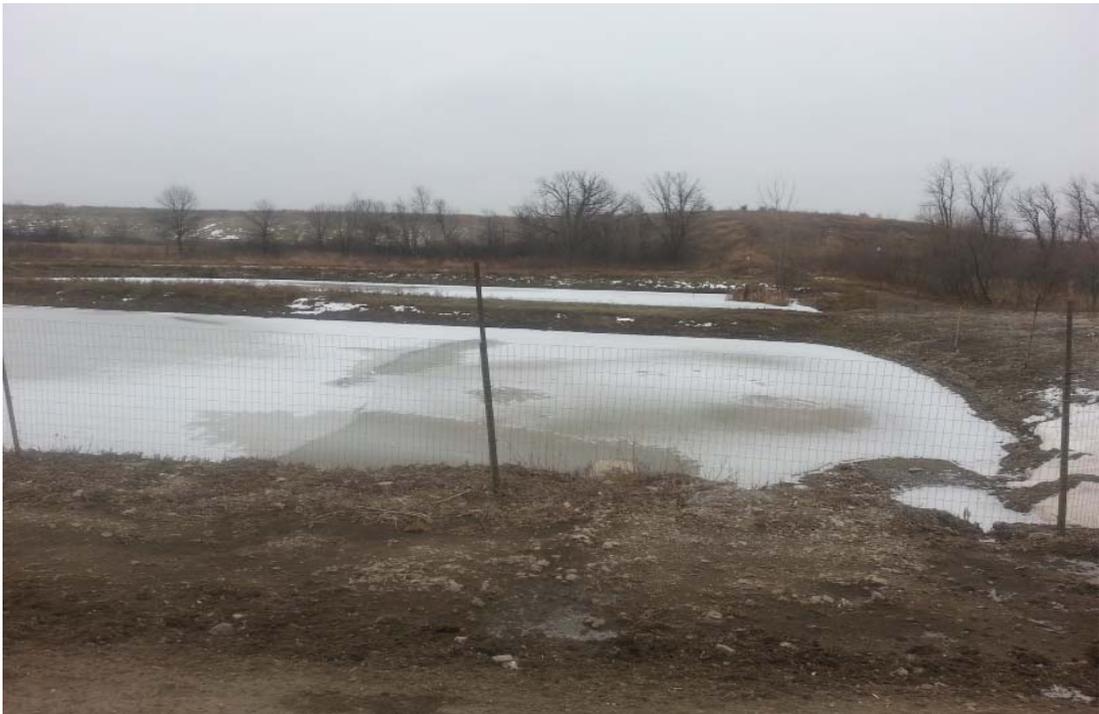
Snow only, site surface water frozen and unflowing

Basin #2, frozen surface
