# ADS Emerald Park Landfill Audit Summary

**To:** ADS Emerald Park Landfill Standing Committee, City of Muskego  
**FROM:** Faith Spear.  
**COPIES:** File  
**DATE:** 01/08/15  
**PROJECT NUMBER:** 1012.10030

Attached is the audit report for activities at the ADS Emerald Park Landfill for the week of December 22, 2014. The audit was performed at 12:45 PM on **December 22, 2014** by Jo Spear, Jr. in the presence of David Geier, Operations Manager.

**ADVANCED DISPOSAL SERVICES  
EMERALD PARK LANDFILL / CITY OF MUSKEGO  
AUDIT PHOTOS**

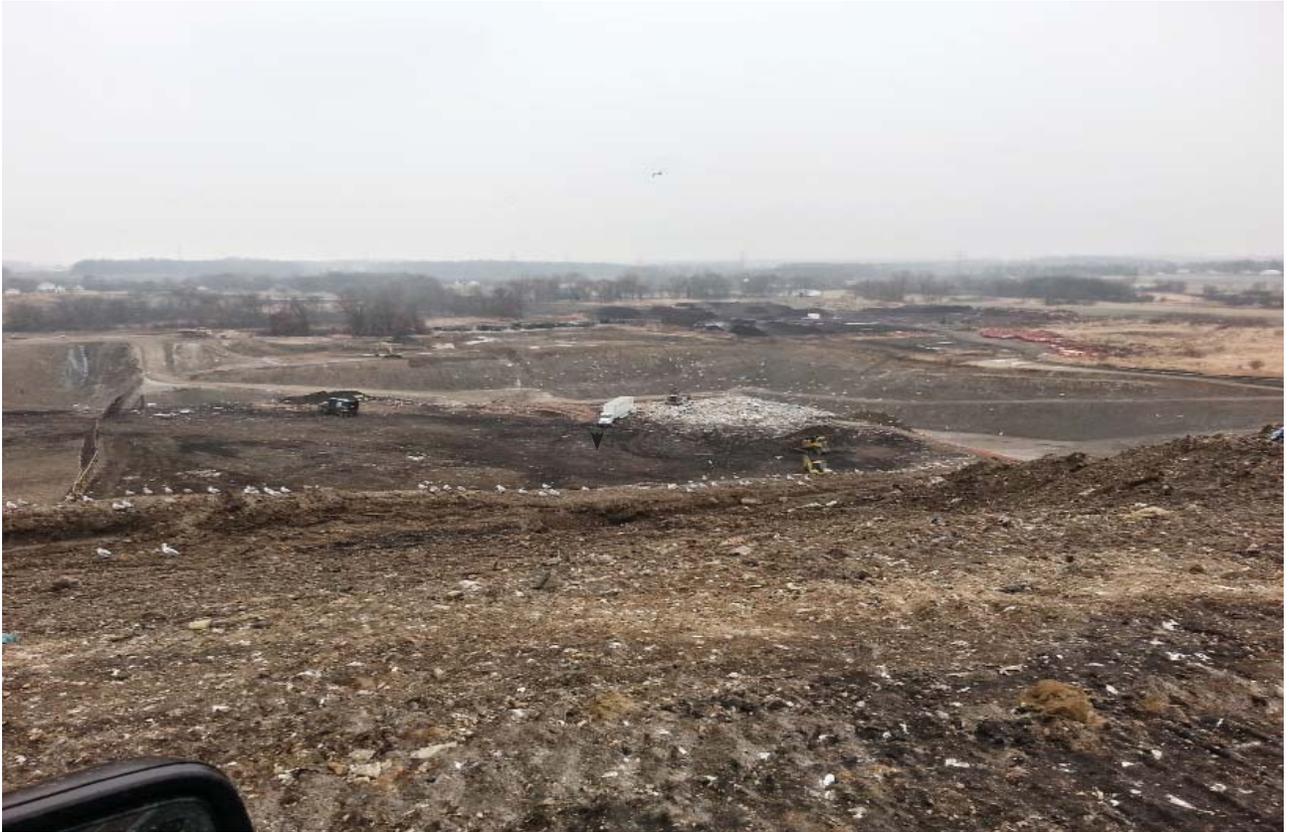
Overview of Phase 7 (whole)

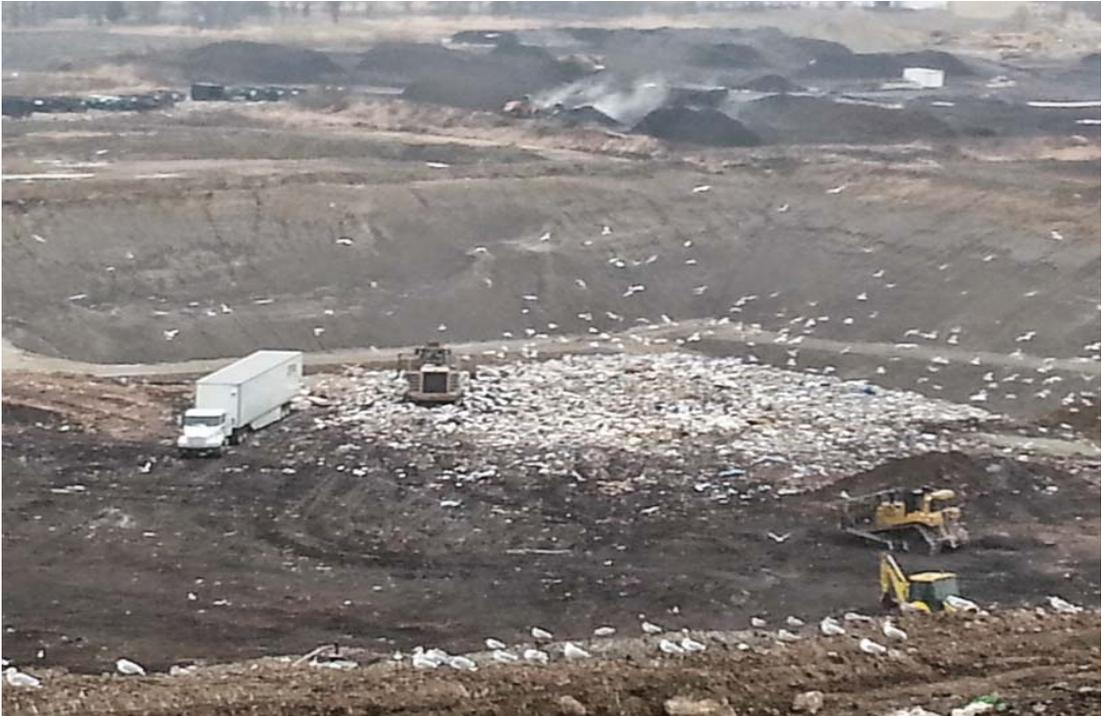
Working face is Southwest corner  
of Phase 7B finishing lift elevation  
small volume of Bio soil tipped in there 4/5  
but not active during audit

Working face in Southwest corner of Phase 7B West

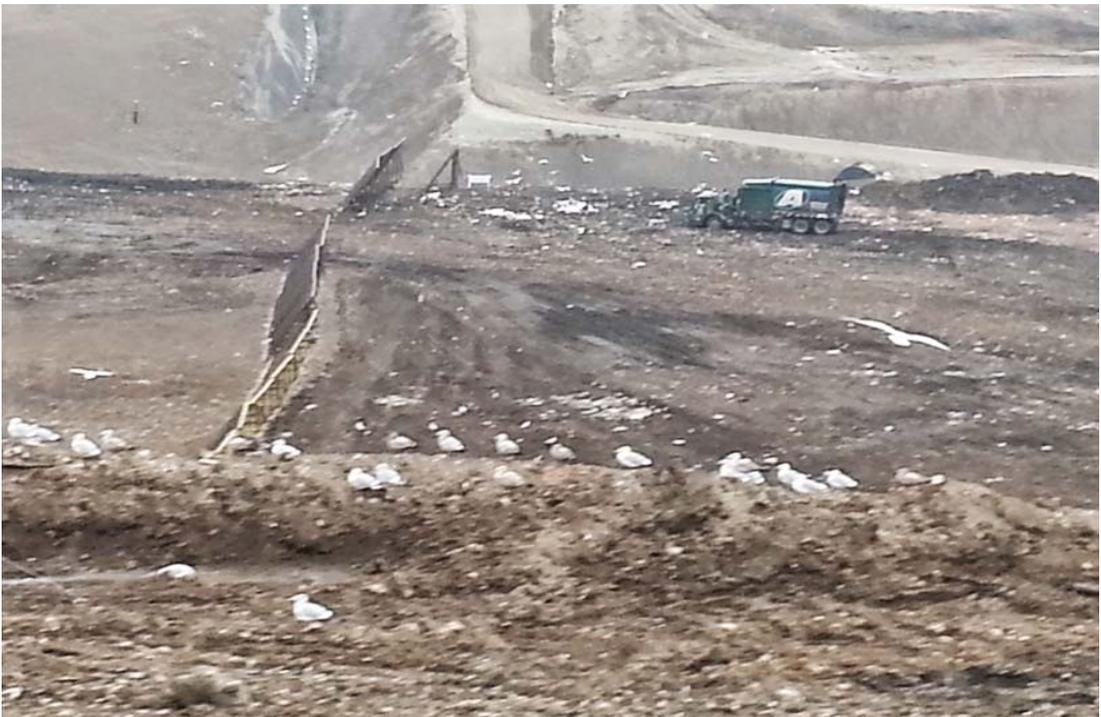
Clean out for tipped trucks on West side of litter fences, East edge of Phase 7B

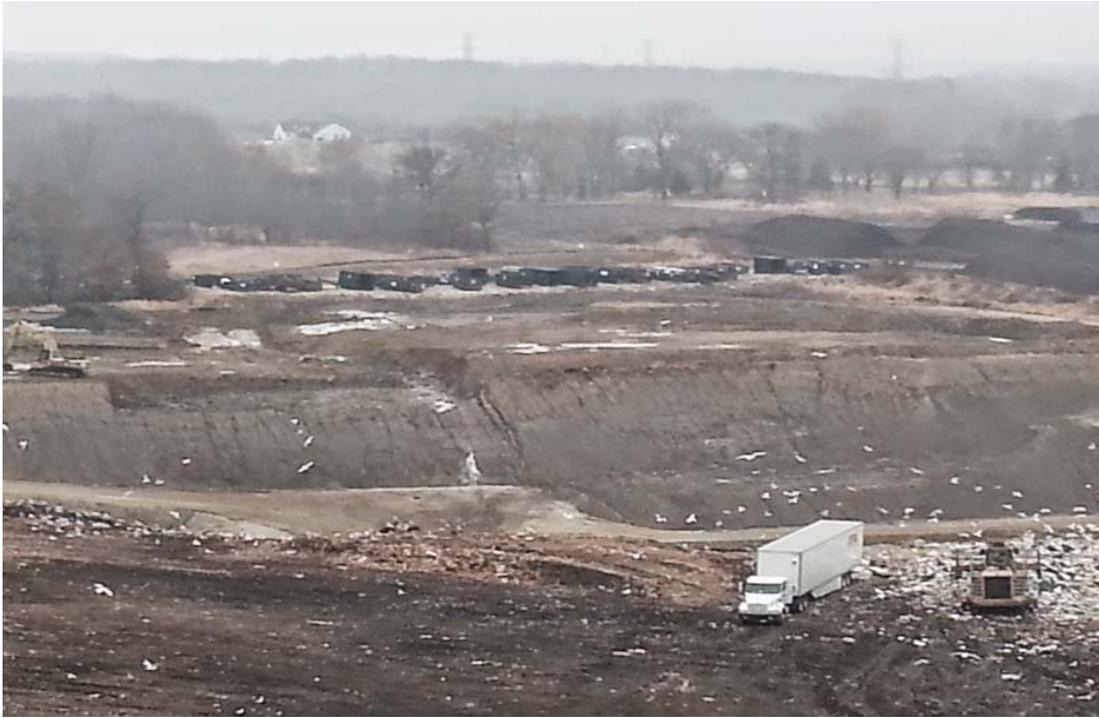
Future Phase 8 being excavated for cover soils

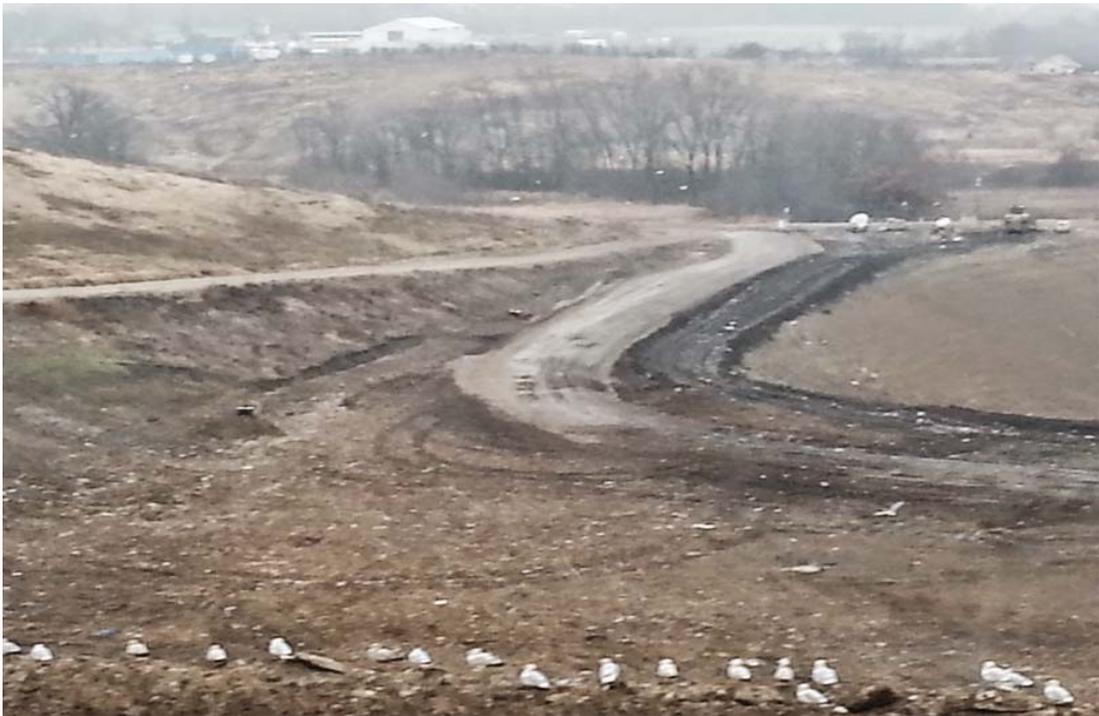
Access ramp into Phase 7 across previously placed waste and intermediate cover

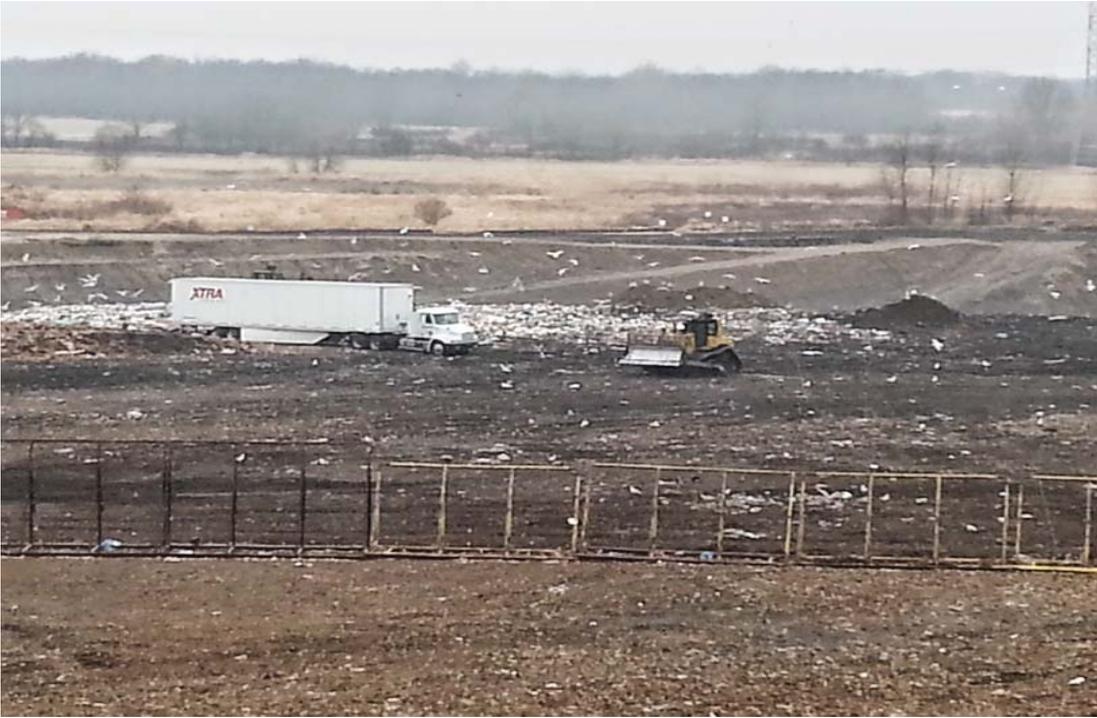
Active area, viewed at grade from the East
