ADS Emerald Park Landfill Audit Summary

To: ADS Emerald Park Landfill Standing Committee, City of Muskego
FROM: Faith Spear.
COPIES: File
DATE: **12/24/14**
PROJECT NUMBER: 1012.10030

Attached is the audit report for activities at the ADS Emerald Park Landfill for the week of November 17, 2014. The audit was performed at 12:10 PM, **November 19, 2014** by Jo Spear, Jr. in the presence of Michael Hackney, General Manager.

**ADVANCED DISPOSAL SERVICES
EMERALD PARK LANDFILL / CITY OF MUSKEGO
AUDIT PHOTOS**

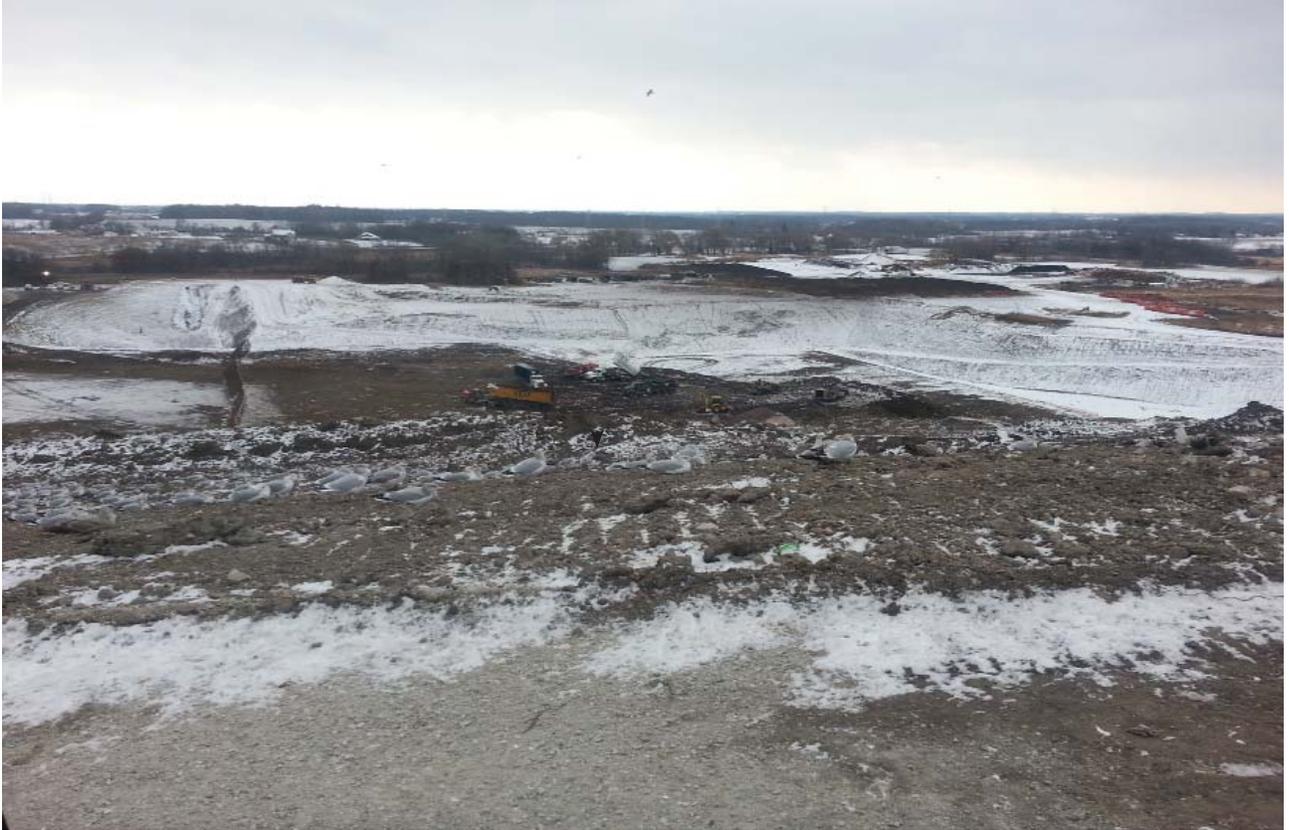
Active area, Phase 7B West

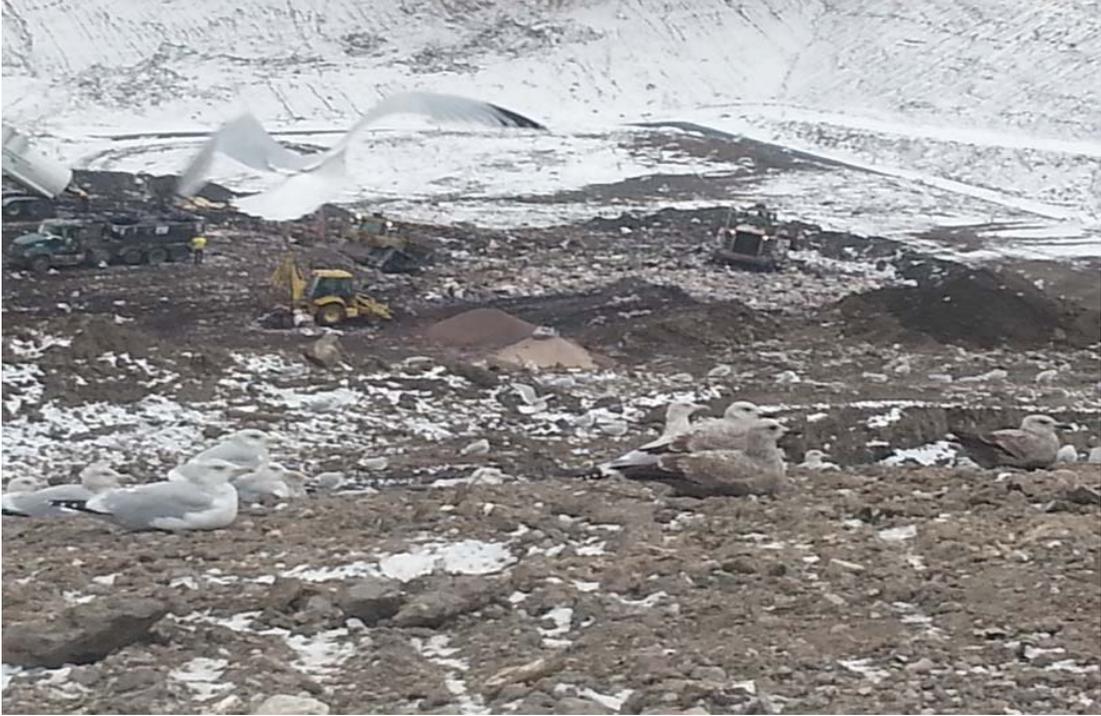
Working face viewed from the North

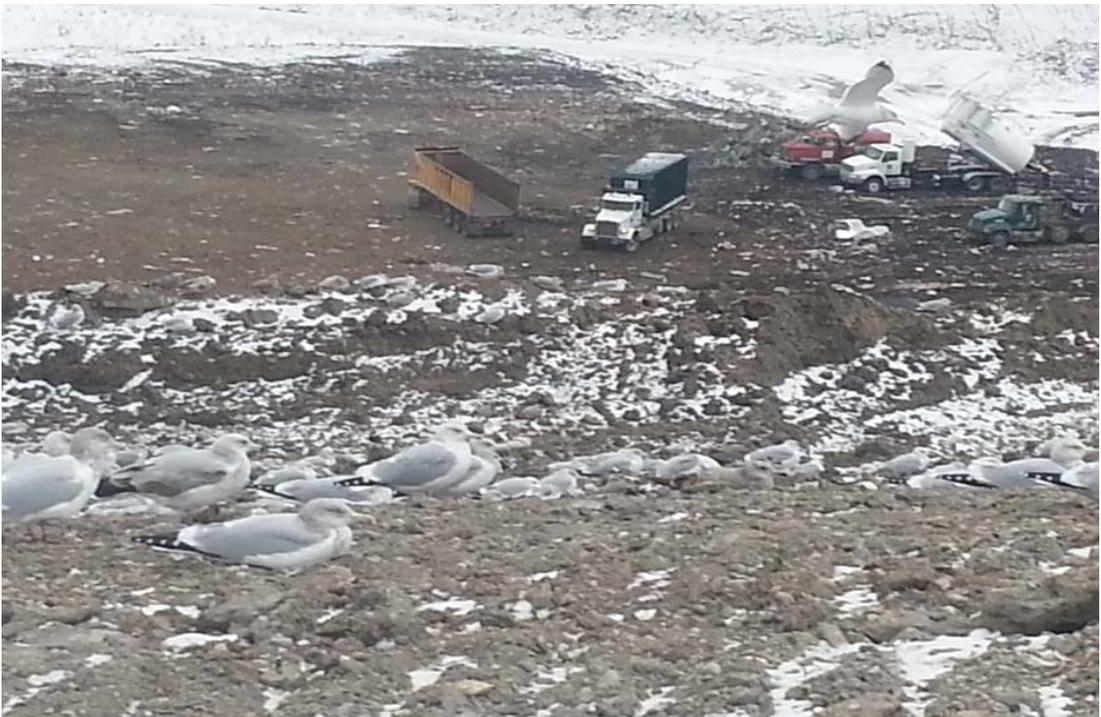
Active area

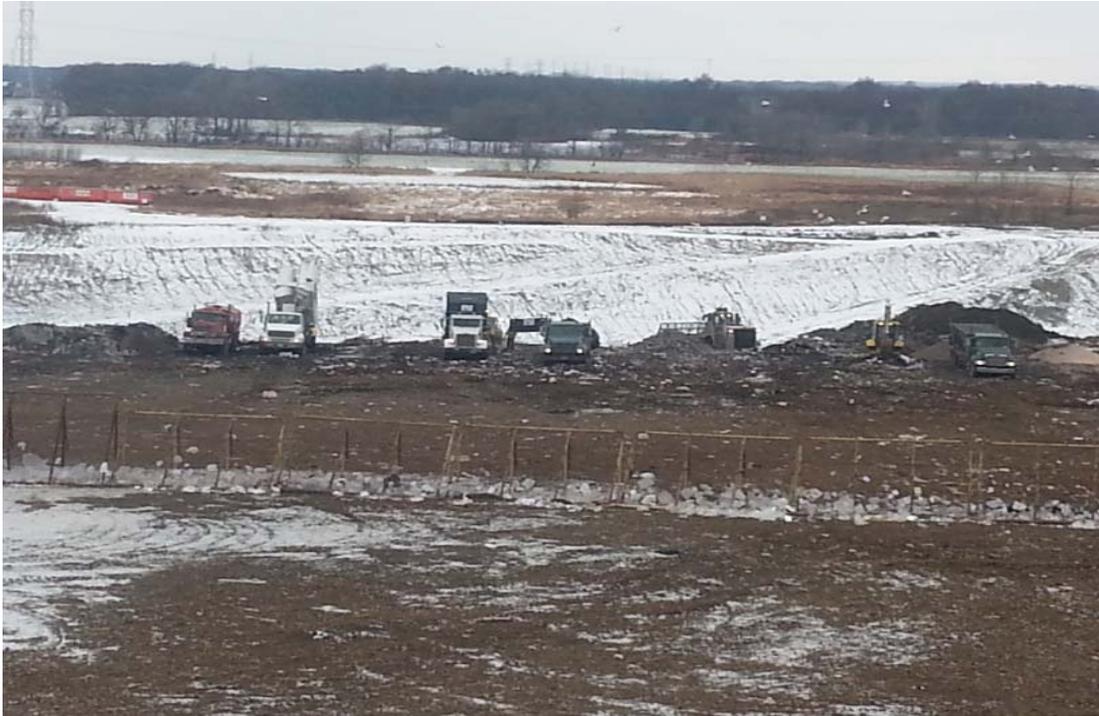
Working face in Phase 7B West, viewed from East

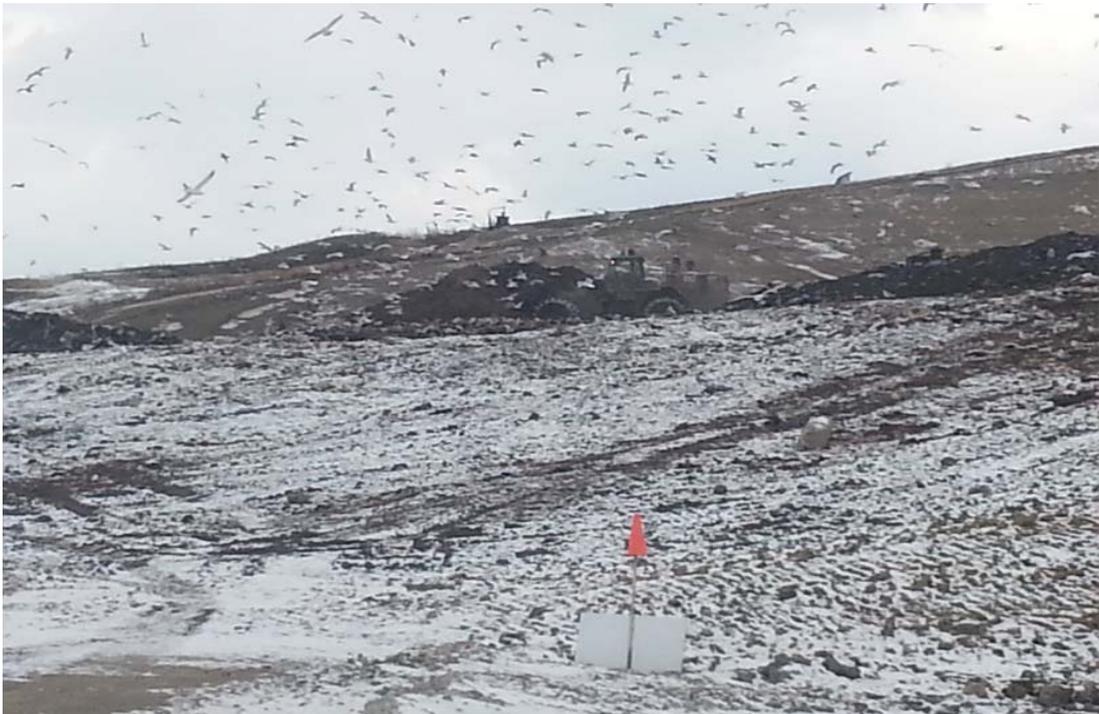
Working face viewed from base of cell

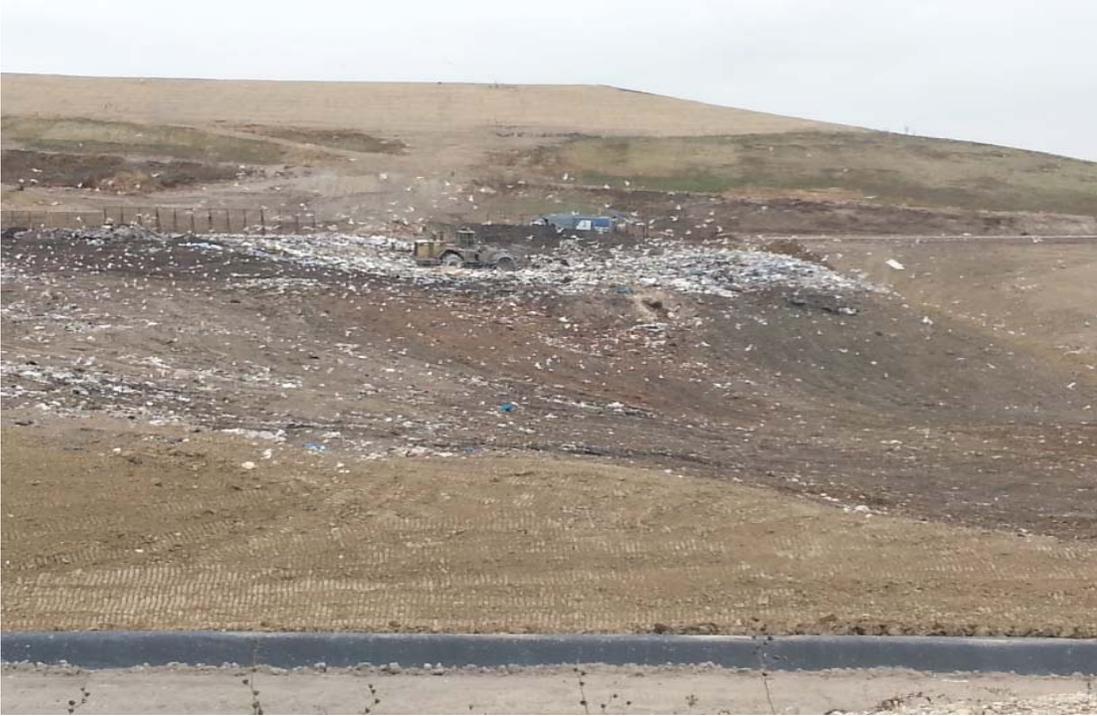
Working face viewed from West

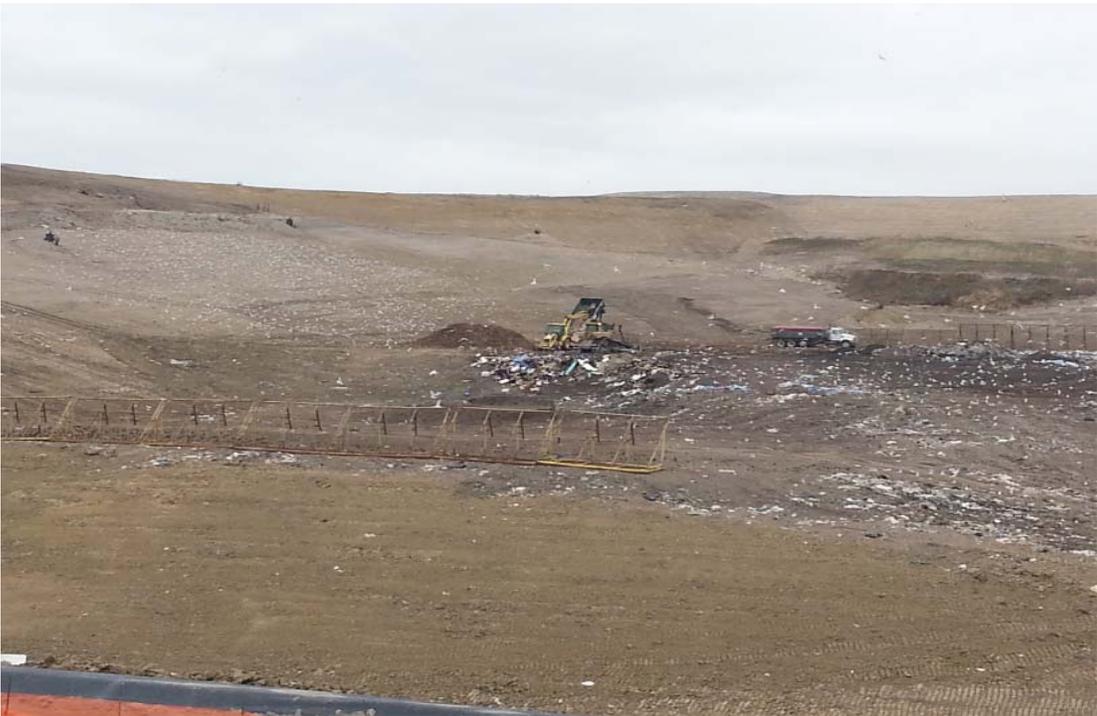
Active area viewed from the West
