2013 Advanced Disposal Services Emerald Park Landfill Year End Compliance Officer Report and Audit Summary

TO: Advanced Disposal Services Emerald Park Standing Committee
FROM: Jo-Walter Spear, Jr., P.E.
COPIES: File
DATE: 02/04/14
PROJECT NUMBER: 1012.10030

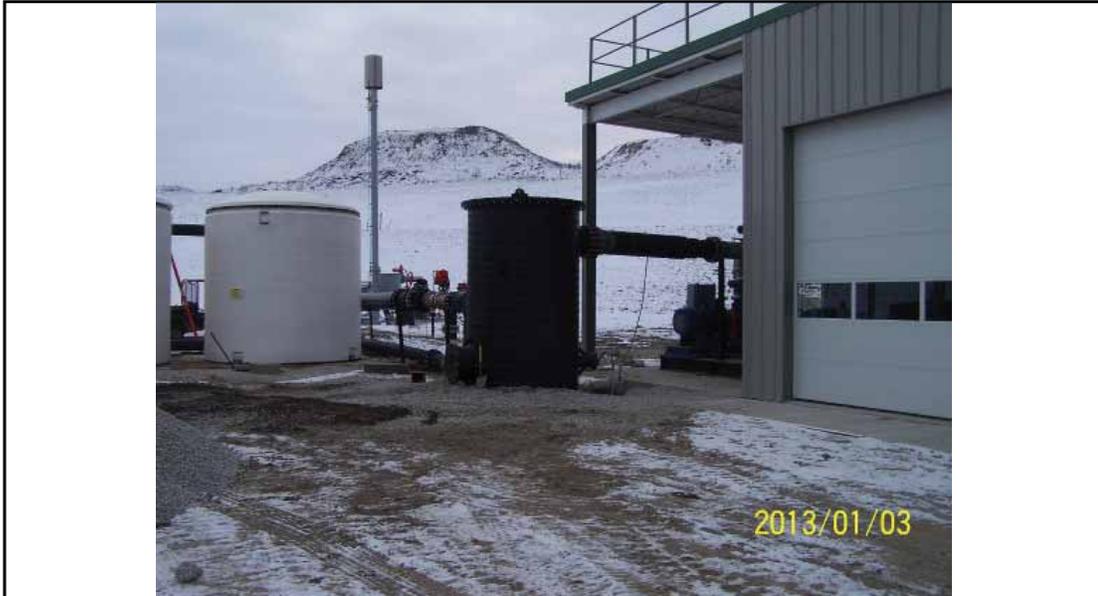
Knock out installed, backfilling during audit

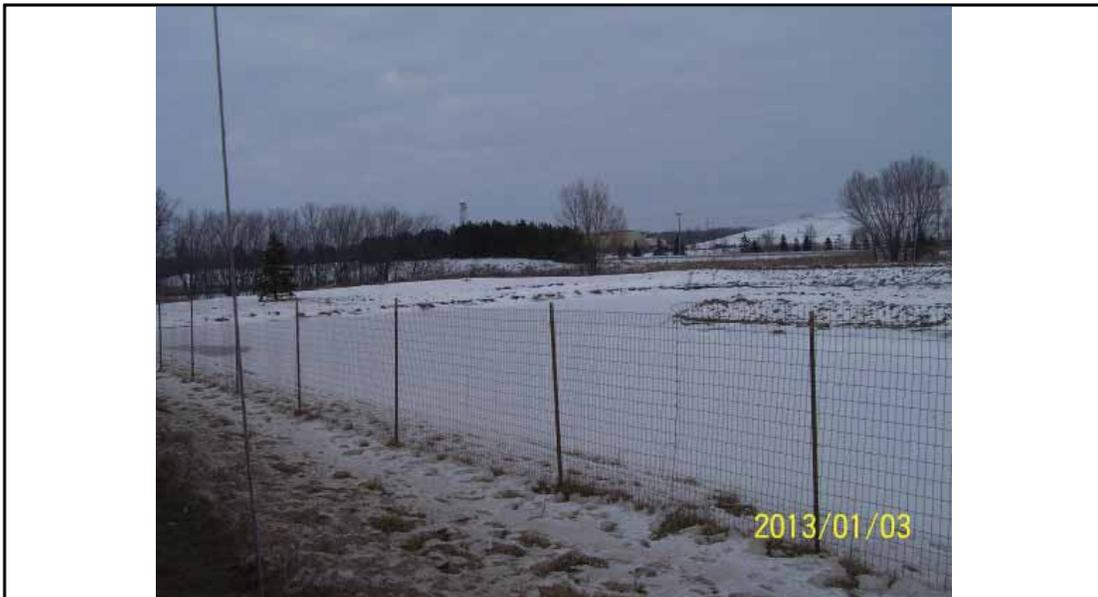
Extent of frozen basin

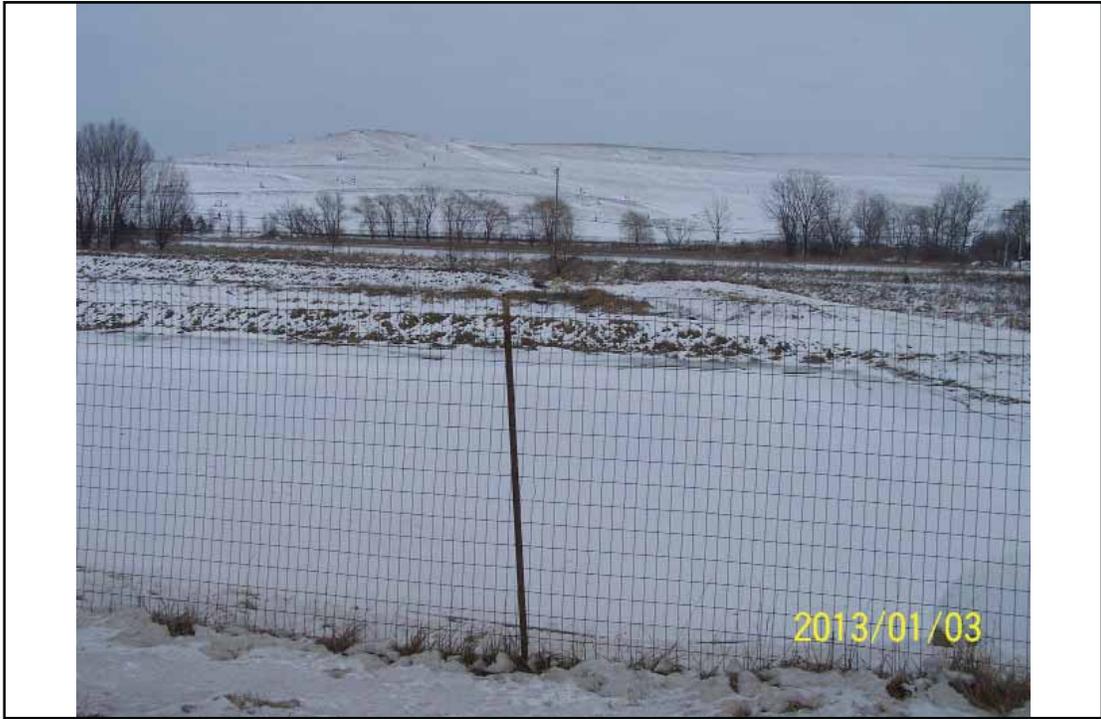
Basin frozen

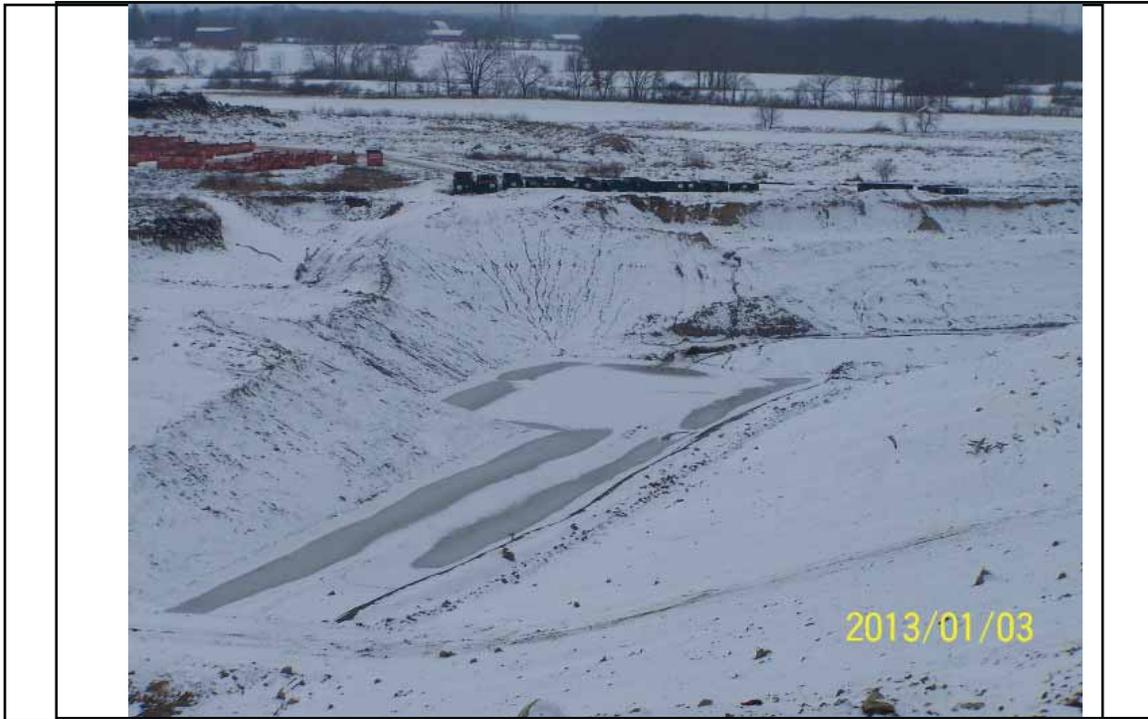
South temp sed basin

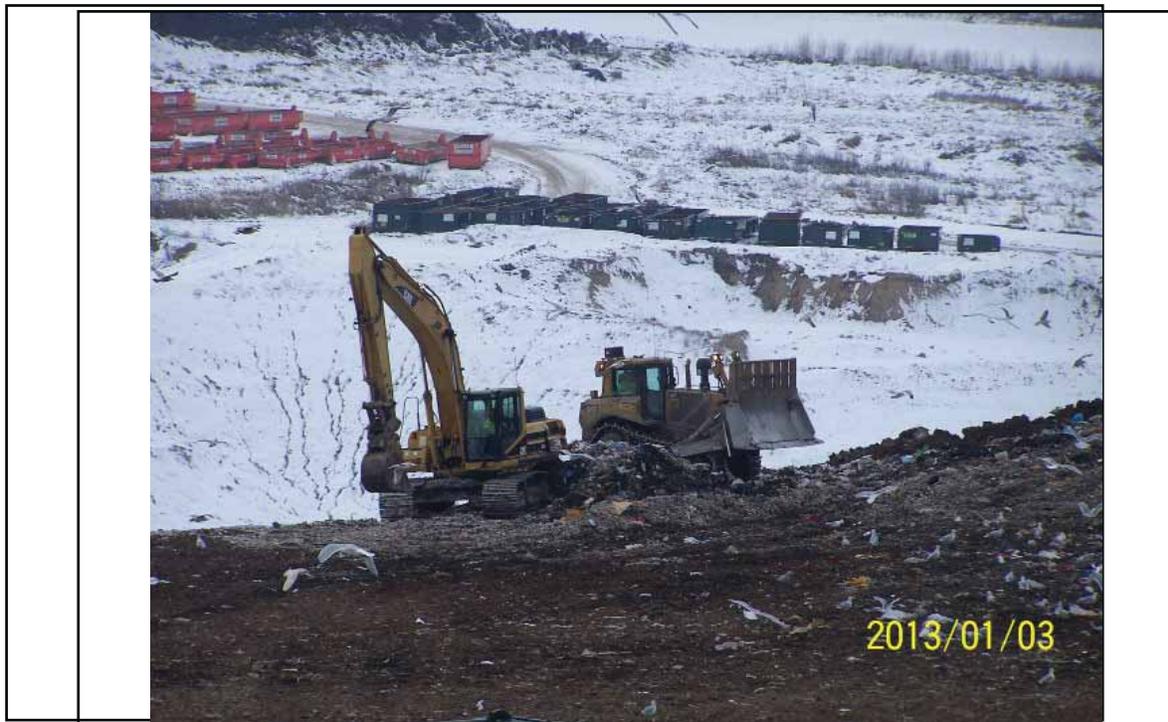
Idling equipment

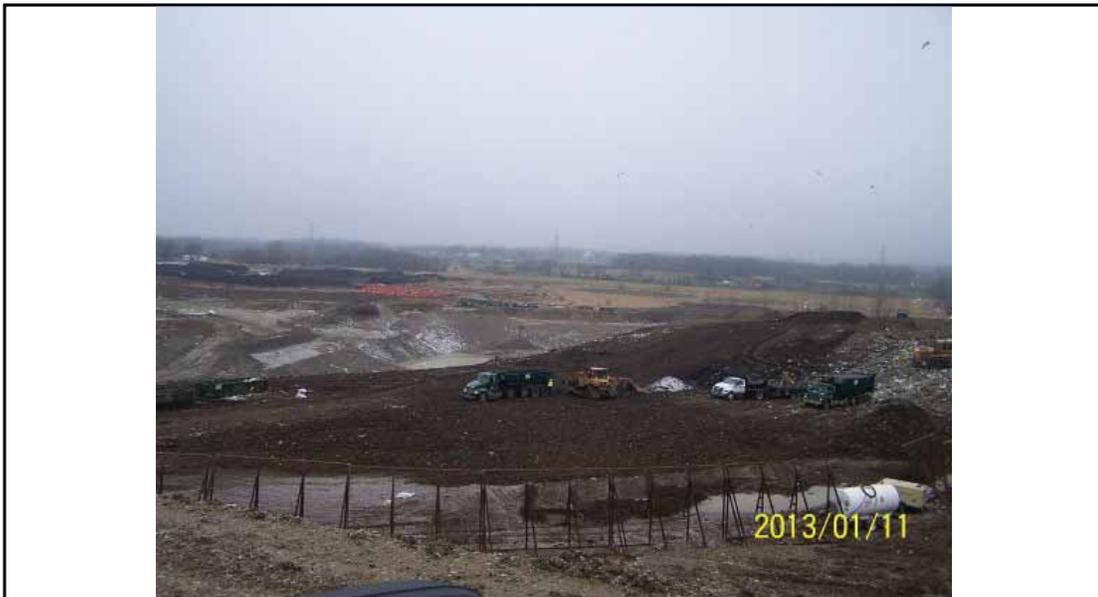
Extent of frozen basin

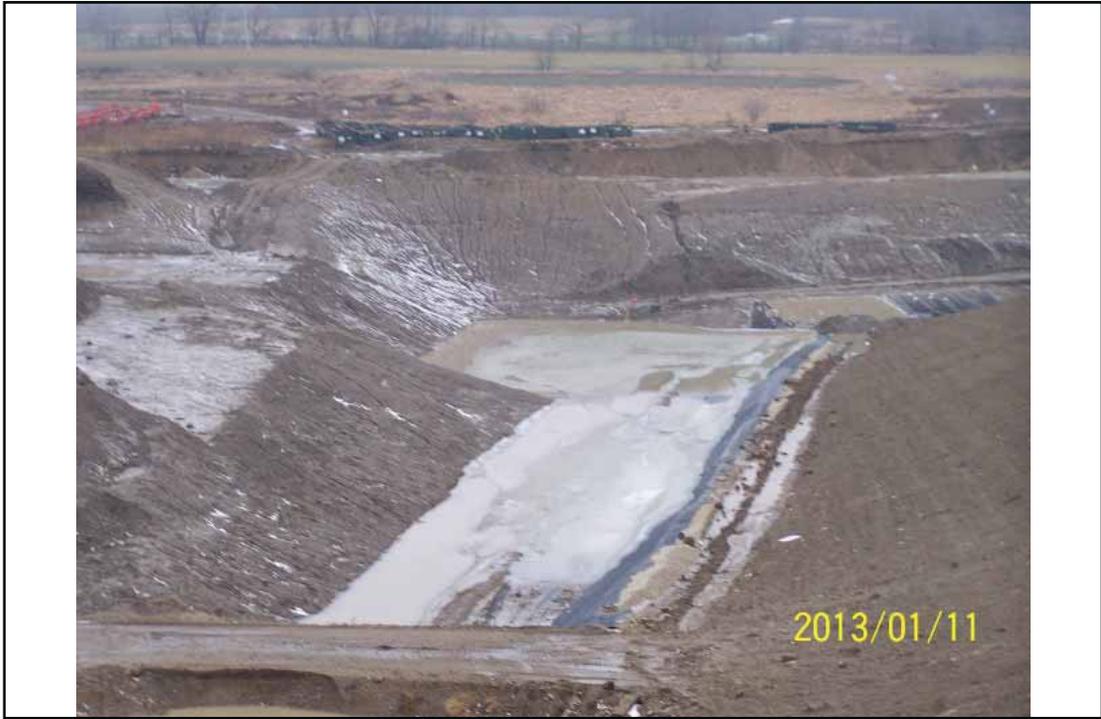
Basin frozen

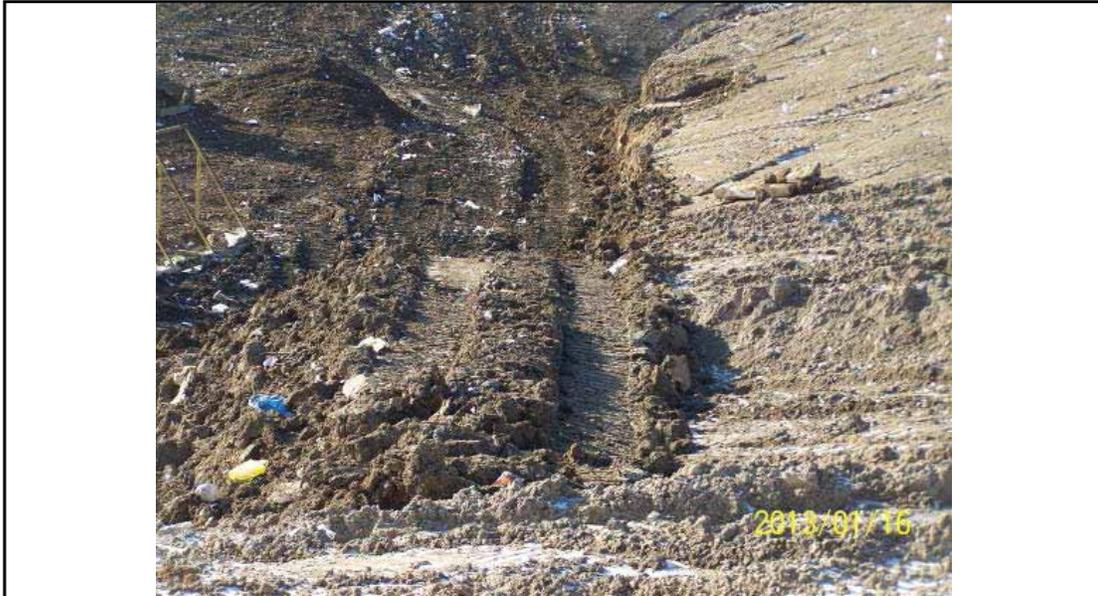
Previously tipped soils being cut and used for intermediate cover

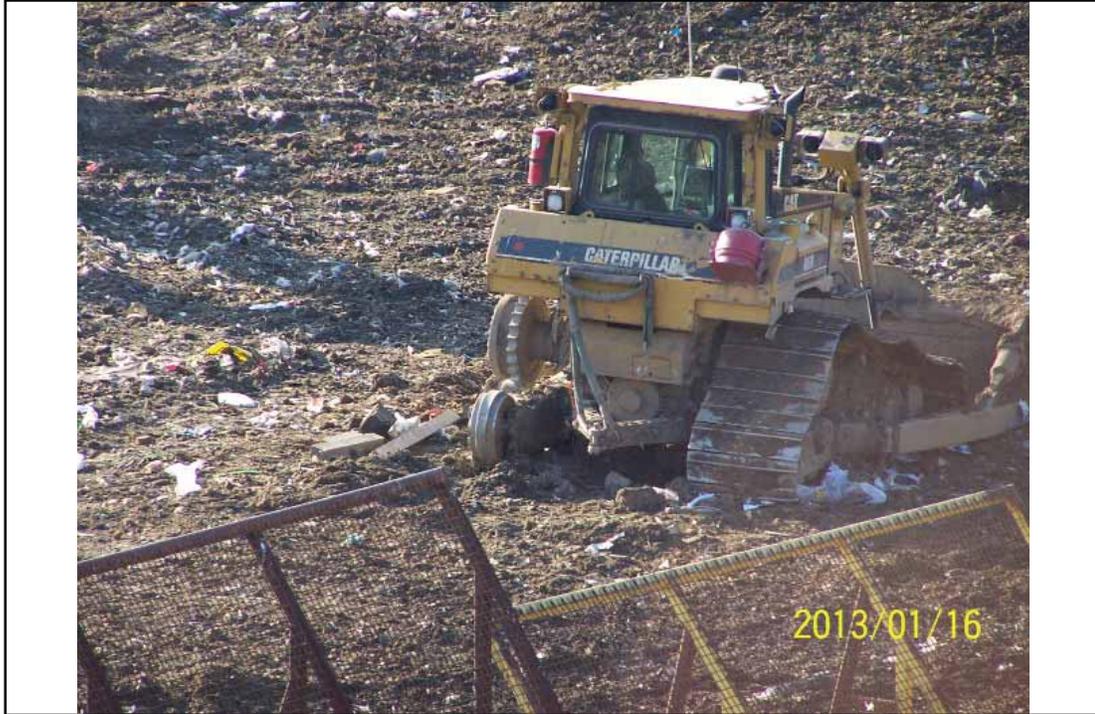
- D6 dozer has broken track
- New gate being installed in compost area
- Temp basins pumping system repaired and actively pumping down

D6 Dozer with broken track

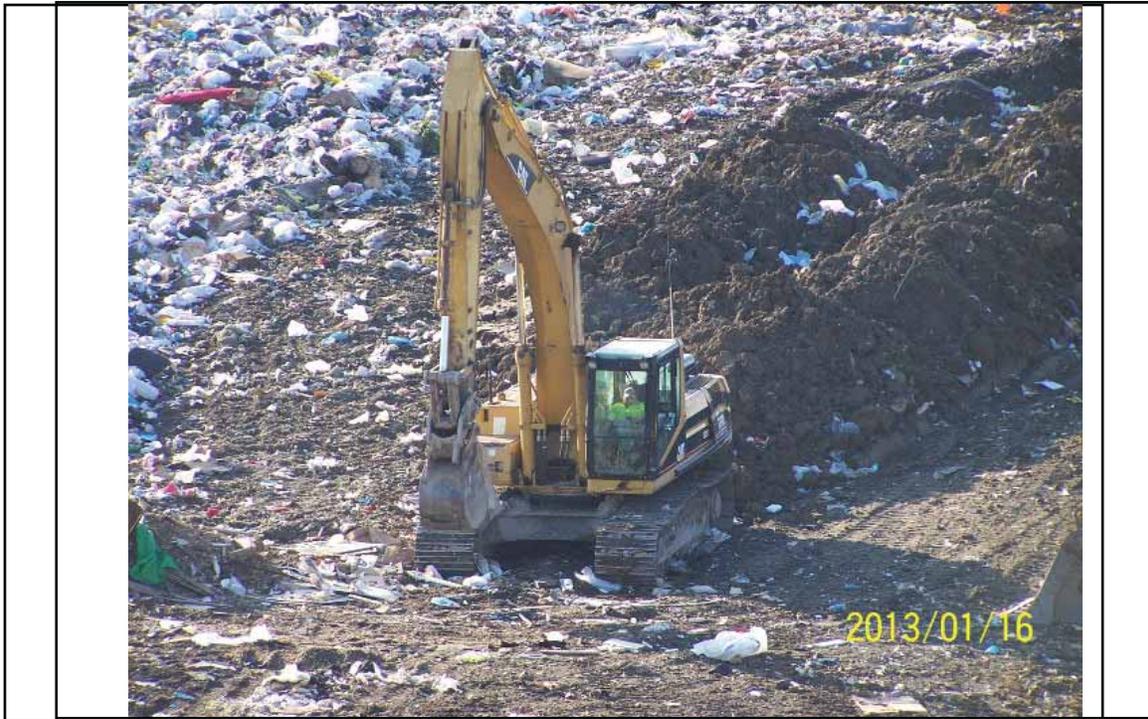
Excavator digging out frozen loads while backhoe is in for repairs

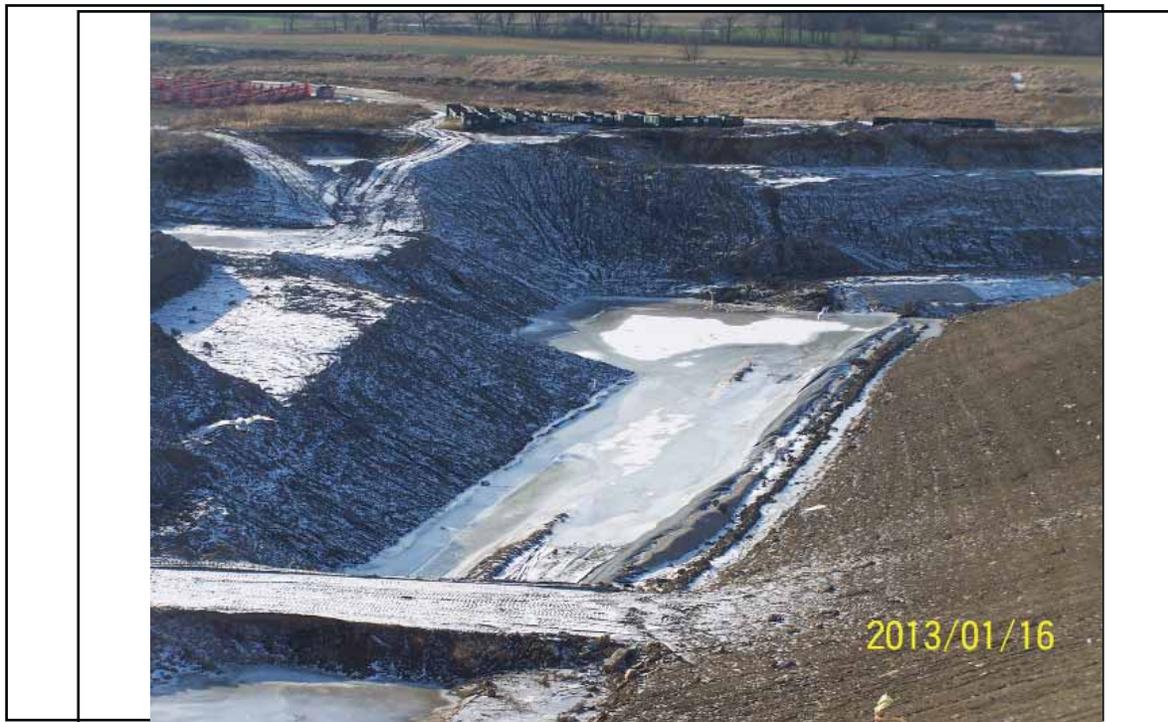
Basin being drained by pump, surface only is frozen

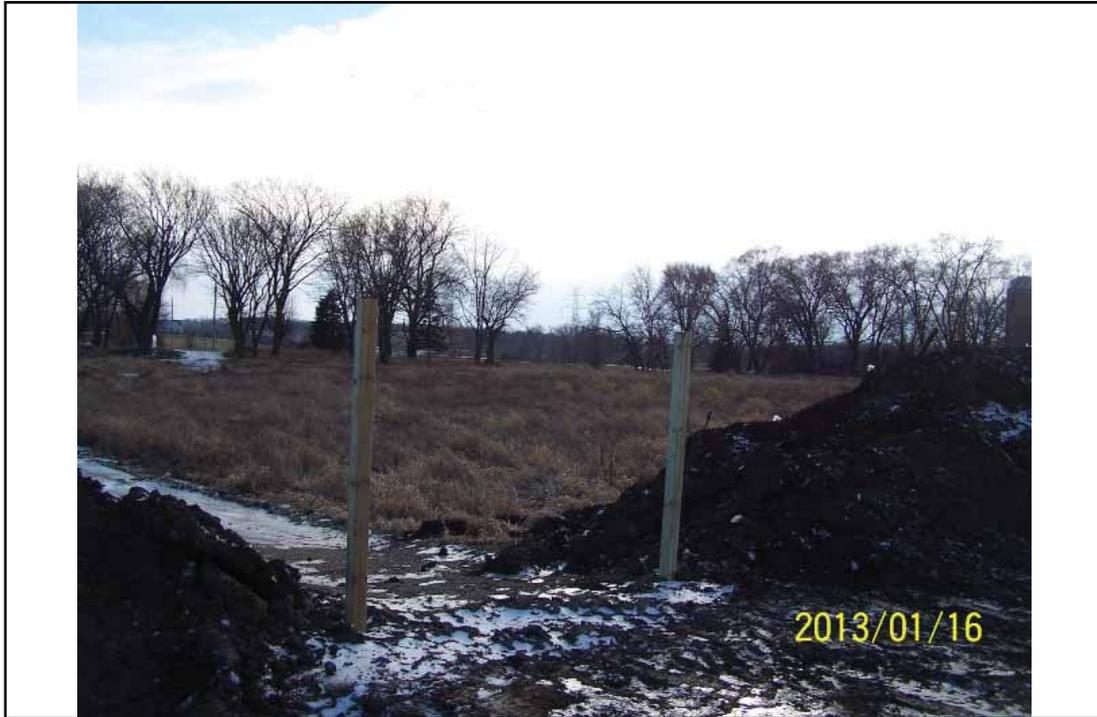
Uprights for new gate into Compost area from the South

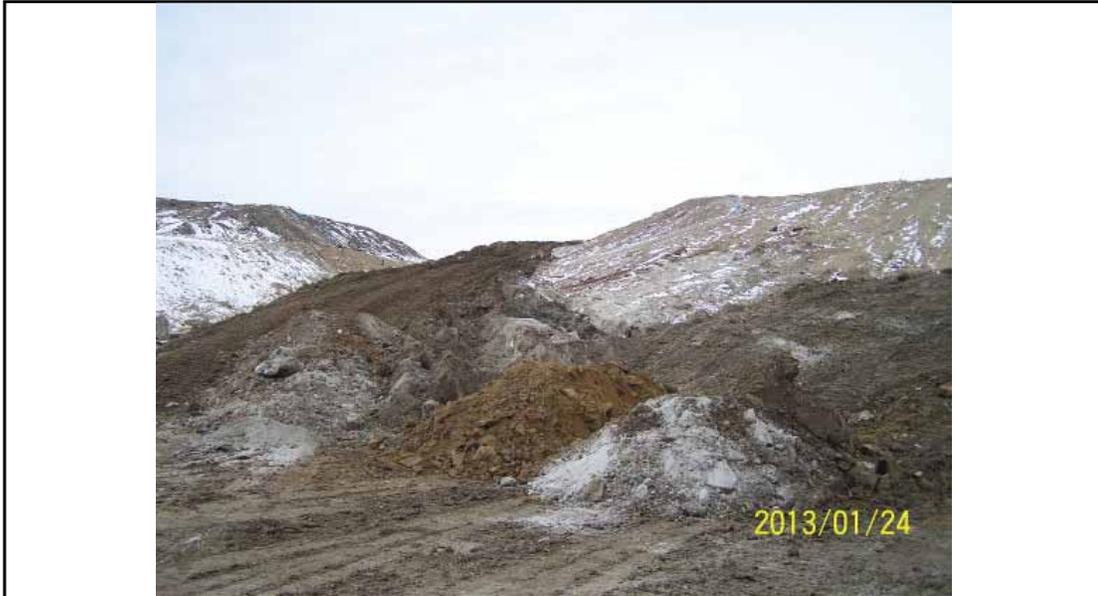
Bio soils being received in Phase 3

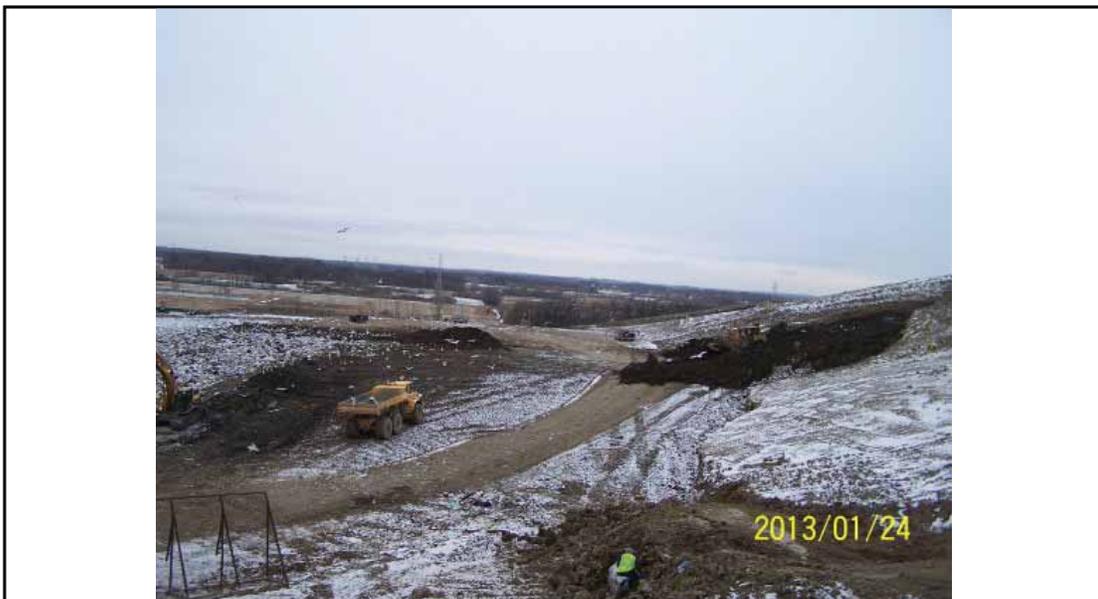
Active area and ramp construction

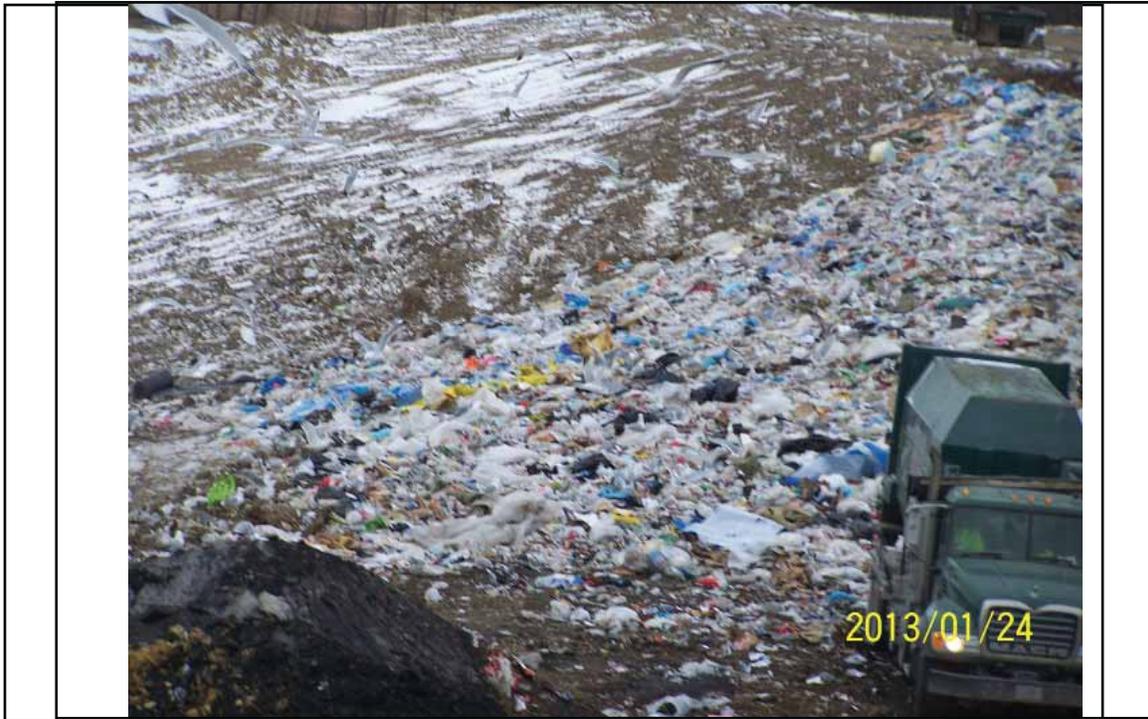
Waste packed in place, prior to cover

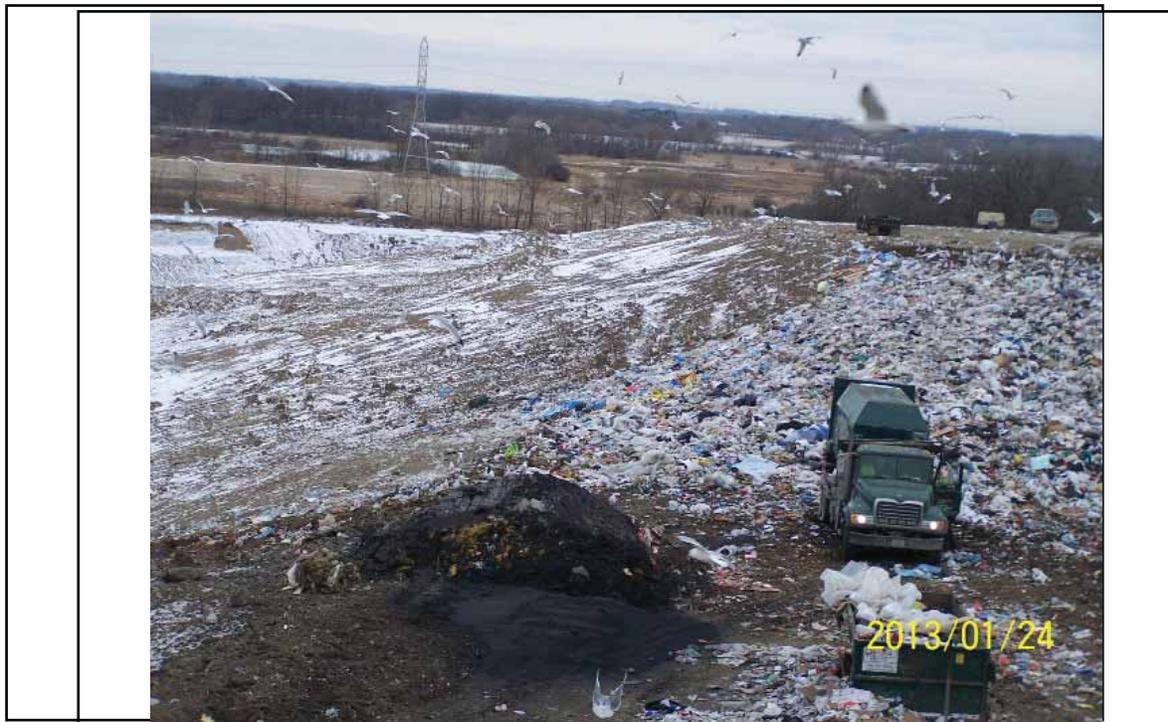
Working face at outboard slope, shaped and compacted by dozer

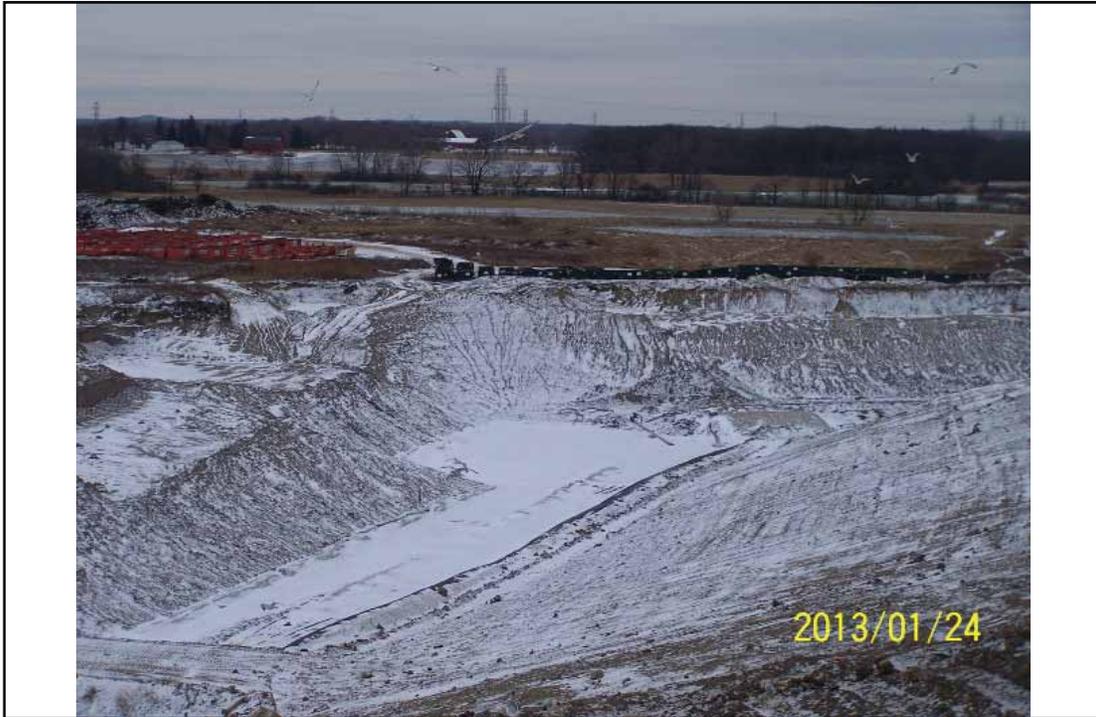
Temp basin drained of flowing water, ice and snow remain
