### ADS Emerald Park Landfill Audit Summary

**To:** ADS Emerald Park Landfill Standing Committee, City of Muskego  
**FROM:** Faith Spear.  
**COPIES:** File  
**DATE:** 02/02/15  
**PROJECT NUMBER:** 1012.10030

**ADVANCED DISPOSAL SERVICES  
EMERALD PARK LANDFILL / CITY OF MUSKEGO  
AUDIT PHOTOS**

PROJECT NO. 1012.10030

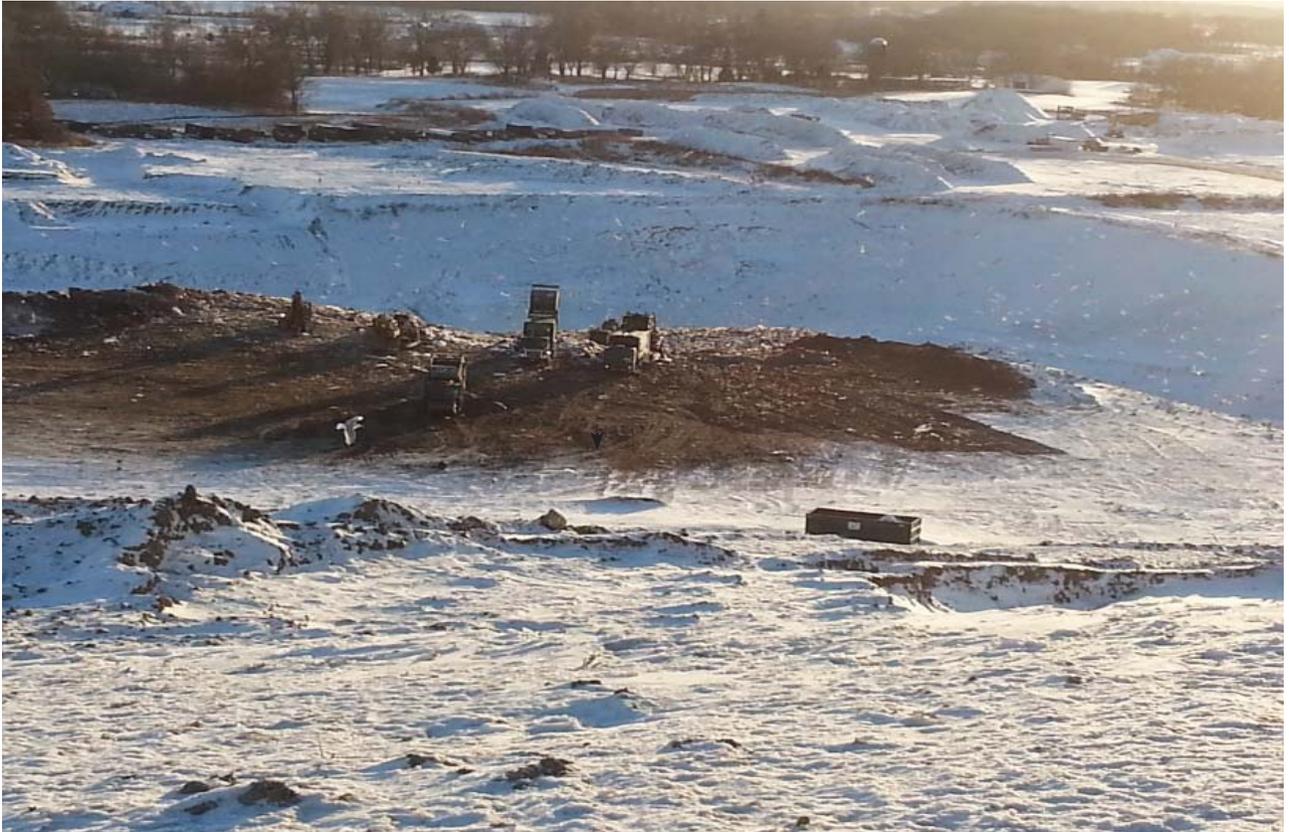
Active area viewed from the North

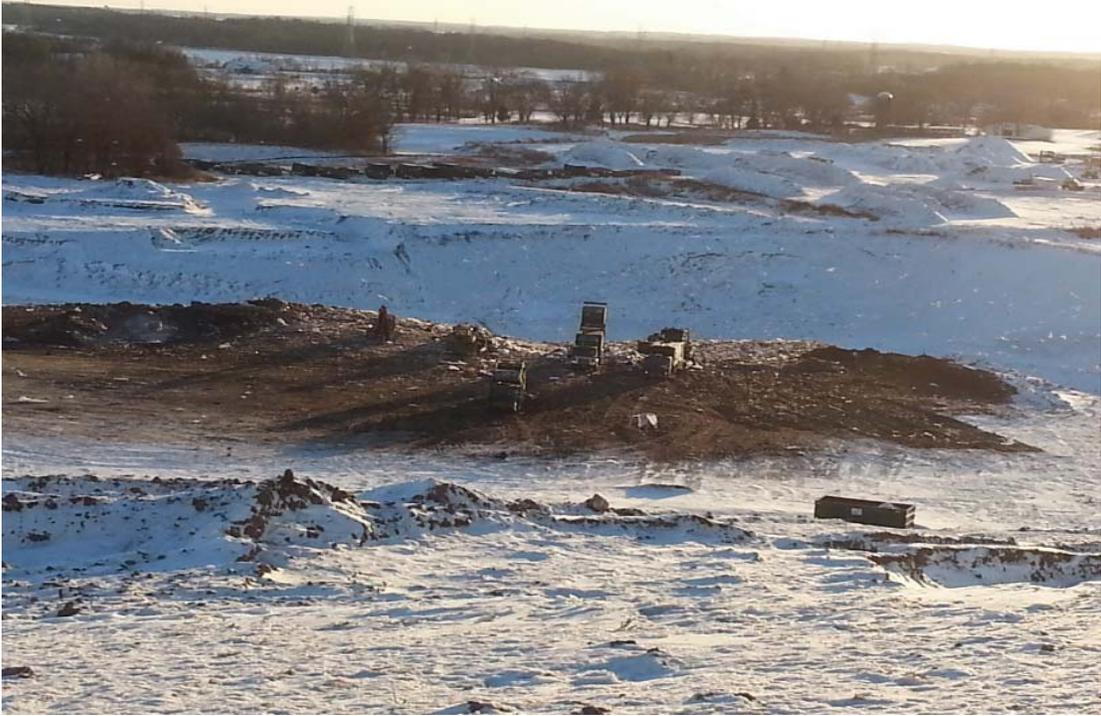
Tipping above working face

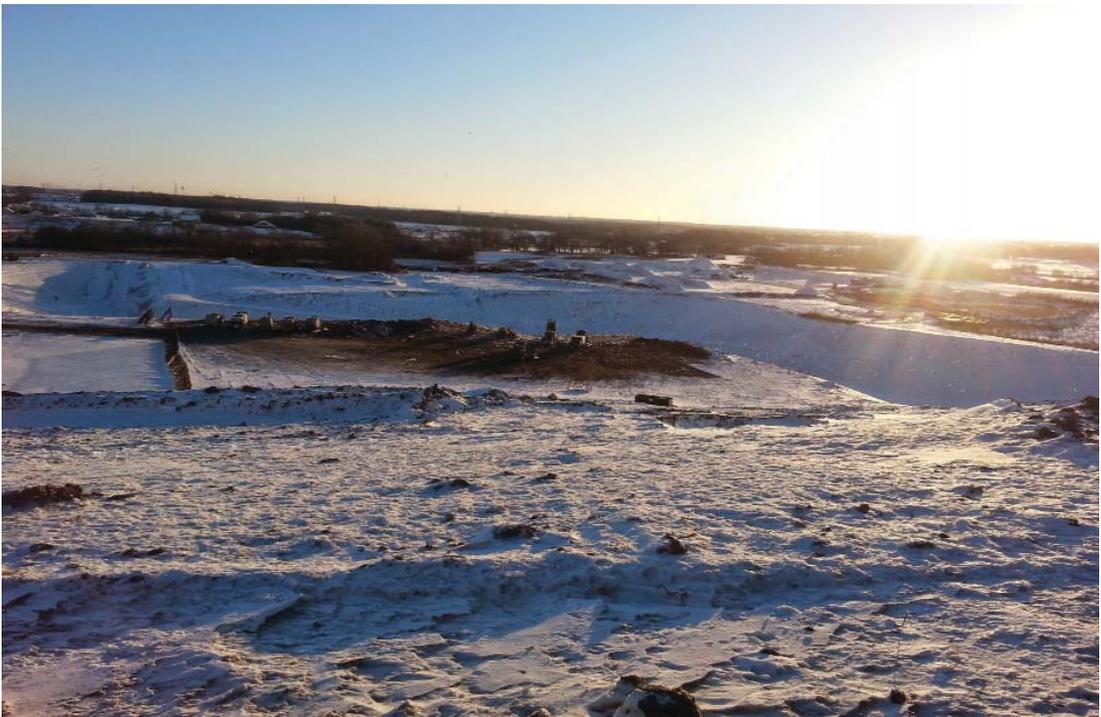
Active area viewed from the North

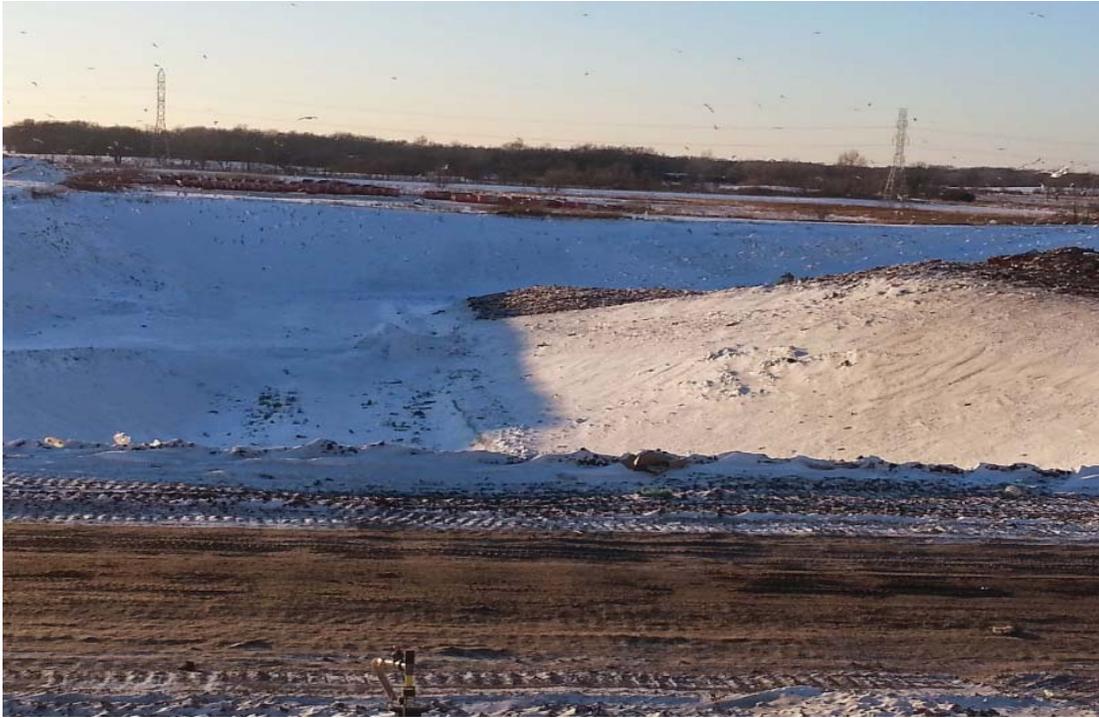
Working face below grade N Southwest  
corner of Phase 2B West.  
Waste being tipped at upper  
elevation and pushed down to lower

Working face at base of slope, waste being placed by dozer

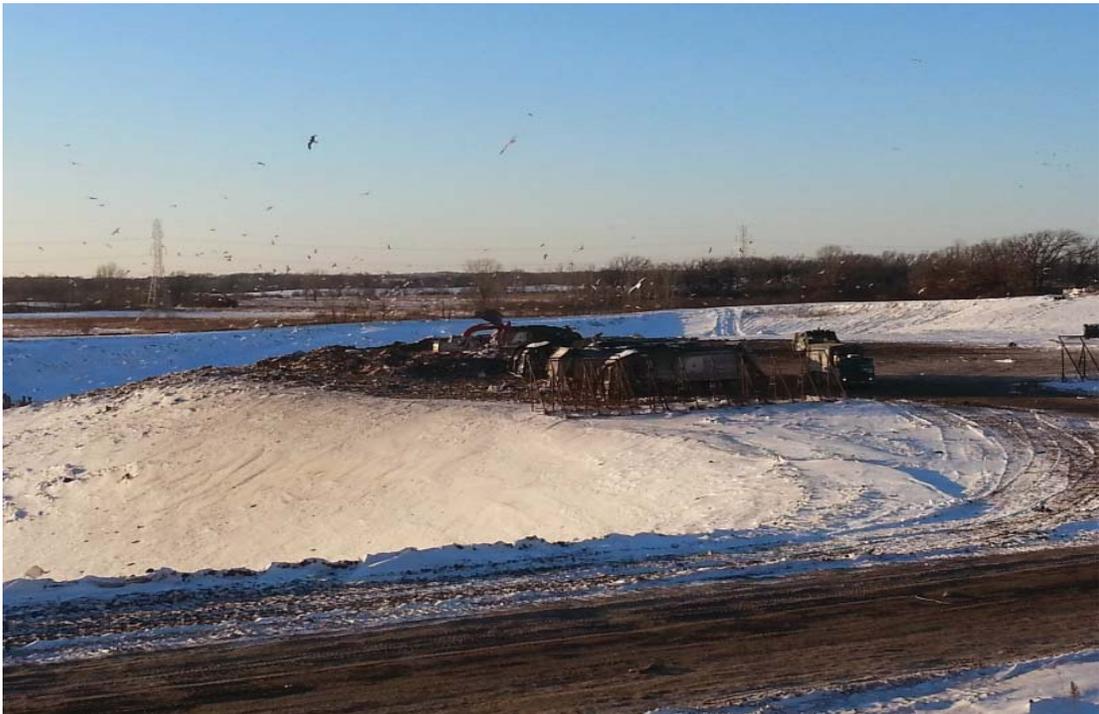
Tipping above working face, dozer pushing down slope
