### ADS Emerald Park Landfill Audit Summary

**To:** ADS Emerald Park Landfill Standing Committee, City of Muskego  
**FROM:** Faith Spear.  
**COPIES:** File  
**DATE:** 02/04/15  
**PROJECT NUMBER:** 1012.10030

ADVANCED DISPOSAL SERVICES EMERALD PARK LANDFILL  
 LANDFILL OPERATIONS AUDIT FORM  
 CITY OF MUSKEGO

**ADVANCED DISPOSAL SERVICES  
EMERALD PARK LANDFILL / CITY OF MUSKEGO  
AUDIT PHOTOS**

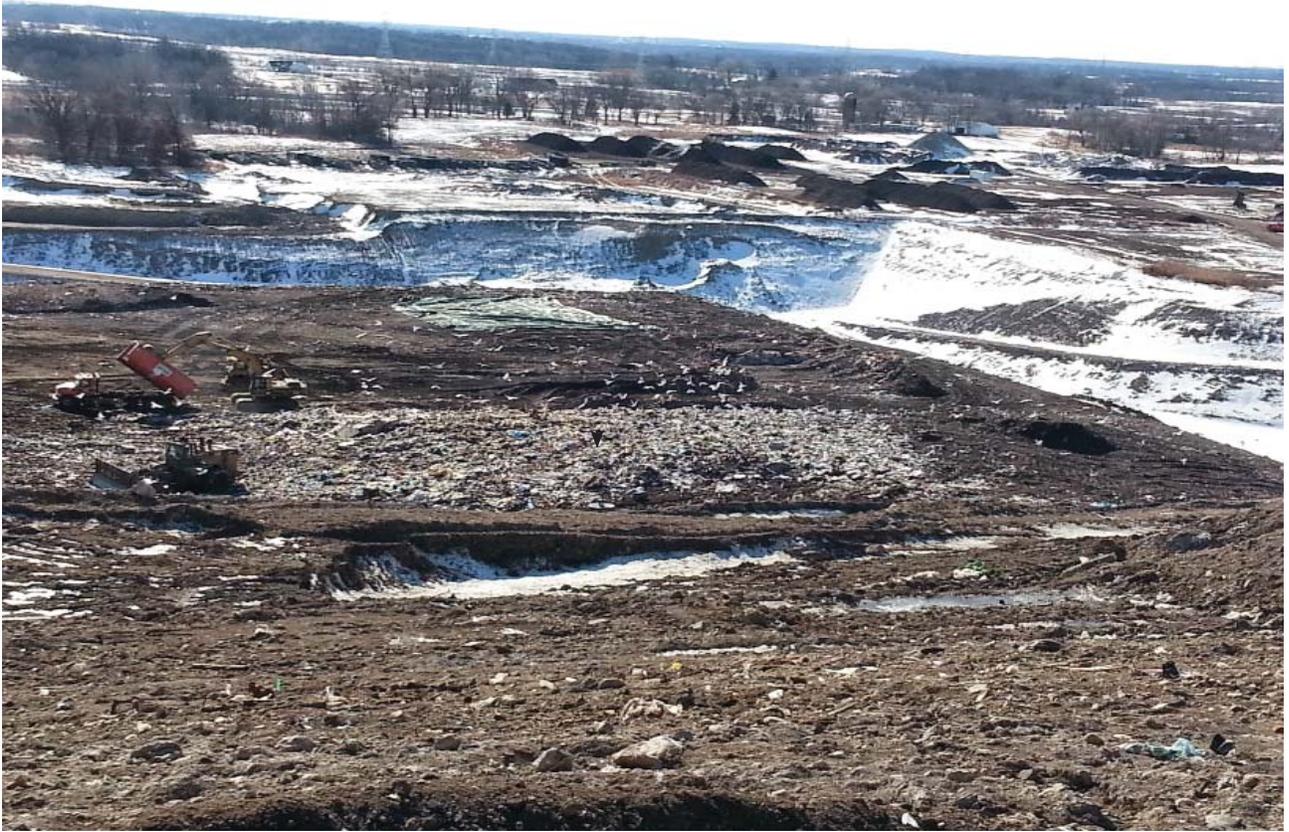
Working face in South west corner  
of Phase 7B. No other working  
faces. Working face well spread  
out.  
Tarp used as cover last night

Working face in Northwest corner of Phase 7B

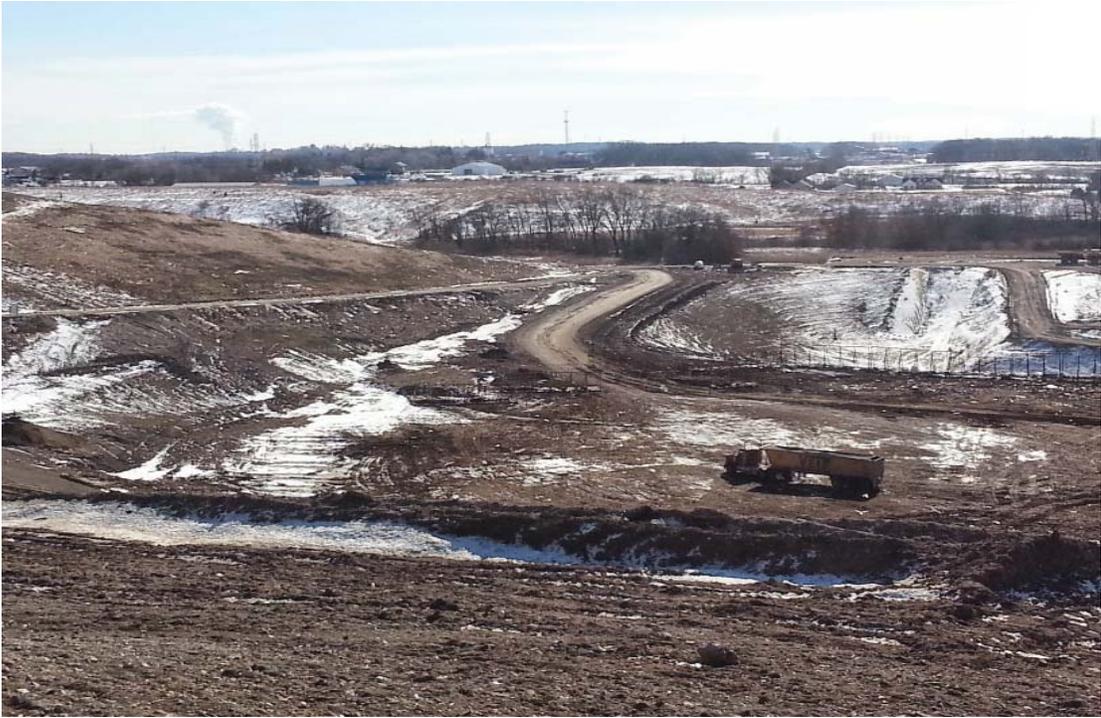
Phase 7 access route

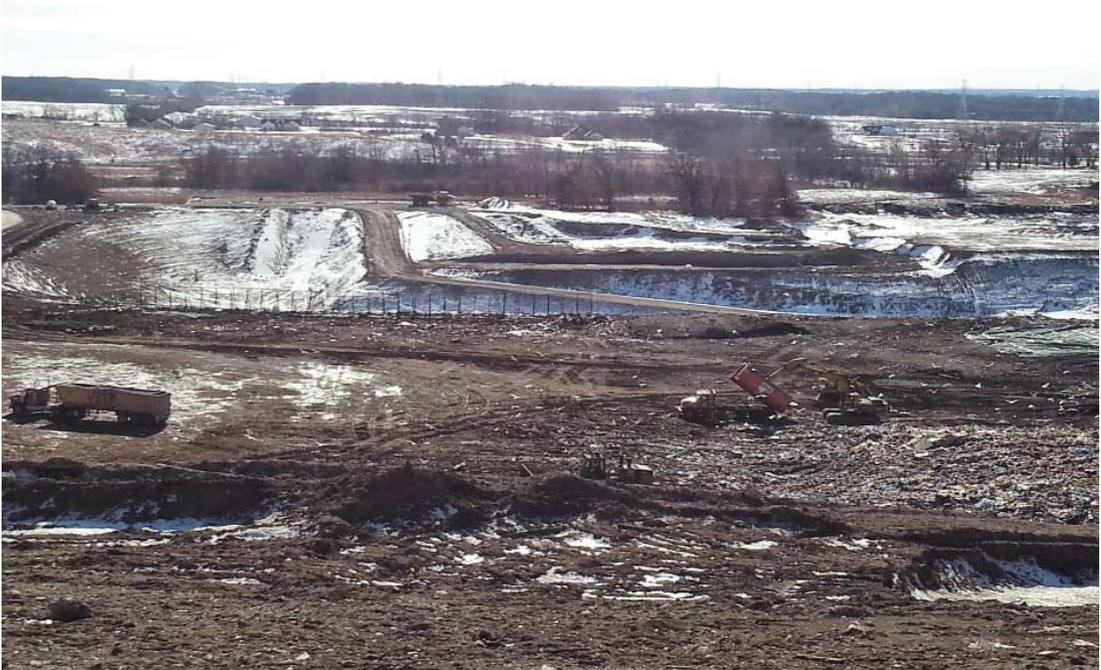
Active area viewed from North

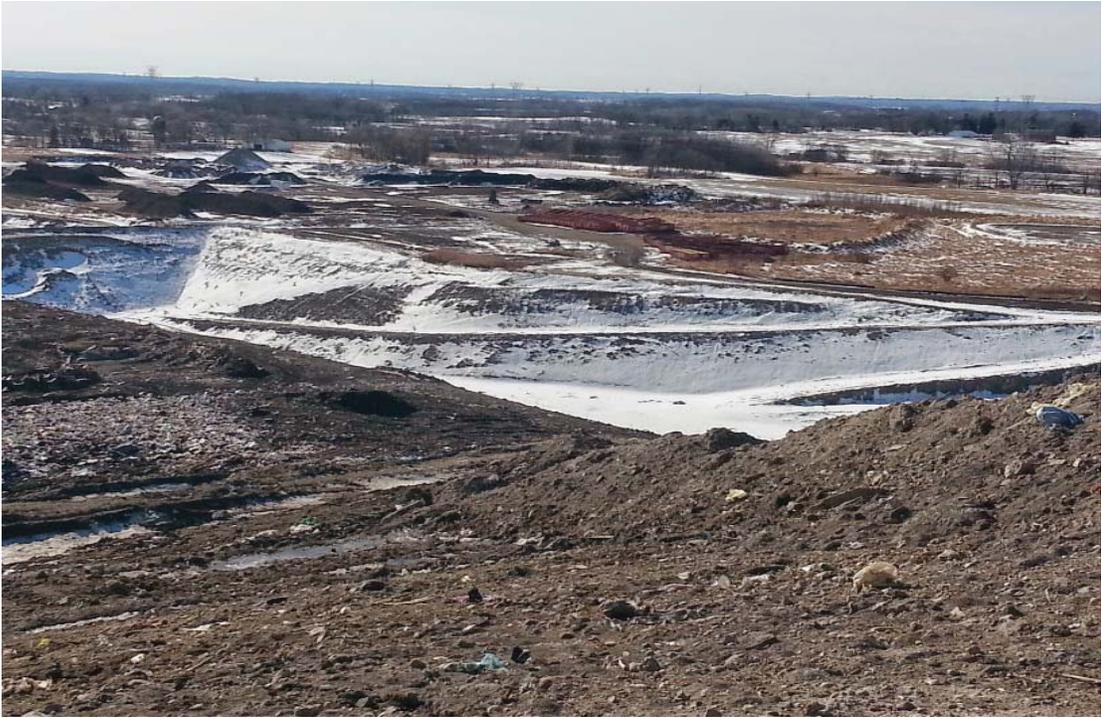
\* Temp Sed Basin in Phase 7B is completely frozen. Pumped down in early January.

Temp sed basin, frozen, drained previous week

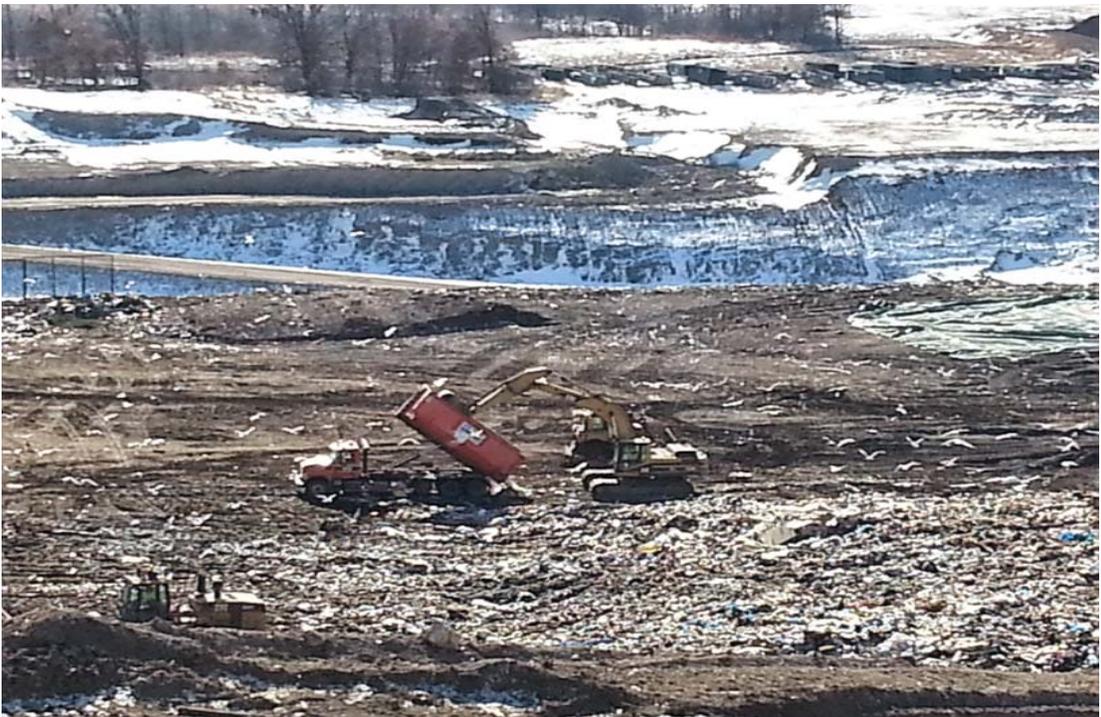
Trucks cleaning out

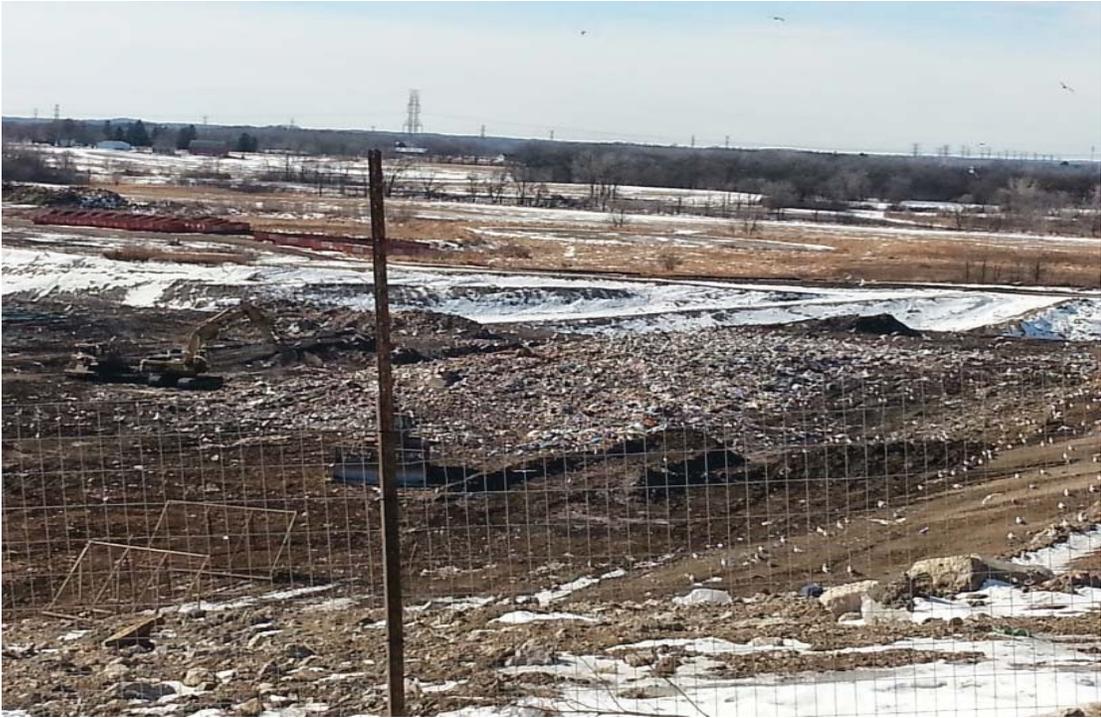
Working face viewed from the Northeast

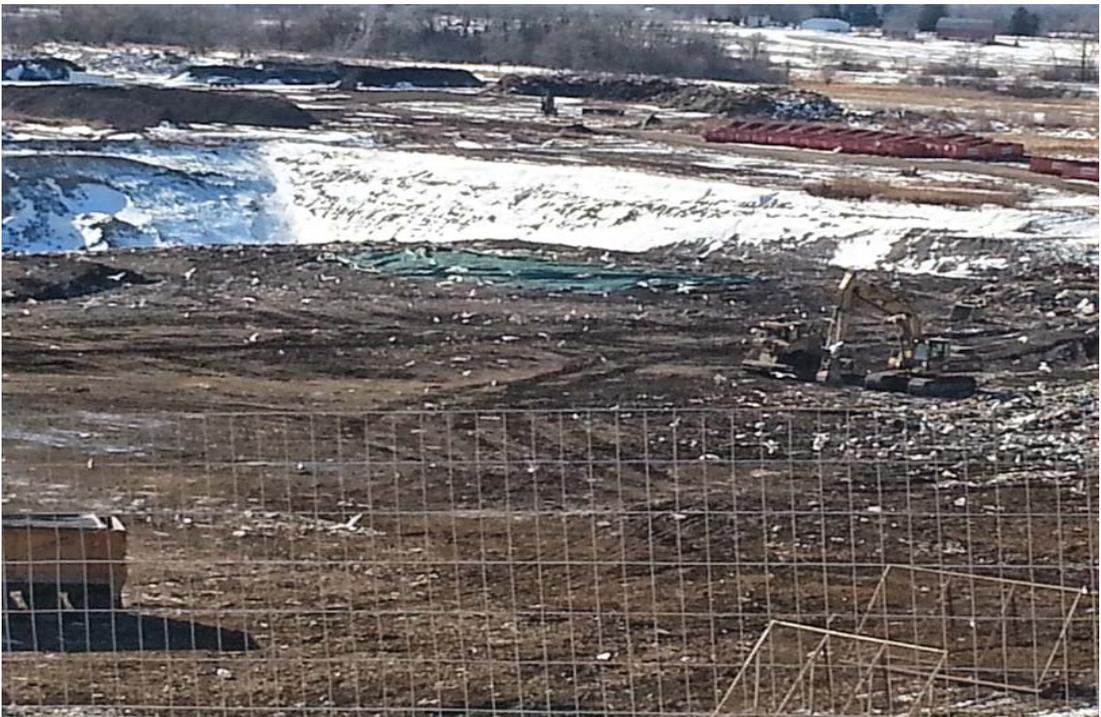
Green tarp for use as daily cover

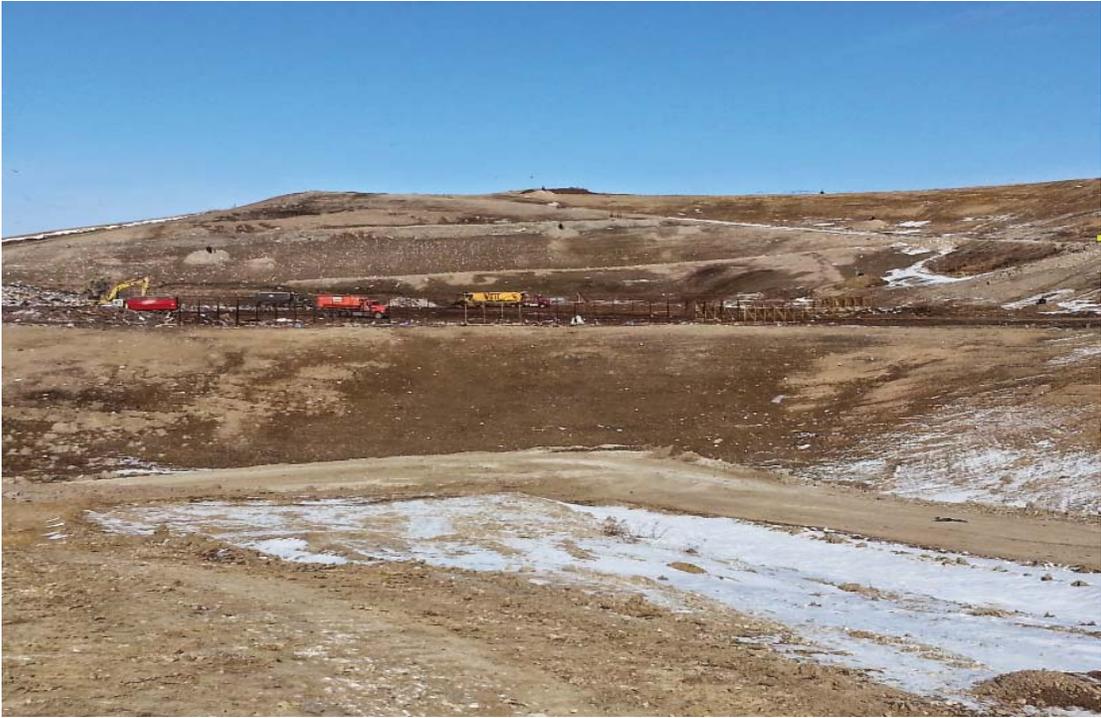
Active Area viewed from the South

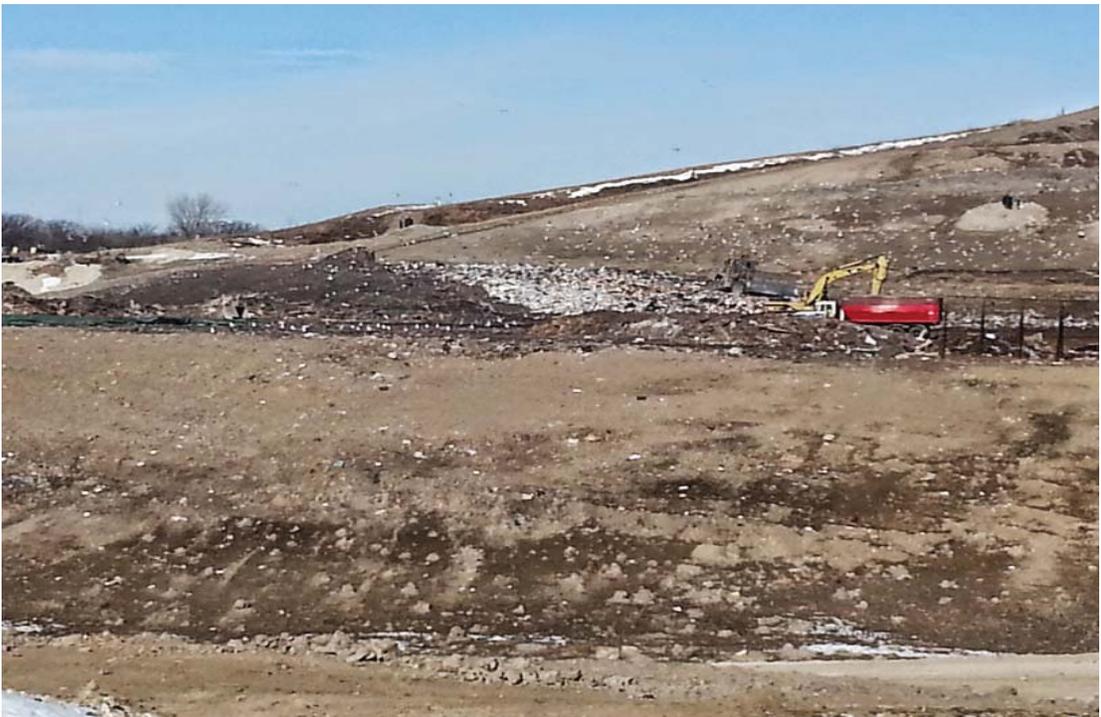
Working face viewed from the South
