Memorandum

ADS Emerald Park Landfill Audit Summary

To: ADS Emerald Park Landfill Standing Committee, City of Muskego
FROM: Faith Spear.
COPIES: File
DATE: 02/27/15
PROJECT NUMBER: 1012.10030

ADVANCED DISPOSAL SERVICES EMERALD PARK LANDFILL
 LANDFILL OPERATIONS AUDIT FORM
 CITY OF MUSKEGO

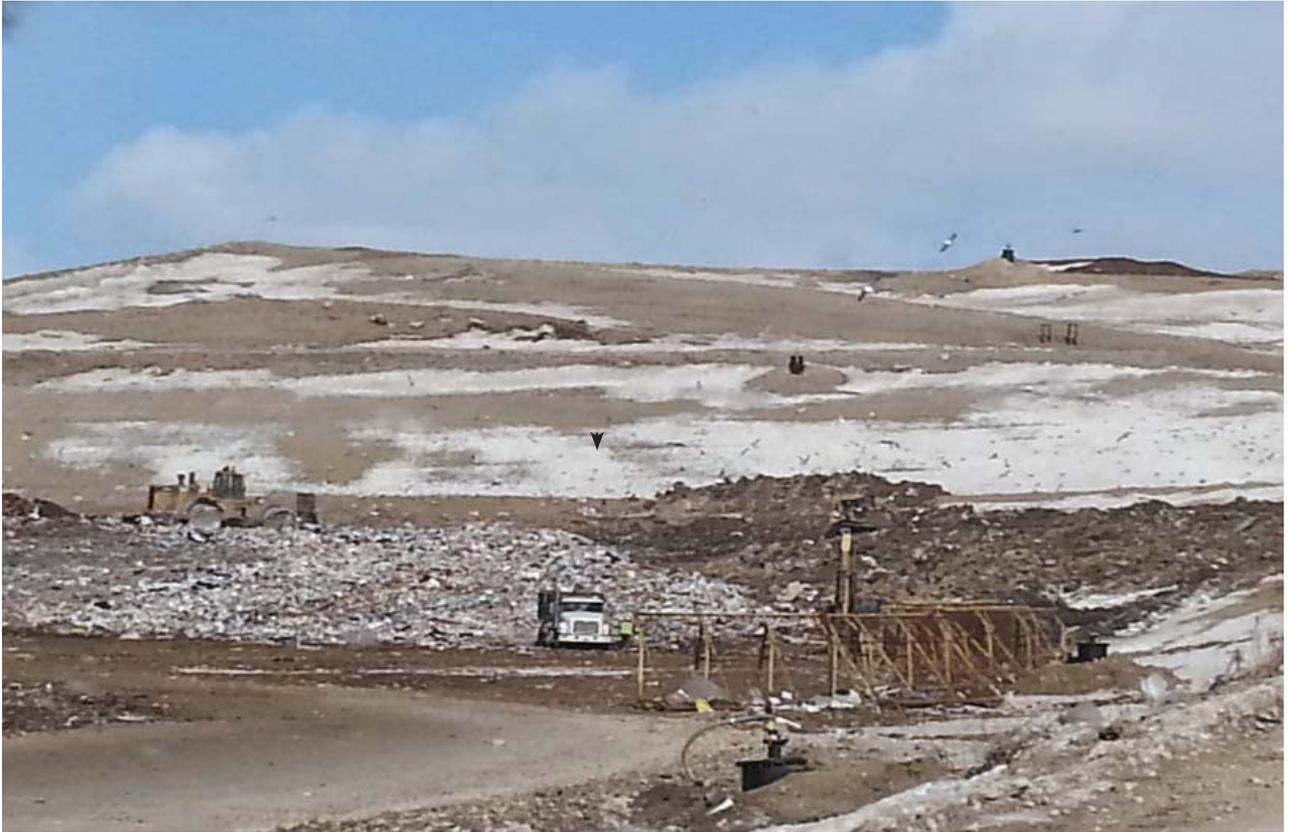
Working face viewed from the Southeast

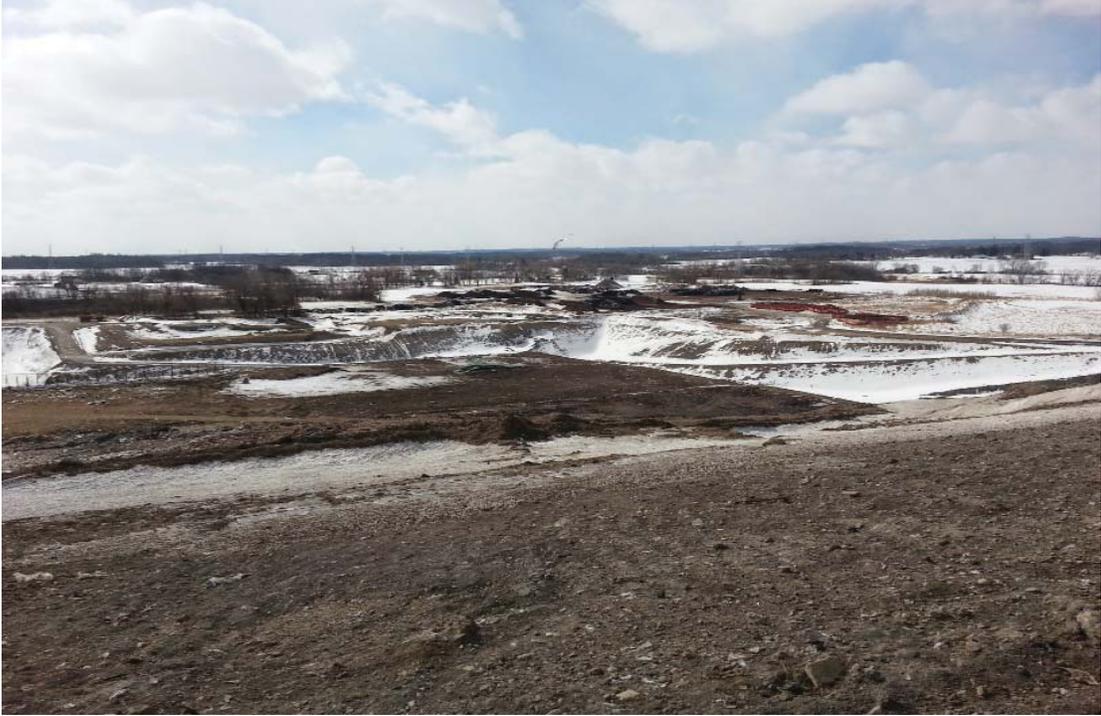
Overview of site from Northeast

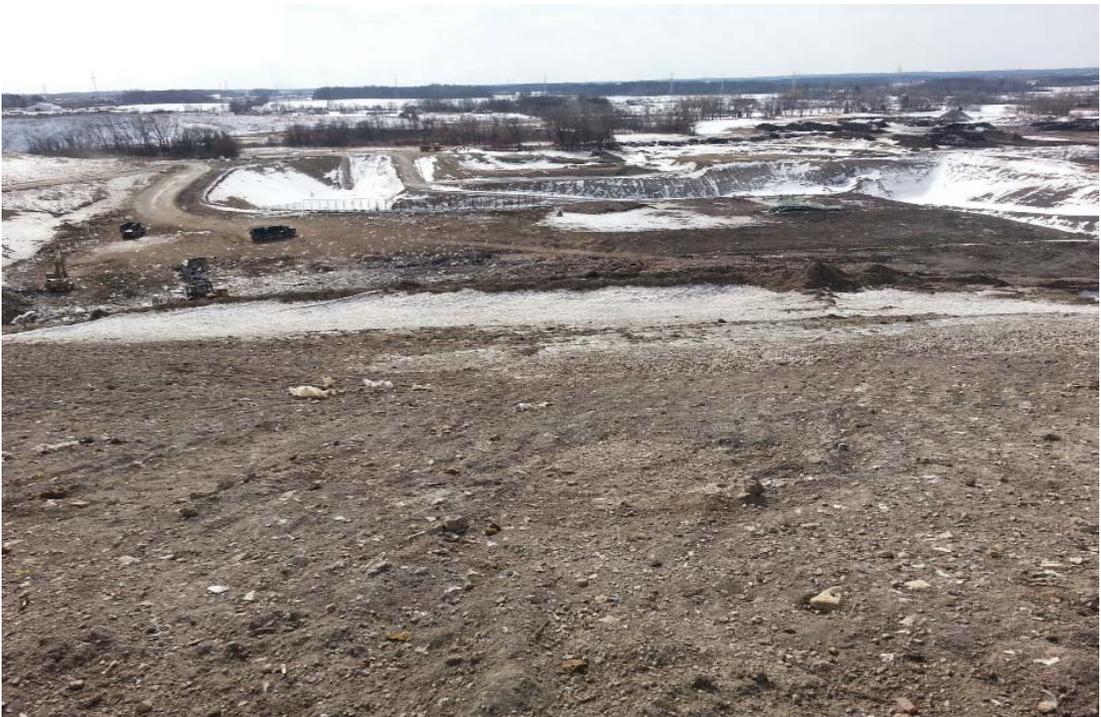
Overview of site from the North, Phase 3

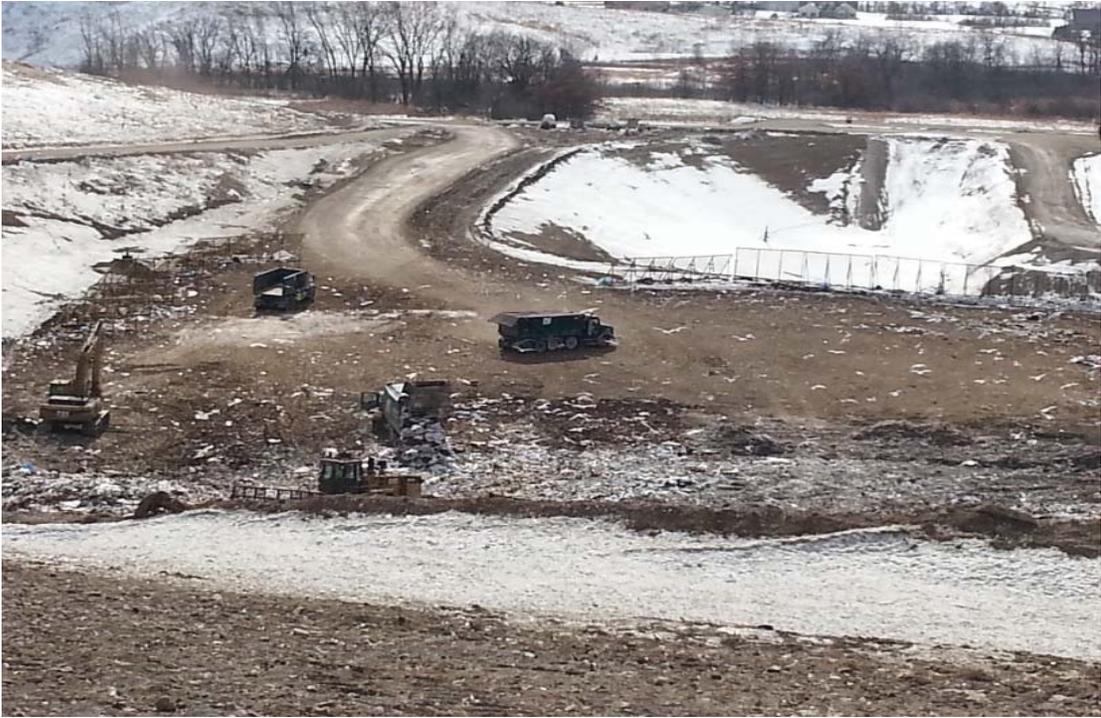
Active area viewed from the North

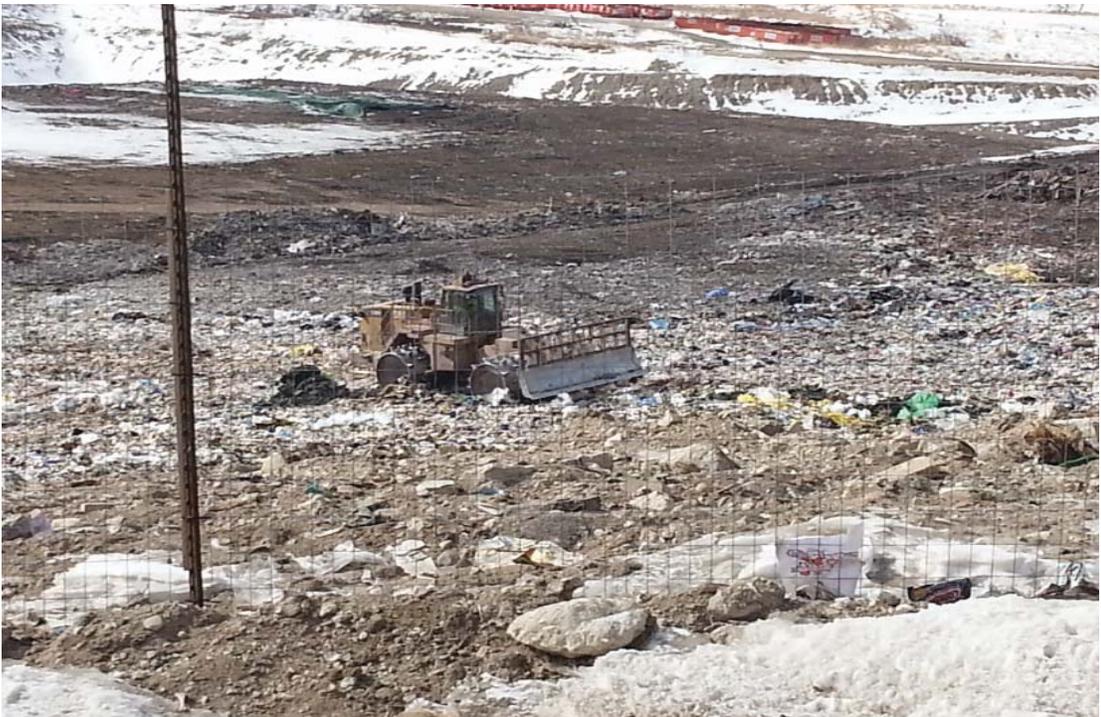
Compactor active in working face

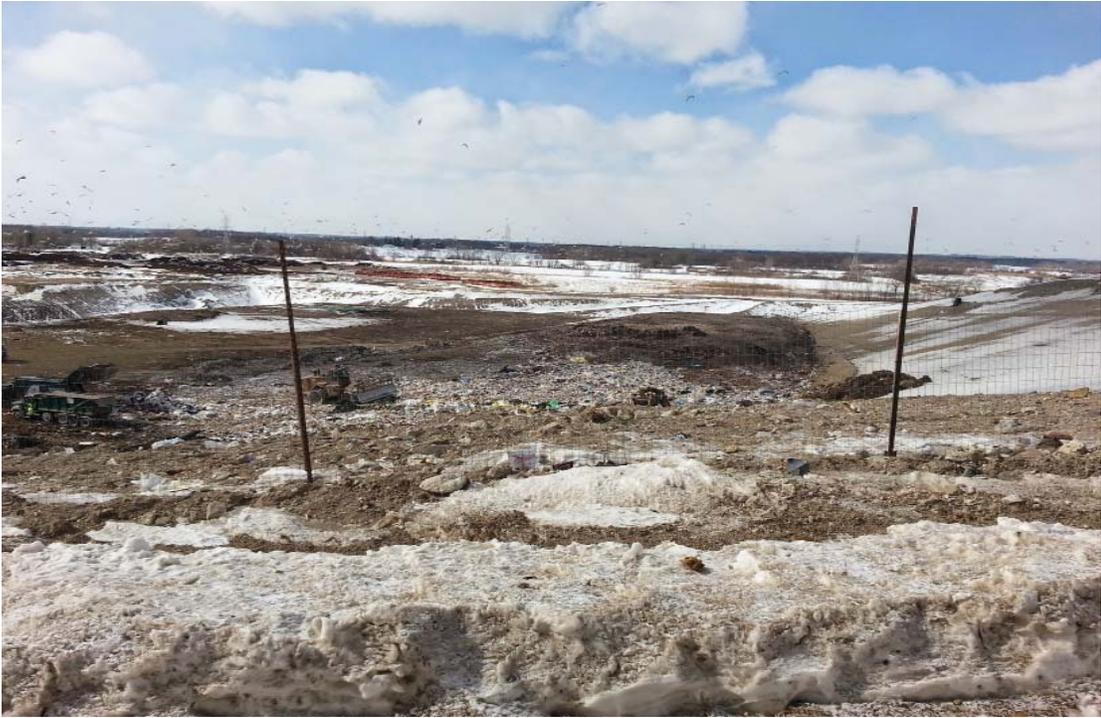
Active area viewed from East

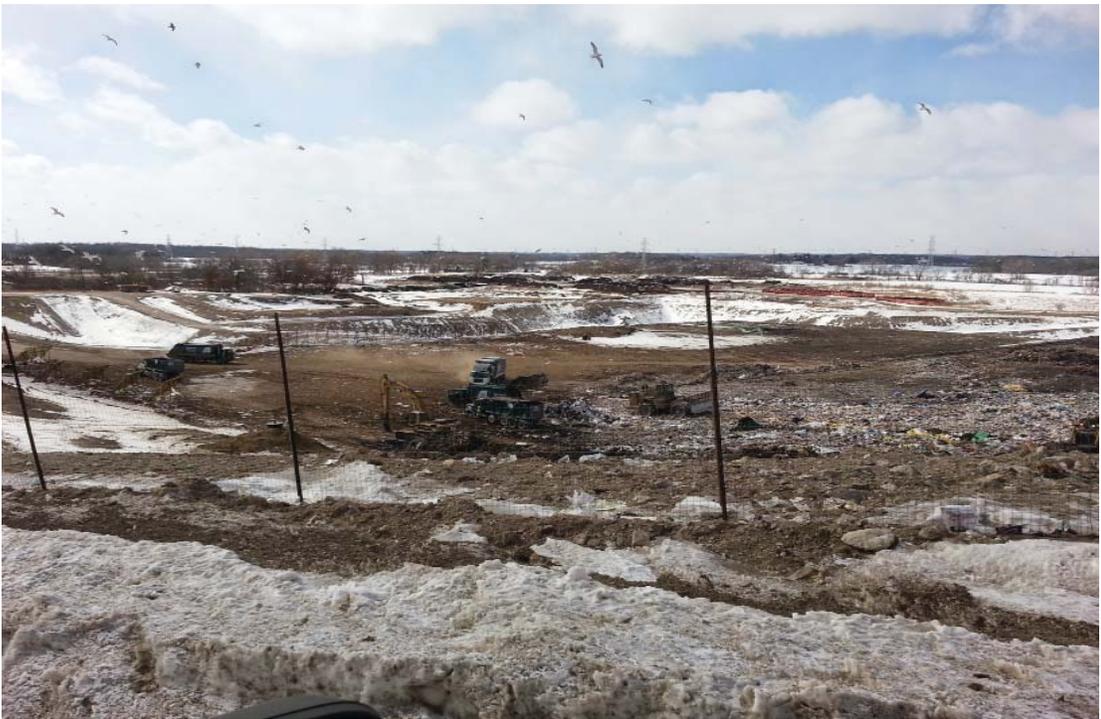
- Working face in Northeast corner of Phase 7B
 - Against South slope of Phases 3 and 7
 - Only one working face in operation
- Soil and polyfluff reclamation happening in Phase 7 above active working face

Working face in Northeast corner of Phase 7B

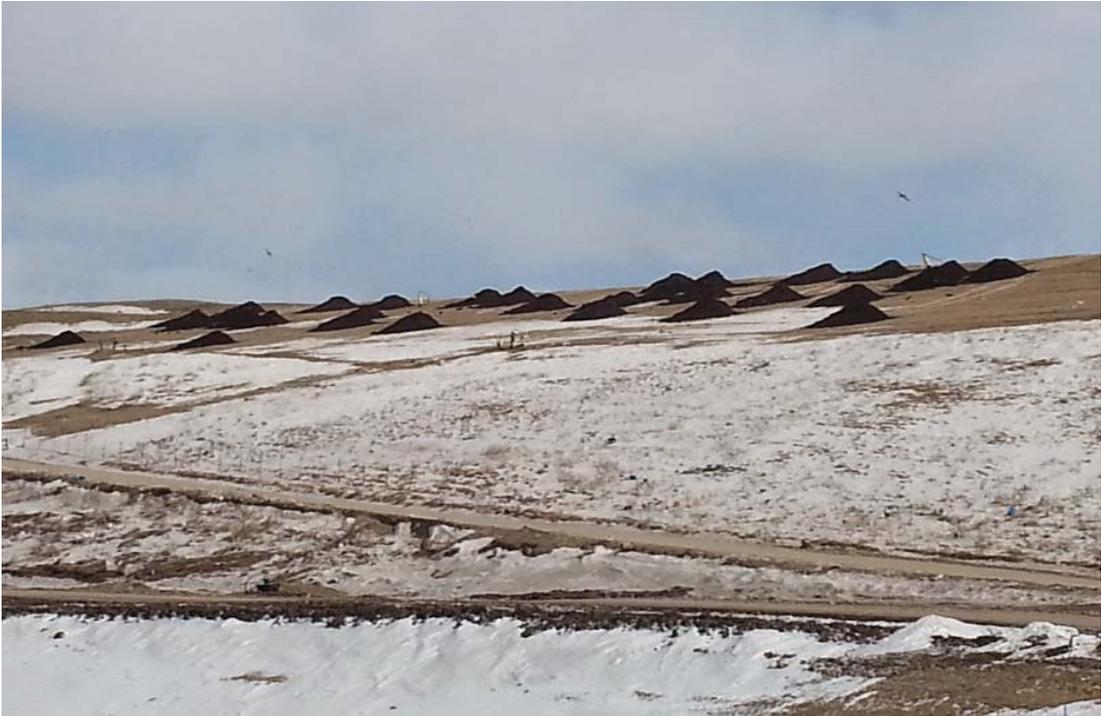
- Contractor placing compost on West slope of Phase 7
 - Previously tipped Land-fill direct soil being recovered and reused as cover material along with polyfluff

Compost to be spread on the West slope of Phase 6
