ADS Emerald Park Landfill Audit Summary

To: ADS Emerald Park Landfill Standing Committee, City of Muskego
FROM: Faith Spear.
COPIES: File
DATE: 03/10/15
PROJECT NUMBER: 1012.10030

Attached is the audit report for activities at the ADS Emerald Park Landfill for the week of February 23, 2015. The audit was performed at 12:35 PM on **February 27, 2015** by Jo Spear, Jr. in the presence of David Geier, Operations Manager.

**ADVANCED DISPOSAL SERVICES
EMERALD PARK LANDFILL / CITY OF MUSKEGO
AUDIT PHOTOS**

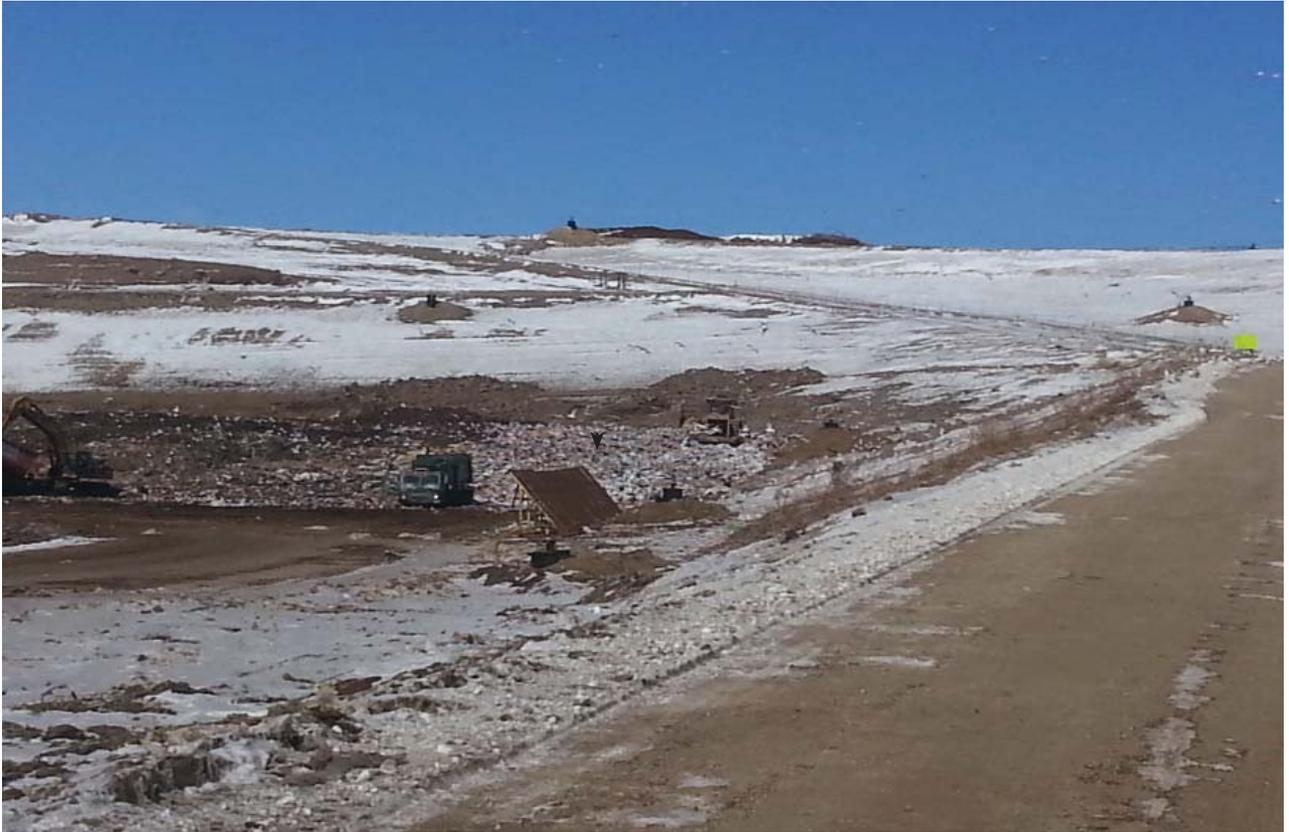
Working face viewed from the Southeast

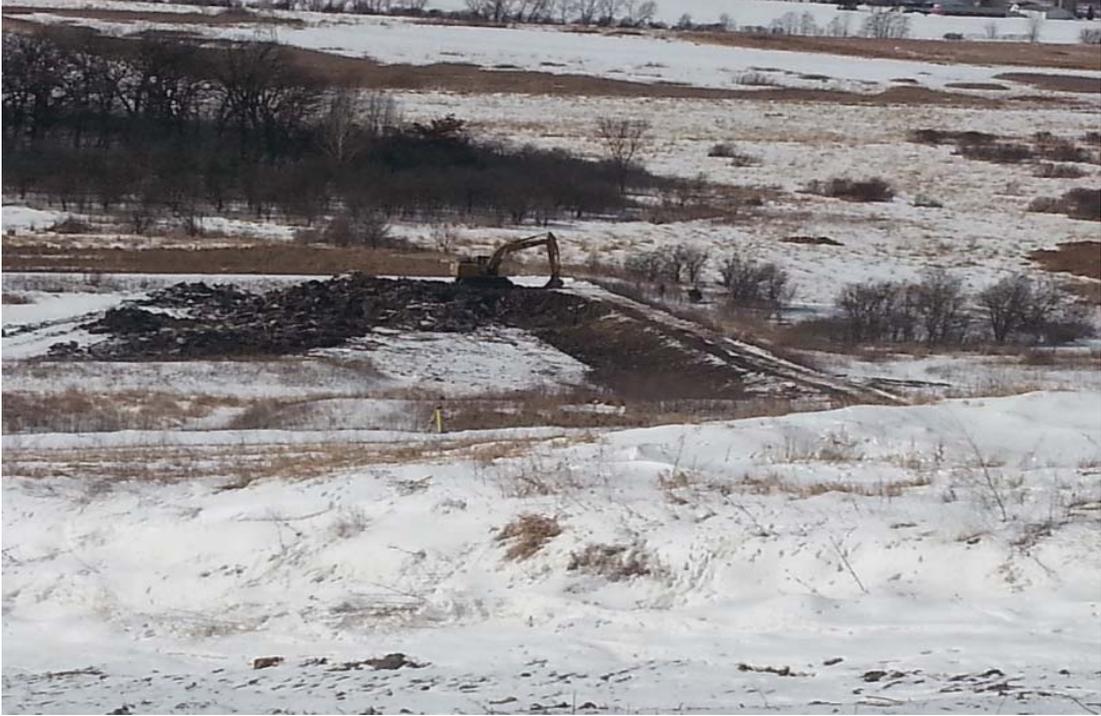
* Cleaning of Basin #1 initiated on 2/27/15, appears it may take several weeks to complete.

Base #1, cleaning has started.

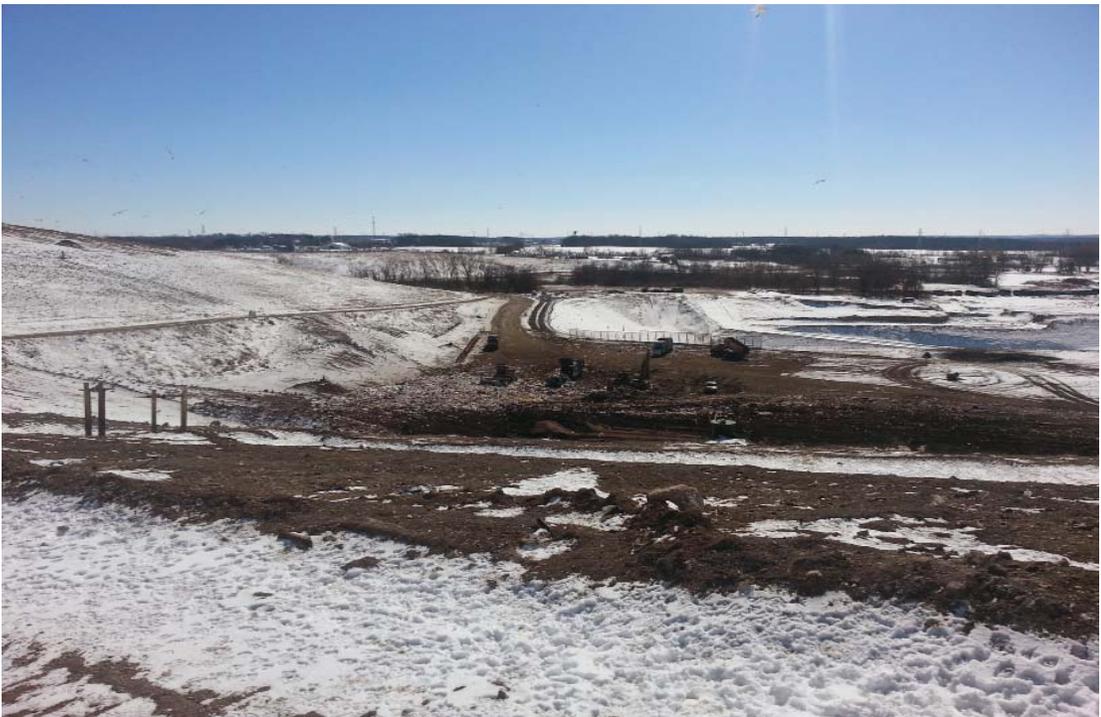
Working face at base of ramp from access road

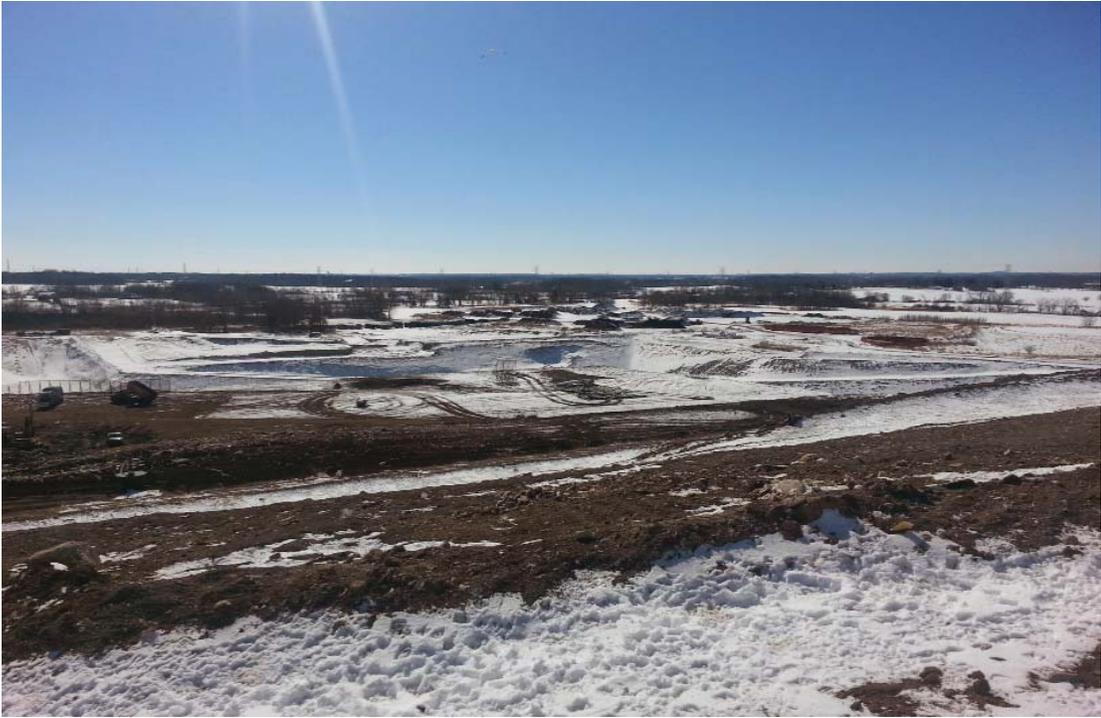
Active area viewed from the North

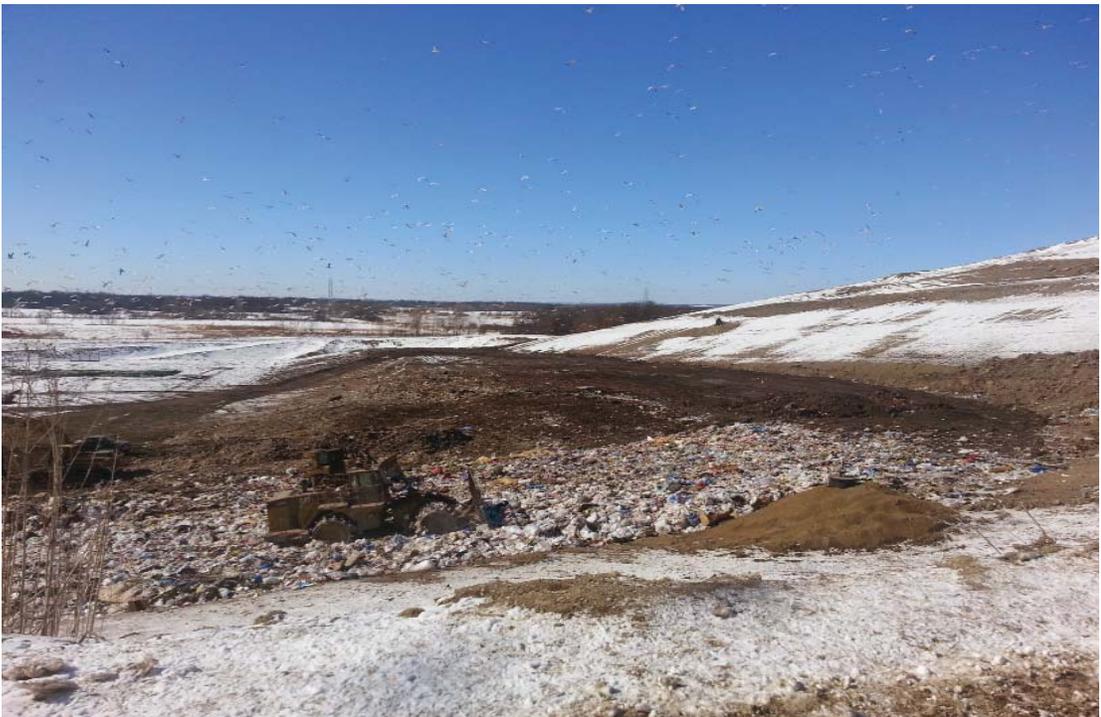
Active area viewed from the East

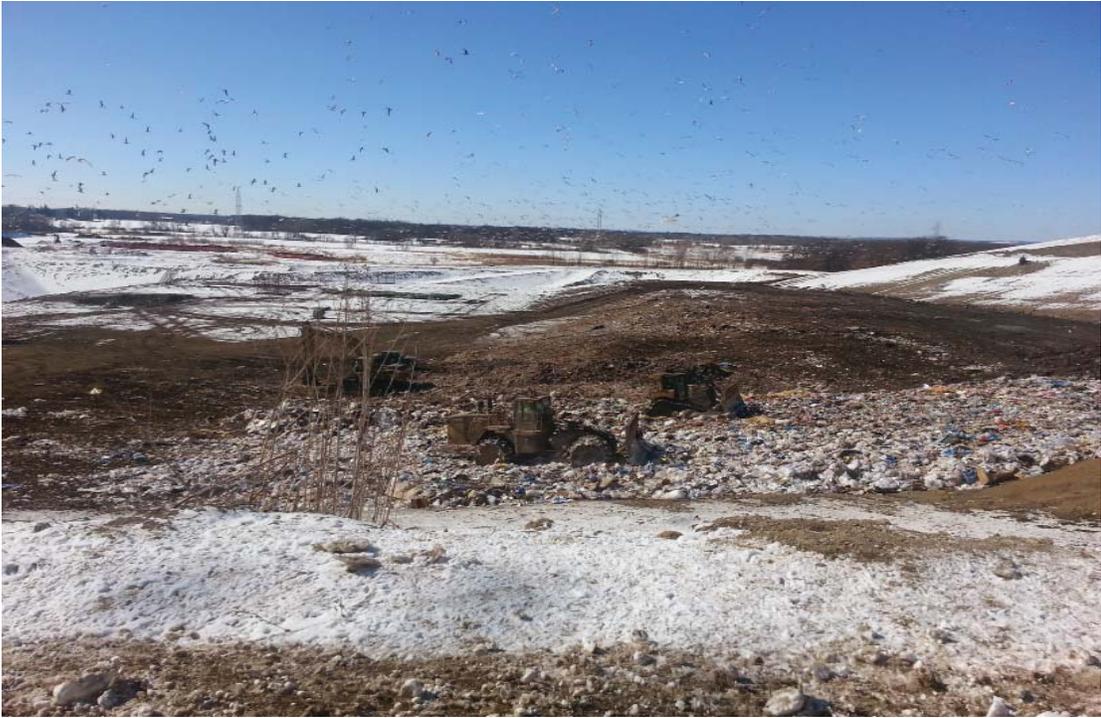
Strong odors above working face

Working face viewed from the East

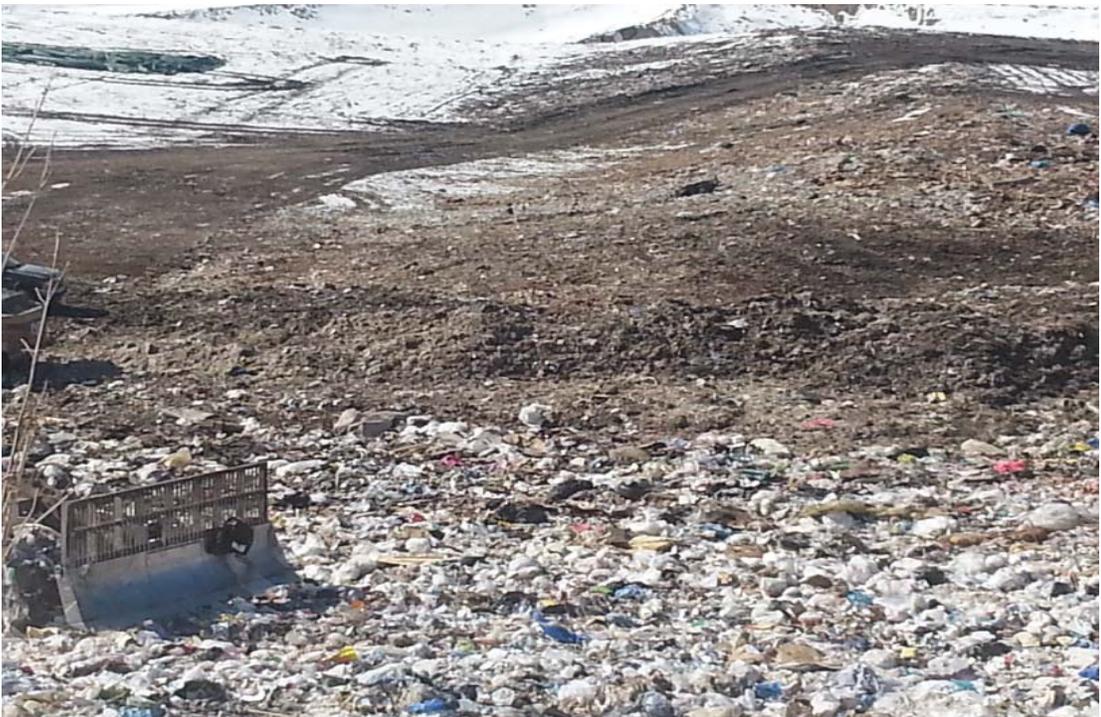
* Poly fluff from previous placement is being recovered for daily cover.

Poly-fluff, shredded plastic, being recovered to use as cover

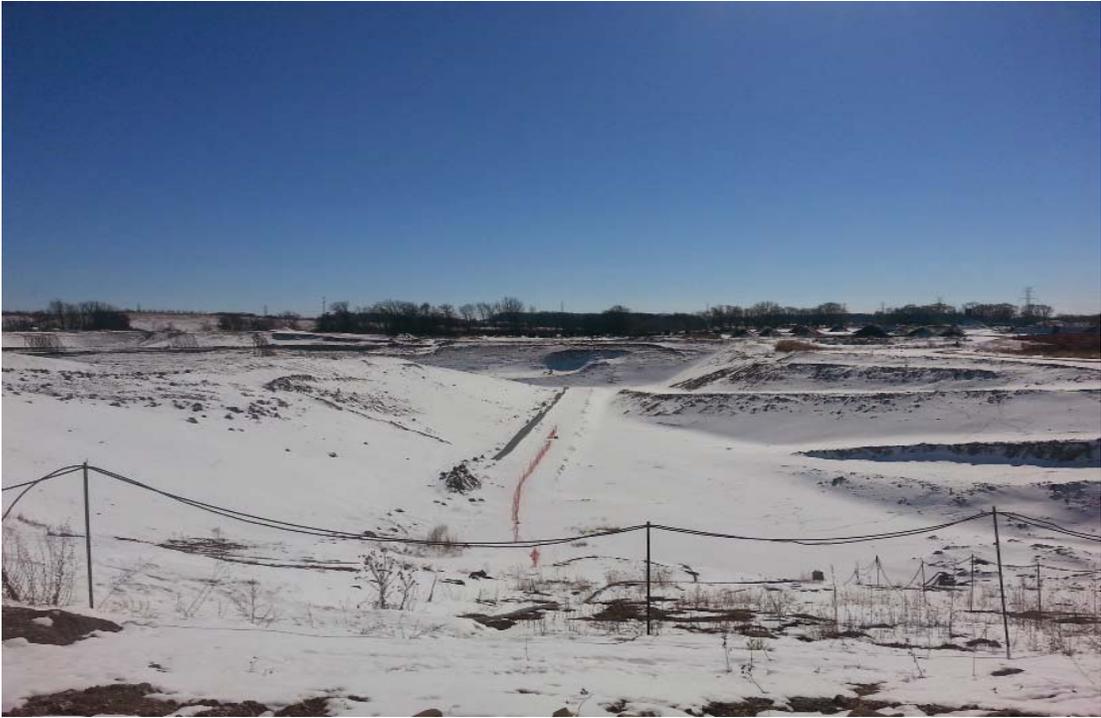
West edge of Phases 7, viewed from the North

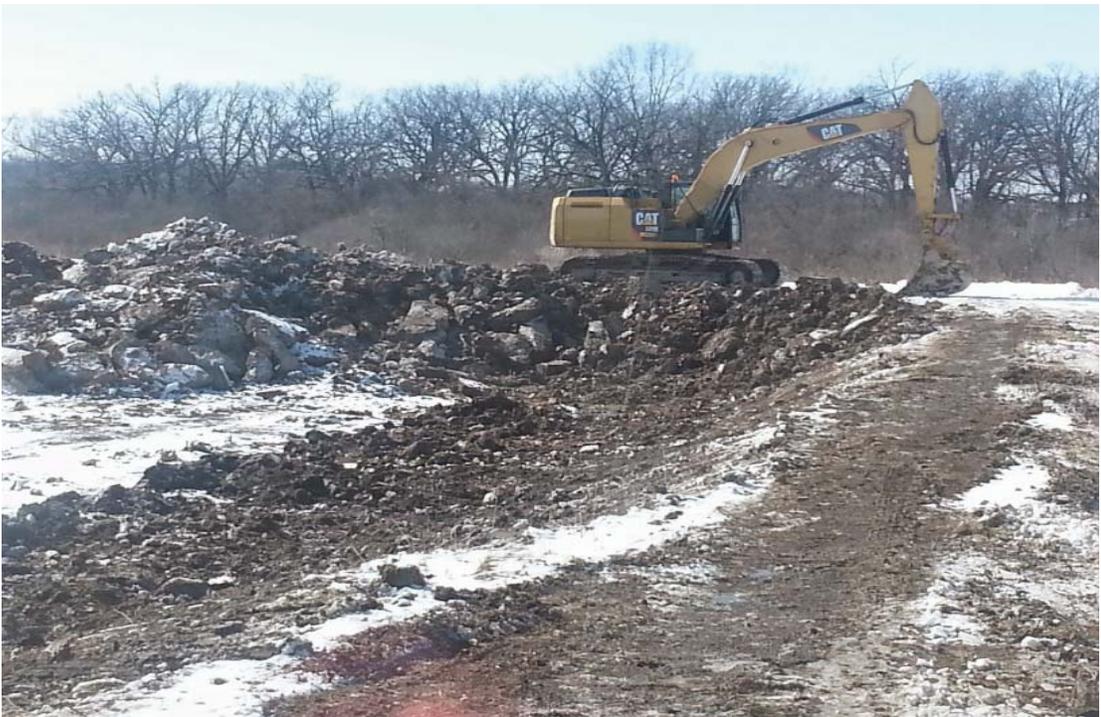
Excavator being used to clean Basin #1
