ADS Emerald Park Landfill Audit Summary

To: ADS Emerald Park Landfill Standing Committee, City of Muskego
FROM: Faith Spear.
COPIES: File
DATE: 03/24/15
PROJECT NUMBER: 1012.10030

ADVANCED DISPOSAL SERVICES EMERALD PARK LANDFILL
 LANDFILL OPERATIONS AUDIT FORM
 CITY OF MUSKEGO

**ADVANCED DISPOSAL SERVICES
EMERALD PARK LANDFILL / CITY OF MUSKEGO
AUDIT PHOTOS**

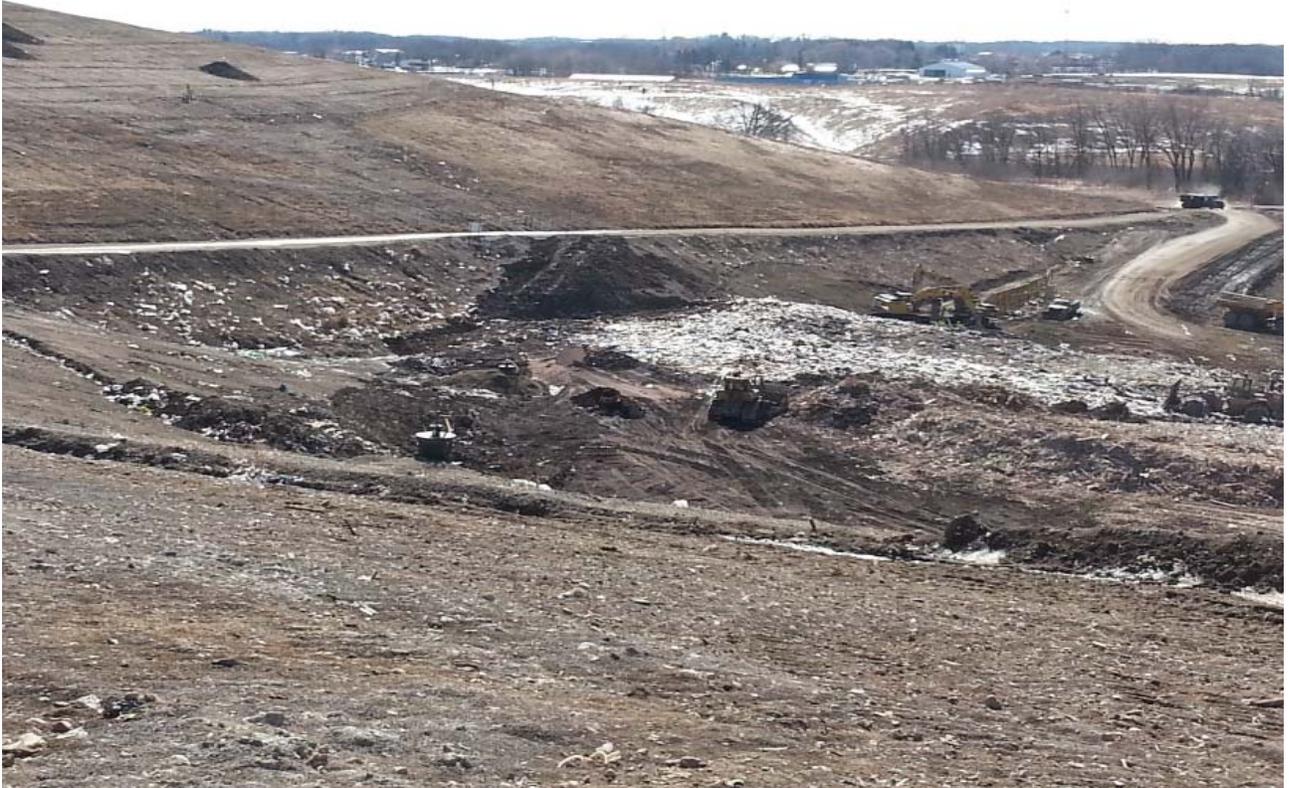
Working face viewed from the North. Possible location of future ramp access

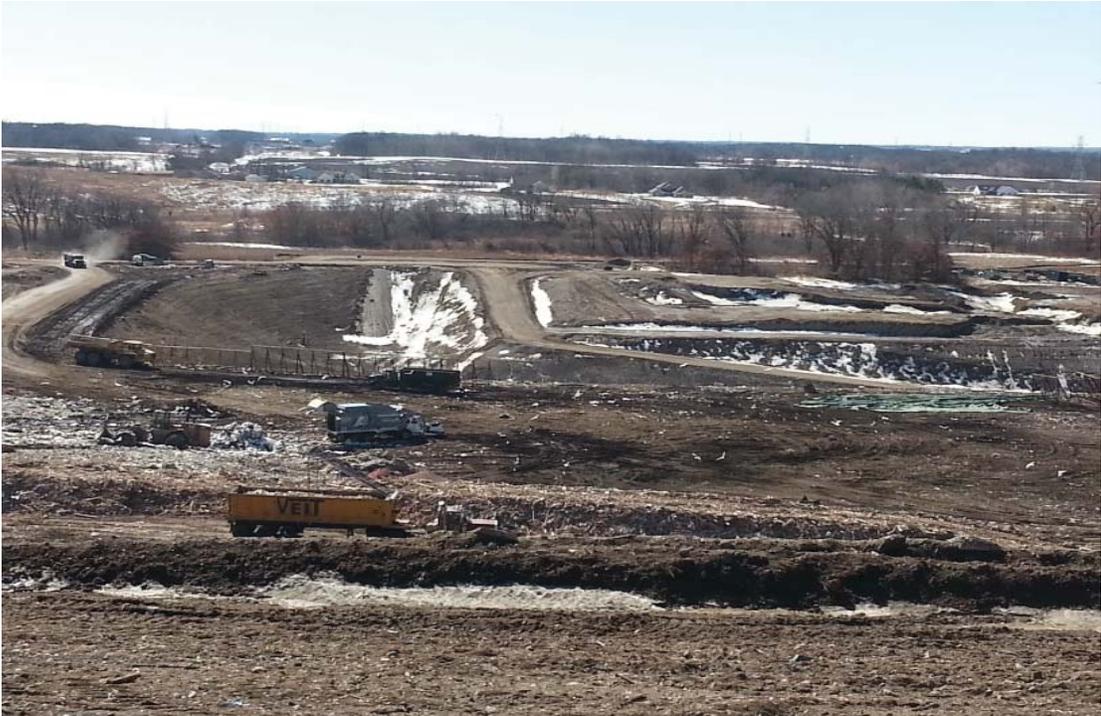
Active area viewed from the North

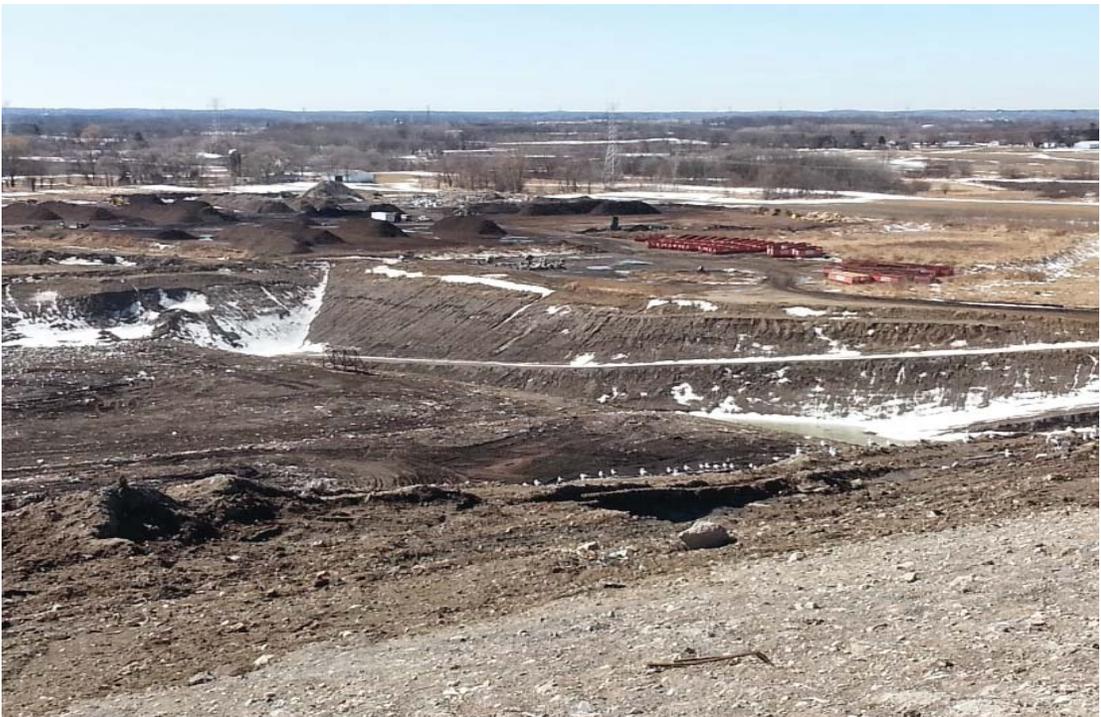
Unused portion of the active area, melt water draining to Temp. Sed. Basin and pumped to Basin #1

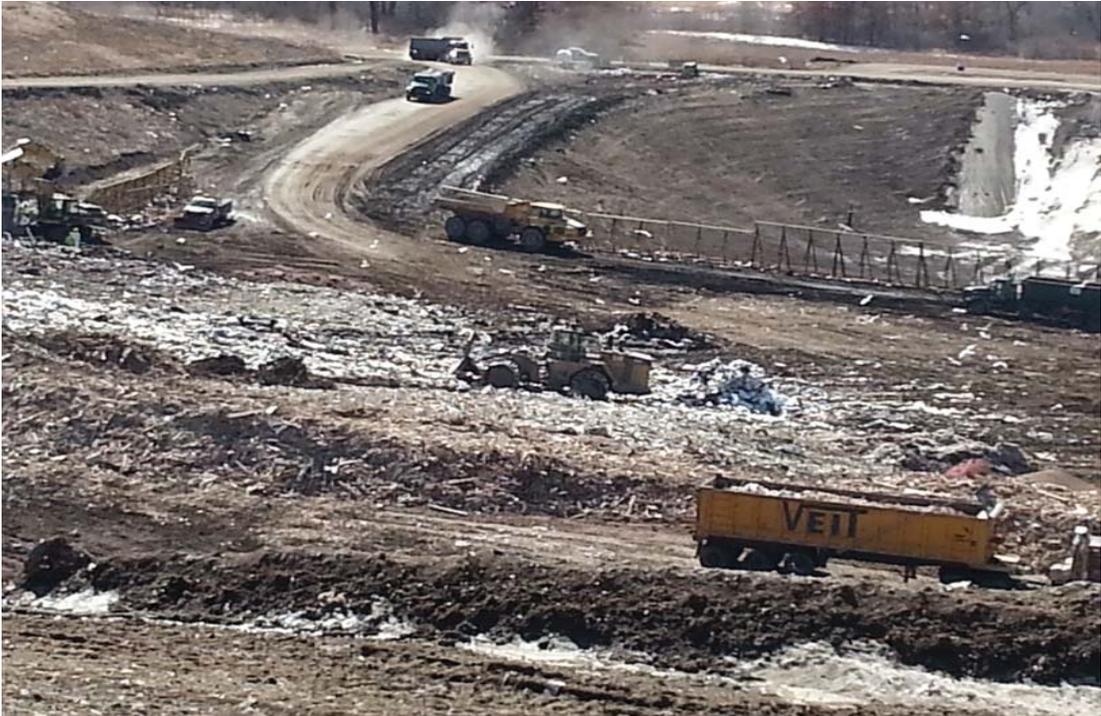
C&D materials being tipped above and separate from MSW for cover activities.

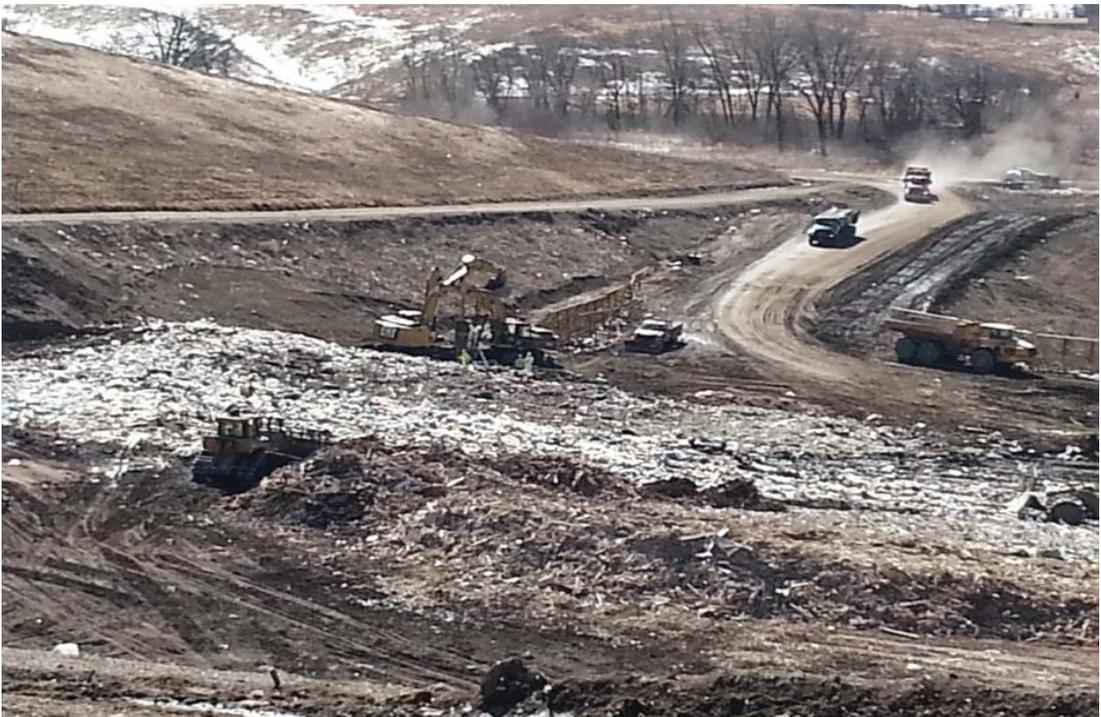
Minor gas odor about well in Phase 6w being raised

Gas well being extended just outside Working face, East edge of Phase 6W

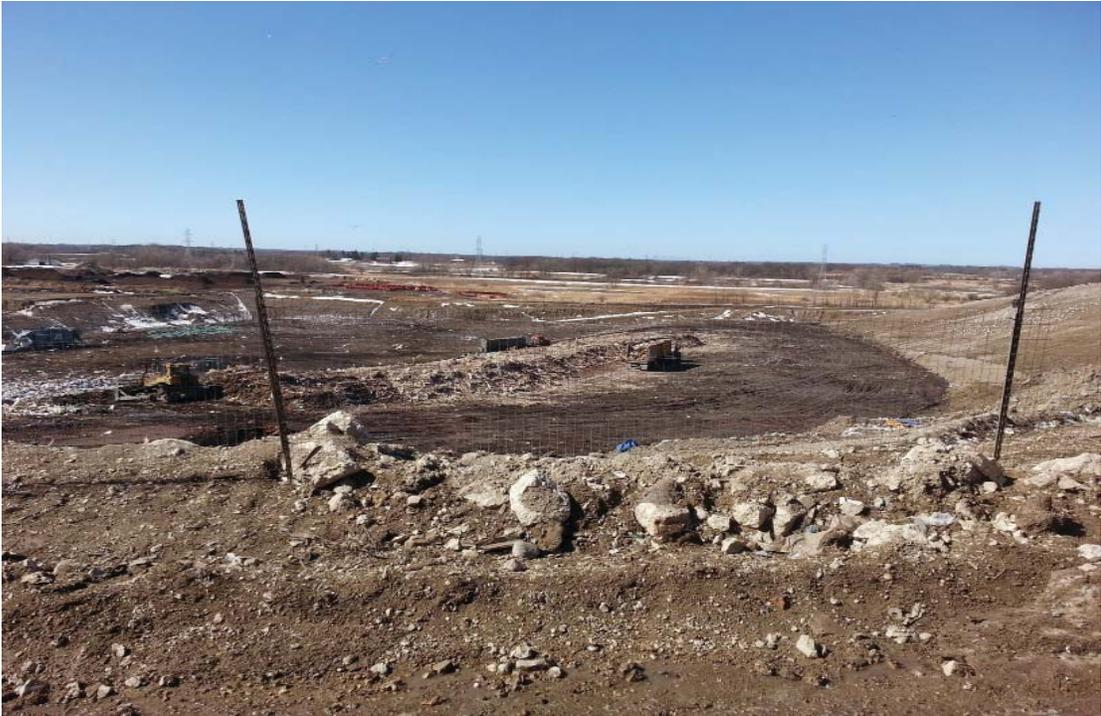
Active area, note the row of tipped C&D to be used for cover support

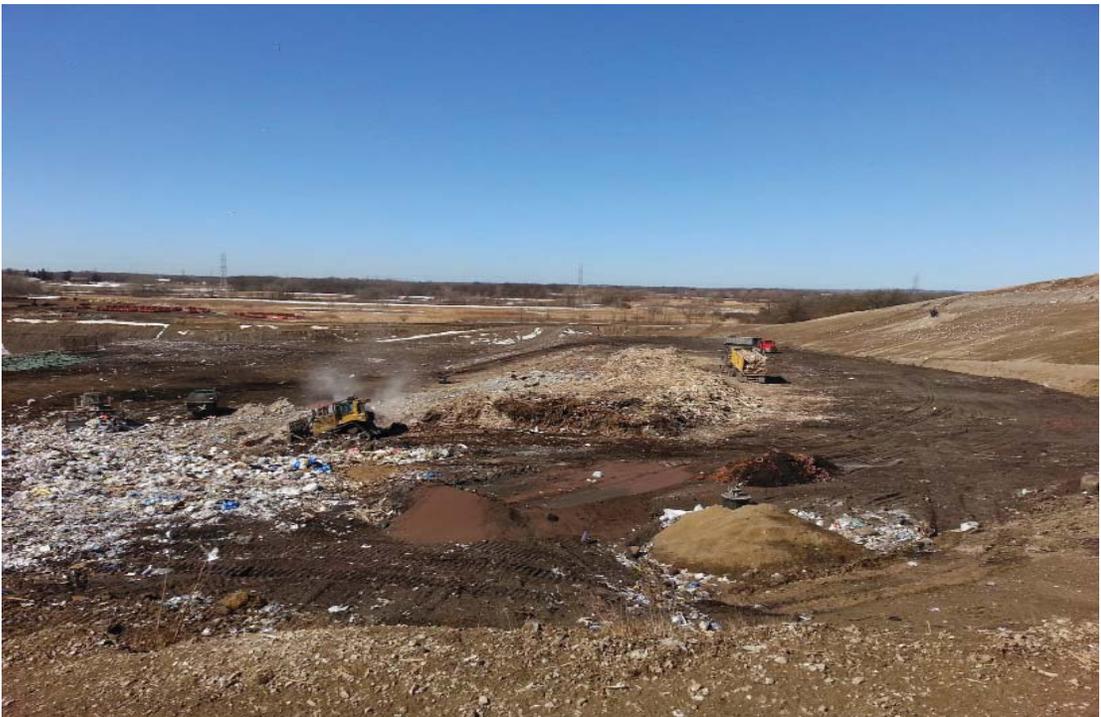
Working face viewed from the East

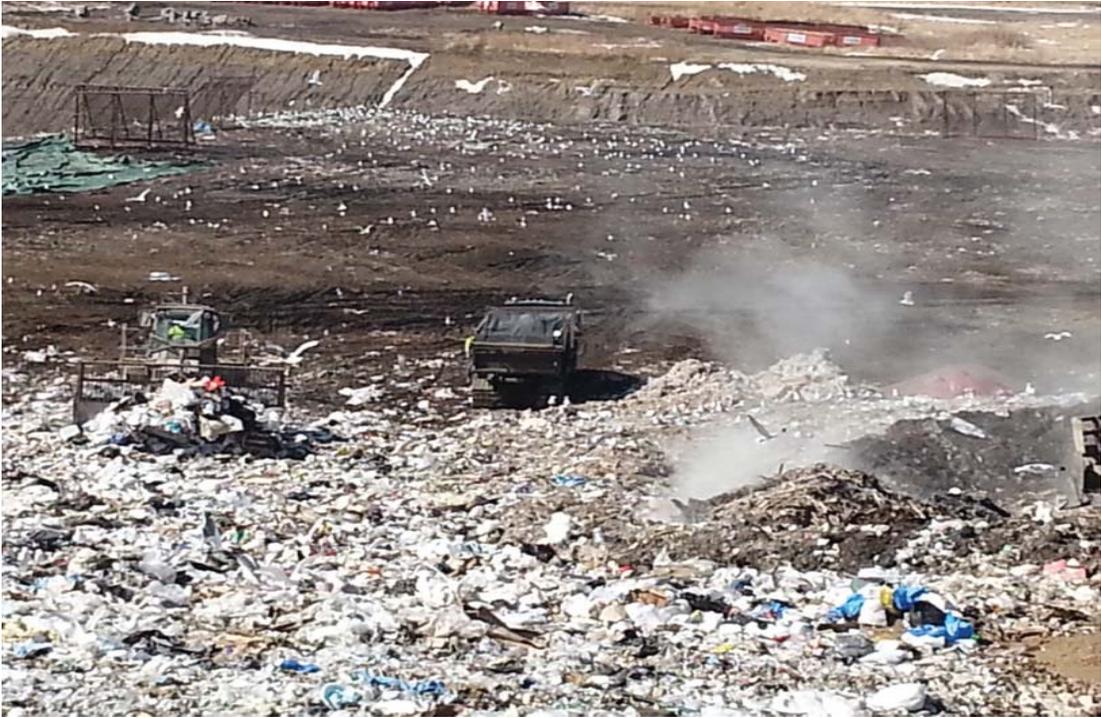
Tipping and compactor moving waste at West edge of Working face

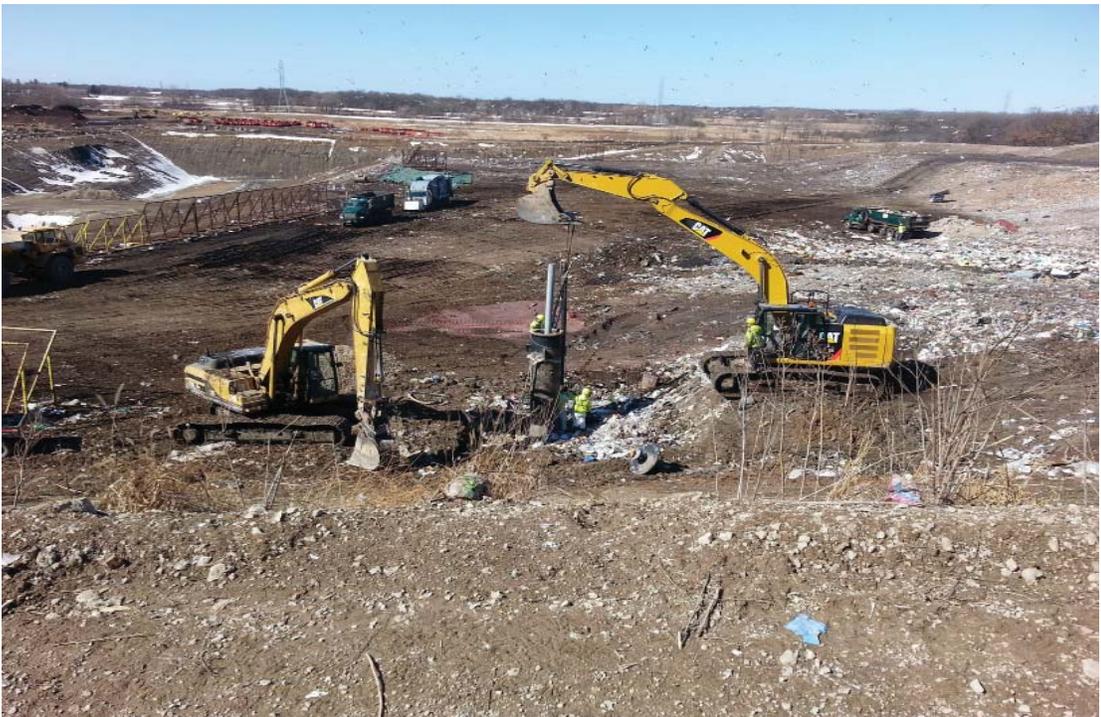
Casson style gas well extension, ongoing

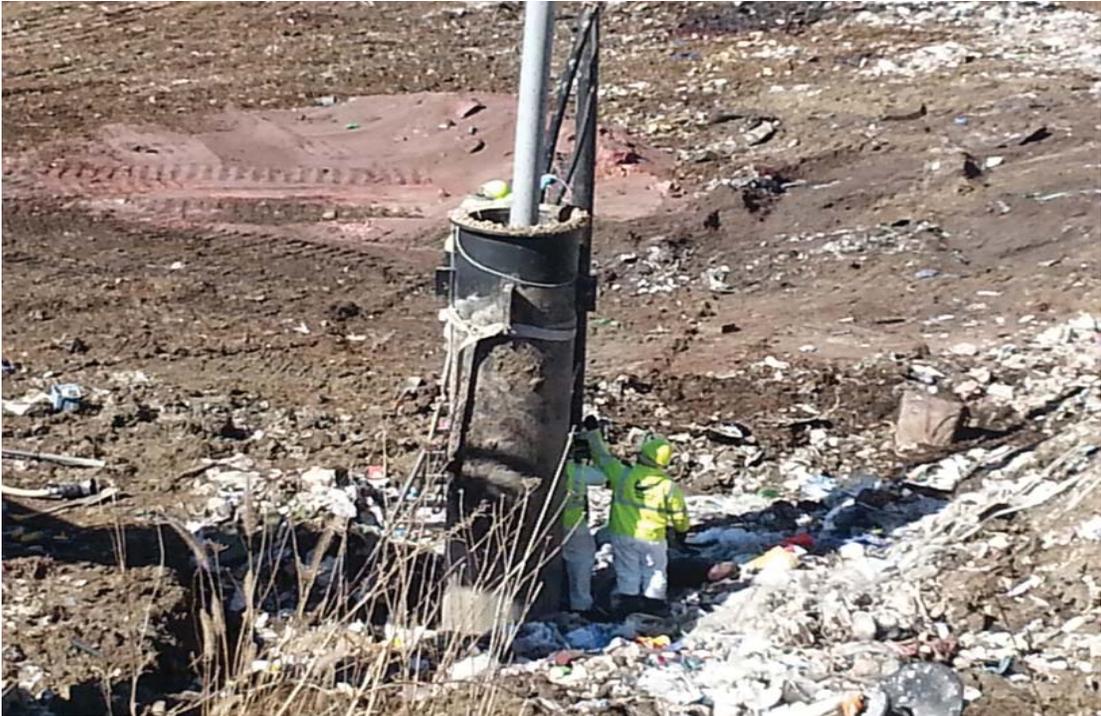
- Casson gas well being raised above water level in Phase 6W

Casson style gas collection well being prepared for raising above waste limits

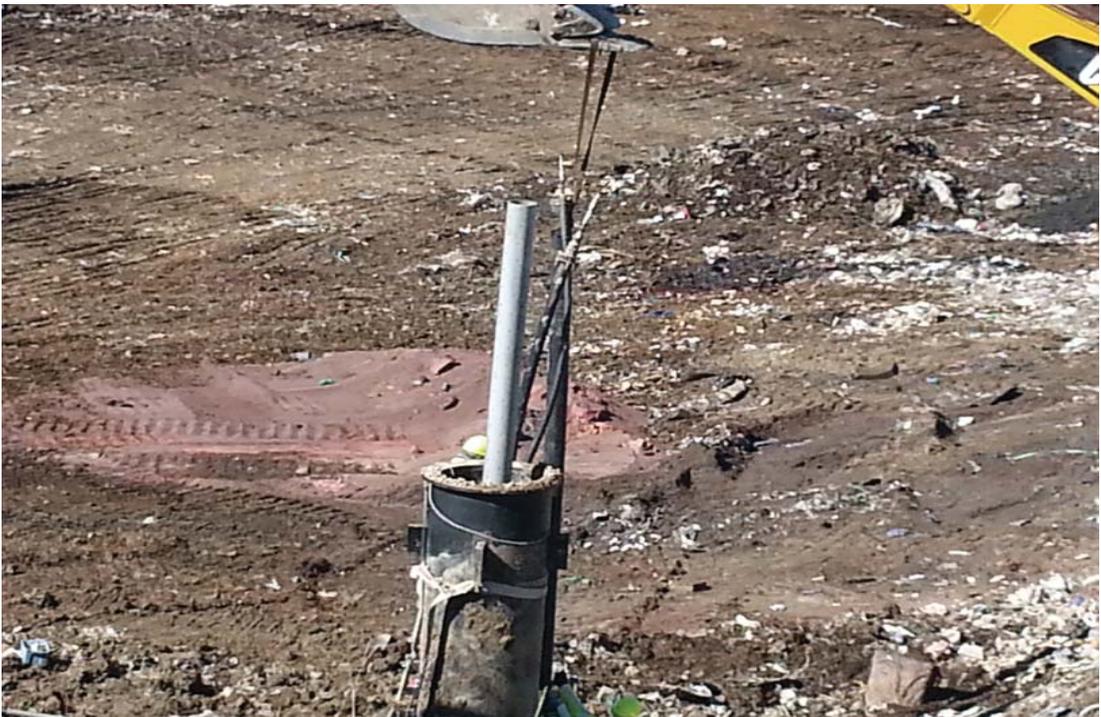
Black casing of well being raised up to meet top of exposed perforated collection pipe
