### ADS Emerald Park Landfill Audit Summary

**To:** ADS Emerald Park Landfill Standing Committee, City of Muskego  
**FROM:** Faith Spear.  
**COPIES:** File  
**DATE:** 03/26/15  
**PROJECT NUMBER:** 1012.10030

**ADVANCED DISPOSAL SERVICES  
EMERALD PARK LANDFILL / CITY OF MUSKEGO  
AUDIT PHOTOS**

PROJECT NO. 1012.10030

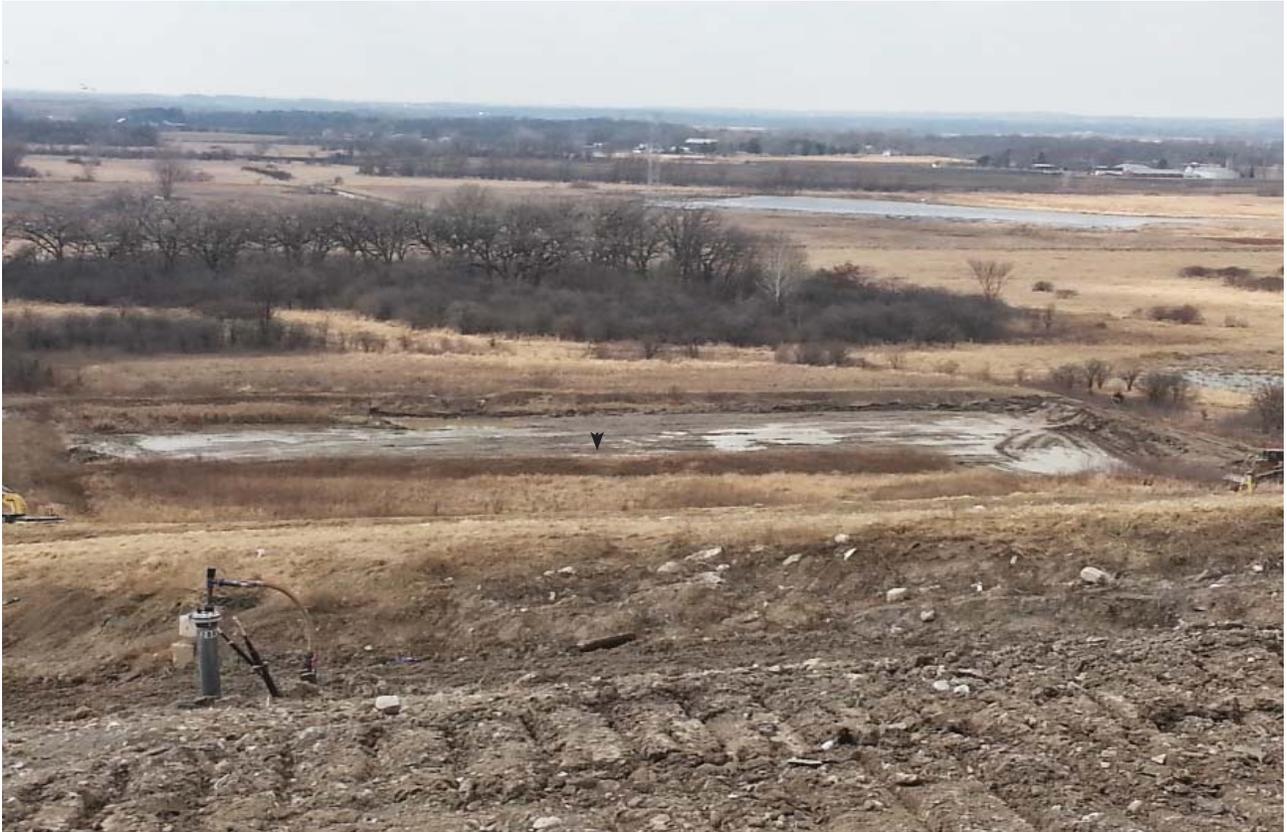
Basin #1, nearly cleaned of silt. Silt has been placed throughout site to dry and be used to improve intermediate cover

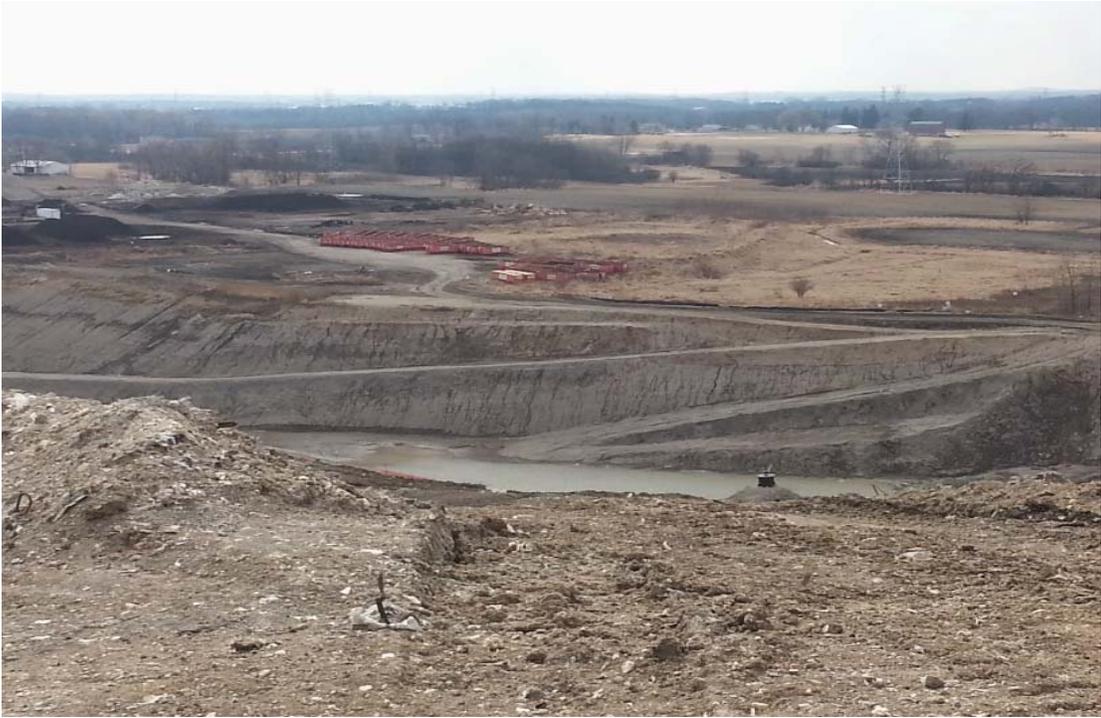
Western portion of footprint and temp sed. basin

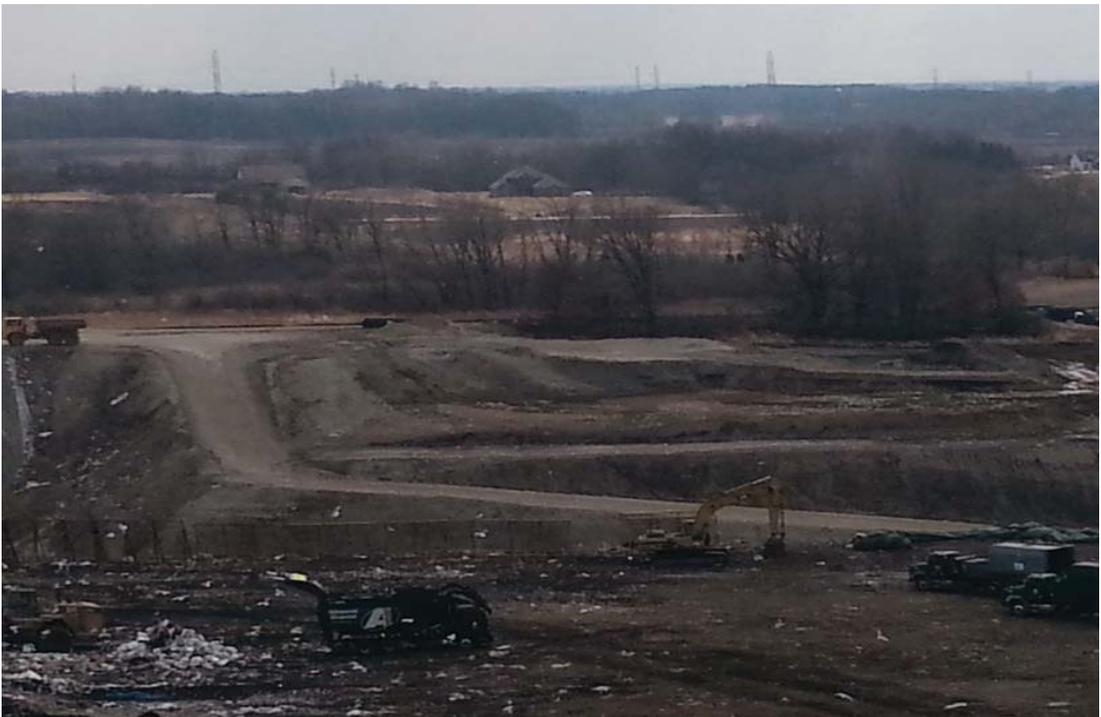
Active area and future Phase 8 in the background

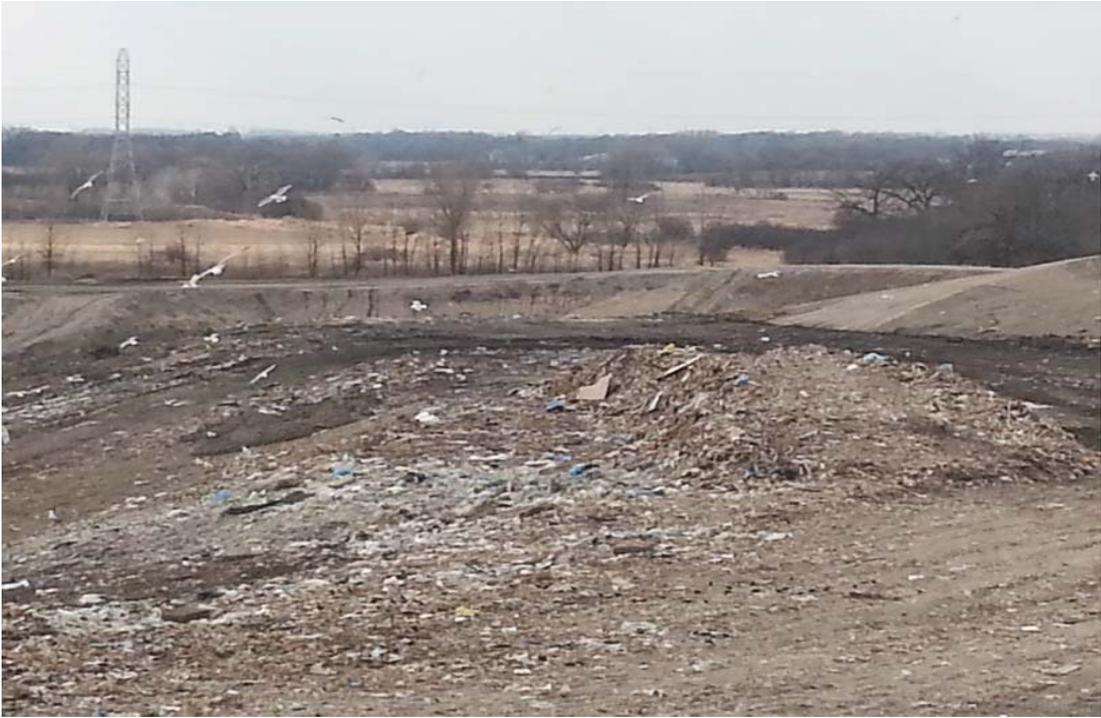
C&D materials being tipped above and separate from MSW for cover activities.

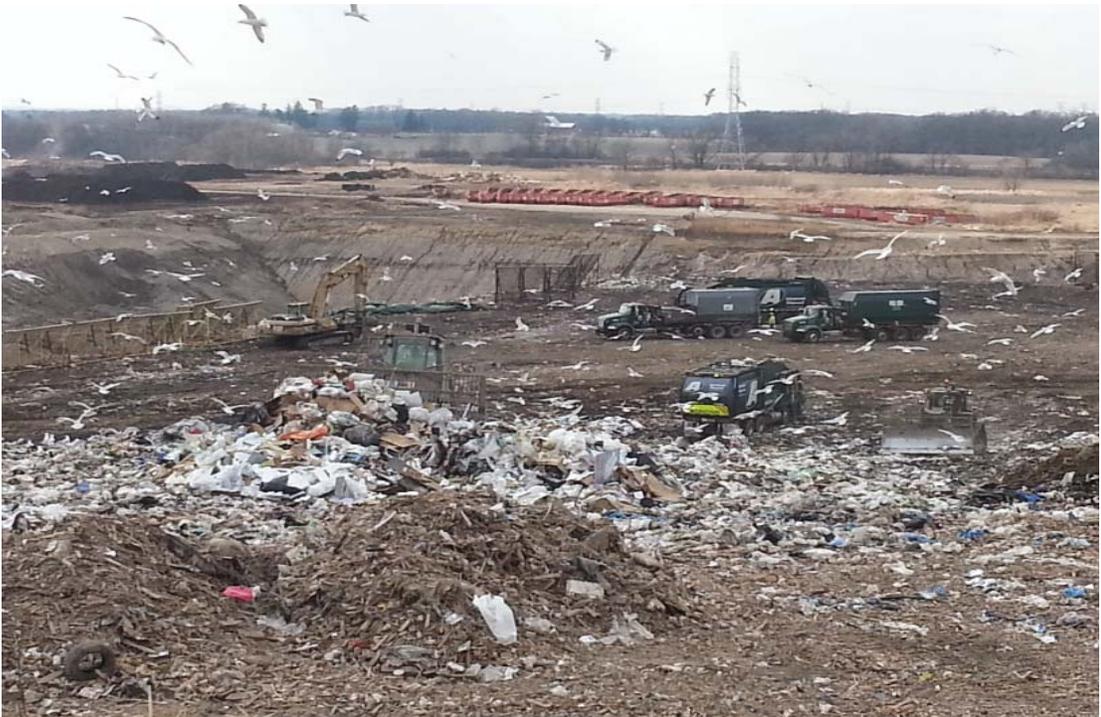
Working face

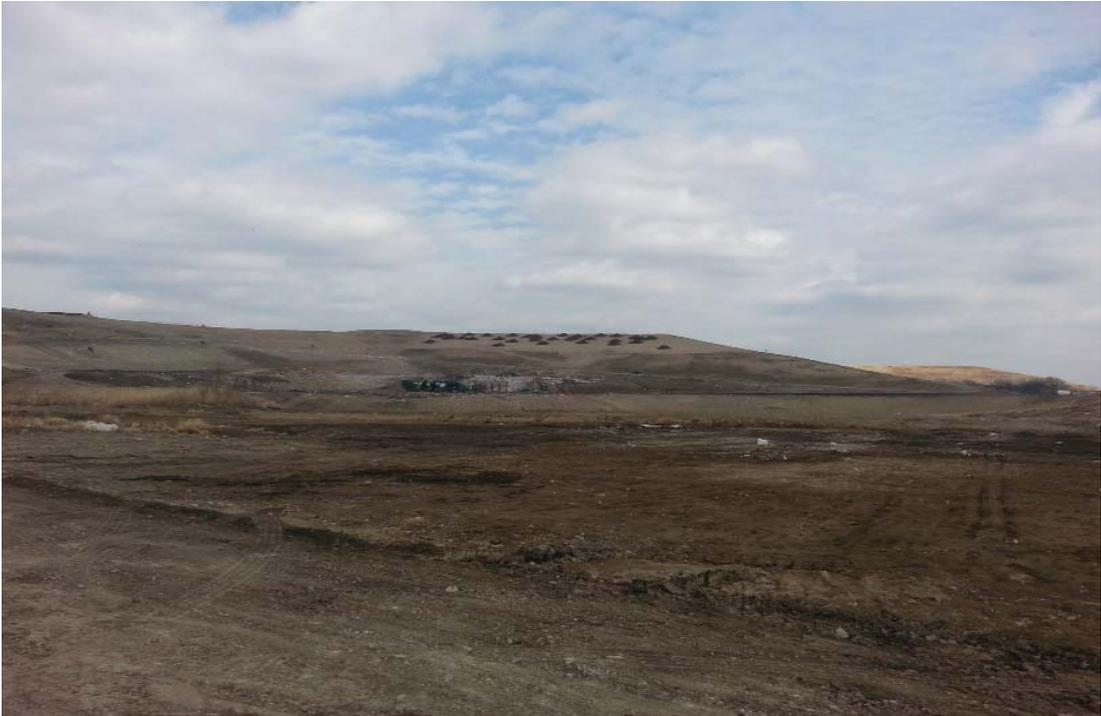
West slopes of site have stockpiled compost for spreading and seeding

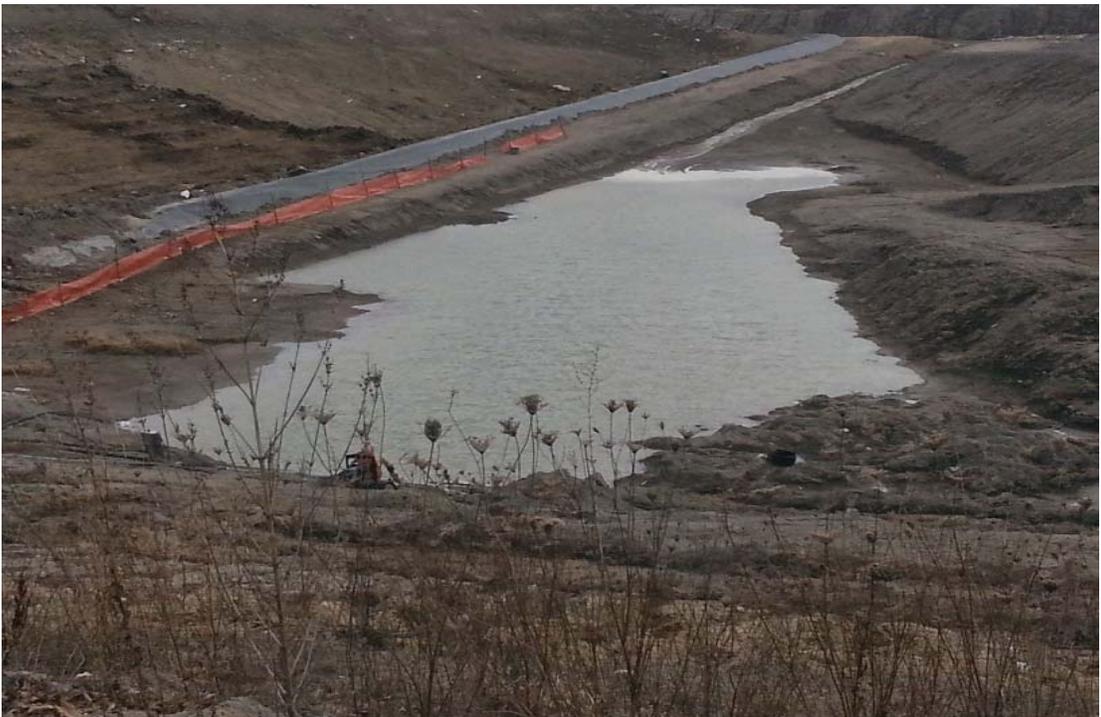
Temp basin minimally filled with melt water. No pumping until Basin #1 is cleaned or a rain event occurs.
