ADS Emerald Park Landfill Audit Summary

To: ADS Emerald Park Landfill Standing Committee, City of Muskego
FROM: Faith Spear.
COPIES: File
DATE: 03/26/15
PROJECT NUMBER: 1012.10030

Attached is the audit report for activities at the ADS Emerald Park Landfill for the week of March 23, 2015. The audit was performed at 1:10 PM on **March 25, 2015** by Jo Spear, Jr. in the presence of David Greier, Operations Manager.

**ADVANCED DISPOSAL SERVICES
EMERALD PARK LANDFILL / CITY OF MUSKEGO
AUDIT PHOTOS**

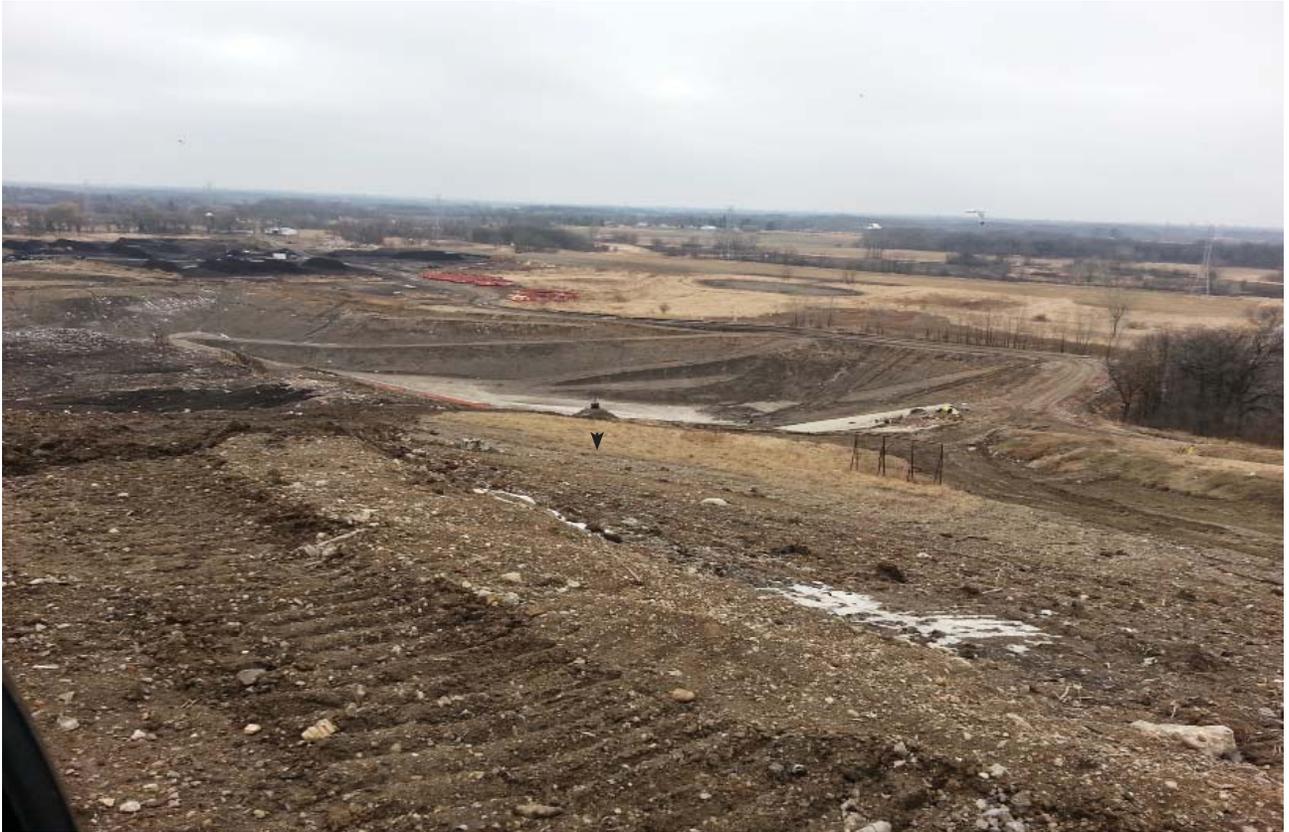
West slope of Phase 2/3, above view of temp sed basin.

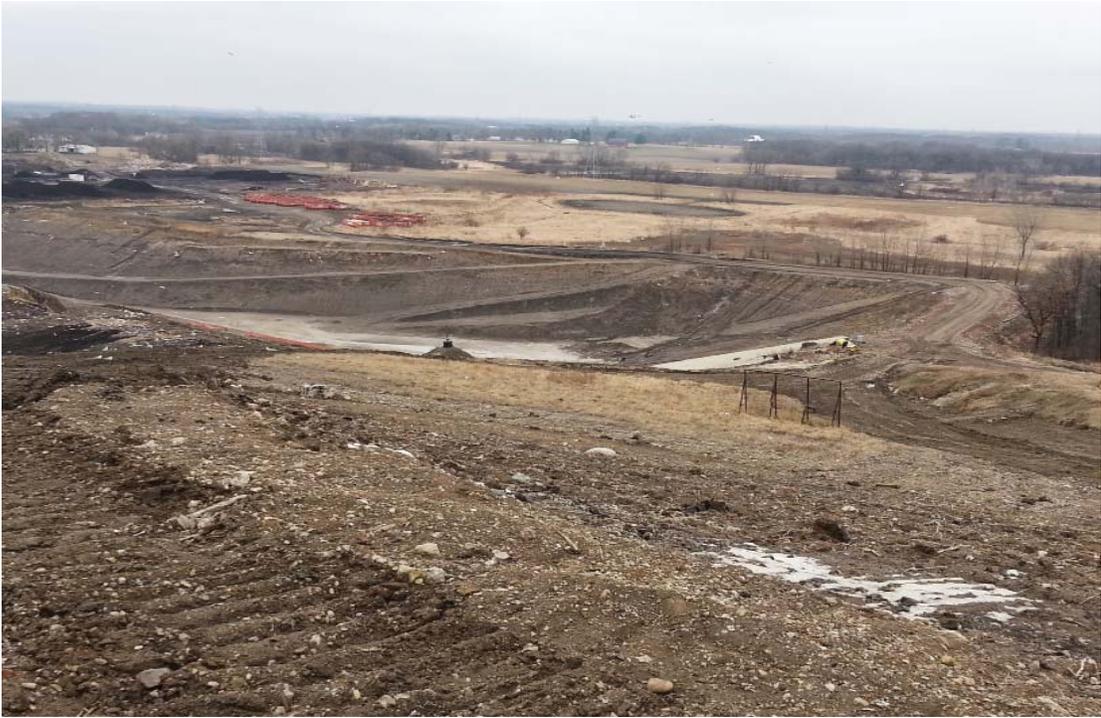
Western portion of footprint and temp sed. basin

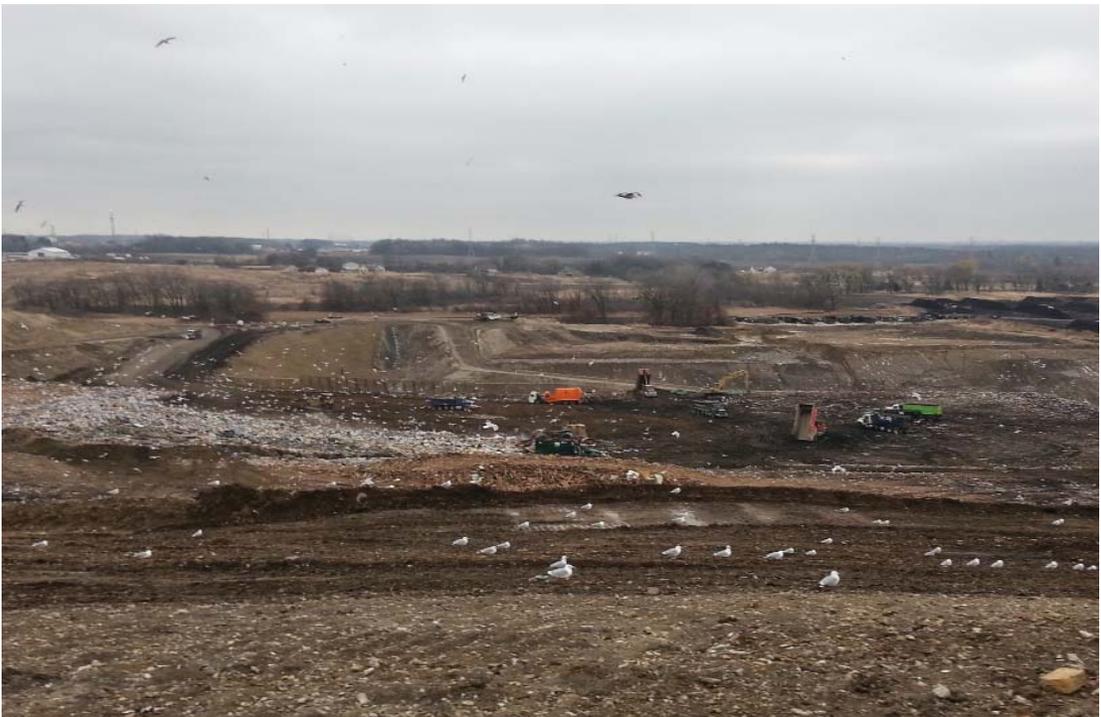
Active area and future Phase 8 in the background

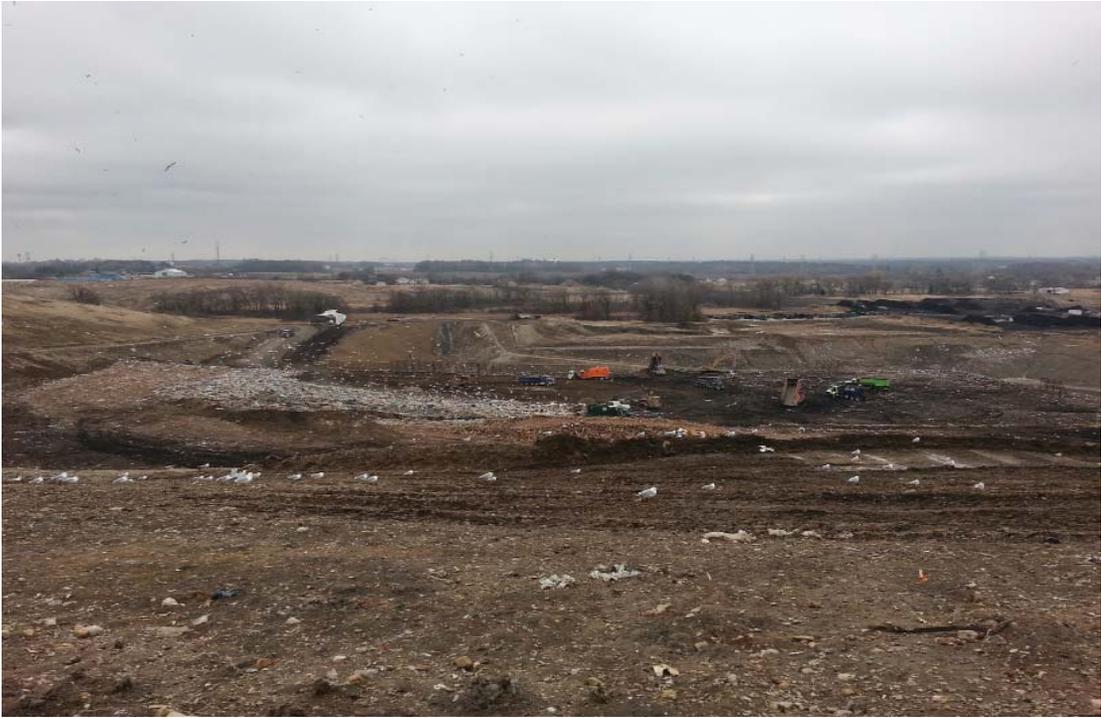
C&D along with wet soils in the foreground above working face

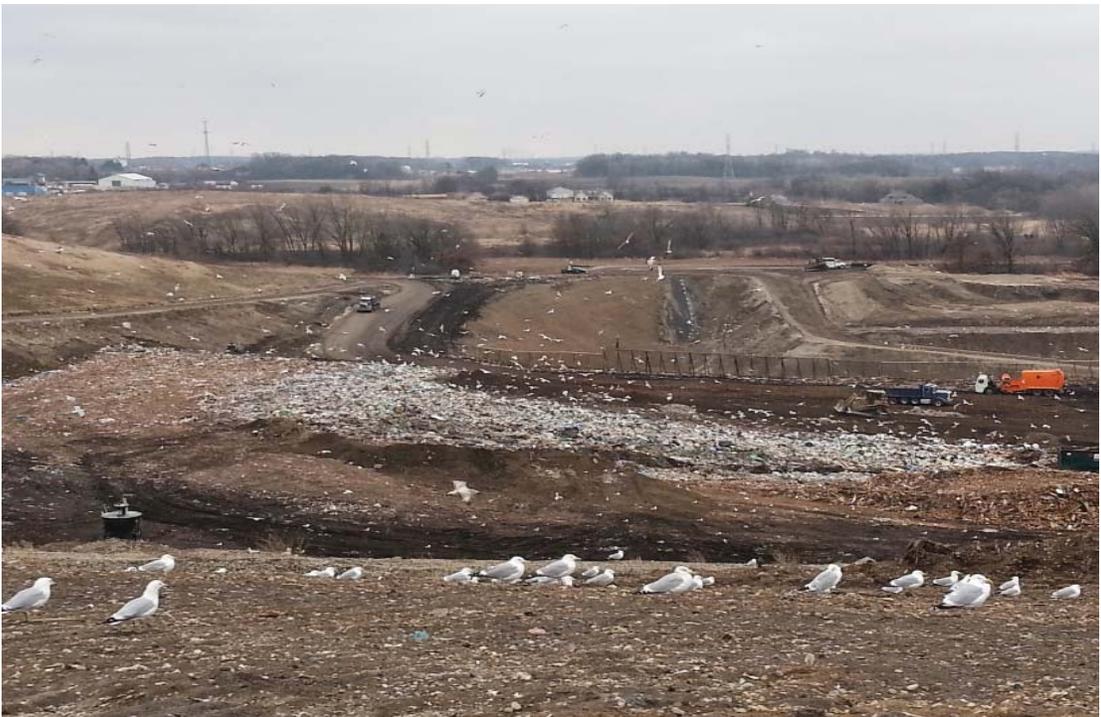
Working face at border of Phase 6W
and Phase 7. Lift moving
westward across Phase 7.
No other working faces on site
Flagging on south slope of Phase
7.

Working face

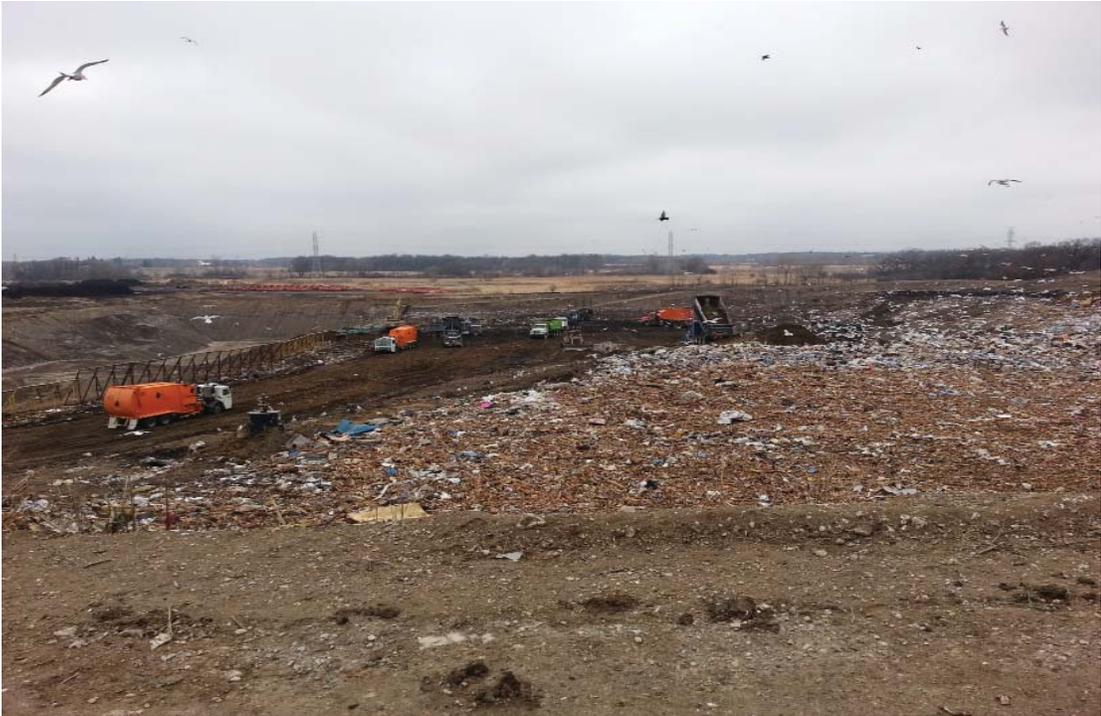
Working face and active area viewed from the East

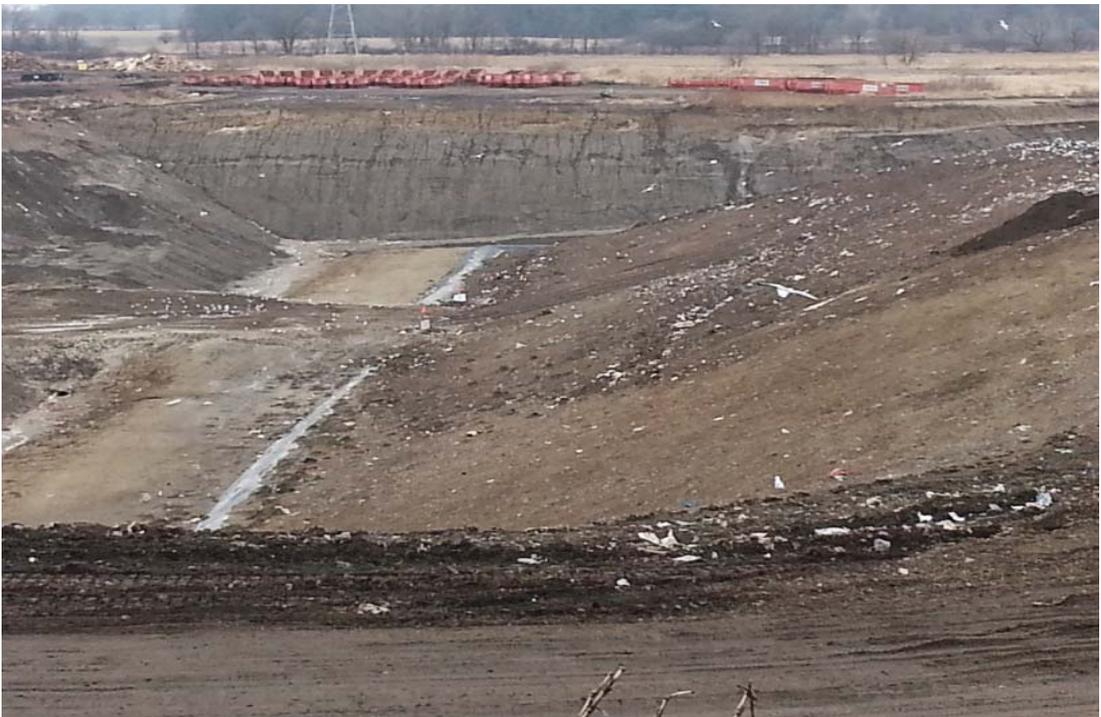
Flagging on the South slope of Phase 6W/7.
