ADS Emerald Park Landfill Audit Summary

To: ADS Emerald Park Landfill Standing Committee, City of Muskego
FROM: Faith Spear.
COPIES: File
DATE: 04/15/15
PROJECT NUMBER: 1012.10030

Attached is the audit report for activities at the ADS Emerald Park Landfill for the week of March 30, 2015. The audit was performed at 11:45 AM on **April 1, 2015** by Jo Spear, Jr. in the presence of David Greier, Operations Manager.

ADVANCED DISPOSAL SERVICES EMERALD PARK LANDFILL
 LANDFILL OPERATIONS AUDIT FORM
 CITY OF MUSKEGO

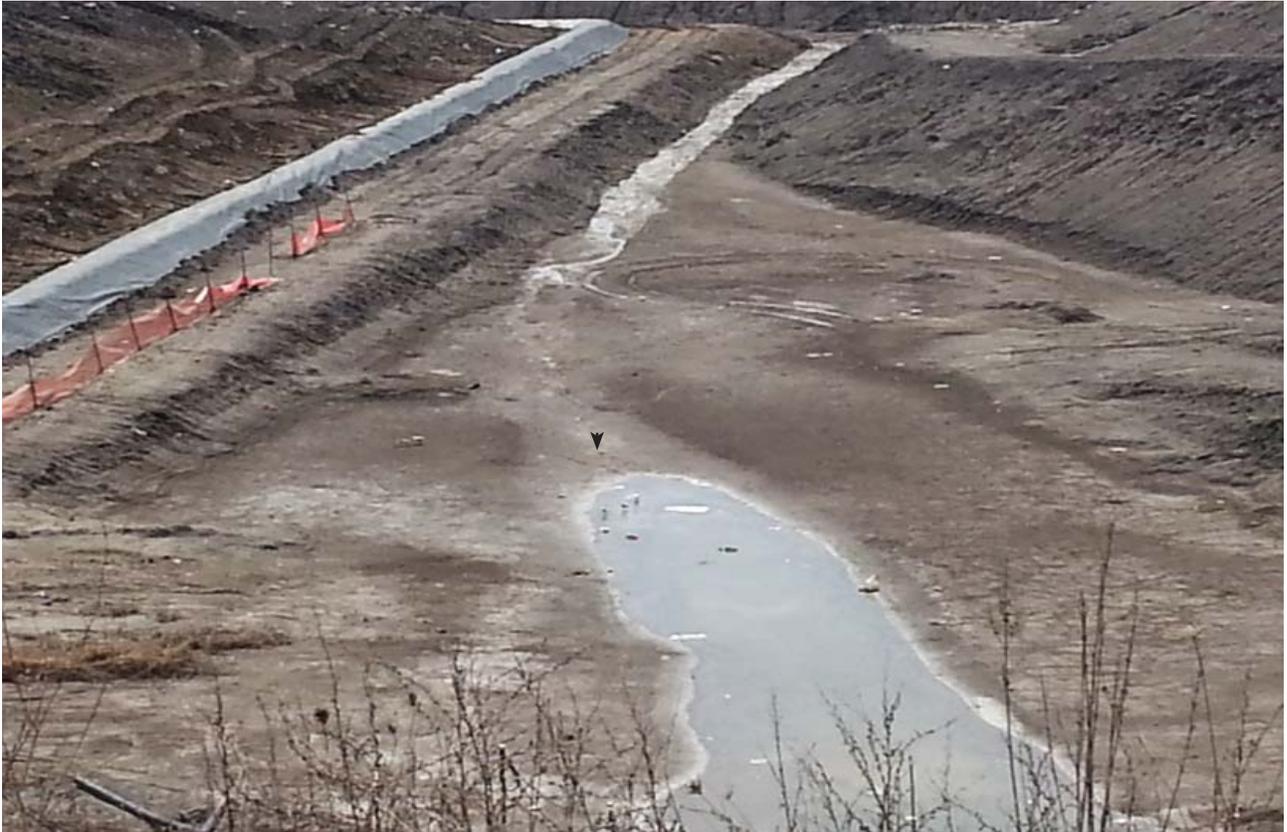
Temp sed basin

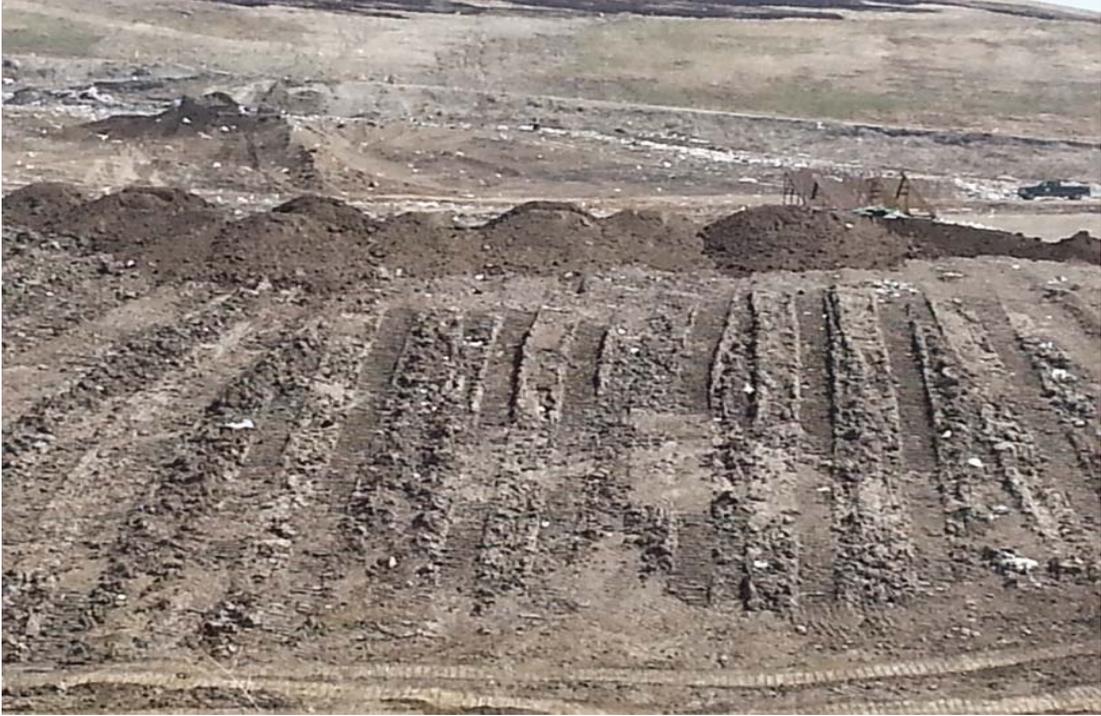
- * Compost on Phase 6, west slope spread will be seeded next week
- * Erosion repairs going on about site
- * Site slopes back dragged end recovered to remove floating material
- * Basin #1 cleaning complete. Removed material drying on slope above Temp sed Basin

Silt from Base #1 drying on slope, C-soils stockpiled for cover at top of slope

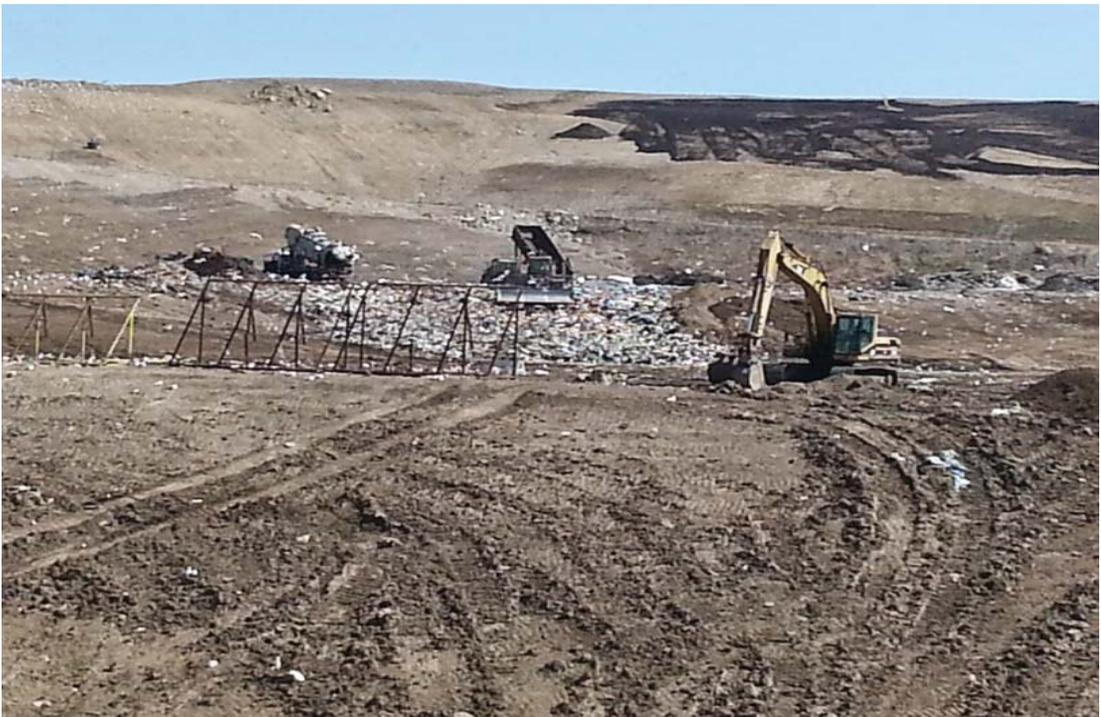
Working face receiving waste

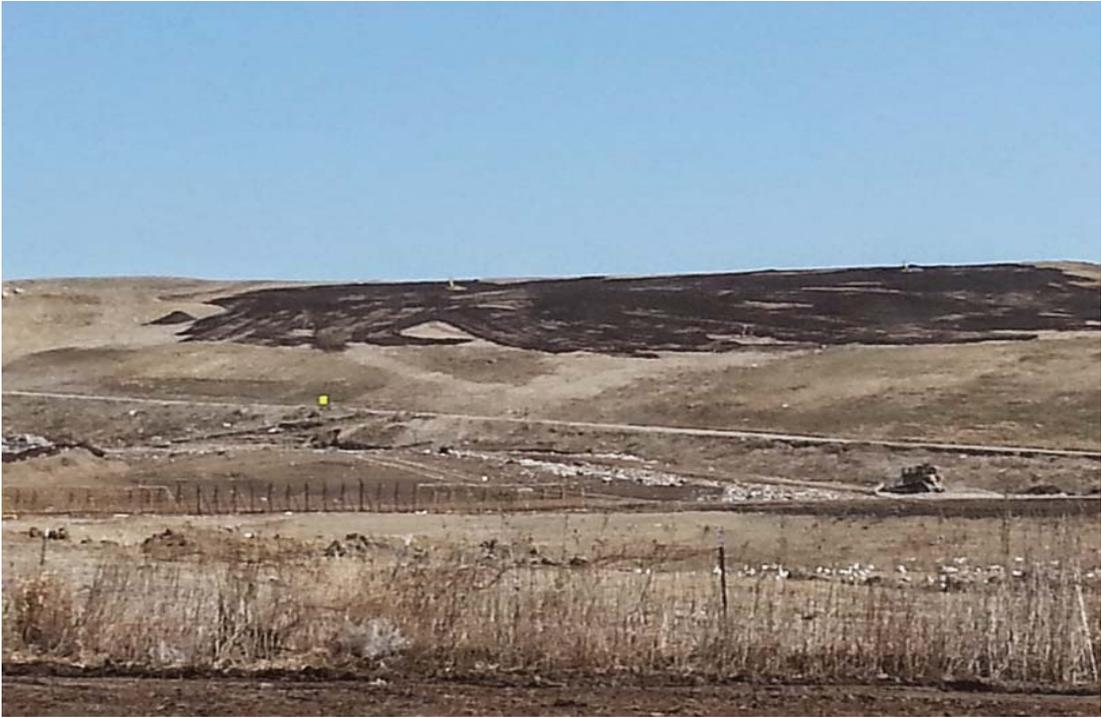
Site viewed from the far West

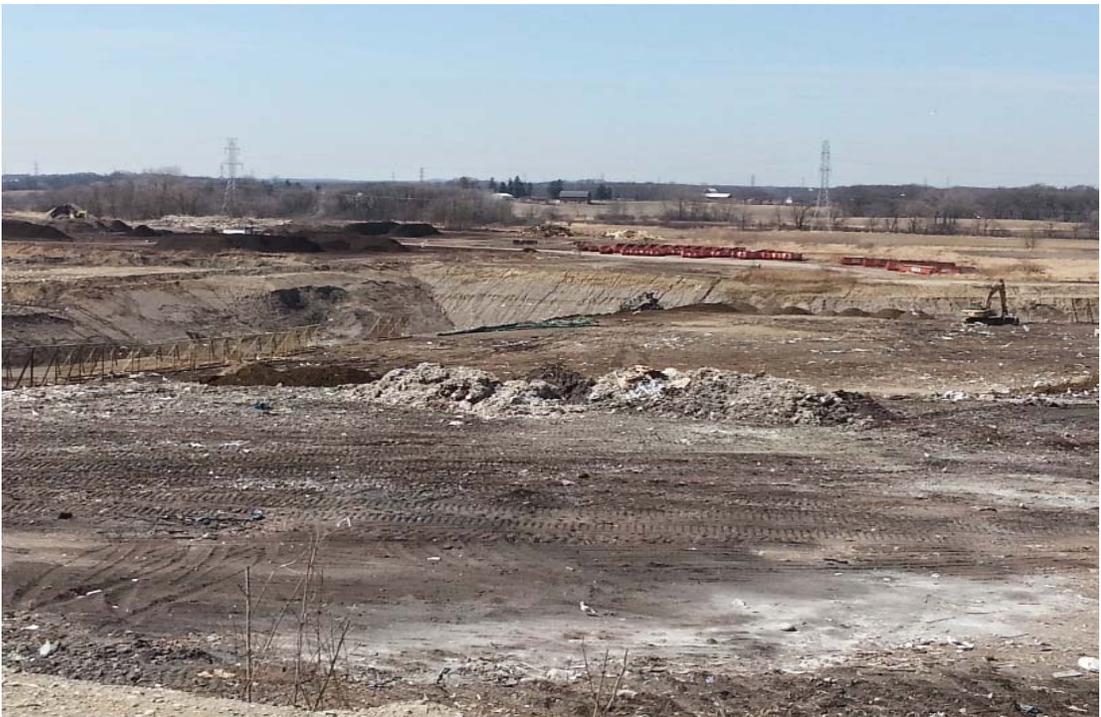
Soils & polyfluff

Poly fluff and soil stockpiles for cover

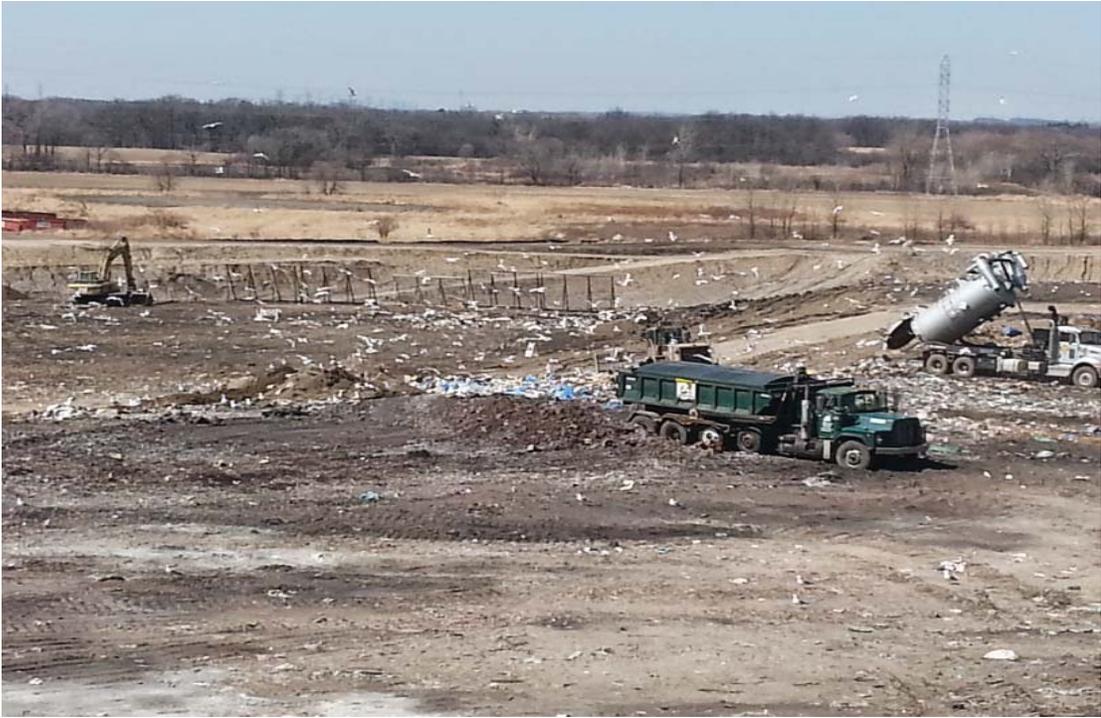
Working face and active area viewed from the East

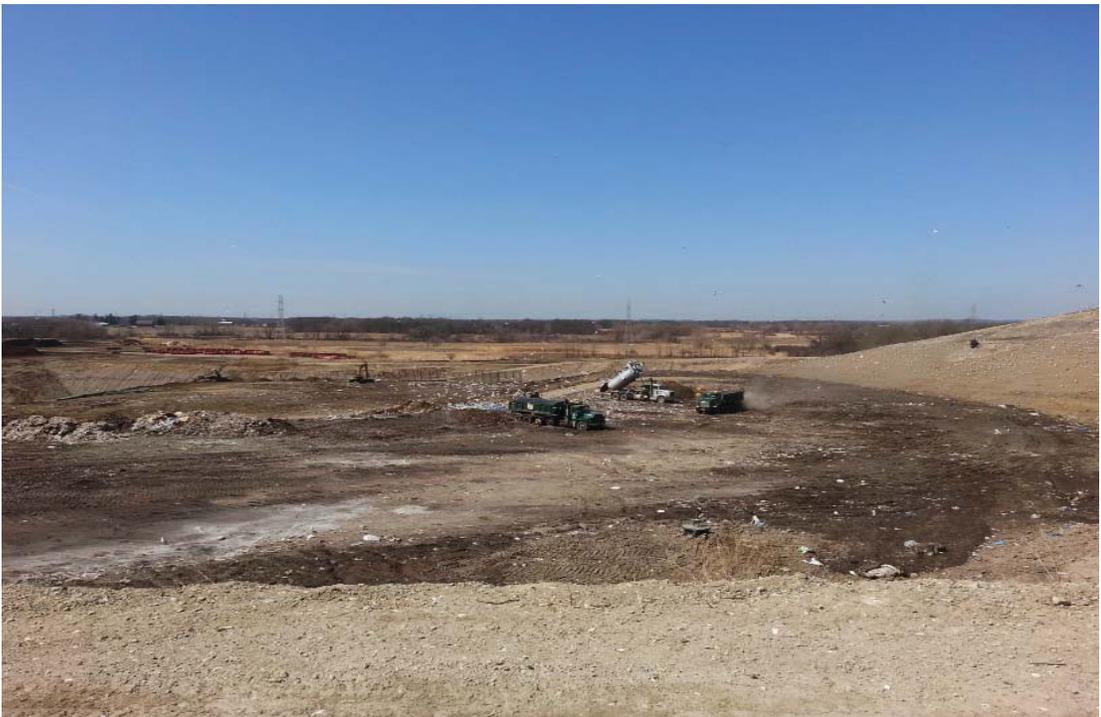
Tipping and active area viewed from the East

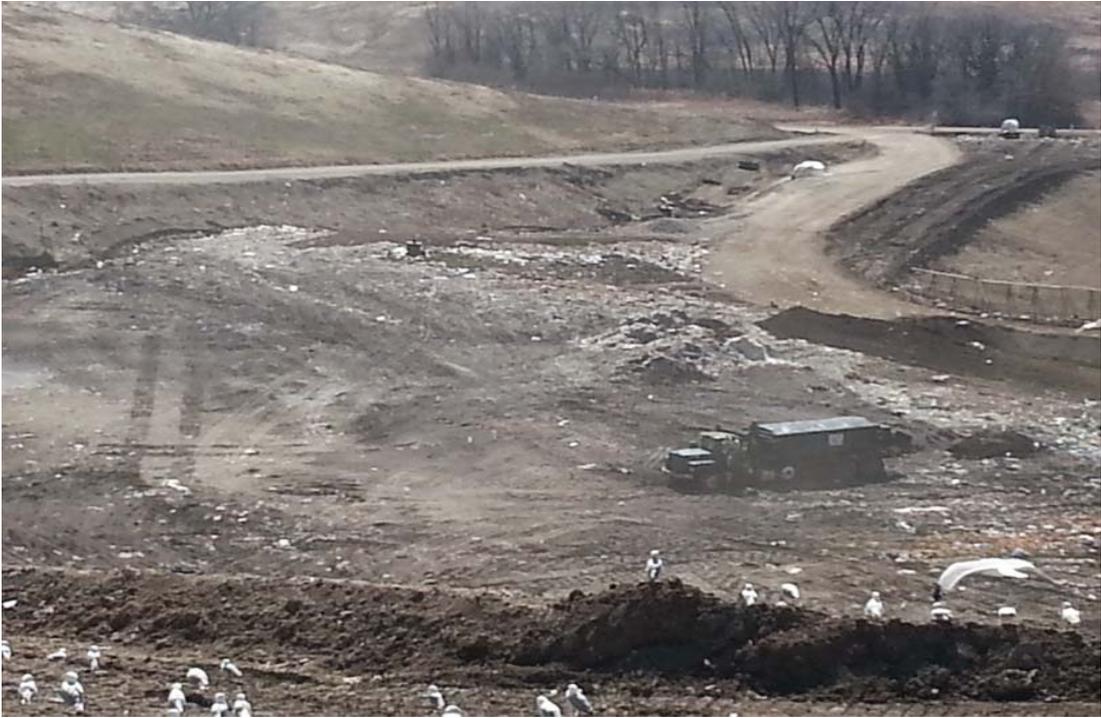
Active area with good cover and travel area

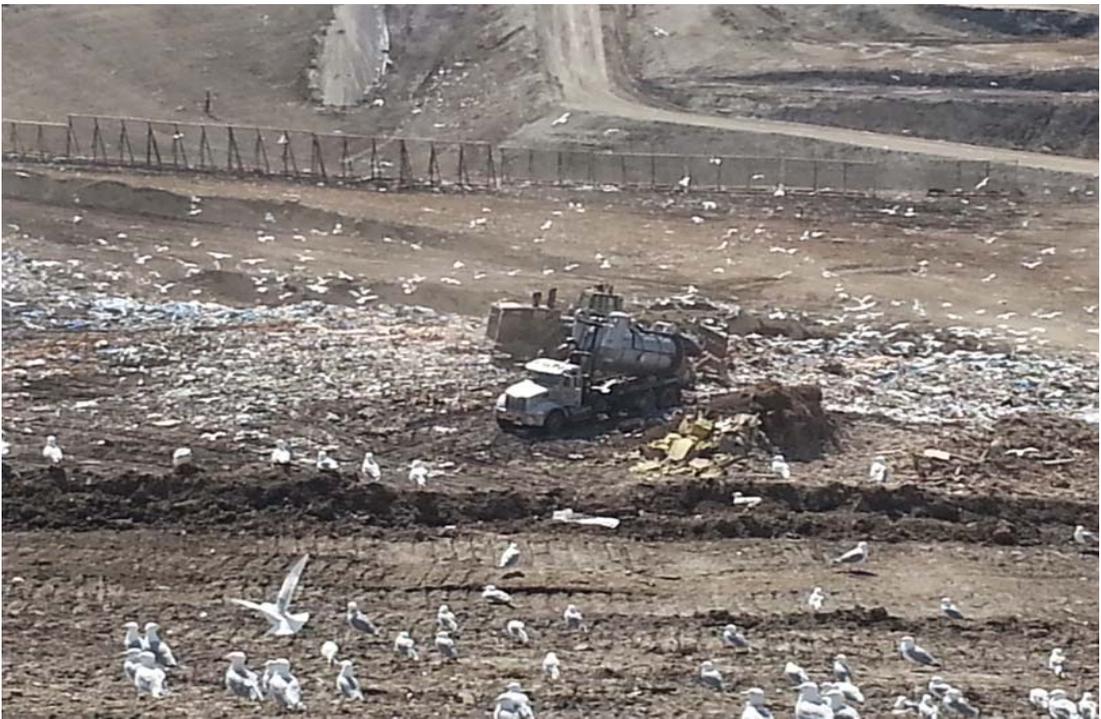
Tipping in working face

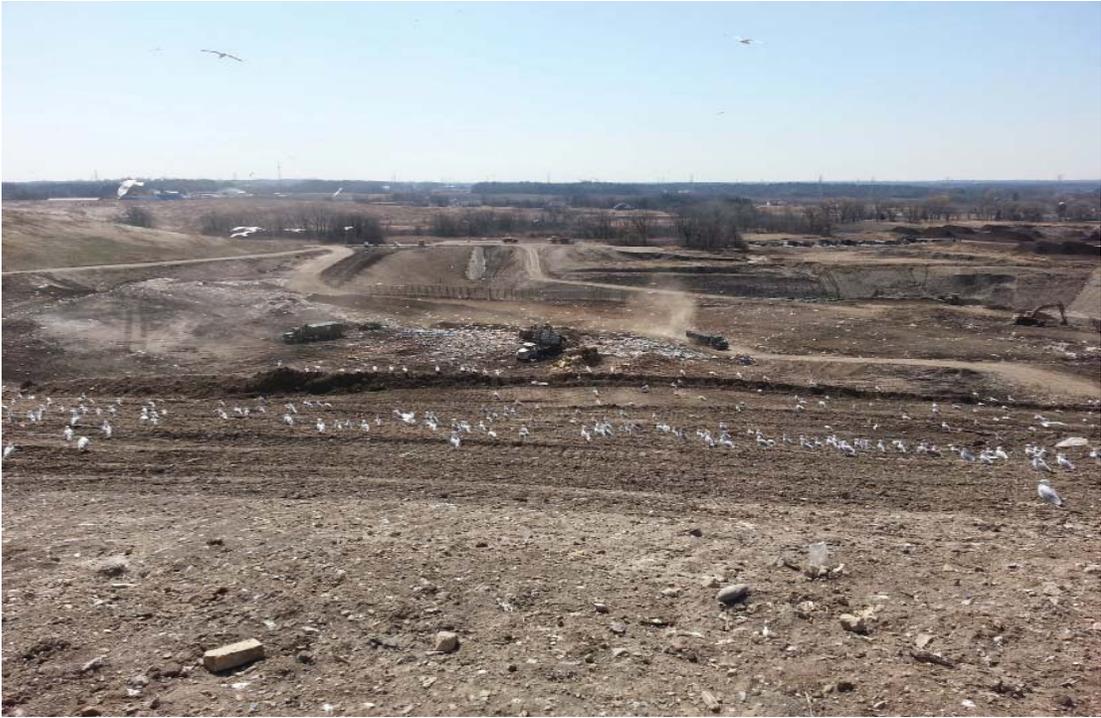
Working face and active area viewed from the North

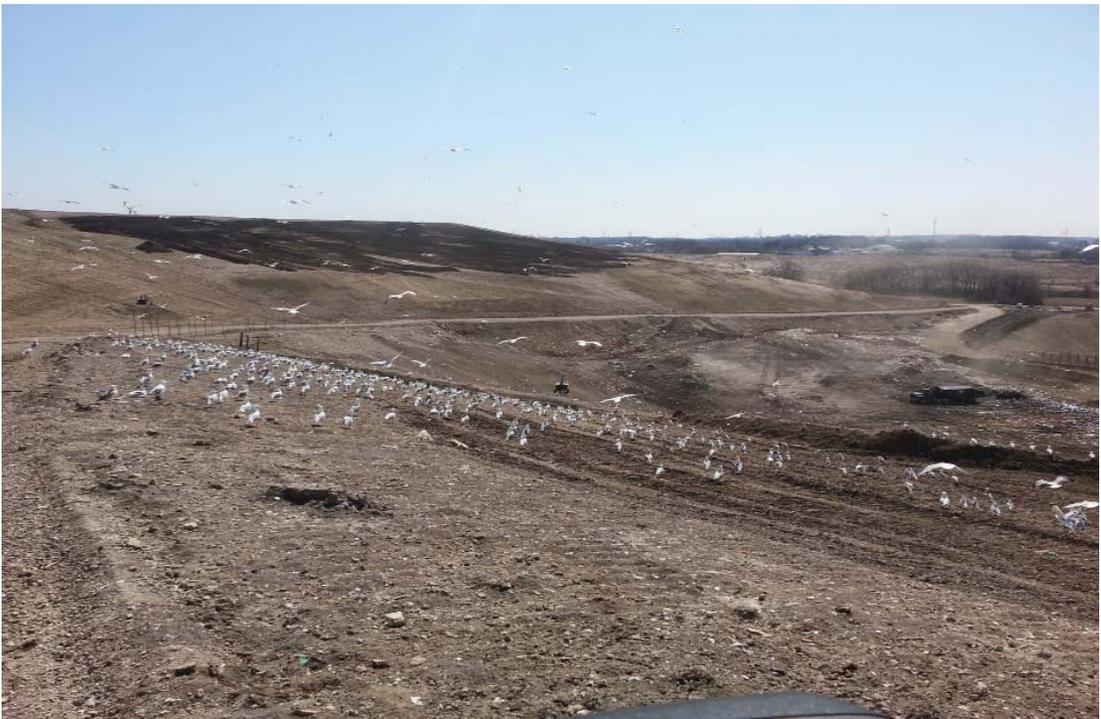
- Compost on Phase 6 West slope has been spread
 - Slope ready for seeding next week
- Erosion repairs on-going in multiple areas of site
- Site slopes have been back-dragged to remove flagging material
- Cleaning complete in Basin #1
 - Removed material drying on slope above temporary sediment basin

Compost spread prior to seeding on West slope of Phase 6
