ADS Emerald Park Landfill Audit Summary

To: ADS Emerald Park Landfill Standing Committee, City of Muskego
FROM: Faith Spear.
COPIES: File
DATE: 07/16/15
PROJECT NUMBER: 1012.10030

ADVANCED DISPOSAL SERVICES EMERALD PARK LANDFILL
 LANDFILL OPERATIONS AUDIT FORM
 CITY OF MUSKEGO

**ADVANCED DISPOSAL SERVICES
EMERALD PARK LANDFILL / CITY OF MUSKEGO
AUDIT PHOTOS**

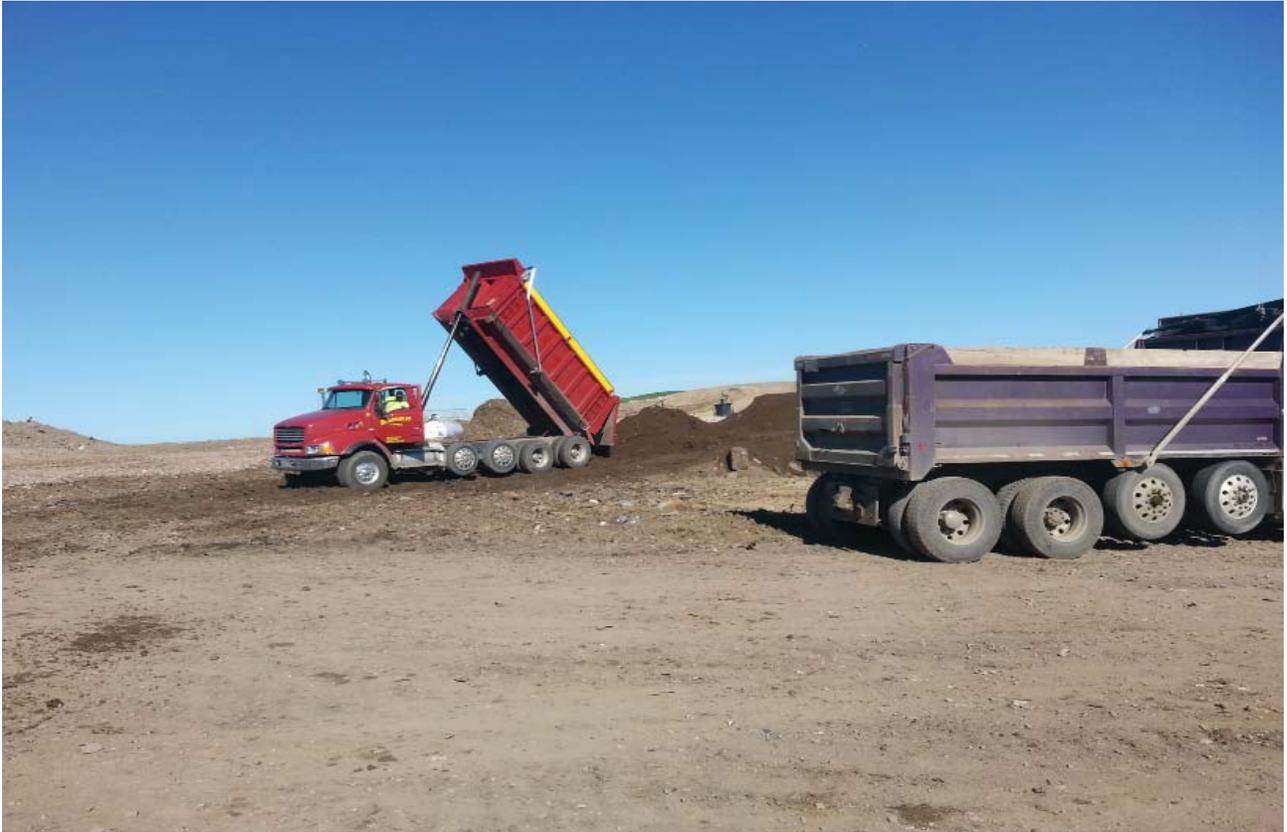
Soils being tipped after standard hours, approved by Committee.

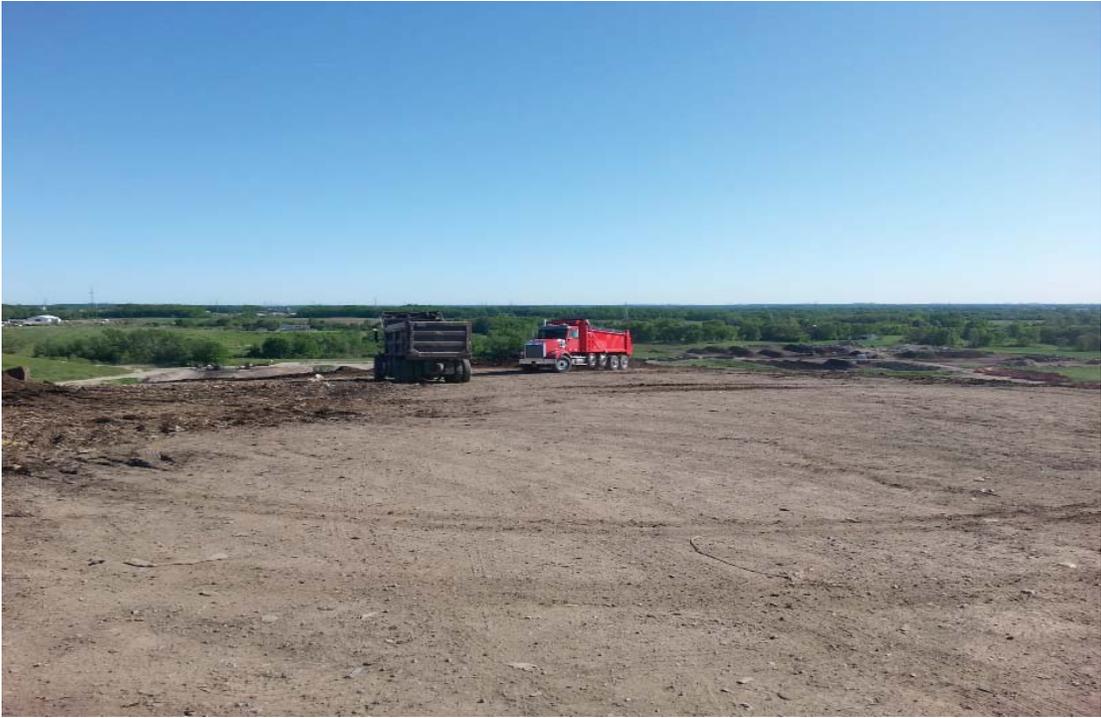
Tipping area in Phase 7

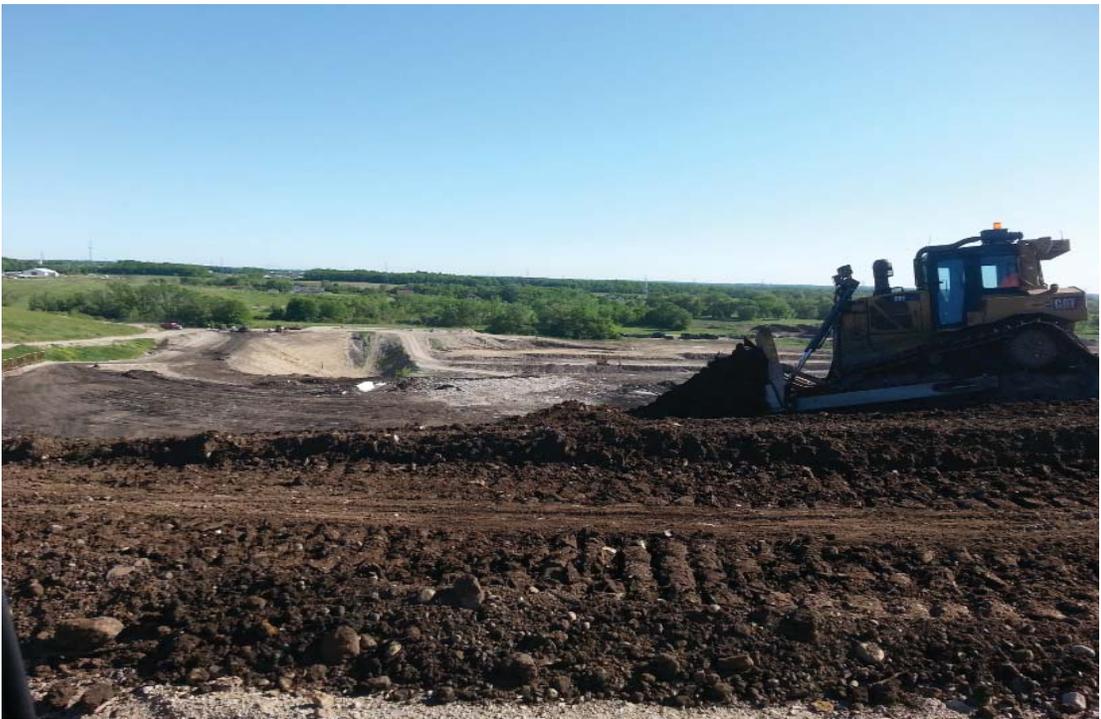
Dozer spreading received soils

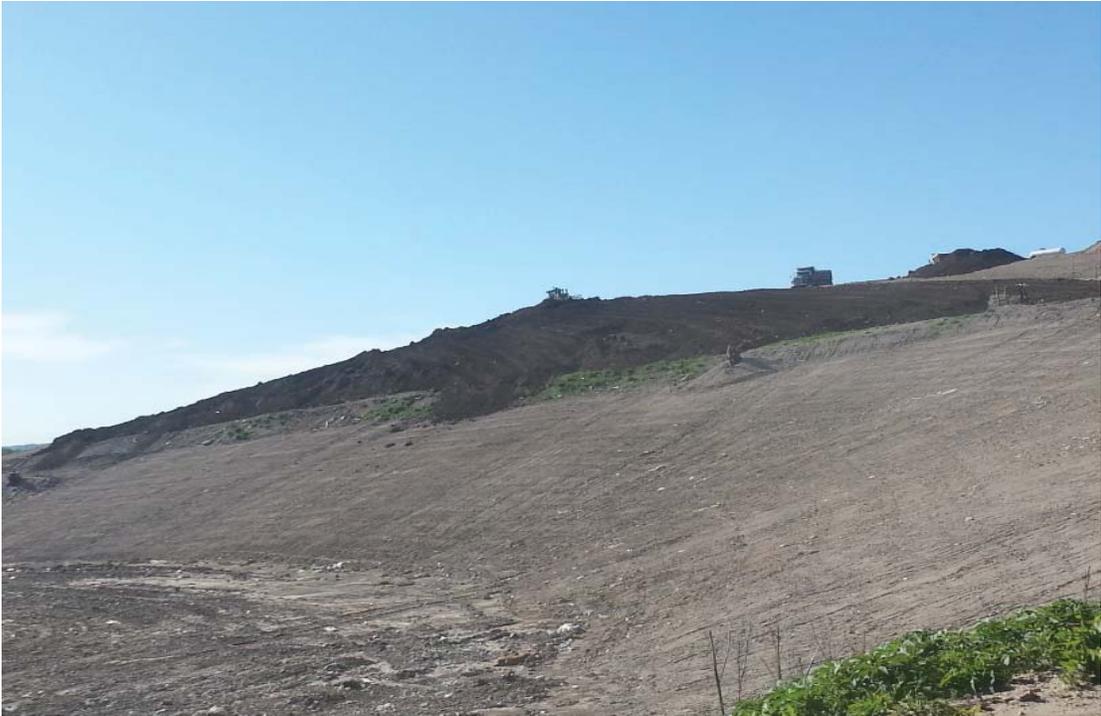
Soils being tipped and spread on the very top of Phase 7

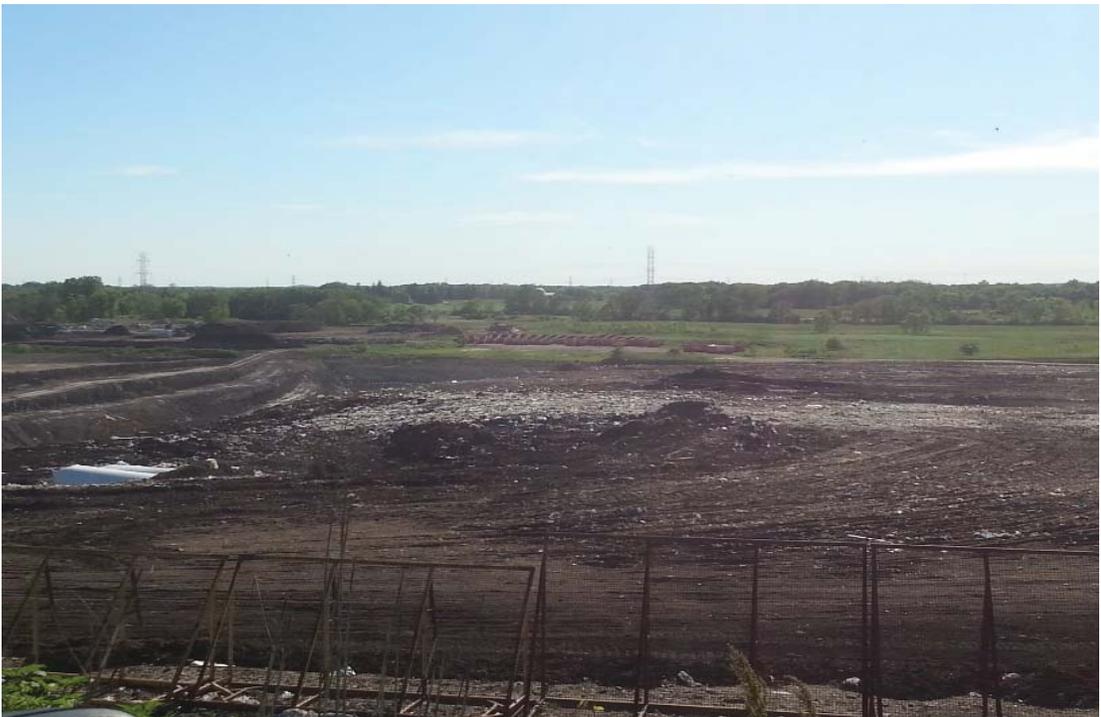
Active area viewed from the East

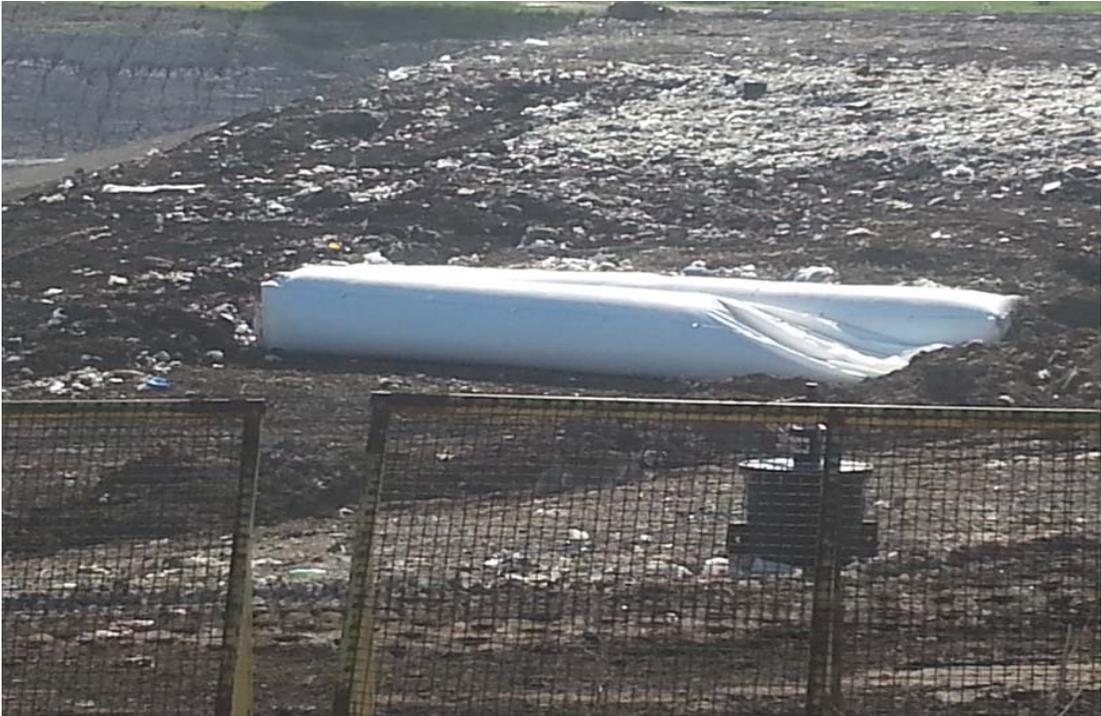
Bags for containing perlite prior to entombment

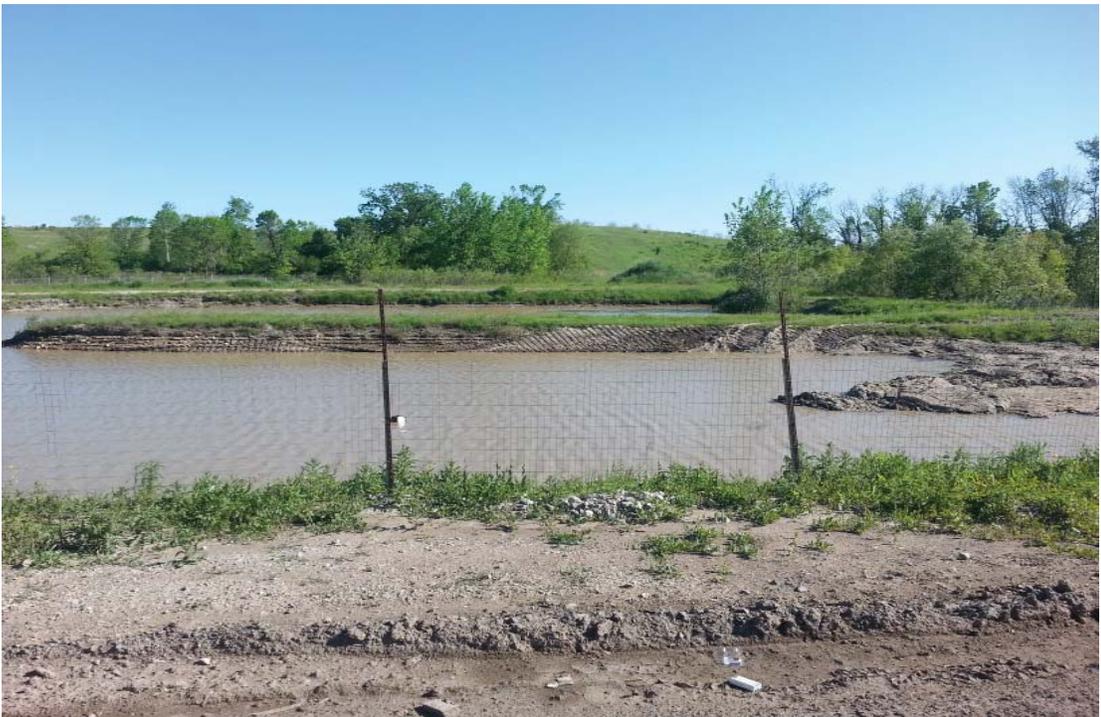
Basin elevation raised by rains, cleaning set back until drier conditions
