ADS Emerald Park Landfill Audit Summary

To: ADS Emerald Park Landfill Standing Committee, City of Muskego
FROM: Faith Spear.
COPIES: File
DATE: 07/28/15
PROJECT NUMBER: 1012.10030

Attached is the audit report for activities at the ADS Emerald Park Landfill for the week of June 21, 2015. The audit was performed at 7:50 AM on **June 26, 2015** by Jo Spear, Jr. in the presence of Michael Hackney, General Manager.

**ADVANCED DISPOSAL SERVICES
EMERALD PARK LANDFILL / CITY OF MUSKEGO
AUDIT PHOTOS**

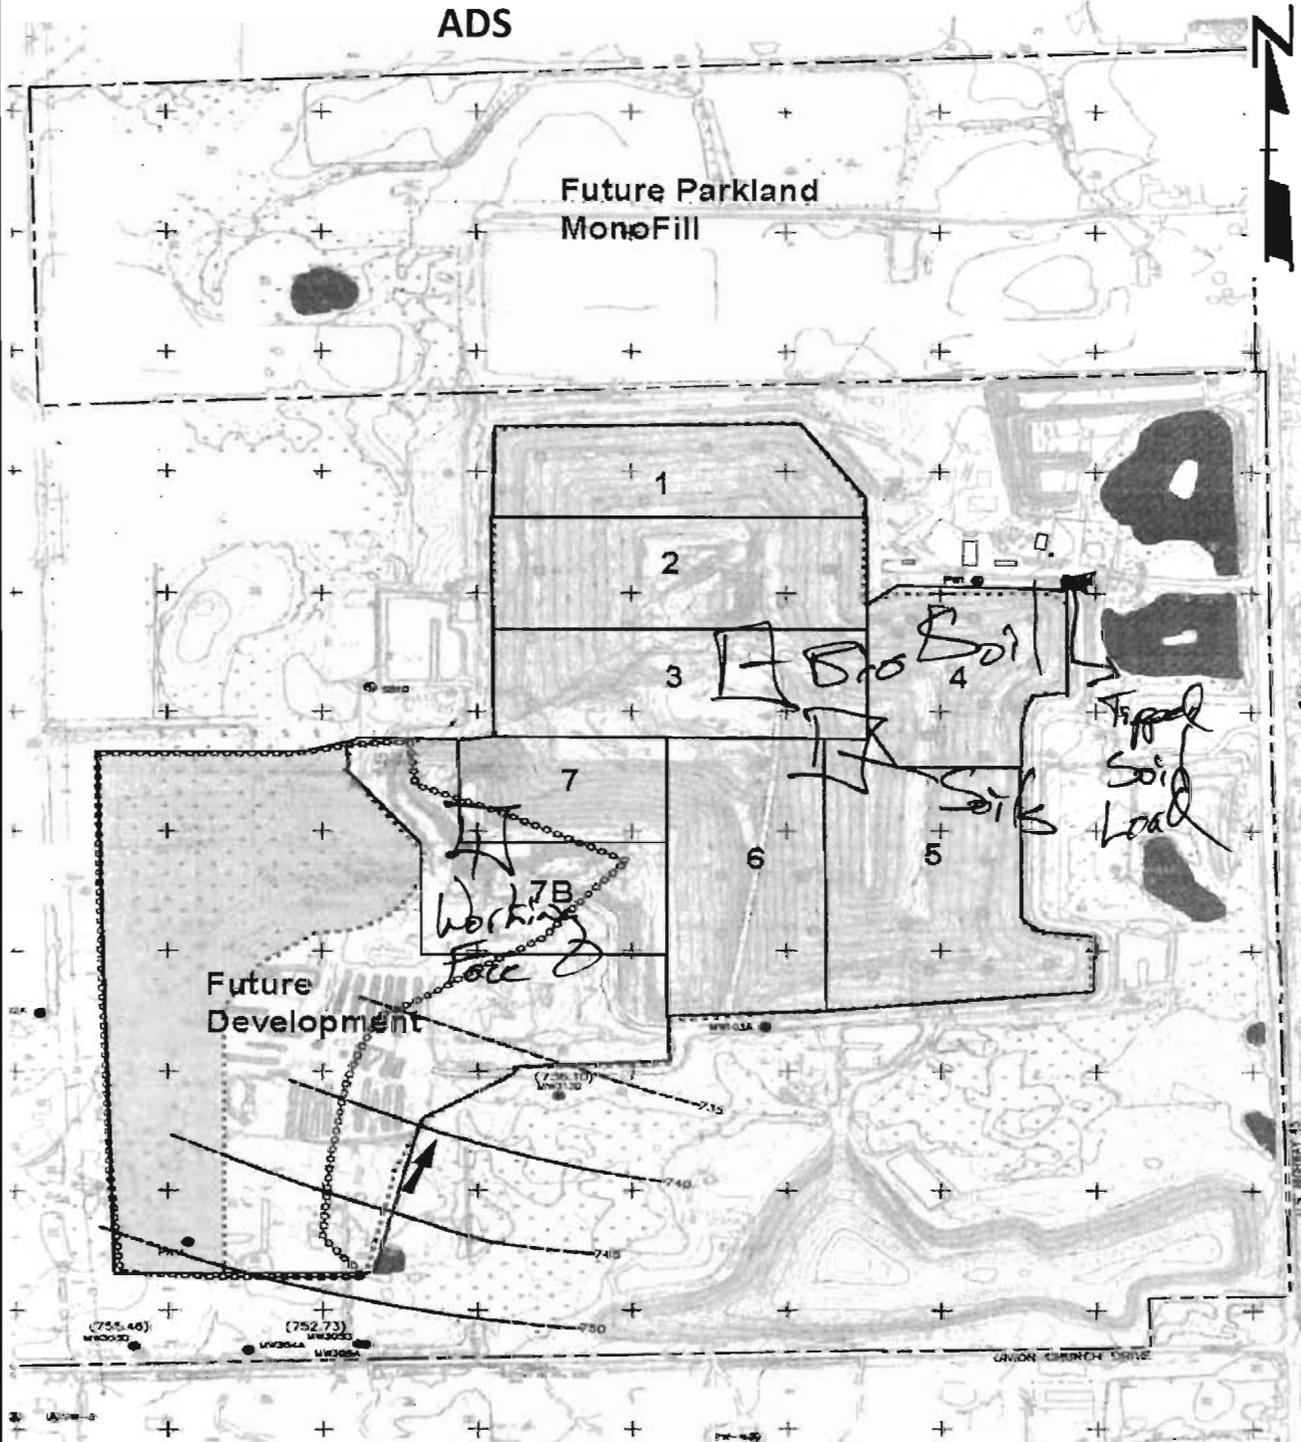
Advanced Disposal Services Emerald Park Landfill
Landfill Audit Map
City of Muskego
Project No. 1020.10030

7B
Working
Face

Soil
Load

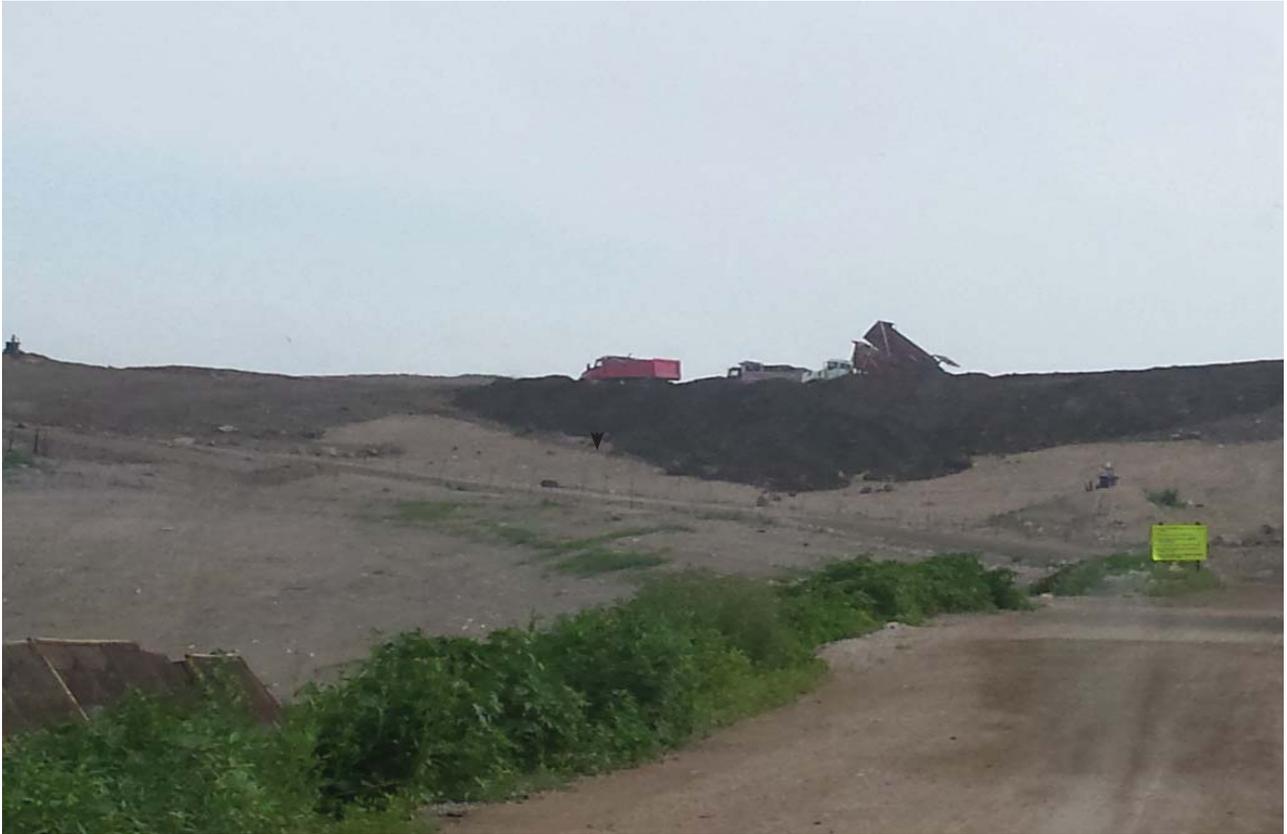
Soil tipping viewed from the South, rapid elevation changes occurring

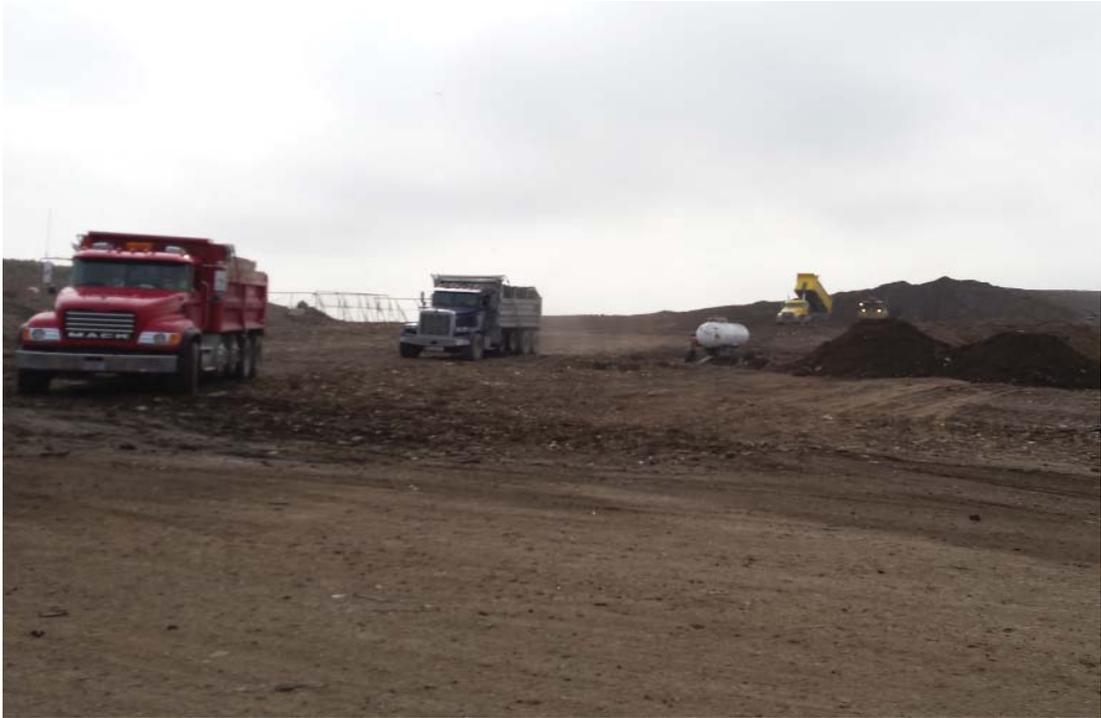
Cover soil being tipped across the tops of Phases 4 thru 7

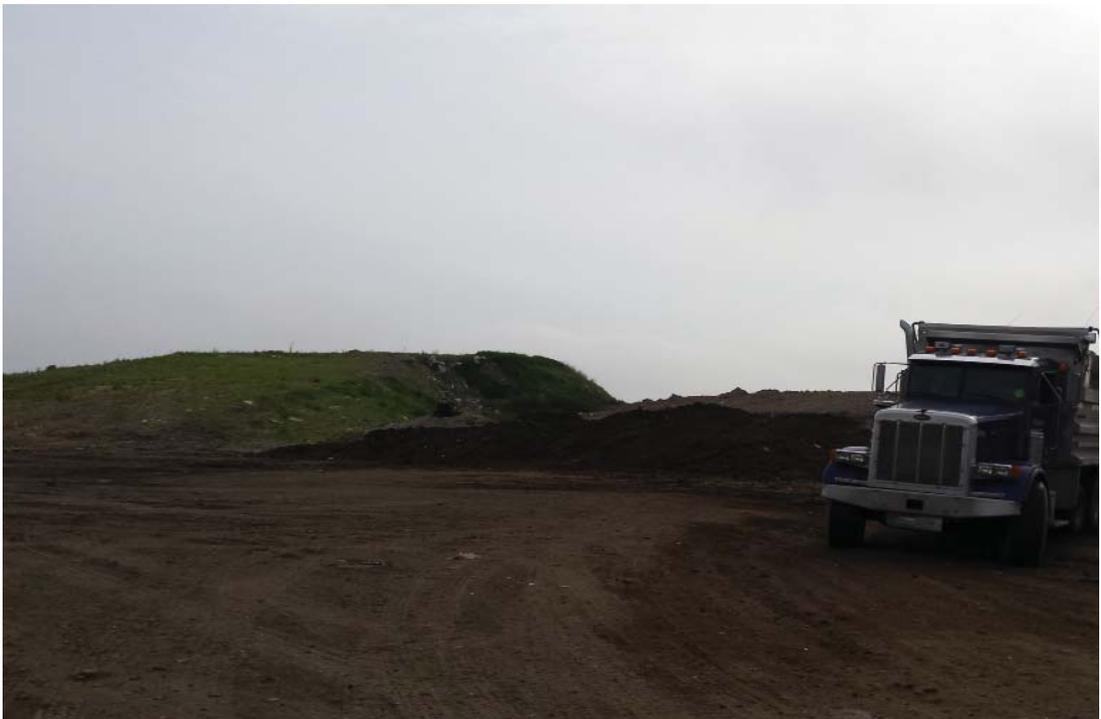
Bio soil pile on left

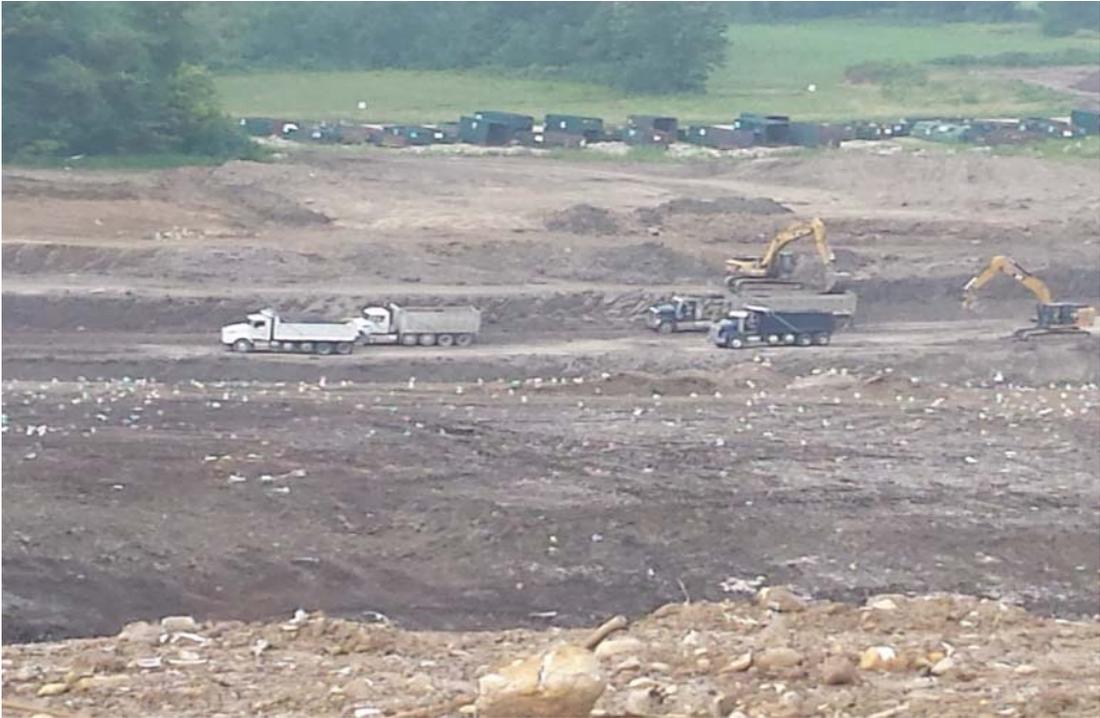
Back haul ongoing, excavators clearing future Phase 8

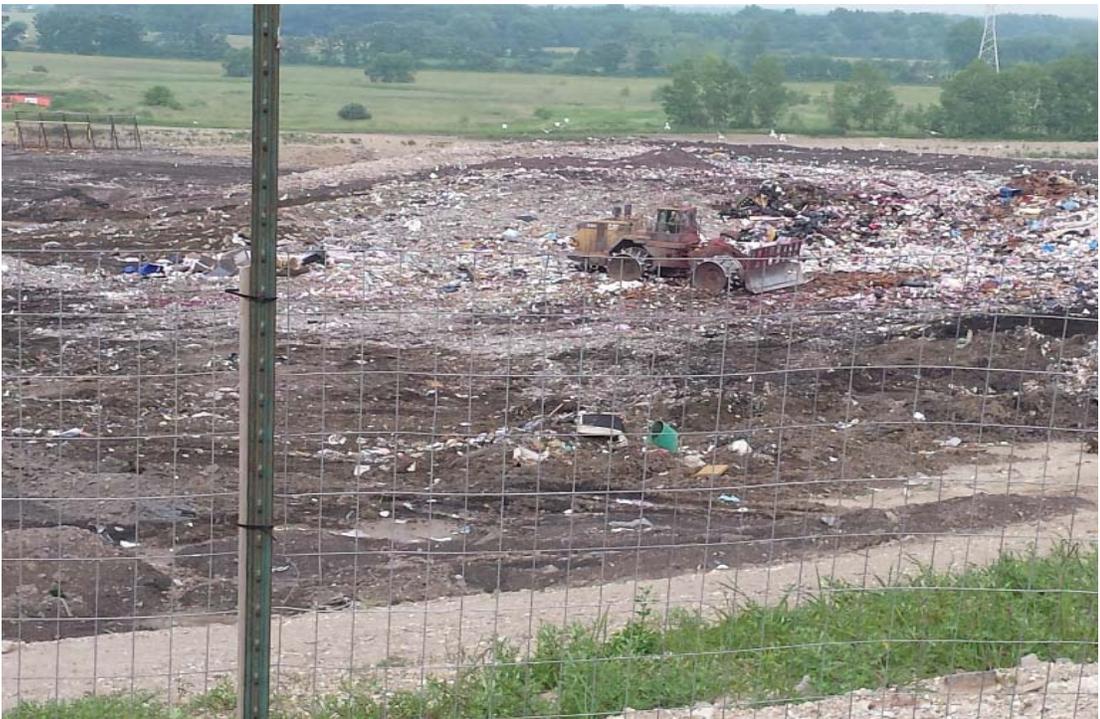
Working face viewed from East

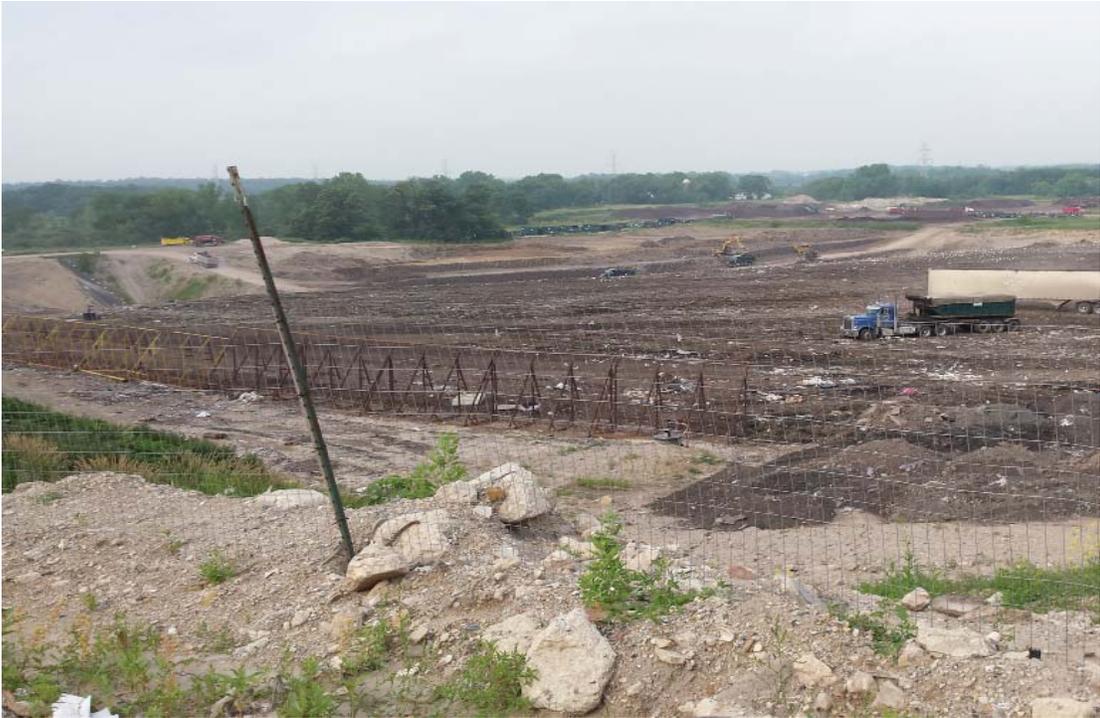
Access to active area, very clean cover
