ADS Emerald Park Landfill Audit Summary

To: ADS Emerald Park Landfill Standing Committee, City of Muskego
FROM: Faith Spear.
COPIES: File
DATE: 07/28/15
PROJECT NUMBER: 1012.10030

Attached is the audit report for activities at the ADS Emerald Park Landfill for the week of June 29, 2014. The audit was performed at 9:27 AM on **June 30, 2015** by Jo Spear, Jr. in the presence of Michael Hackney, General Manager.

**ADVANCED DISPOSAL SERVICES
EMERALD PARK LANDFILL / CITY OF MUSKEGO
AUDIT PHOTOS**

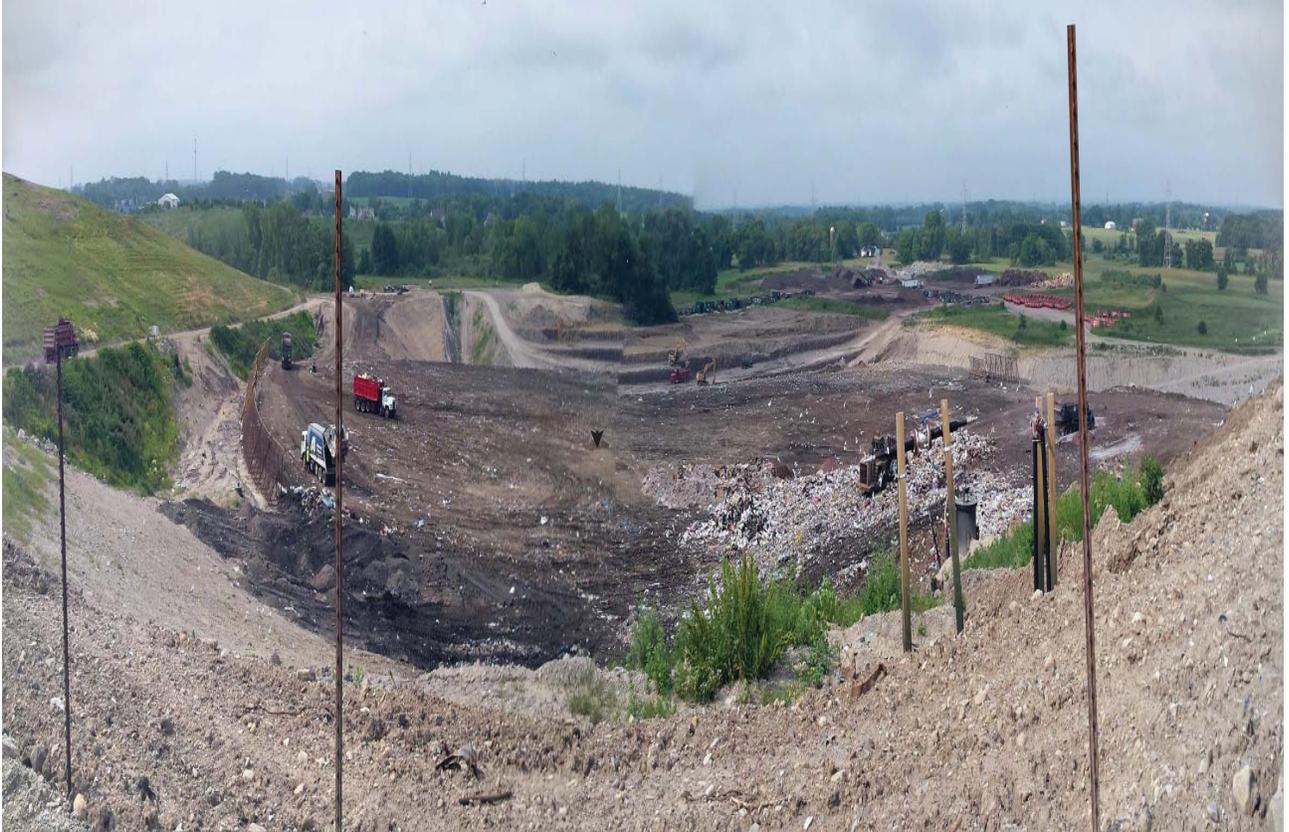
Panoramic view

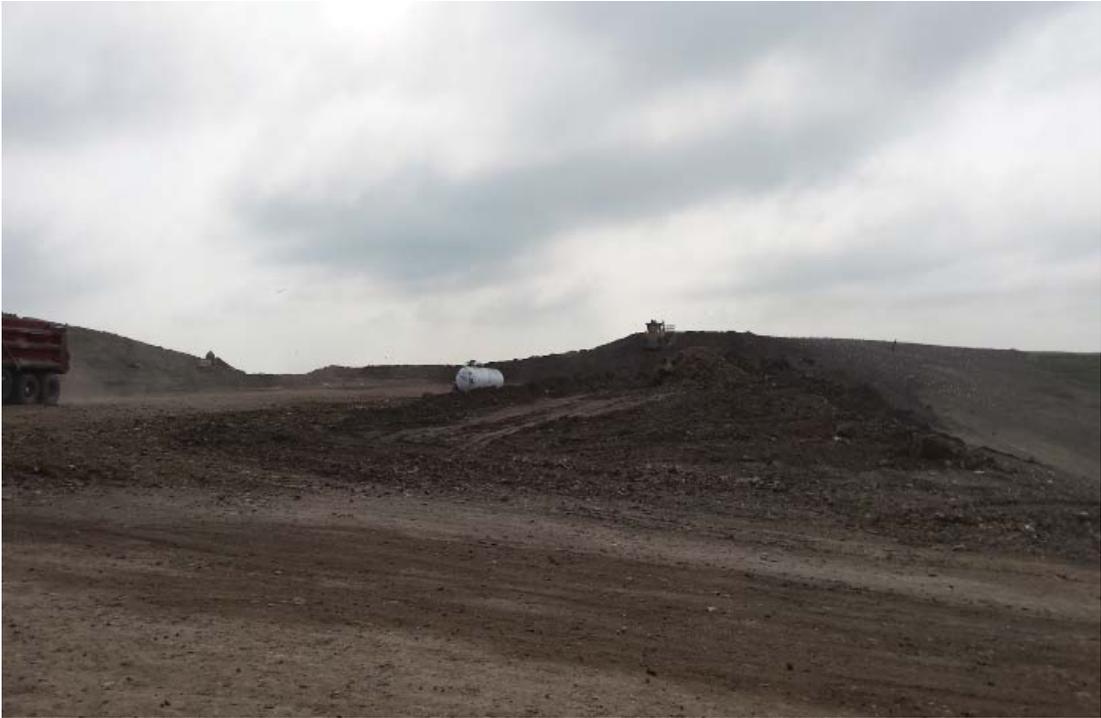
Tipping area on Phase 4/5 receiving soils

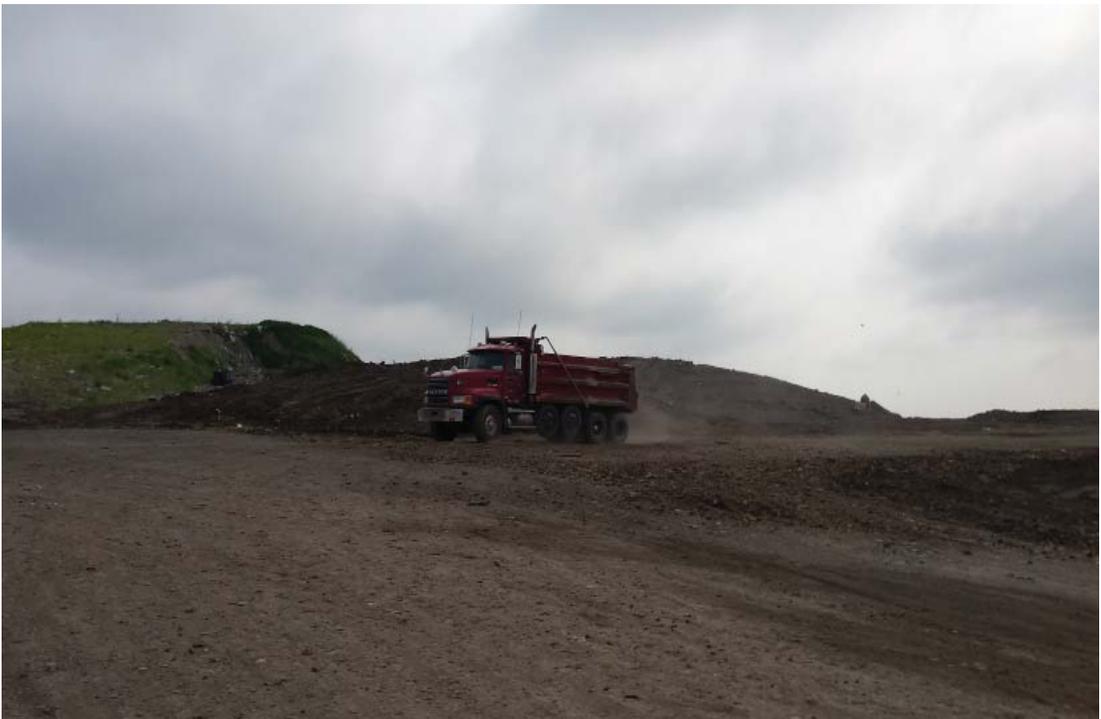
Bio soils and tipping truck

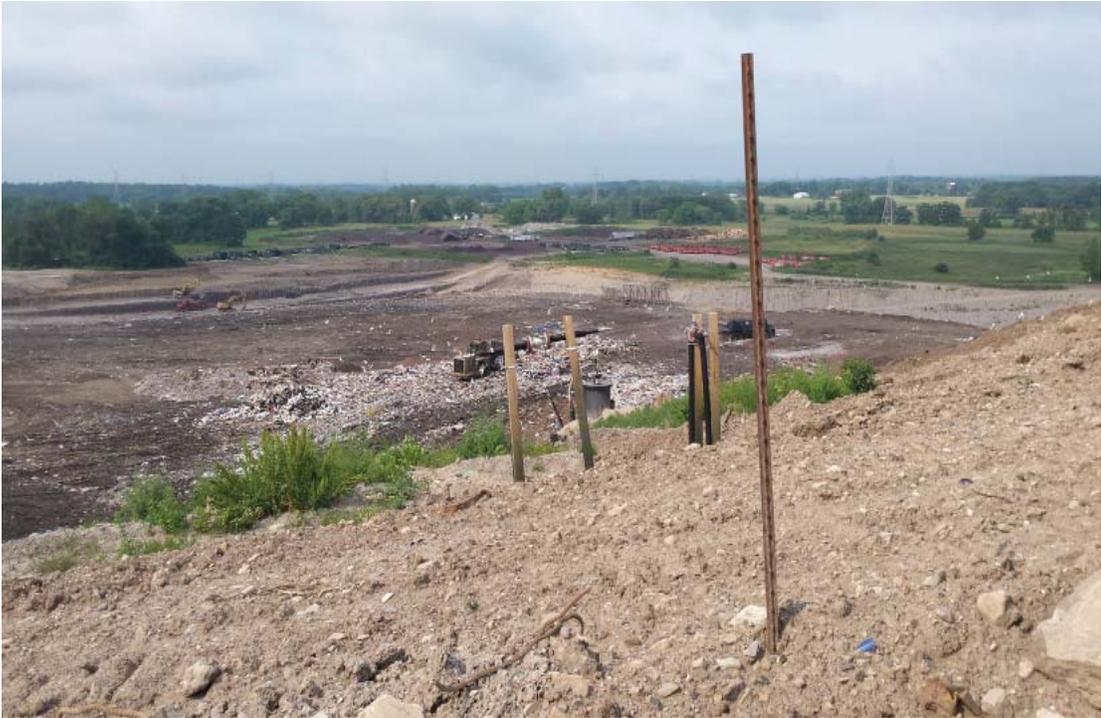
Working face viewed from North

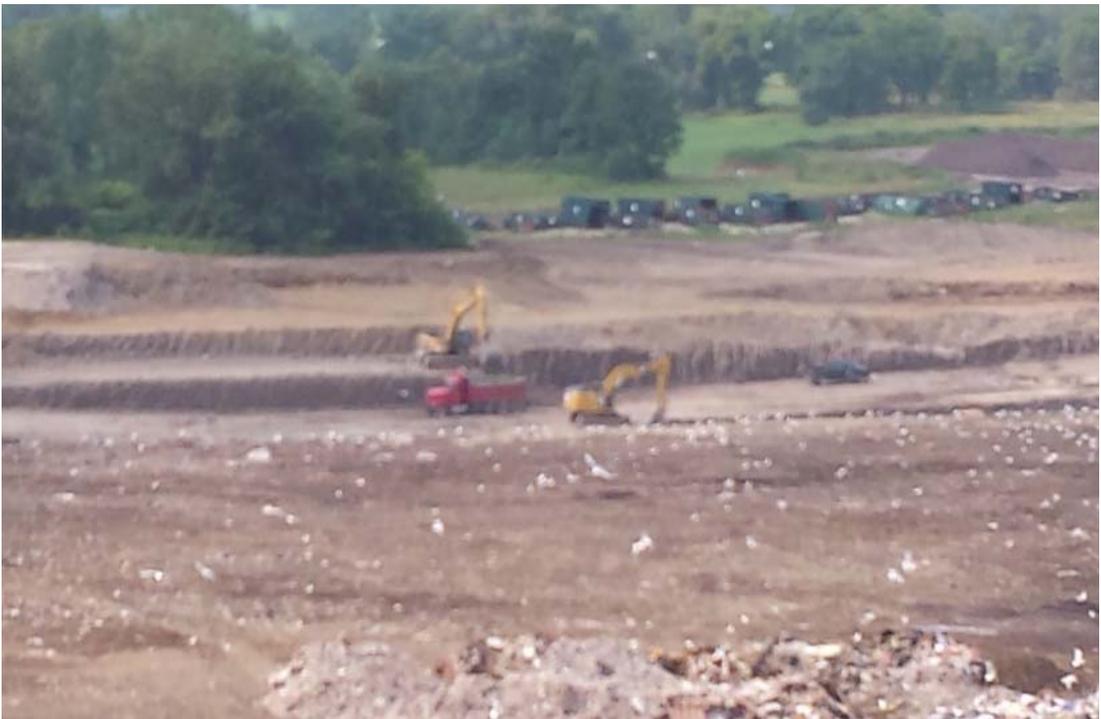
Excavation in future Phase 8 ongoing

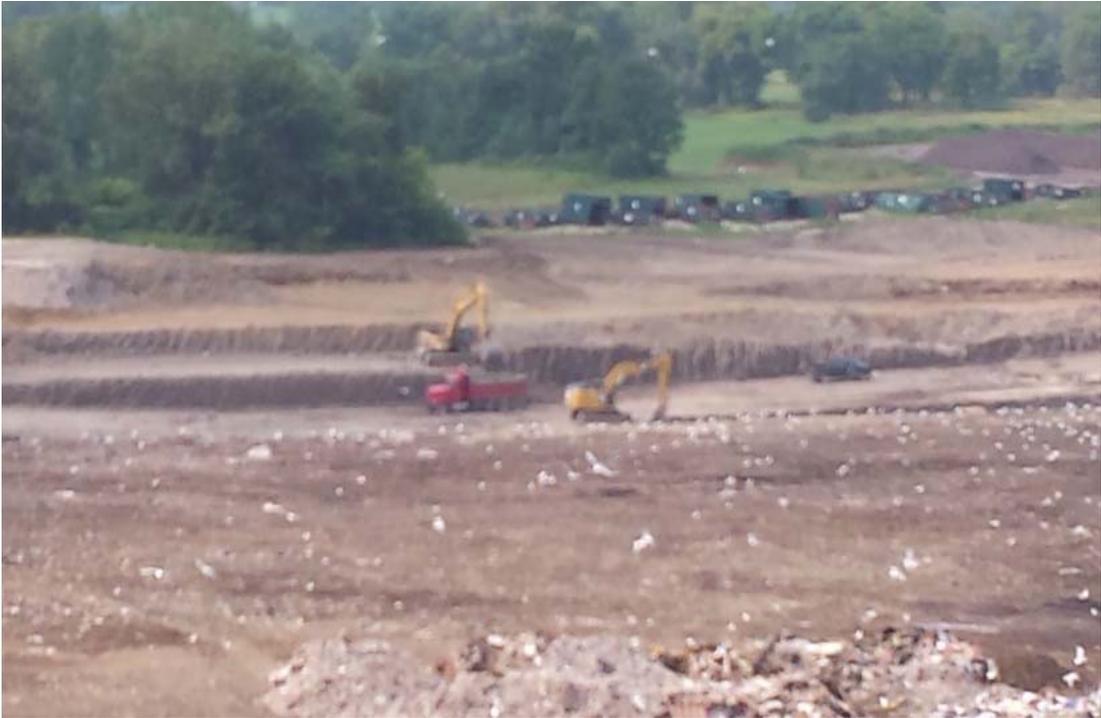
Future Phase 8, ongoing excavation

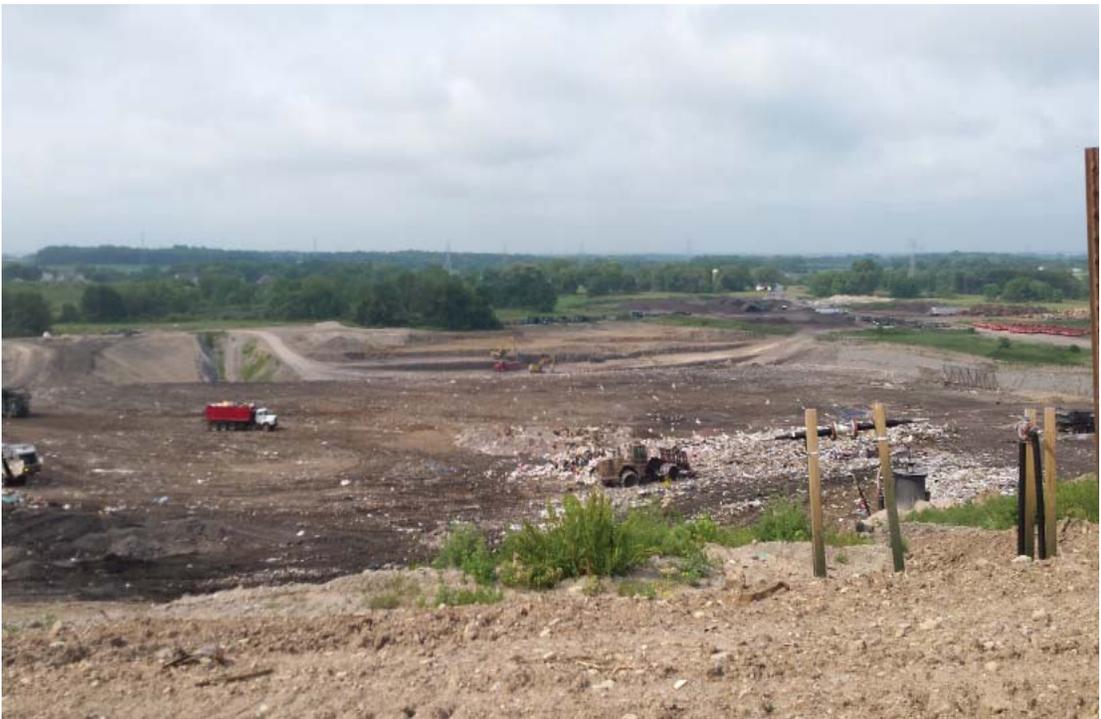
Phase 7 and 7B viewed from North

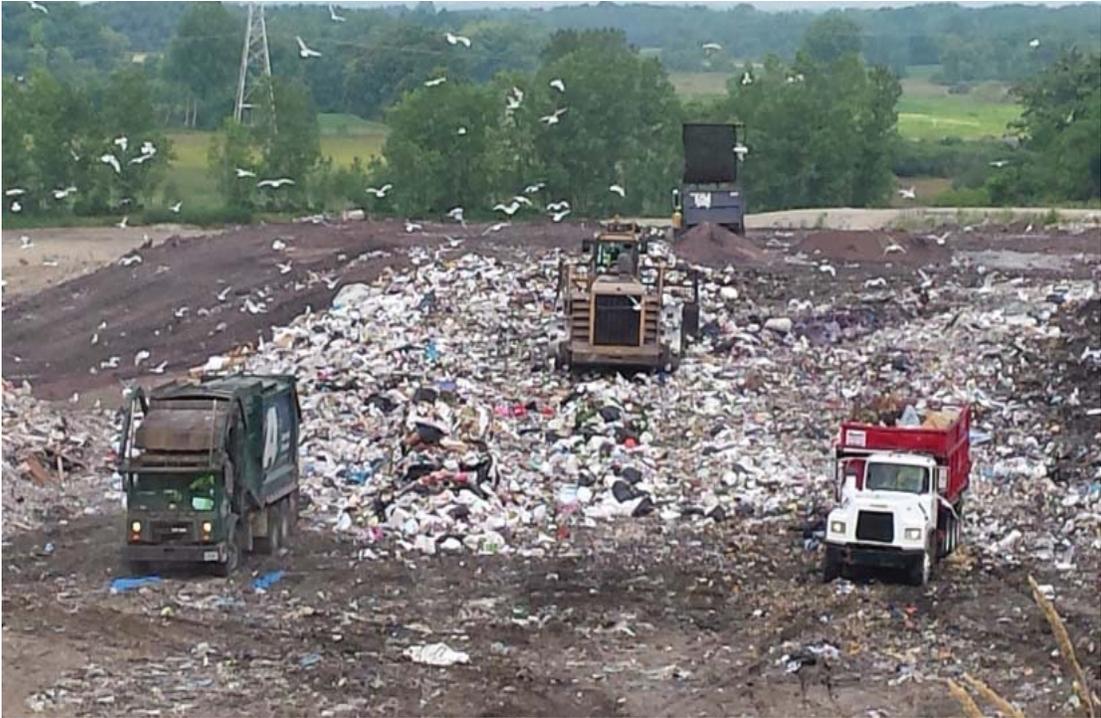
Working face in Phase 7

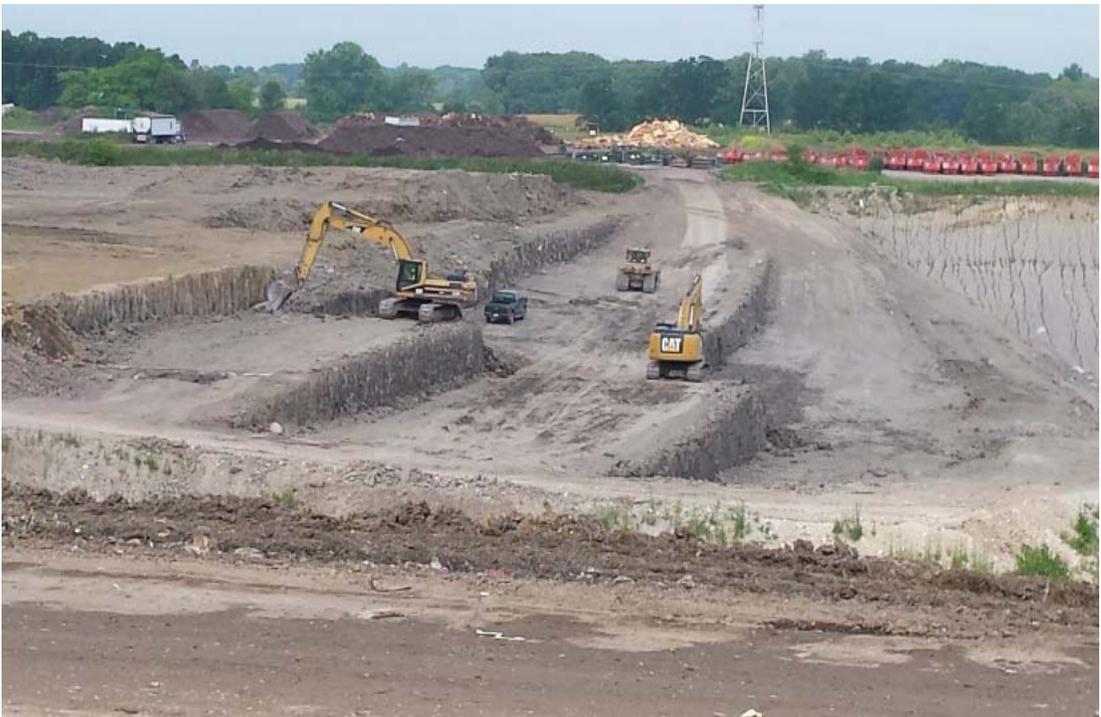
Bench excavation of Phase 8, soils involved in back haul
