### ADS Emerald Park Landfill Audit Summary

**To:** ADS Emerald Park Landfill Standing Committee, City of Muskego  
**FROM:** Faith Spear.  
**COPIES:** File  
**DATE:** 09/28/15  
**PROJECT NUMBER:** 1012.10030

**ADVANCED DISPOSAL SERVICES  
EMERALD PARK LANDFILL / CITY OF MUSKEGO  
AUDIT PHOTOS**

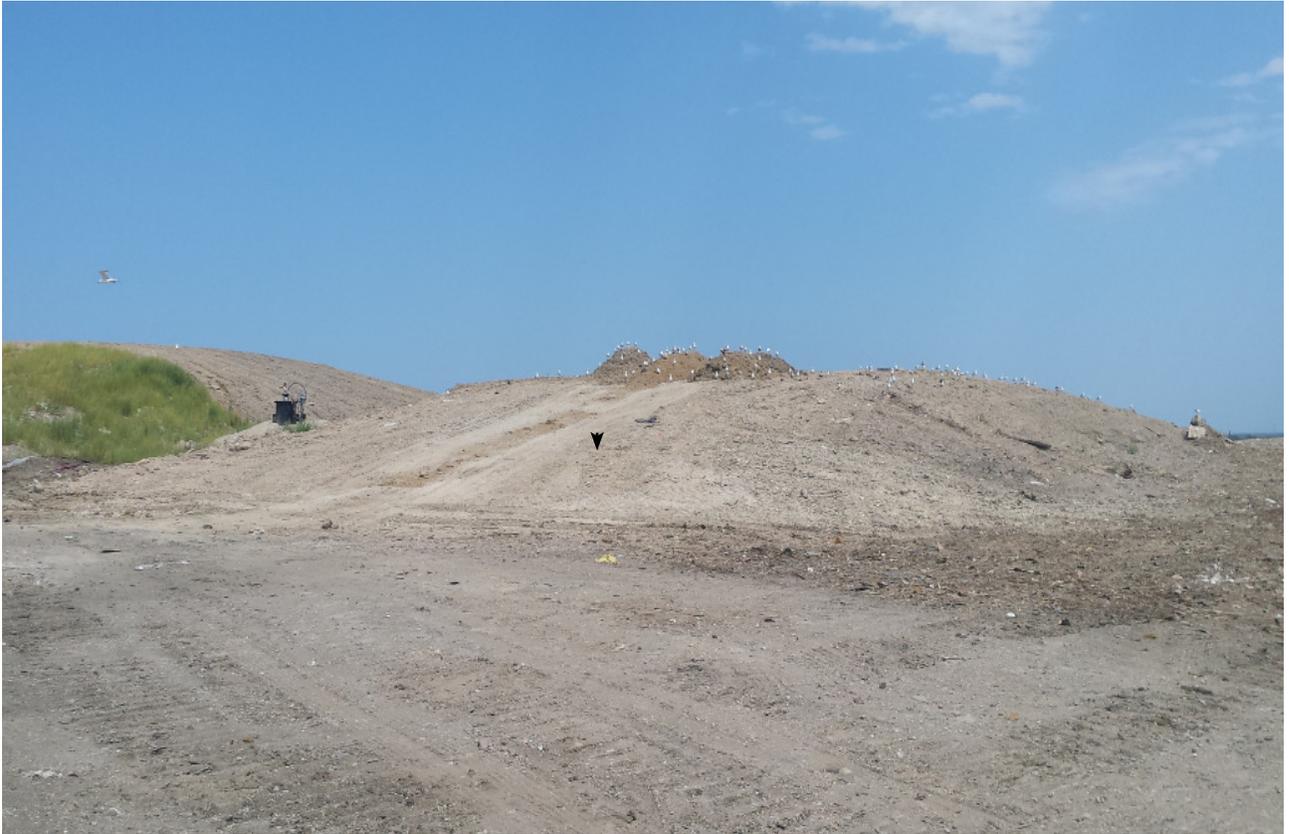
Bio-soil pile, received on three loads this week.

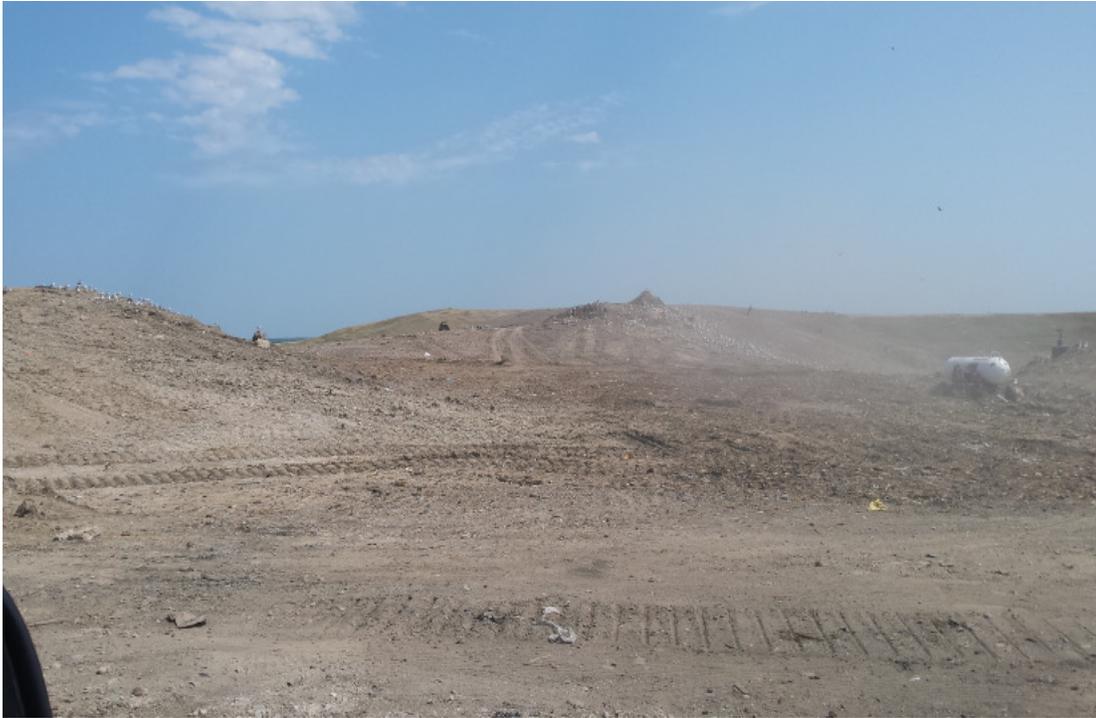
Soils on Phase 5&6, shapped to minimize erosion; not receiving additional material.

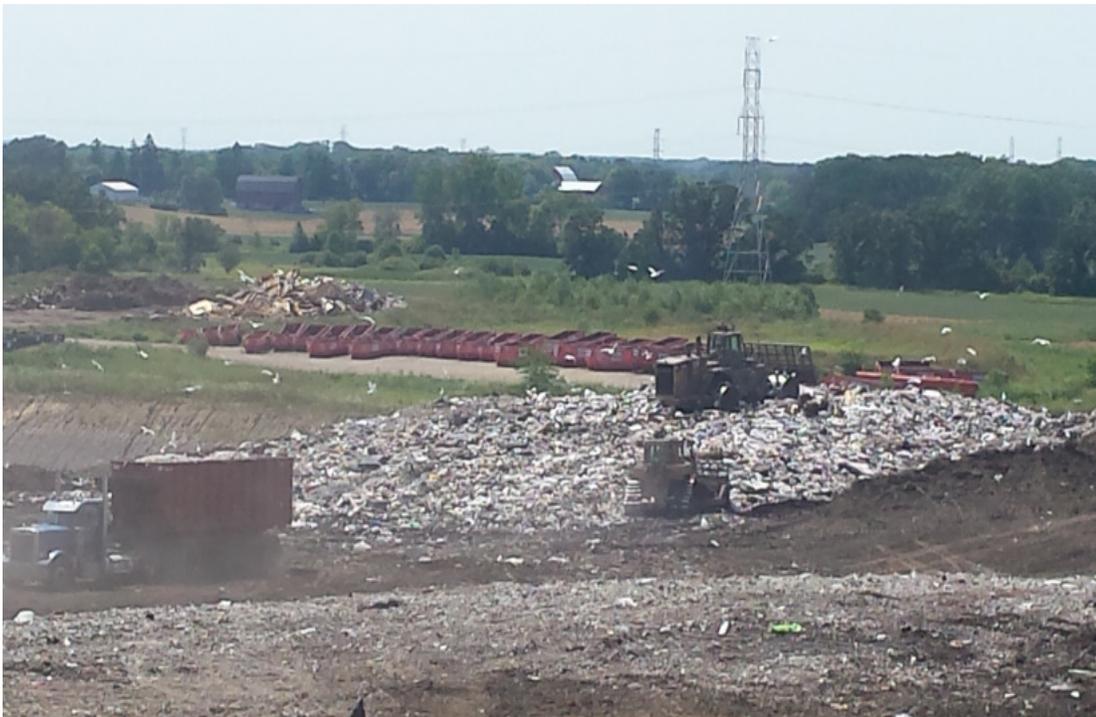
Active side of working face, viewed from East

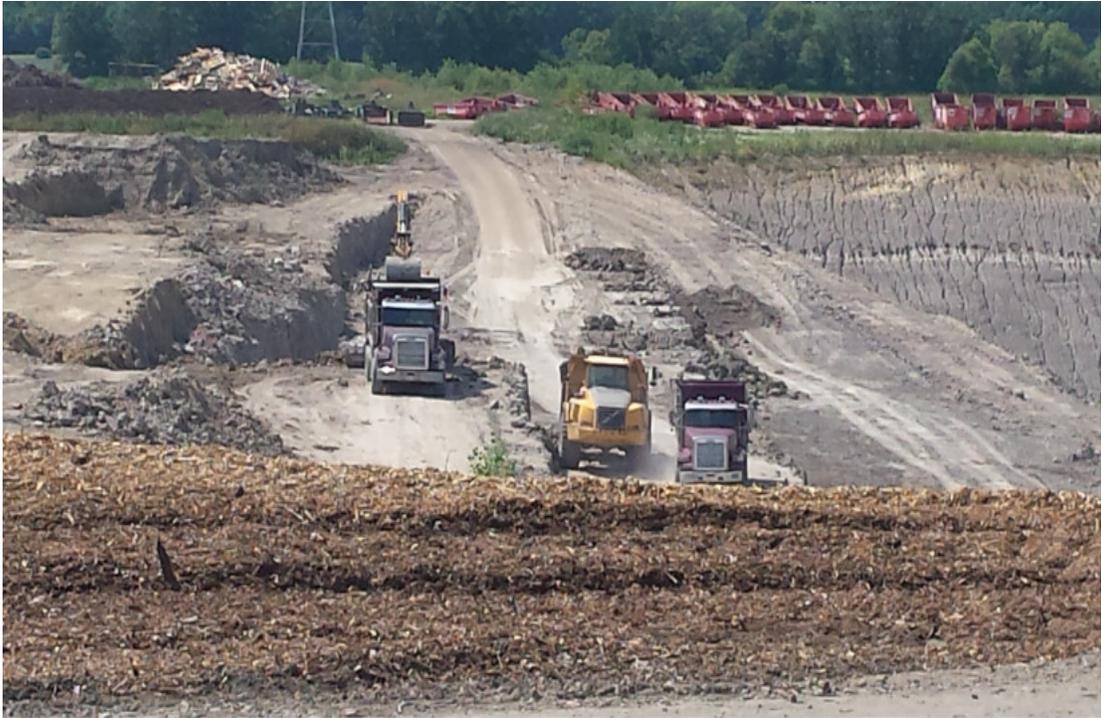
Clay being excavated for back haul and for use as intermediate cover

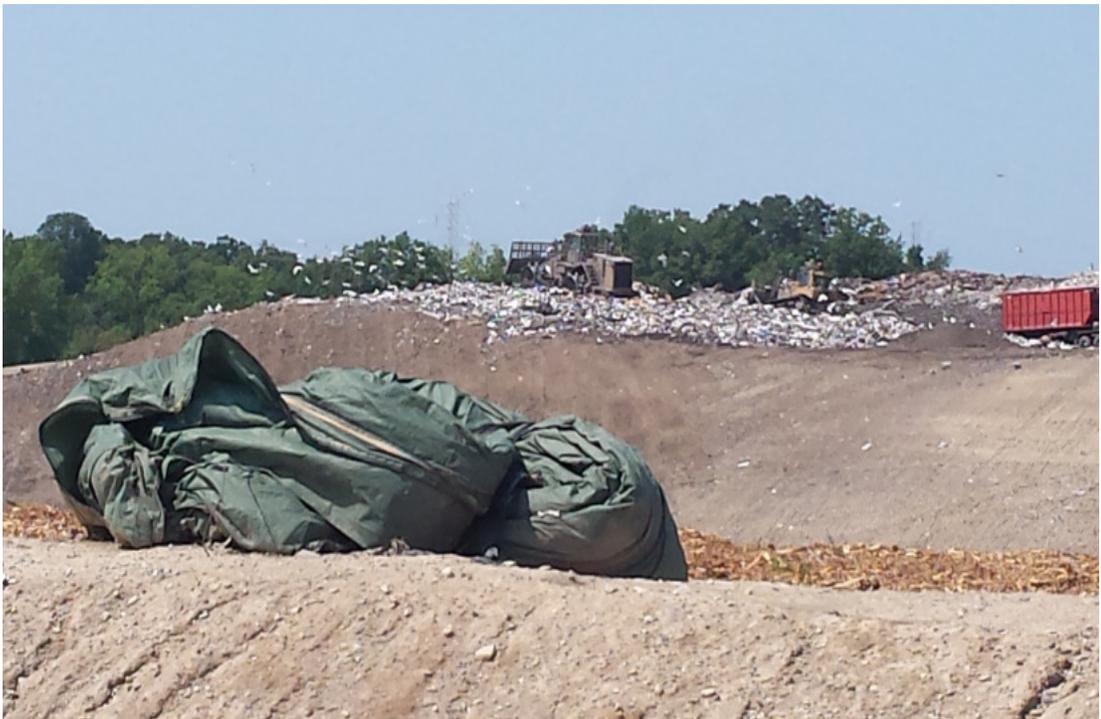
Working face viewed from the South

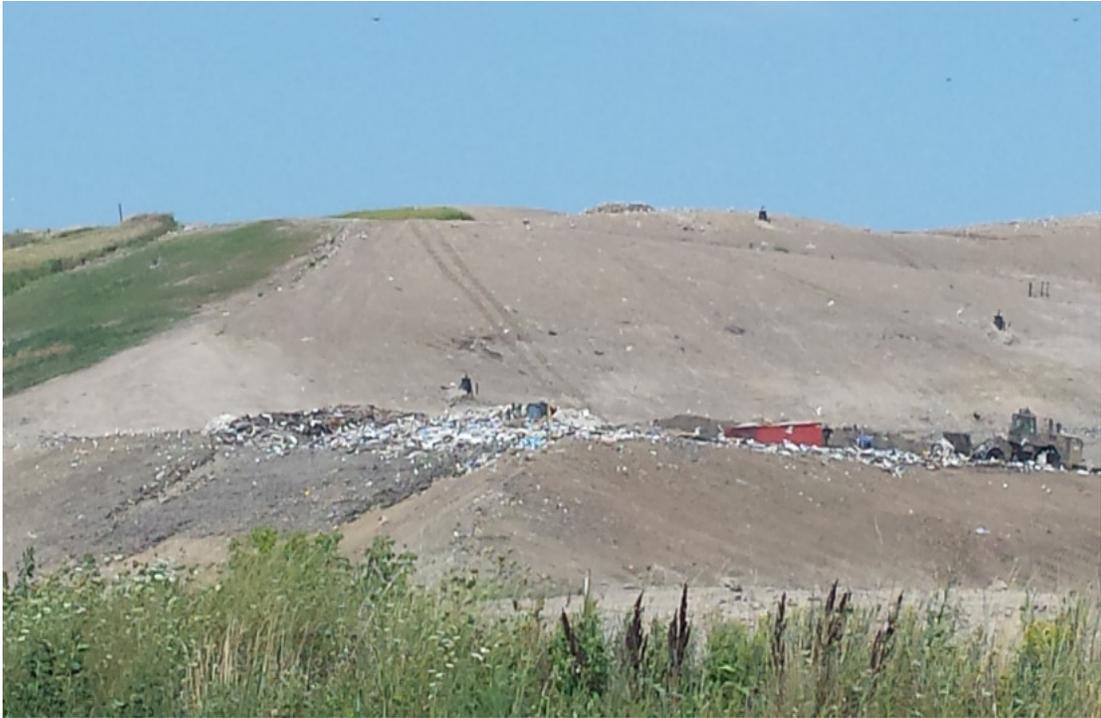
Slope cover in soils, top cover in sands, fluff, and soils

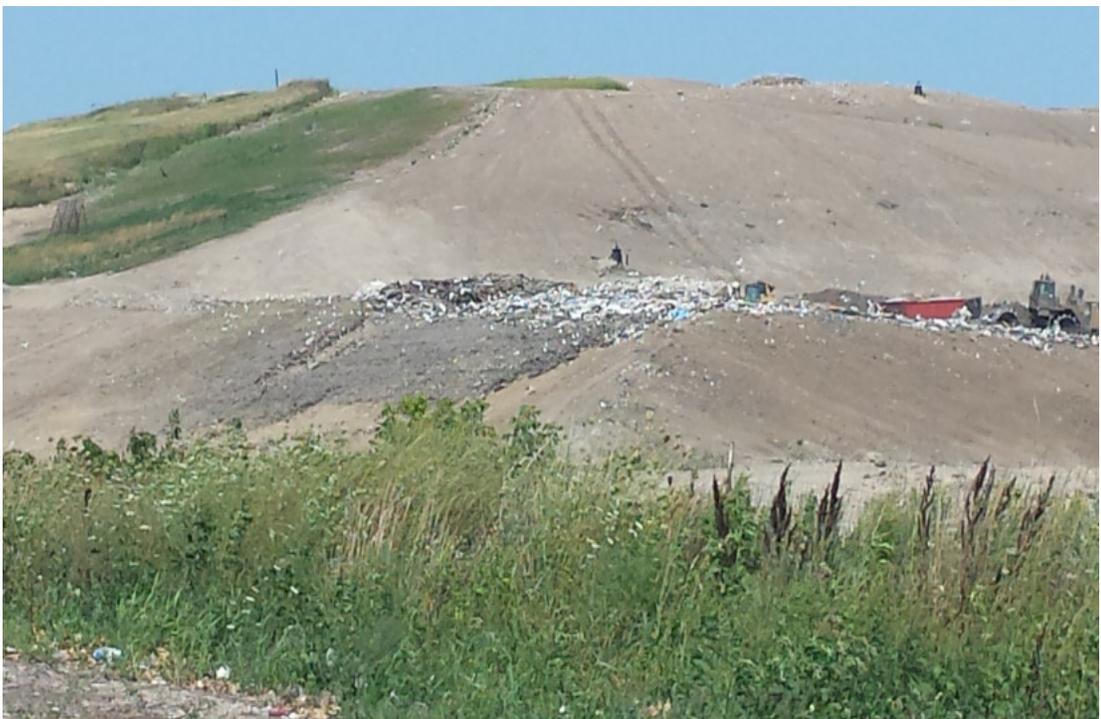
Working face on Southwest corner of Phase 7B, on outboard slope
