ADS Emerald Park Landfill Audit Summary

To: ADS Emerald Park Landfill Standing Committee, City of Muskego
FROM: Faith Spear.
COPIES: File
DATE: 10/05/15
PROJECT NUMBER: 1012.10030

Attached is the audit report for activities at the ADS Emerald Park Landfill for the week of August 17, 2015. The audit was performed at 2:55 PM on **August 20, 2015** by Jo Spear, Jr. in the presence of Michael Hackney, General Manager.

**ADVANCED DISPOSAL SERVICES
EMERALD PARK LANDFILL / CITY OF MUSKEGO
AUDIT PHOTOS**

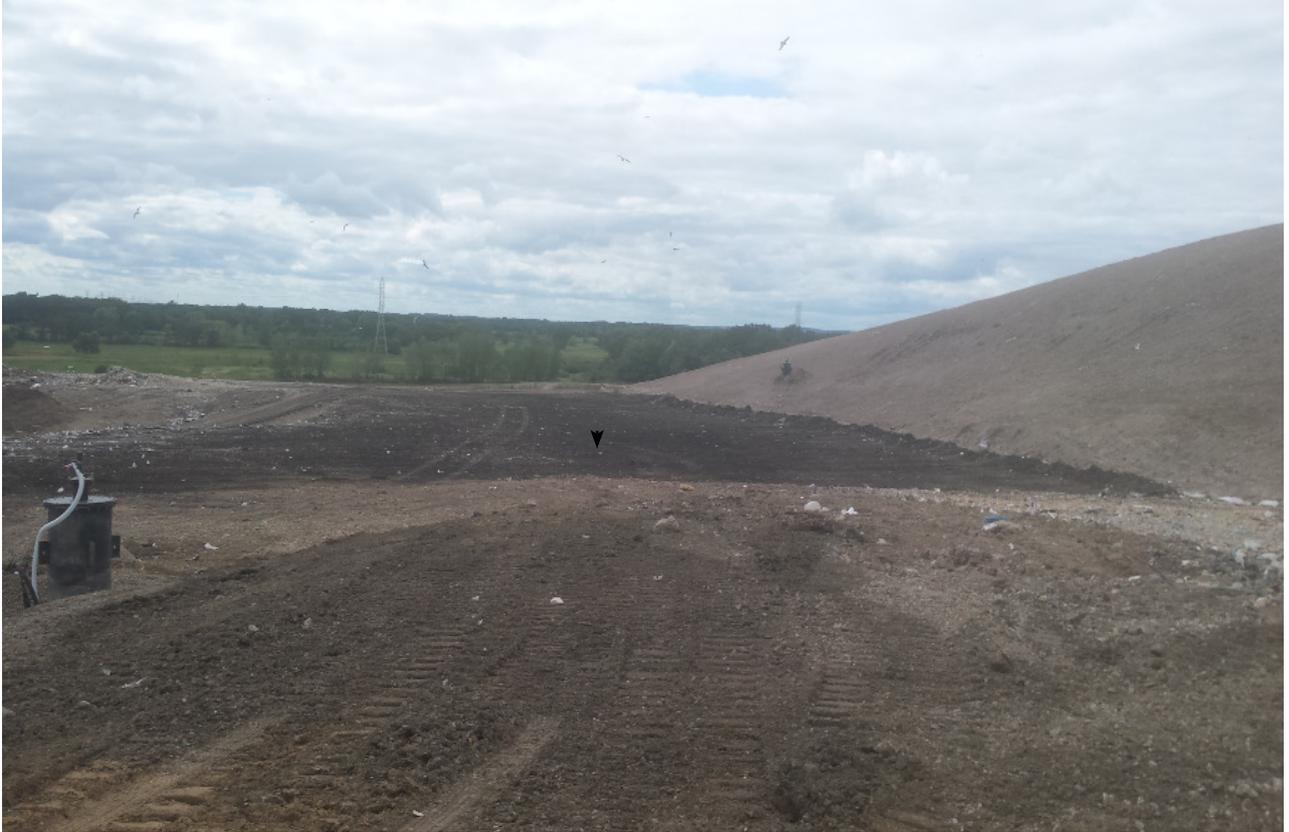
Cover soils placed over unused portion (North) area of active area

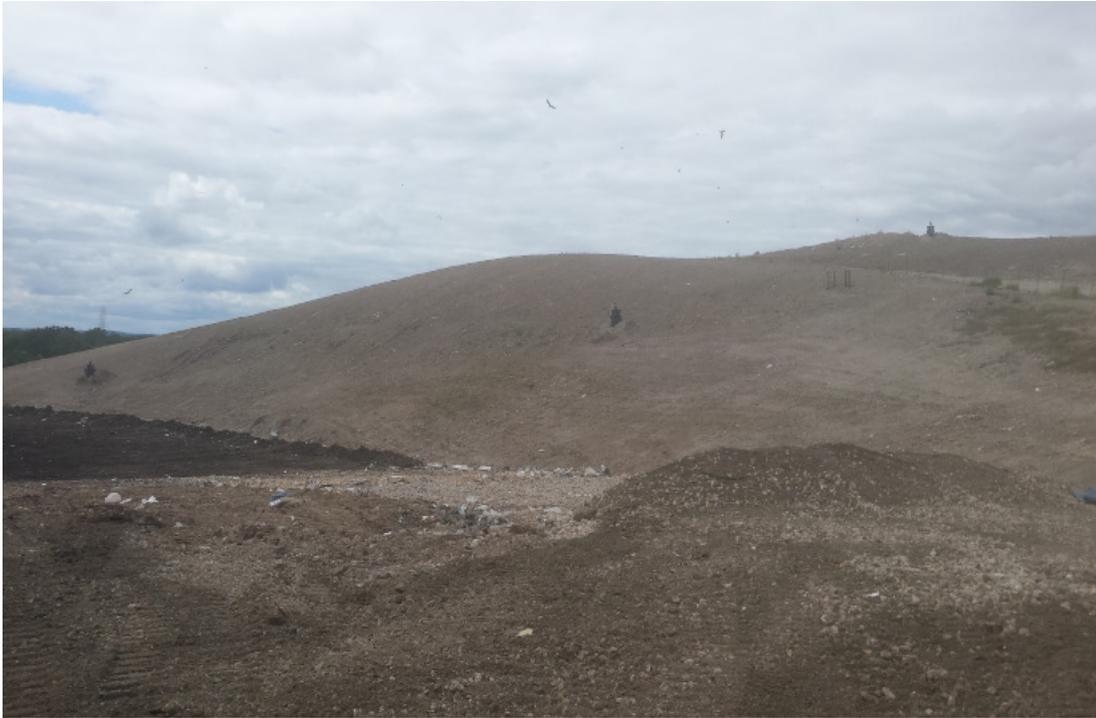
Junction of Phase 7 and Phase 3. Intermediate cover on Phase 3 South slope and daily cover on horizontal lift of Phase 7

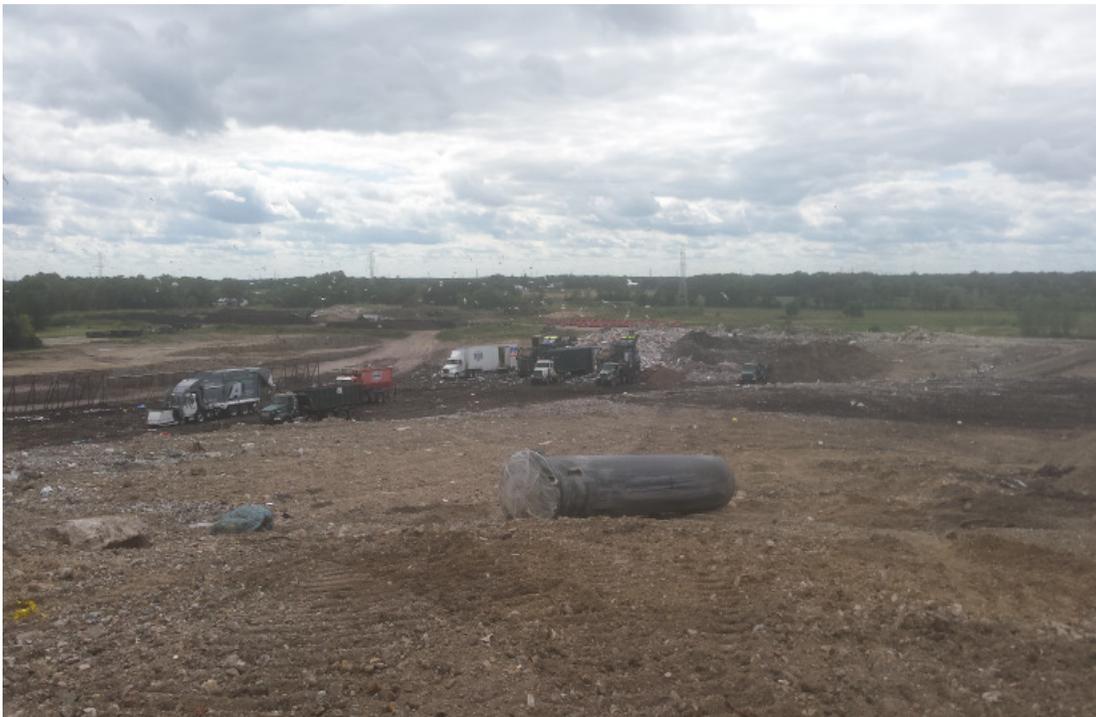
Working face viewed across active area. Broken well head in the foreground, replaced at time of breaking. Well head will be repaired and re-used

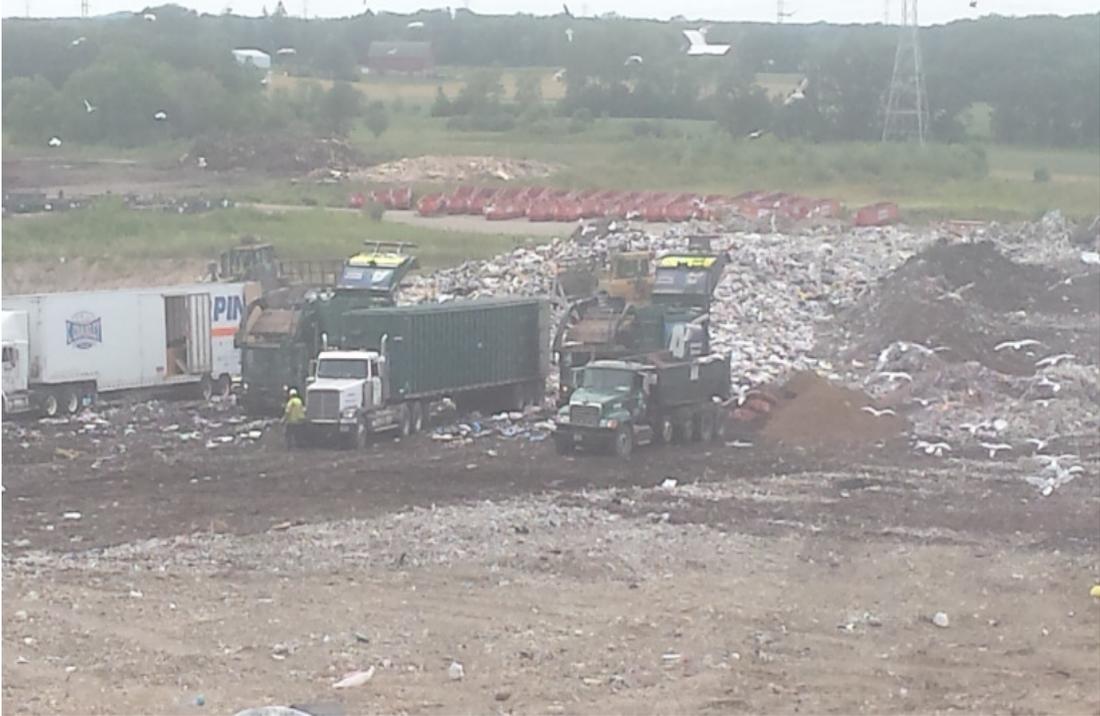
Working face receiving waste

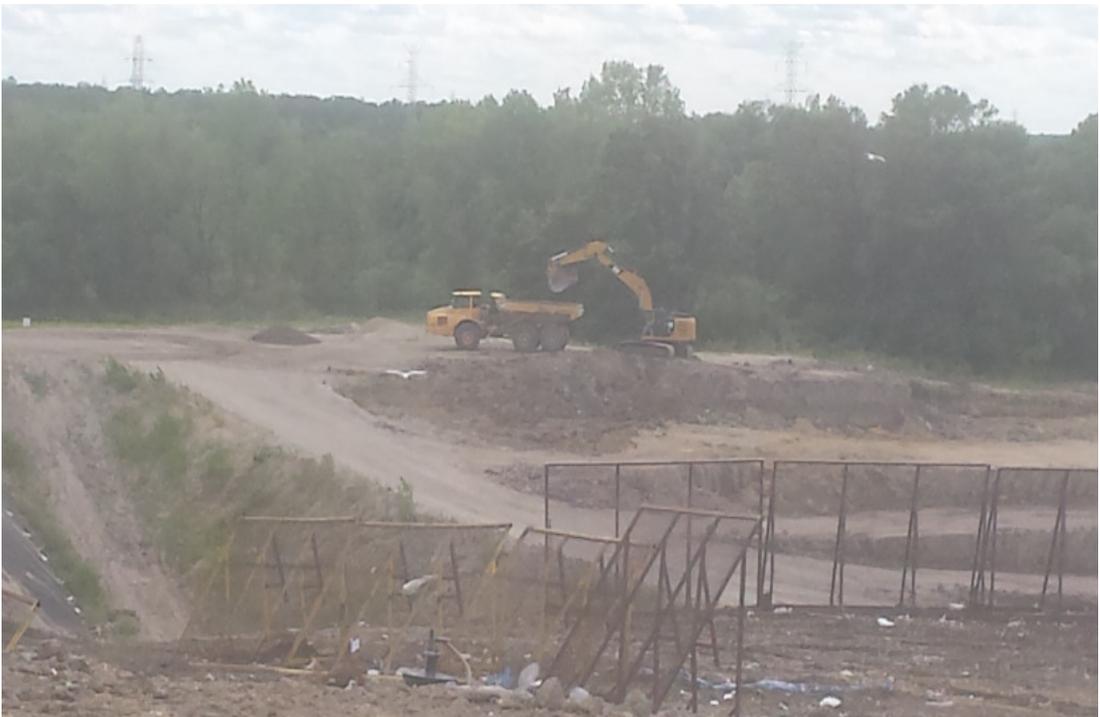
Poor quality clay/soil being excavated for use of cover and access to higher quality clay

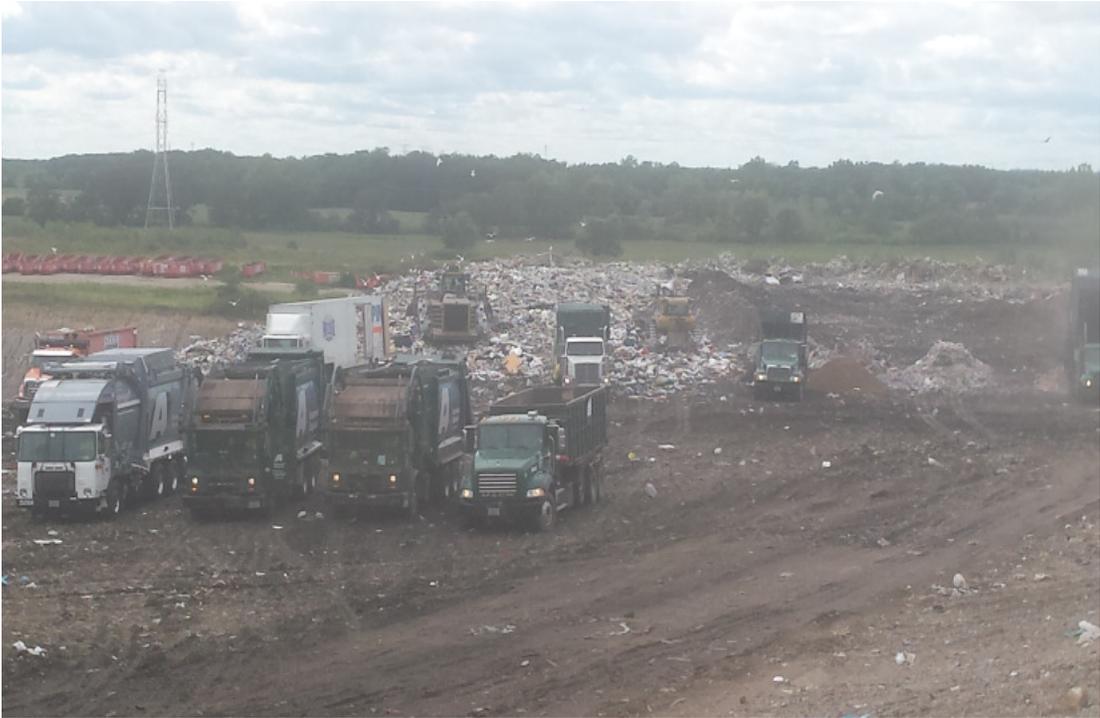
Working face viewed from the East

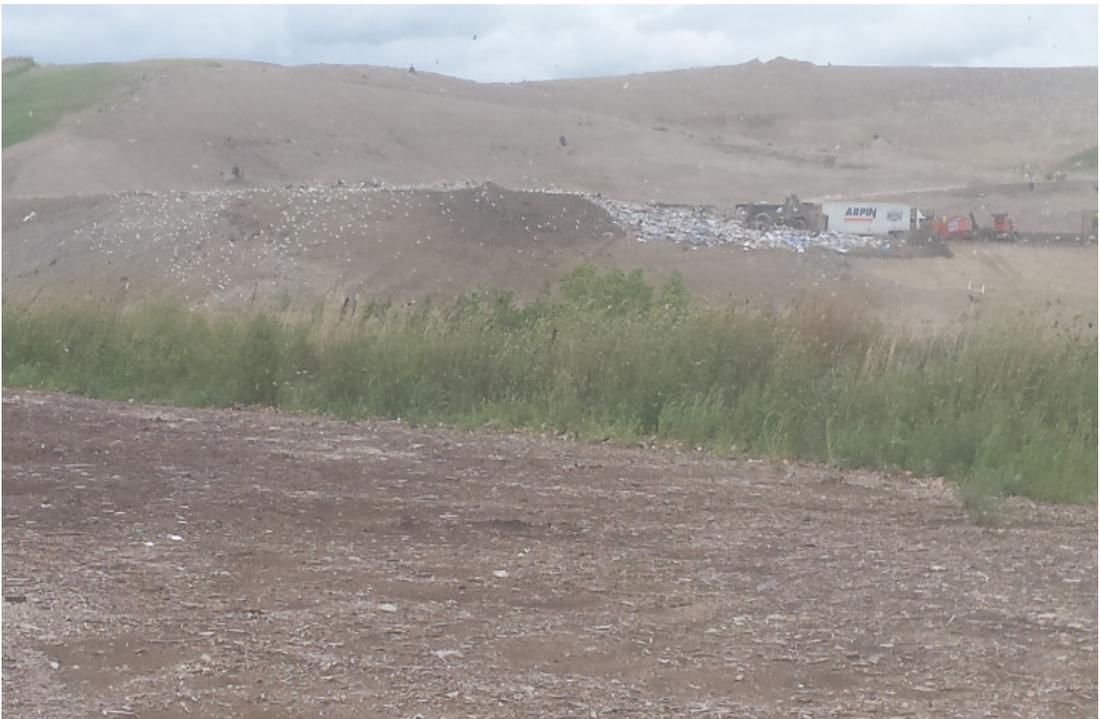
Southwest corner of Phase 7B, slopes to be covered with intermediate cover of soil

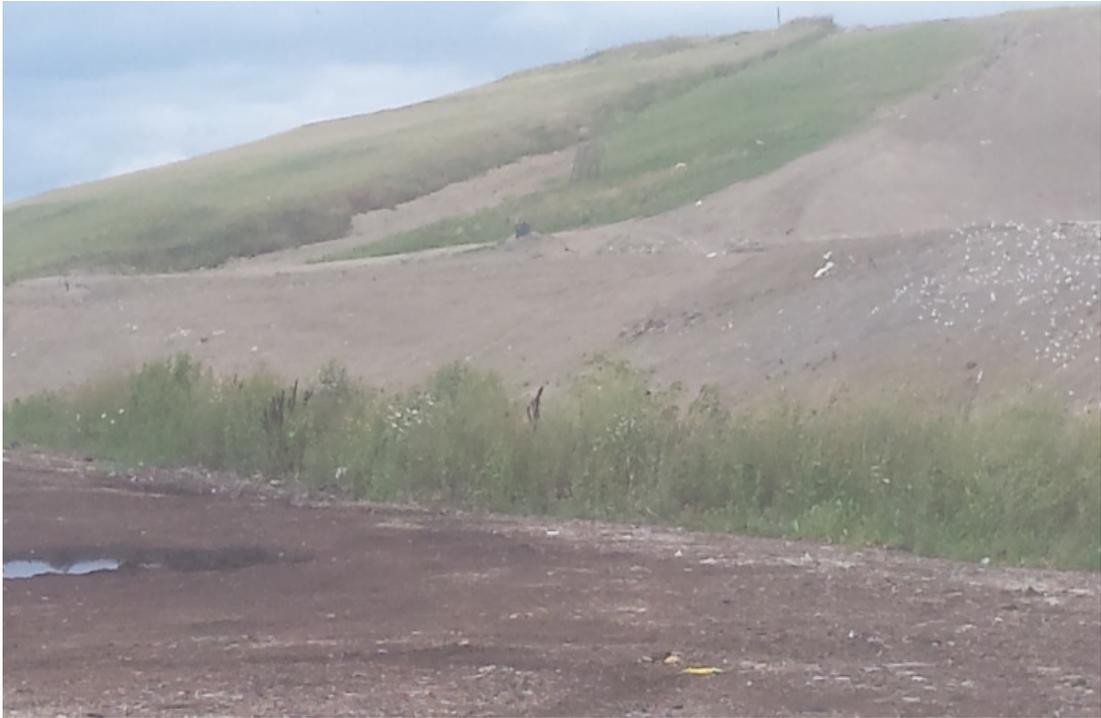
Junction of Phase 3 and Phase 7

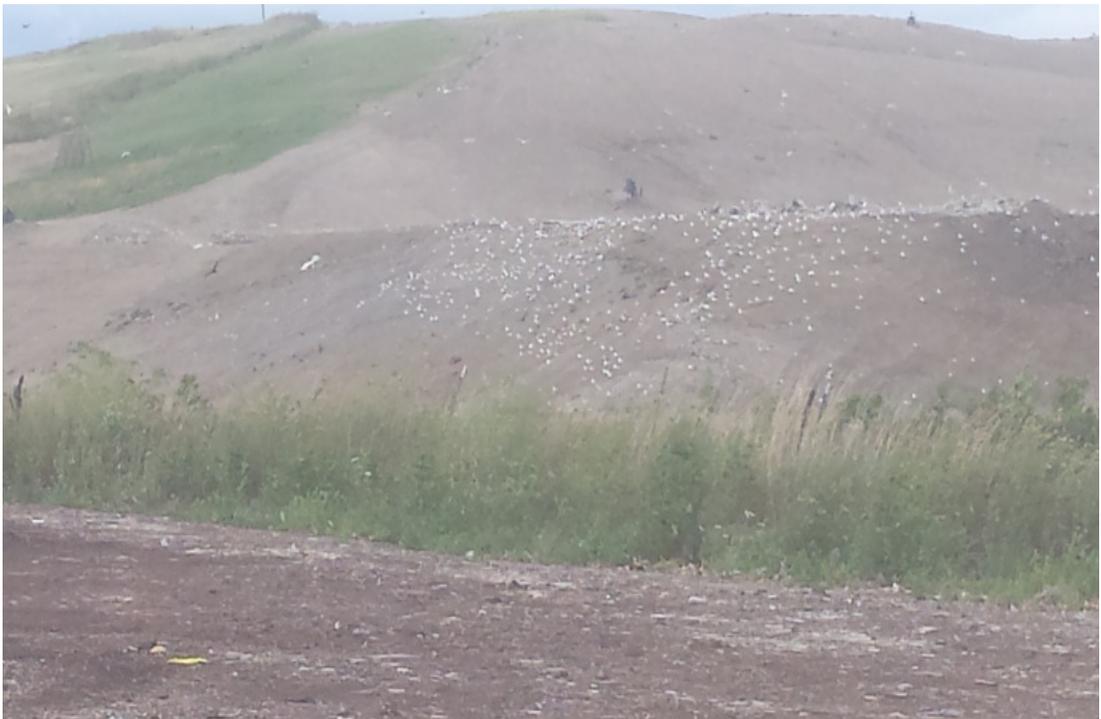
West slope of Phase 7/7B, intermediate cover of soils.

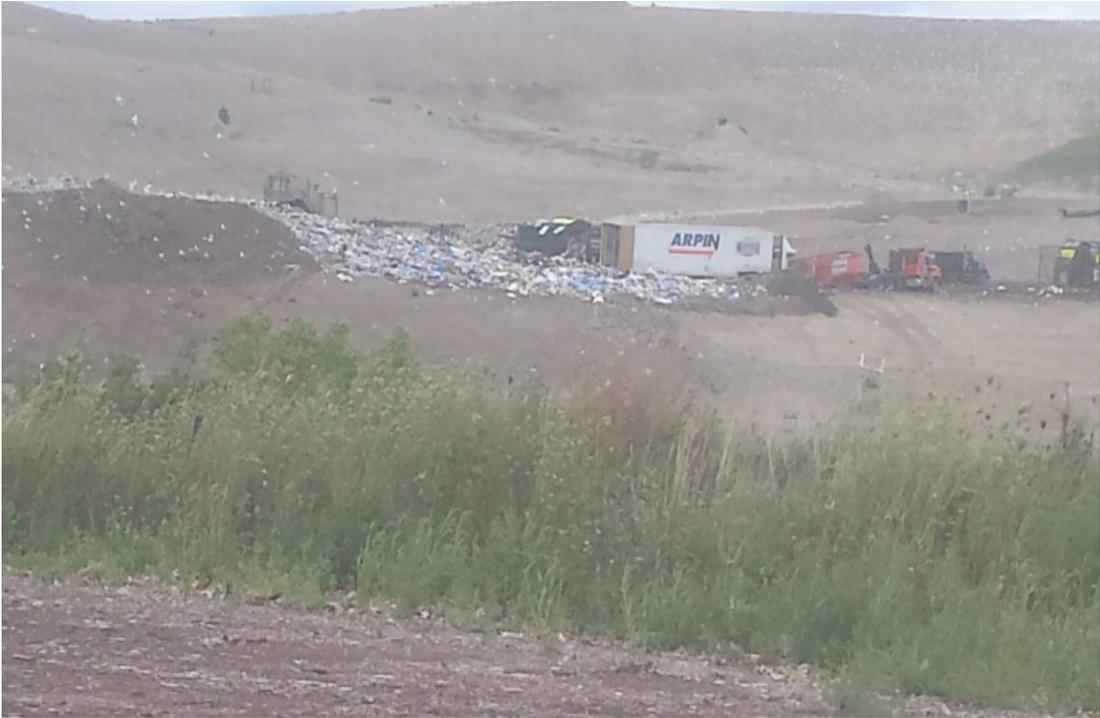
Working face viewed from Southwest

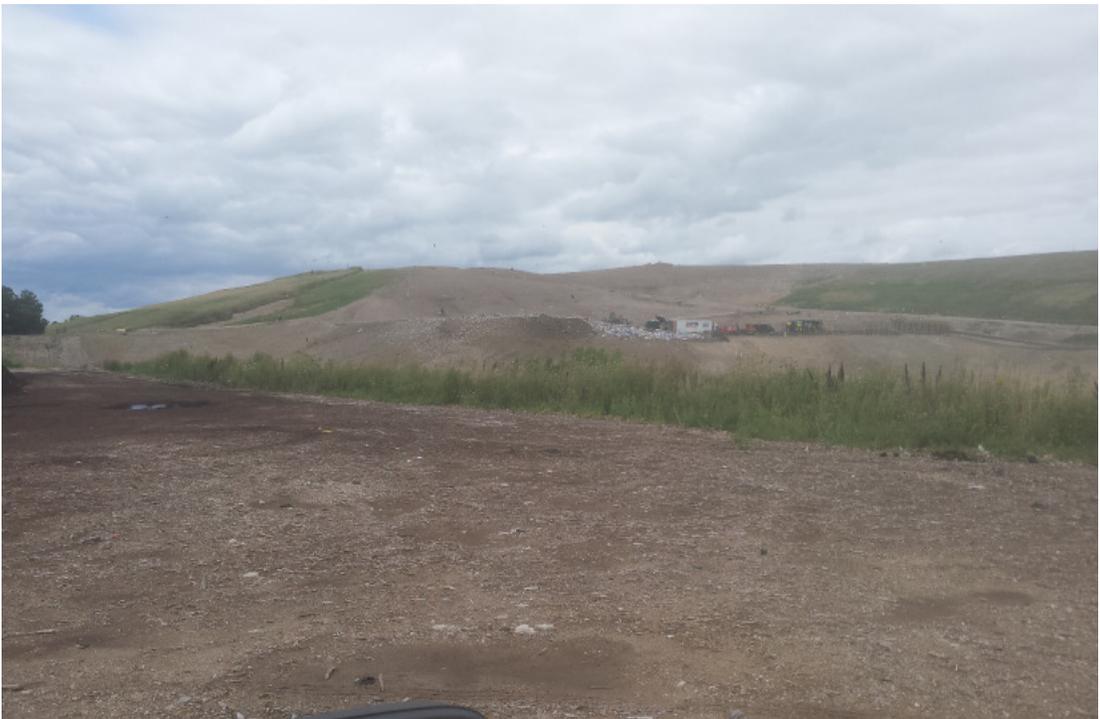
Landfill footprint viewed from Southwest
