ADS Emerald Park Landfill Audit Summary

To: ADS Emerald Park Landfill Standing Committee, City of Muskego
FROM: Faith Spear.
COPIES: File
DATE: 11/16/15
PROJECT NUMBER: 1012.10030

ADVANCED DISPOSAL SERVICES EMERALD PARK LANDFILL
LANDFILL OPERATIONS AUDIT FORM
CITY OF MUSKEGO

**ADVANCED DISPOSAL SERVICES
EMERALD PARK LANDFILL / CITY OF MUSKEGO
AUDIT PHOTOS**

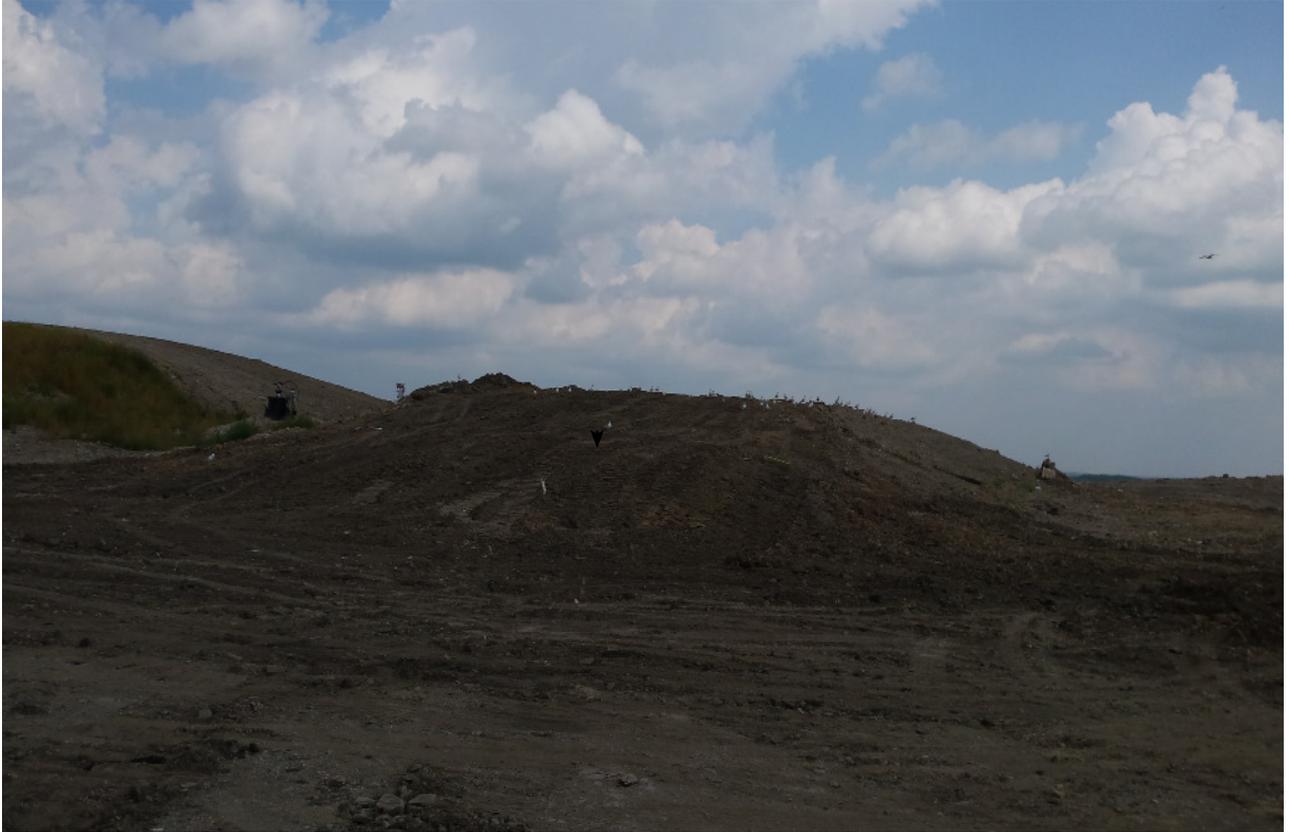
Bio soil stockpile receiving soils this week.

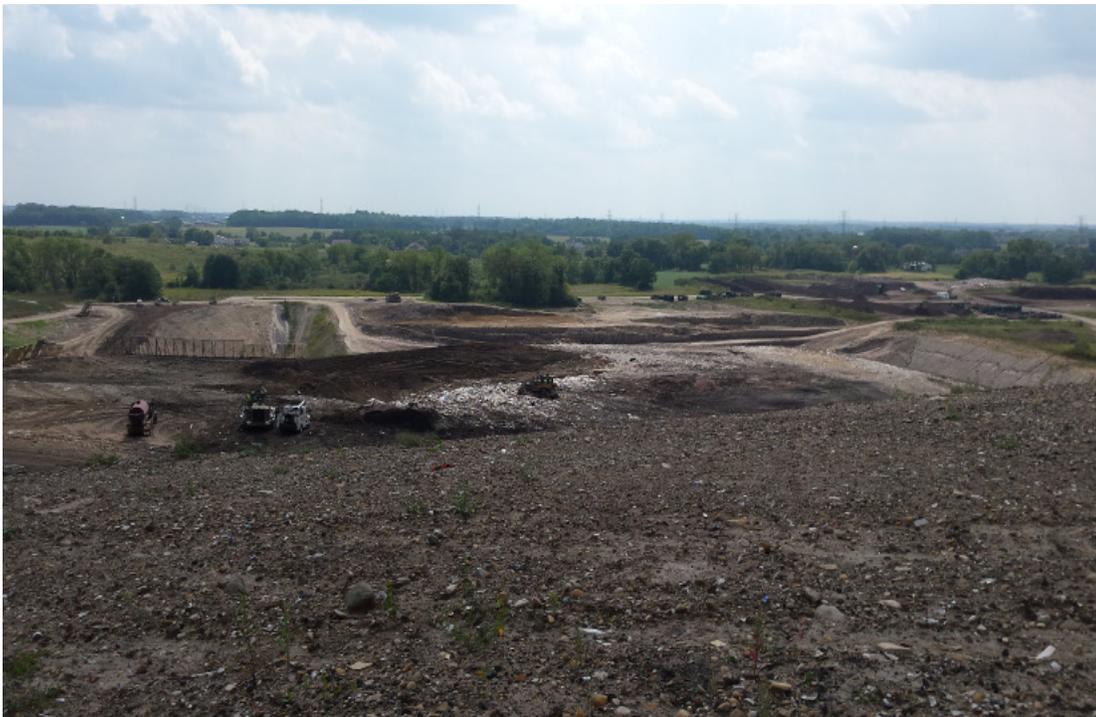
Working face and active area viewed from the North

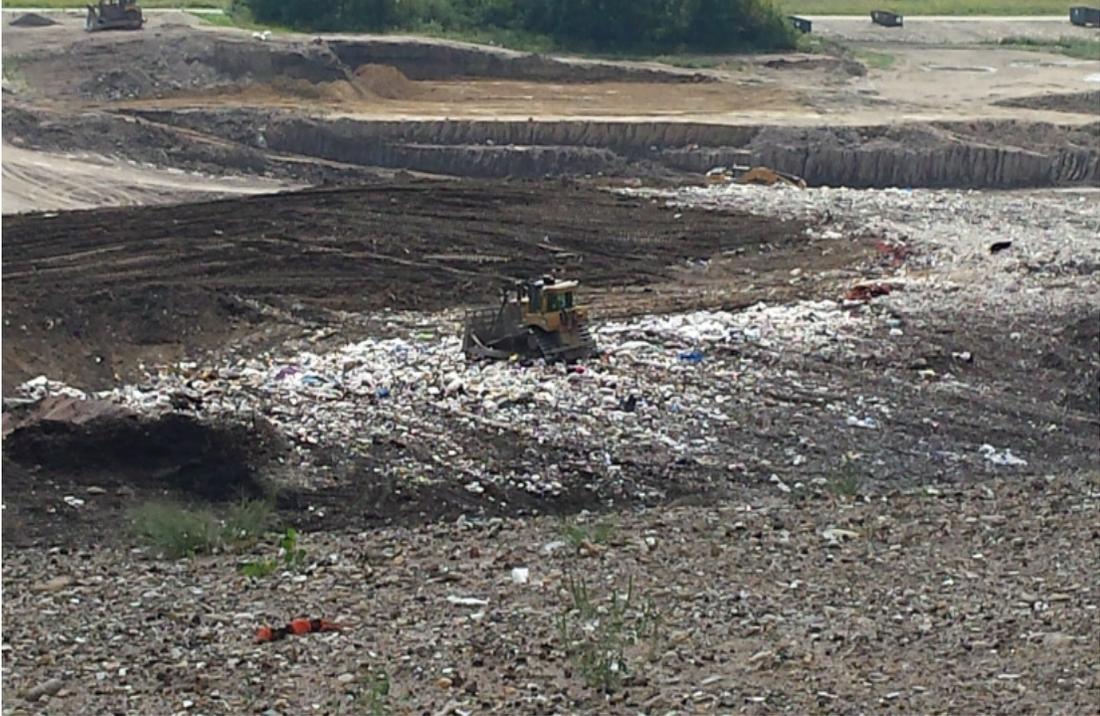
Active area viewed from the North

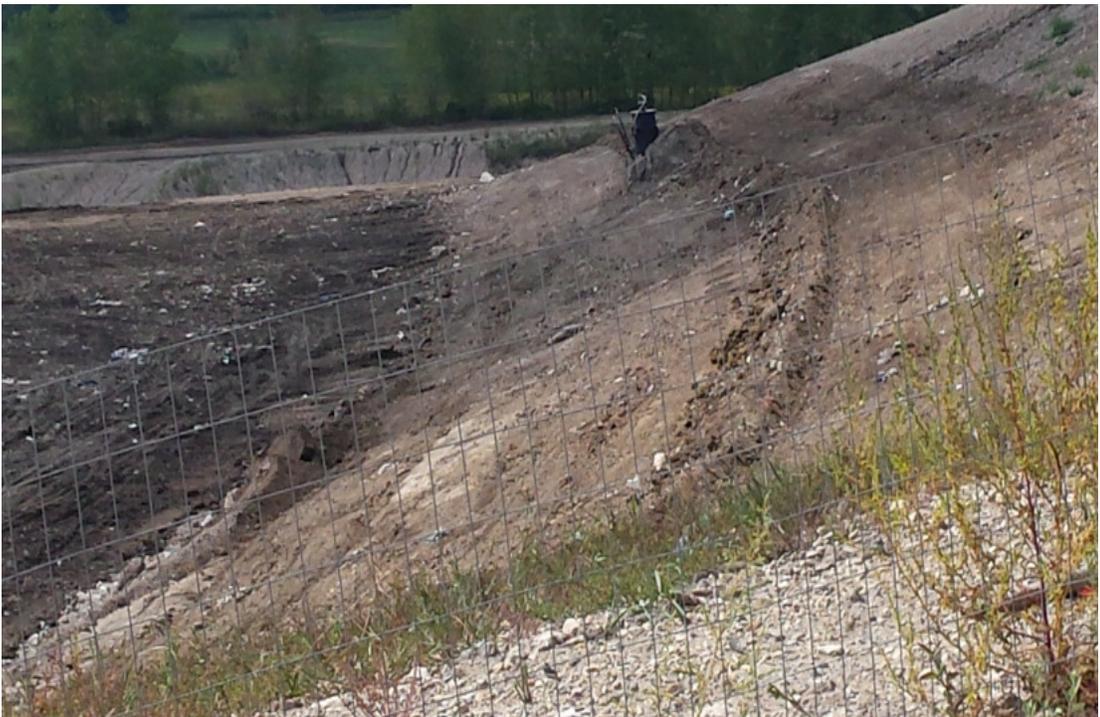
Berm created on West slopes of 1,2, and 3 to prevent flows onto active area of Phase 7

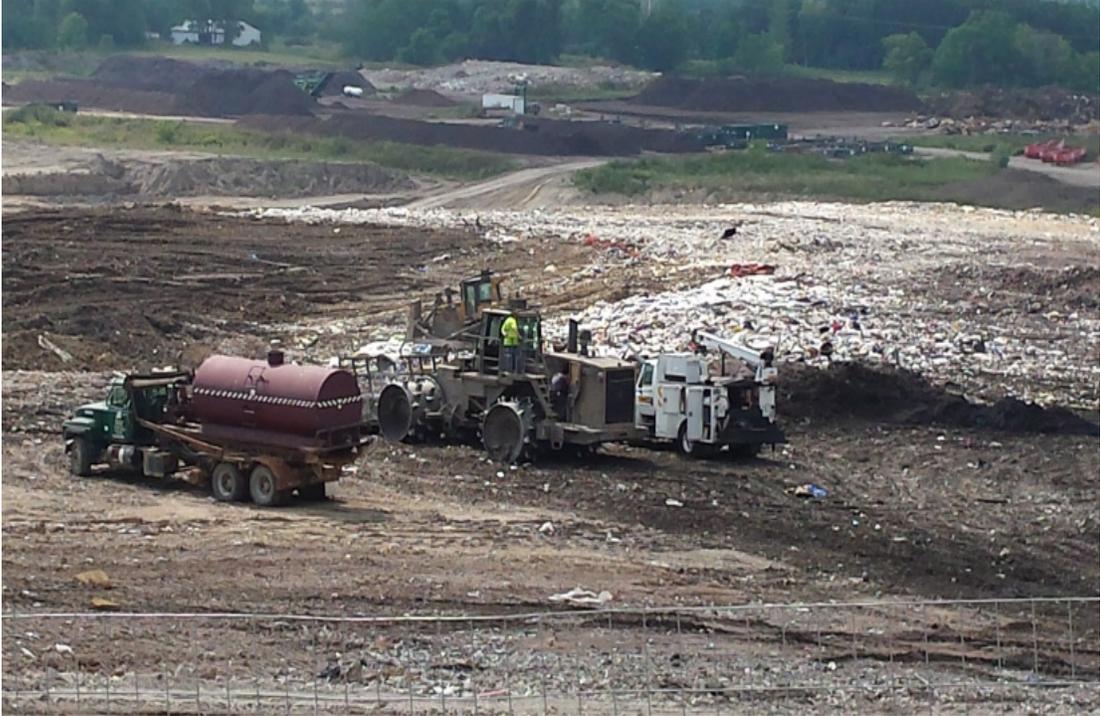
Working face viewed from Northwest

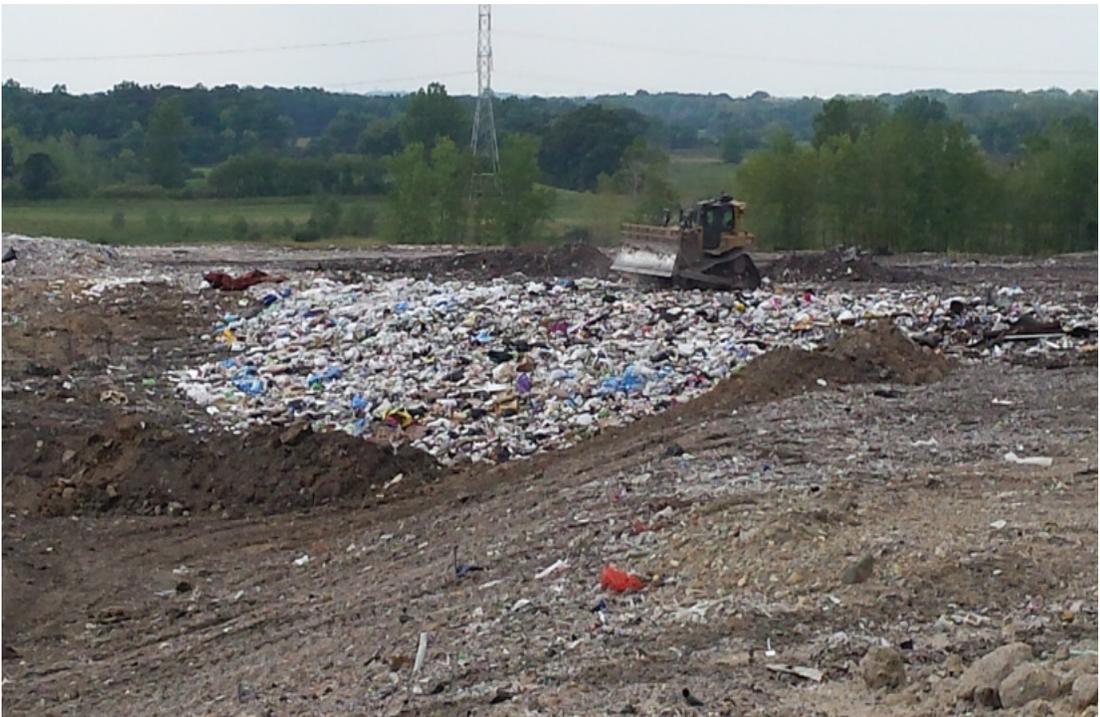
Working face viewed from the East

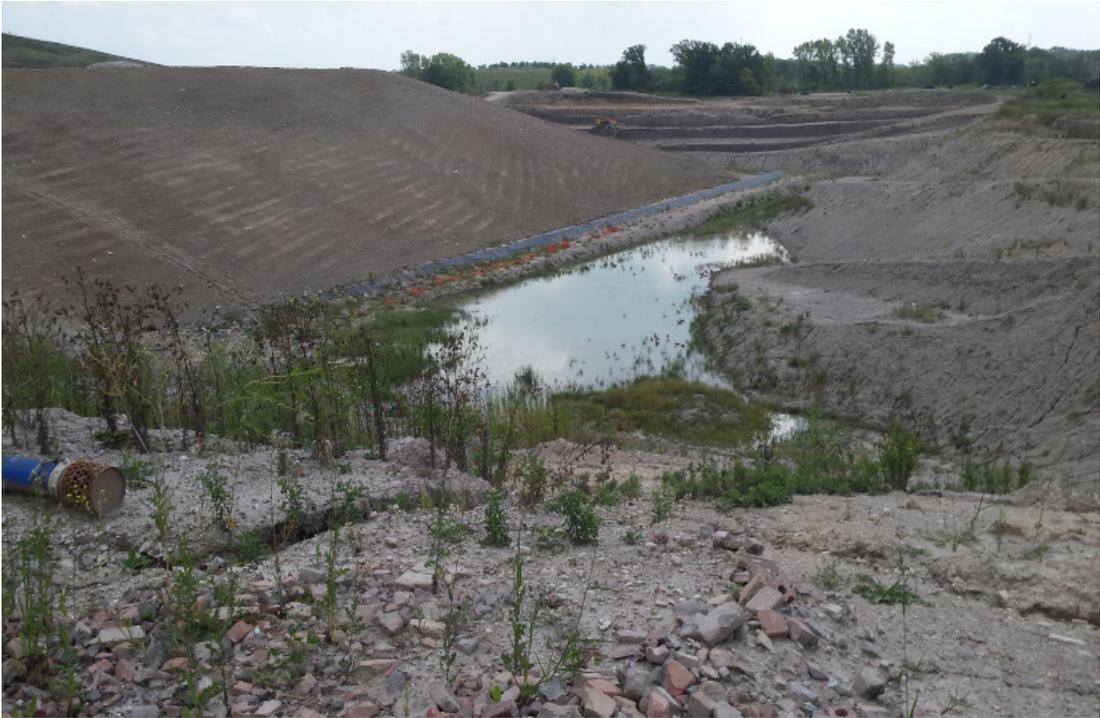
Temp sed basin at the West slope of Phase 7B

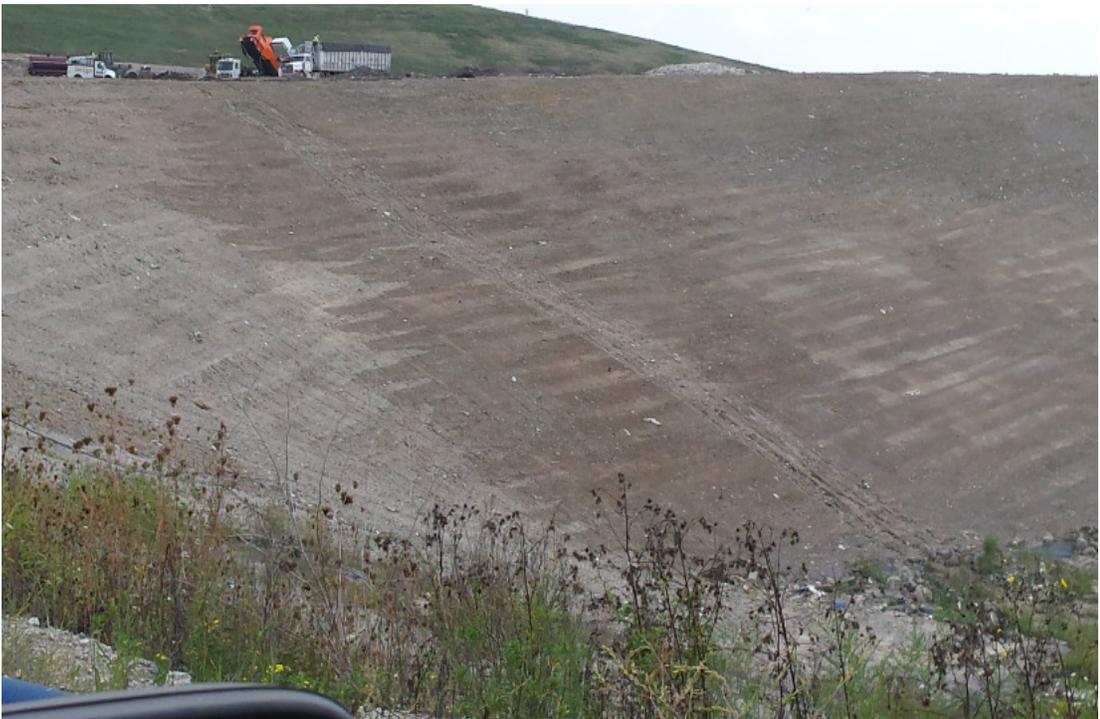
Erosion on West slope of Phase 7 above temp. sed. basin
