Memorandum

ADS Emerald Park Landfill Audit Summary

To: ADS Emerald Park Landfill Standing Committee, City of Muskego
FROM: Faith Spear.
COPIES: File
DATE: 11/17/15
PROJECT NUMBER: 1012.10030

**ADVANCED DISPOSAL SERVICES
EMERALD PARK LANDFILL / CITY OF MUSKEGO
AUDIT PHOTOS**

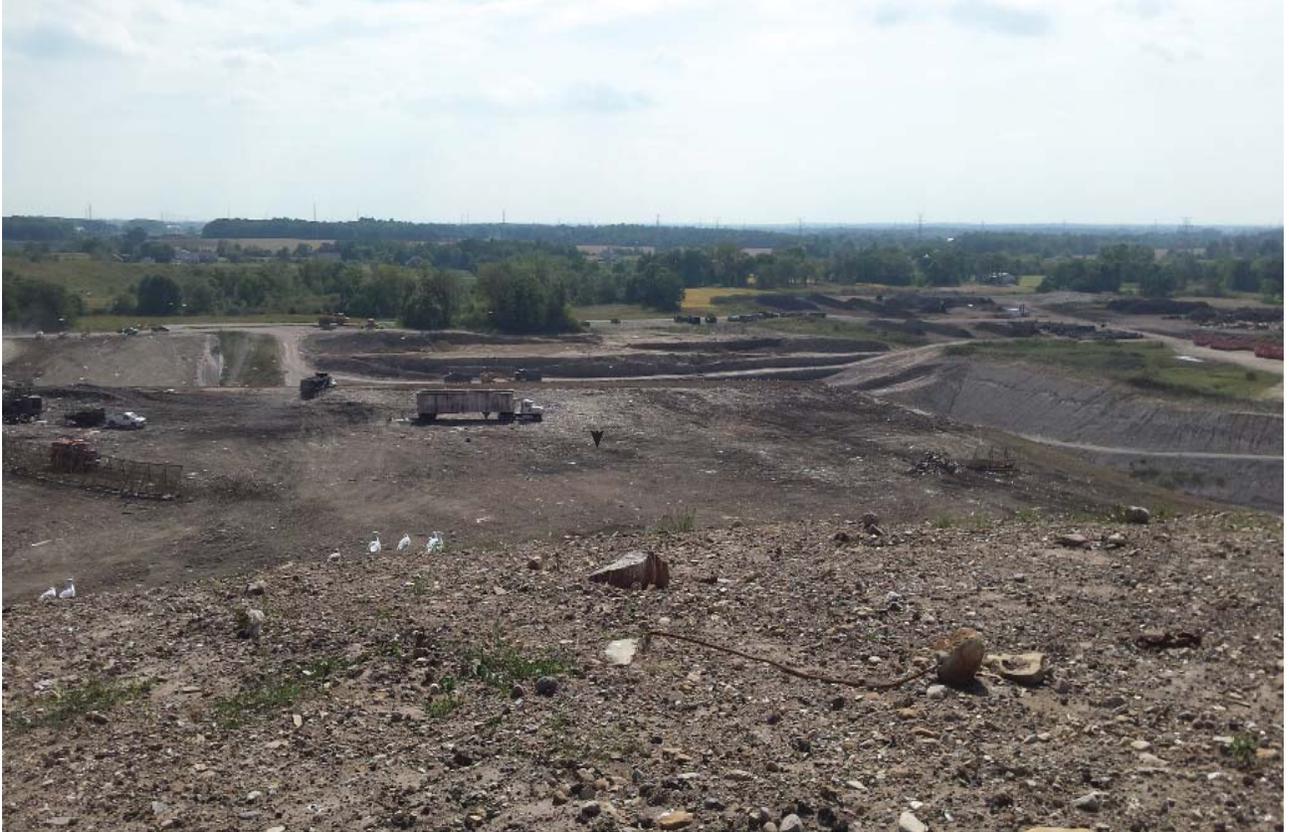
Active area viewed from North

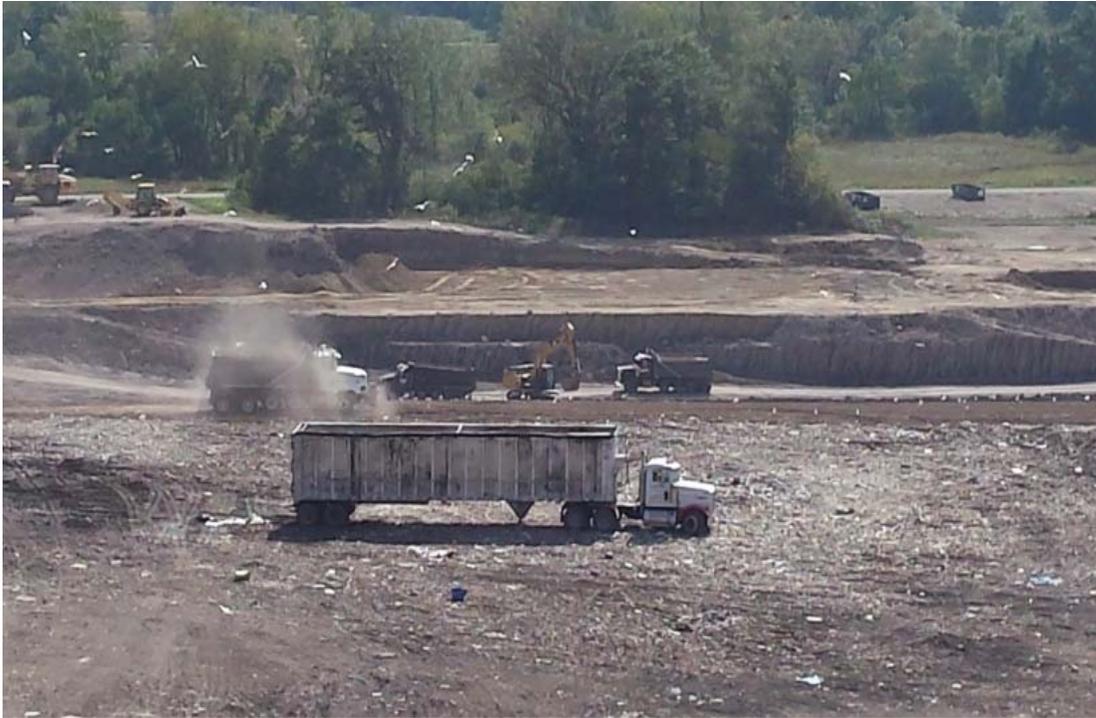
Active area receiving additional cover soils, via tipping

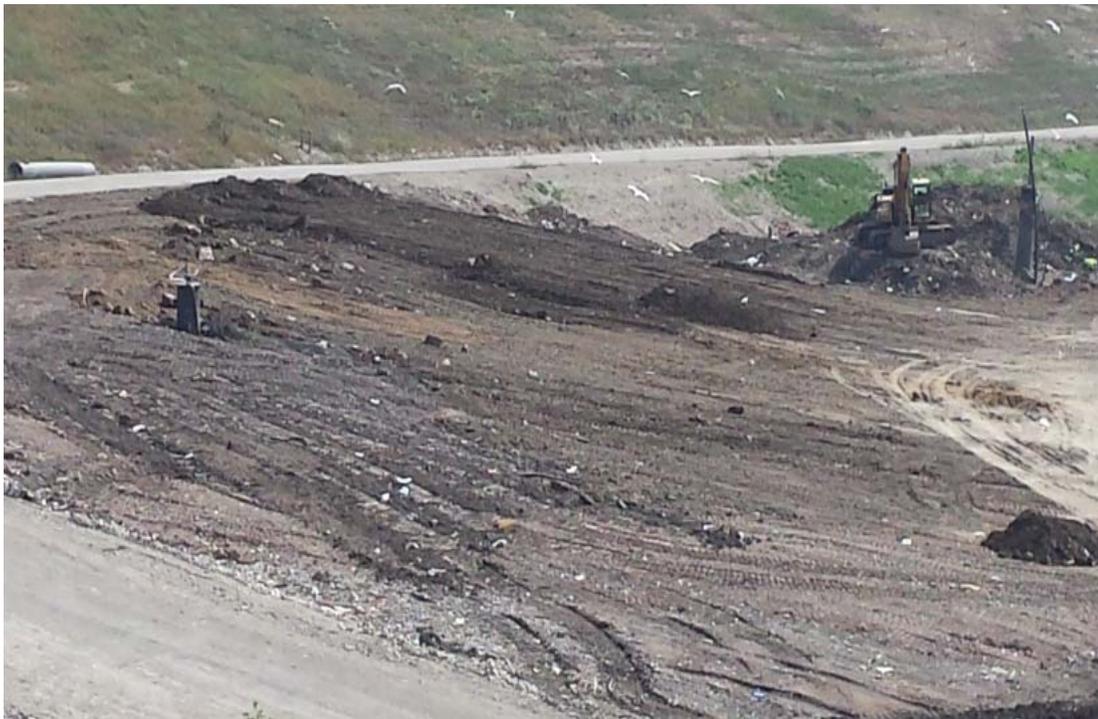
Cover about access road

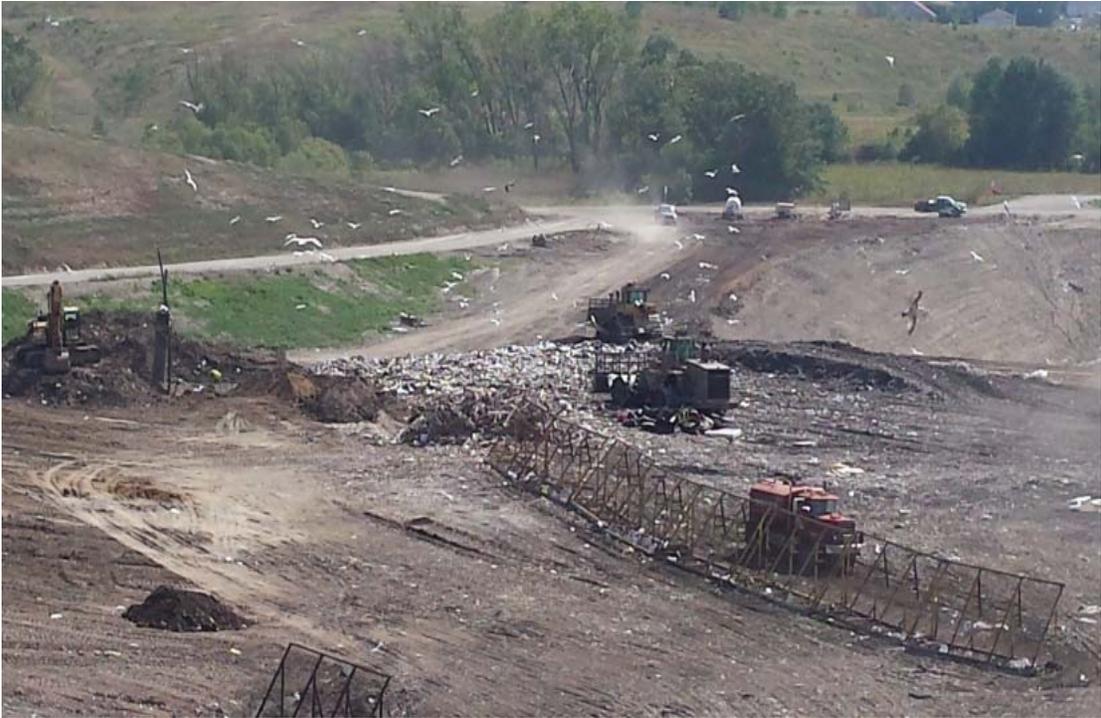
Working face

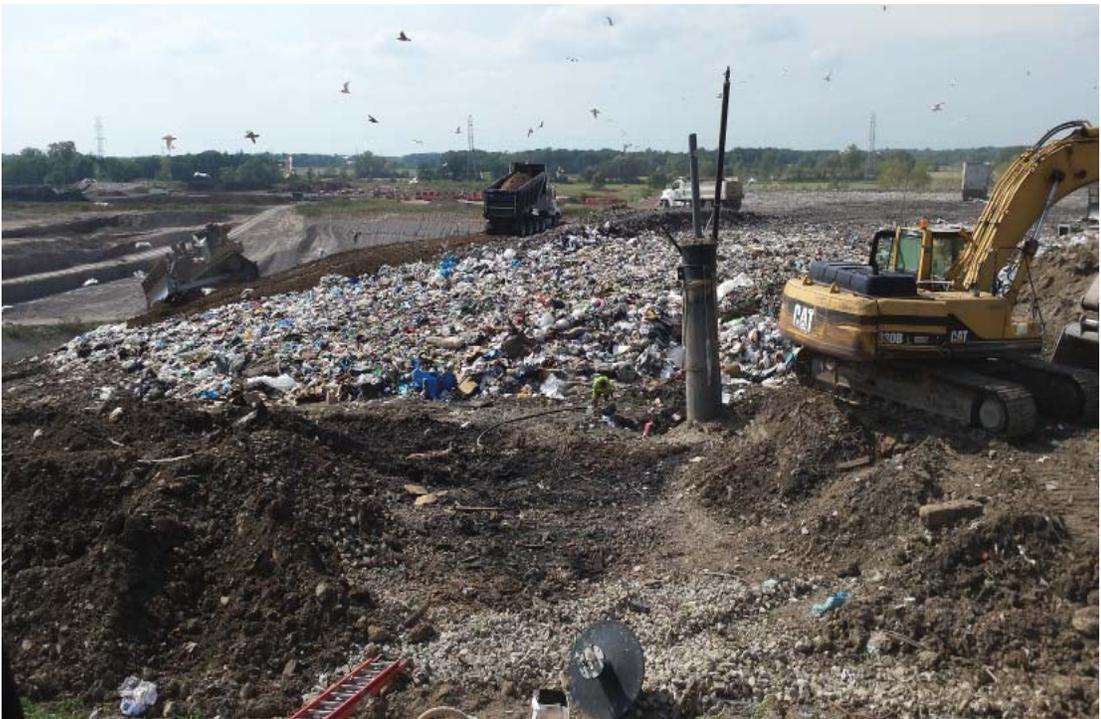
Working face and well undergoing extension in Phase 7

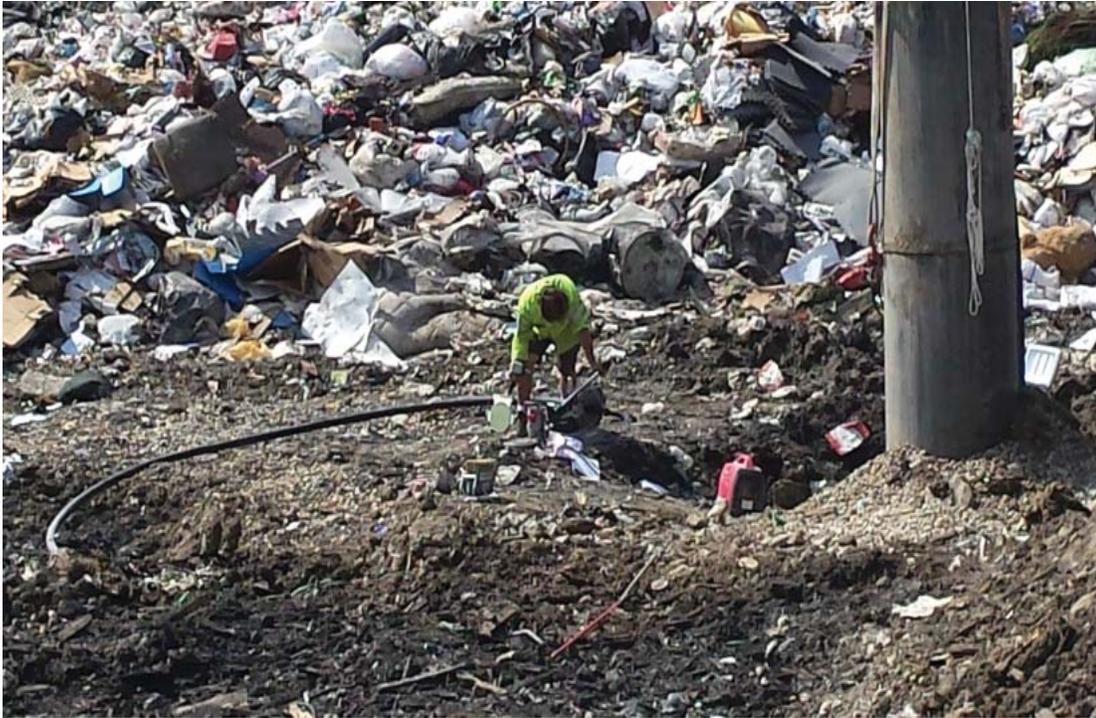
Cason well being extended in Southeast region of Phase 7

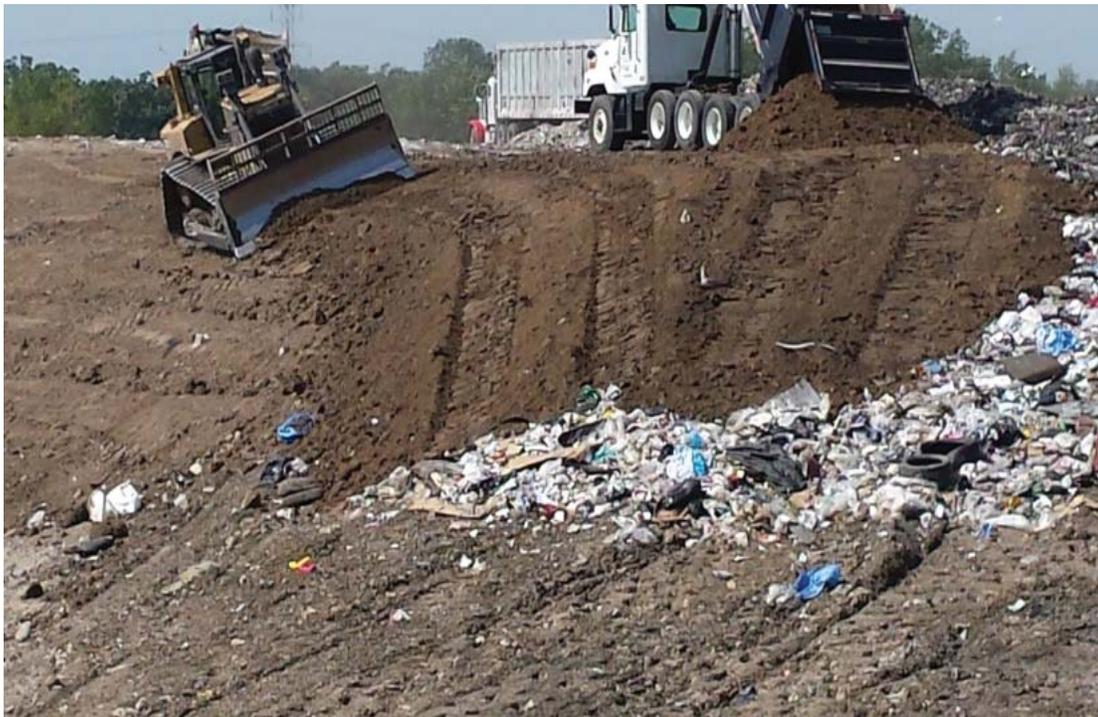
Cover placement on South slope of Phase 7B

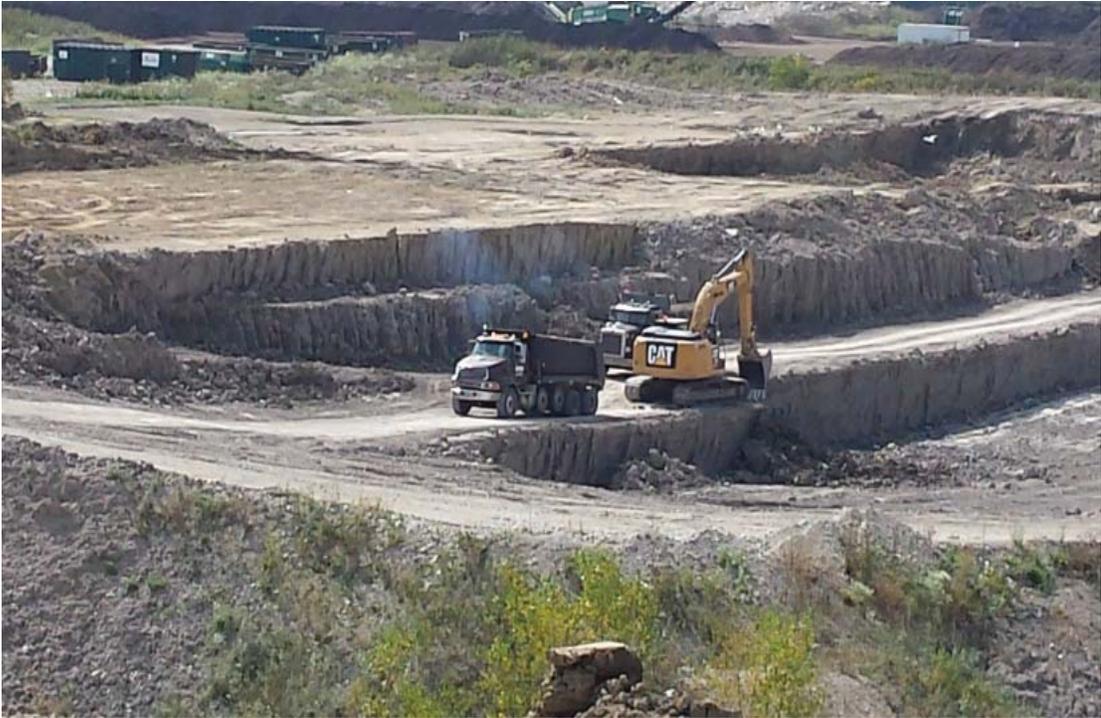
Clay back hauls continue and Phase 8 is being excavated
