ADS Emerald Park Landfill Audit Summary

To: ADS Emerald Park Landfill Standing Committee, City of Muskego
FROM: Faith Spear.
COPIES: File
DATE: 11/18/15
PROJECT NUMBER: 1012.10030

Attached is the audit report for activities at the ADS Emerald Park Landfill for the week of September 21, 2015. The audit was performed at 11:09 AM on **September 21, 2015** by Jo Spear, Jr. in the presence of Brett Coogan, Operations Manager.

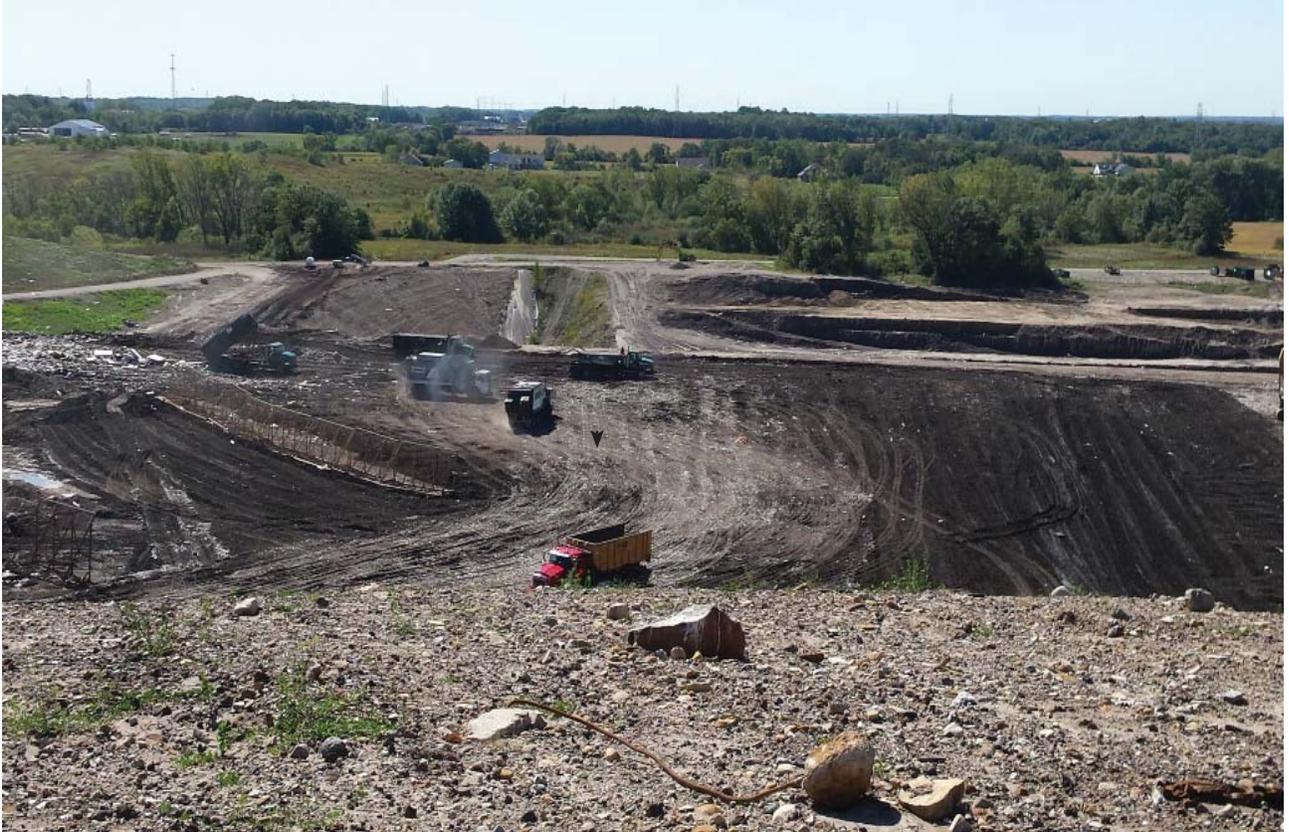
Active area viewed from North

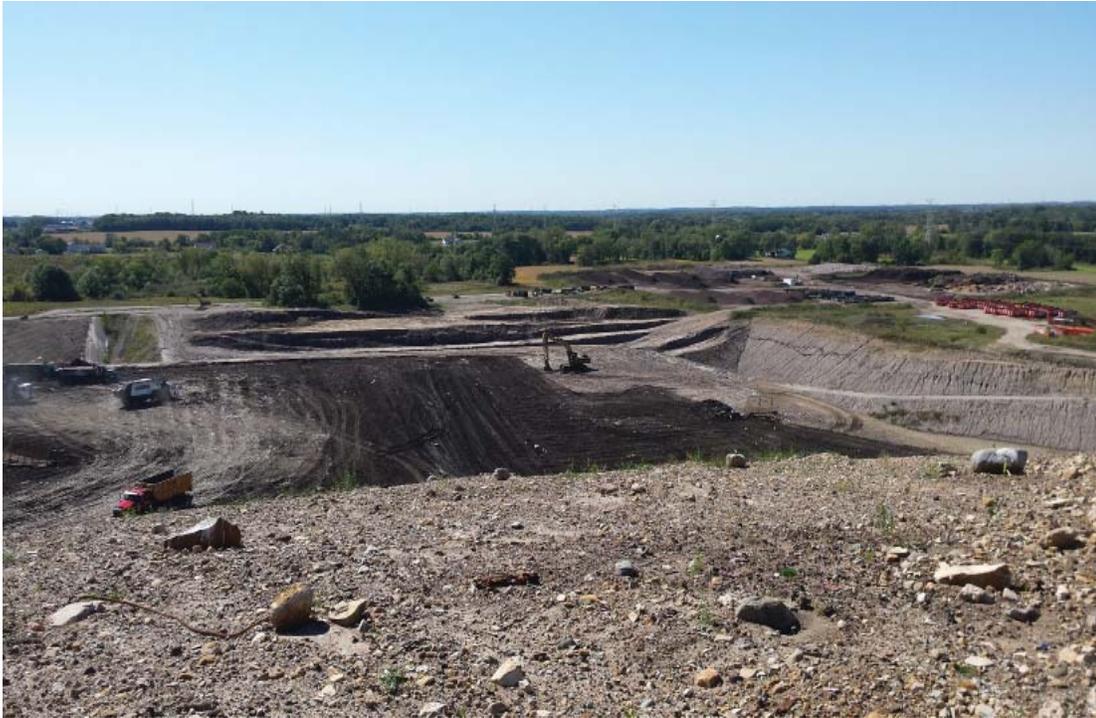
High volumes of cover soils being tipped have made for excellent cover conditions throughout active area

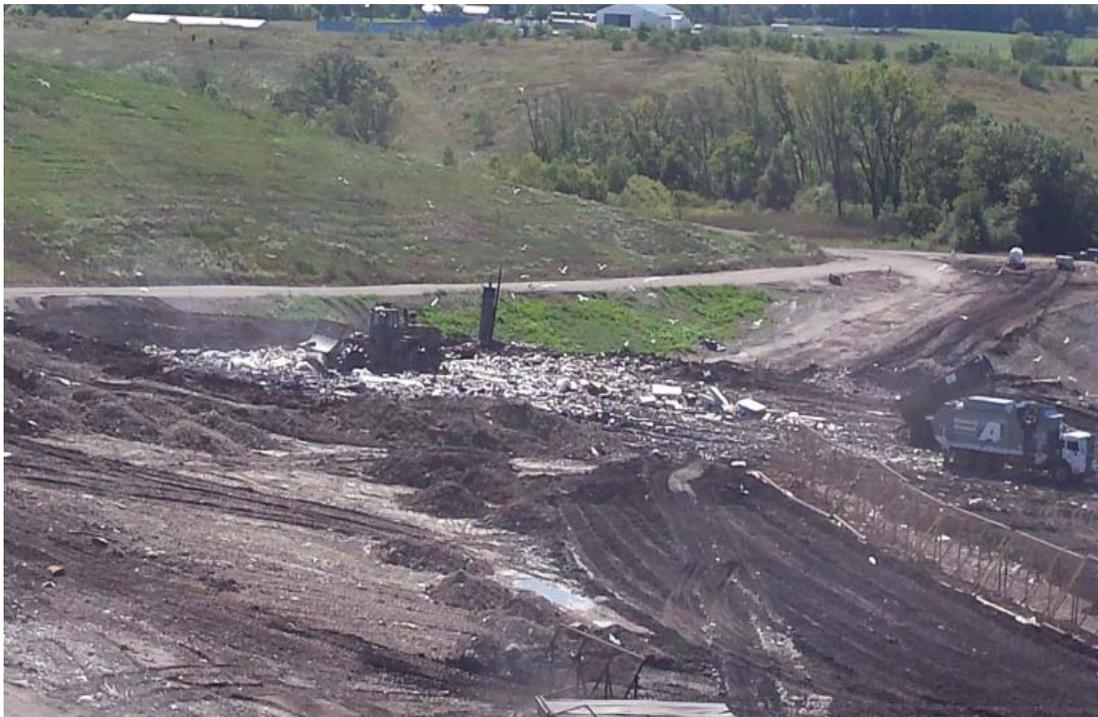
Working face viewed from the North

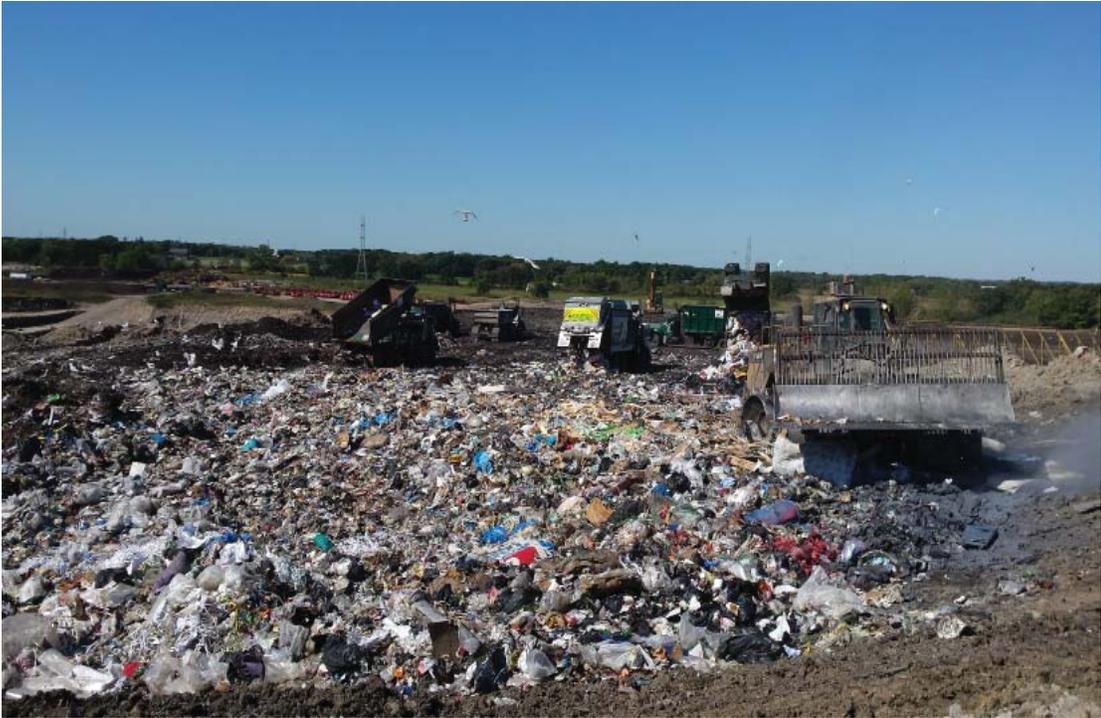
Working face

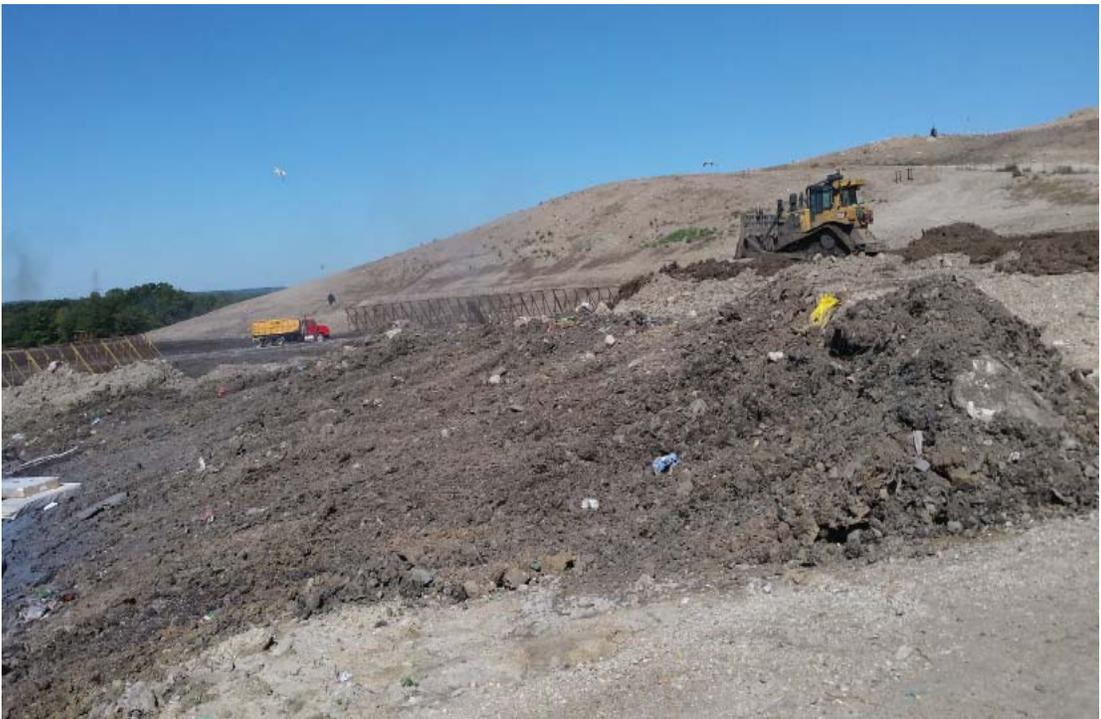
Soils being stockpiled for future cover use

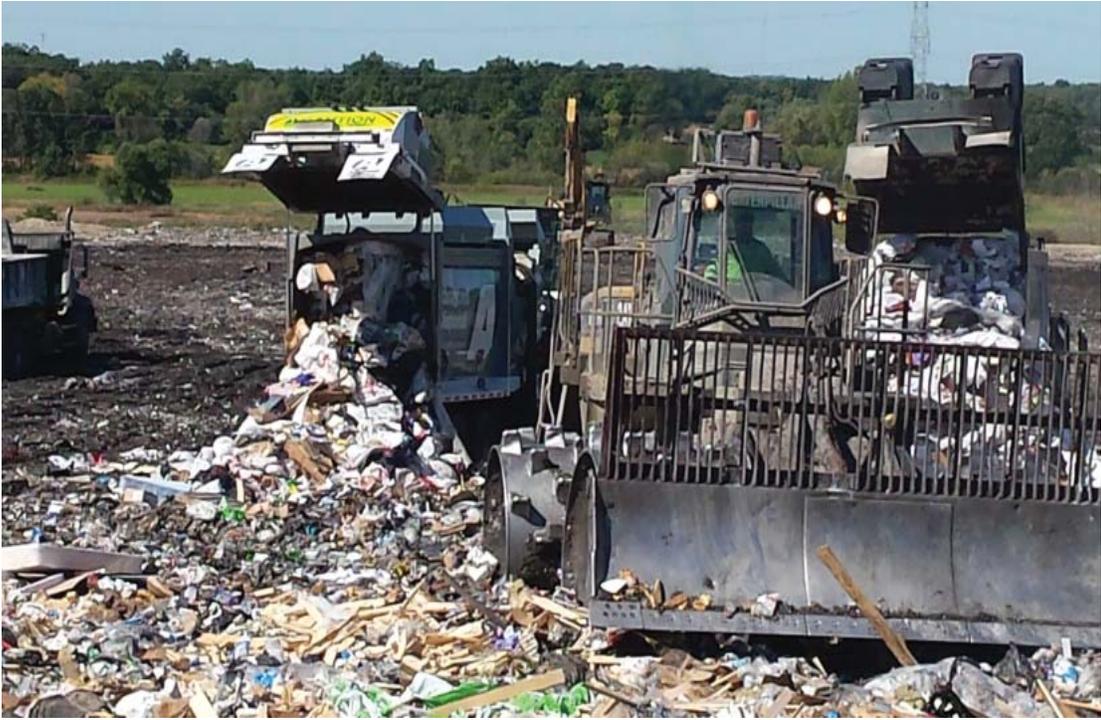
Working face

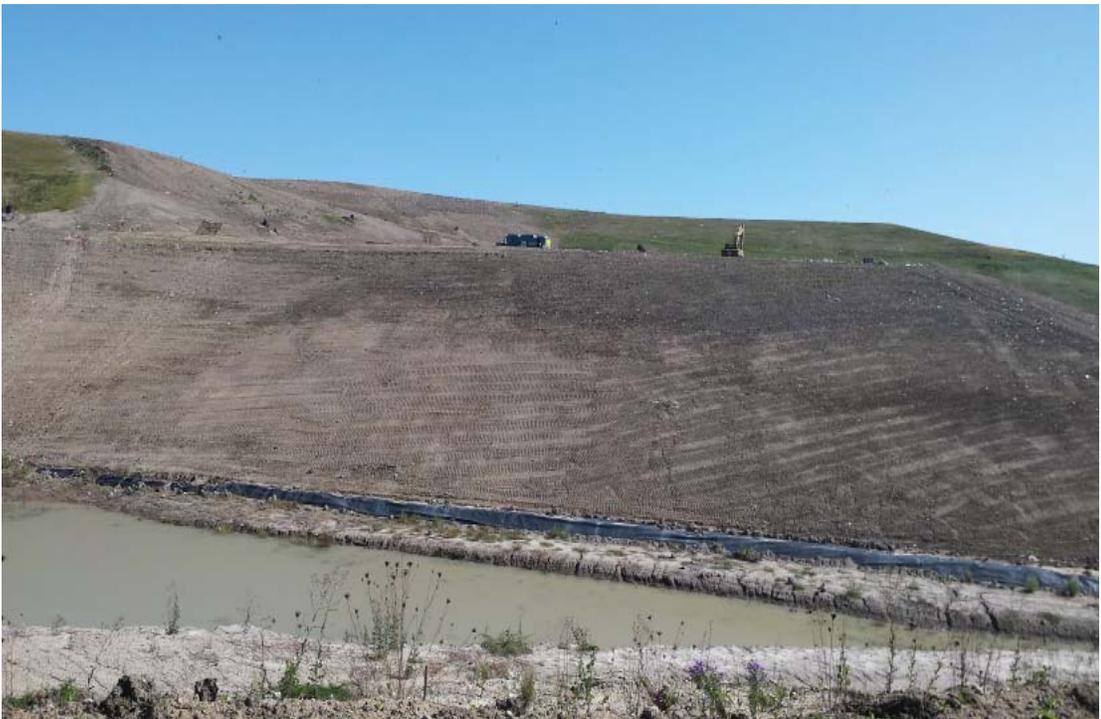
West slope of Phase 7B

- Erosion noticeable on West slope of Phase 7
 - Not significant enough yet to impact cover conditions

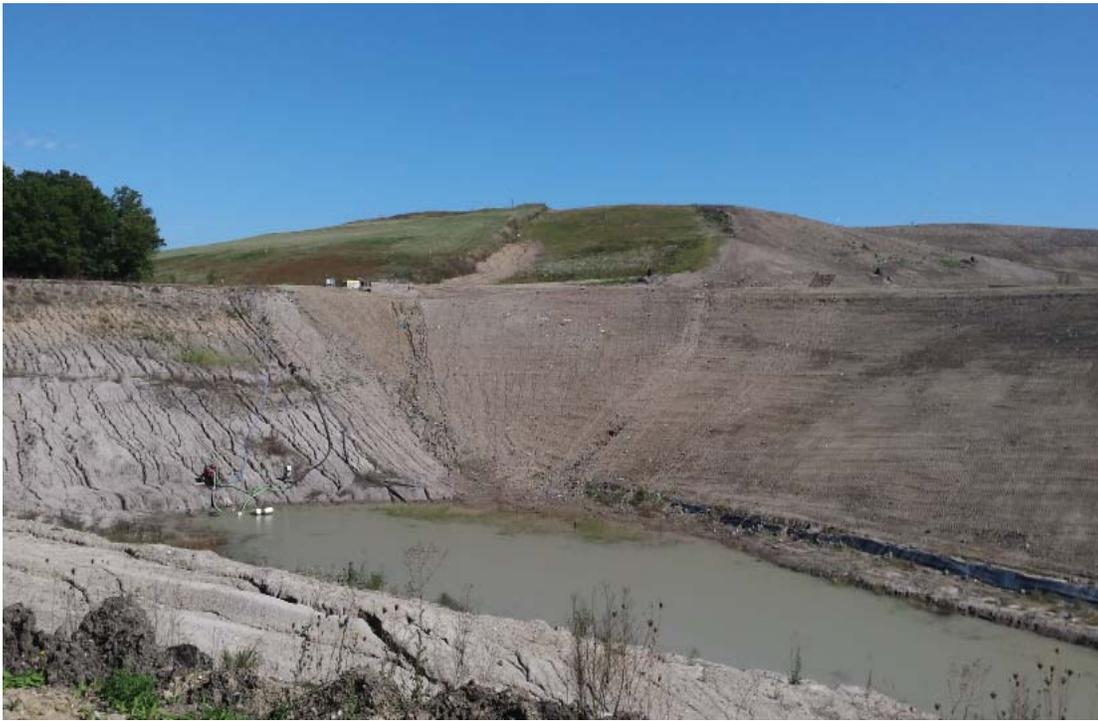
West slope of landfill footprint above Temp. Sed. Basin
