ADS Emerald Park Landfill Audit Summary

To: ADS Emerald Park Landfill Standing Committee, City of Muskego
FROM: Faith Spear.
COPIES: File
DATE: 12/09/15
PROJECT NUMBER: 1012.10030

Attached is the audit report for activities at the ADS Emerald Park Landfill for the week of October 19, 2015. The audit was performed at 12:00 PM on **October 22, 2015** by Jo Spear, Jr. in the presence of Brett Coogan, Operations Manager.

**ADVANCED DISPOSAL SERVICES
EMERALD PARK LANDFILL / CITY OF MUSKEGO
AUDIT PHOTOS**

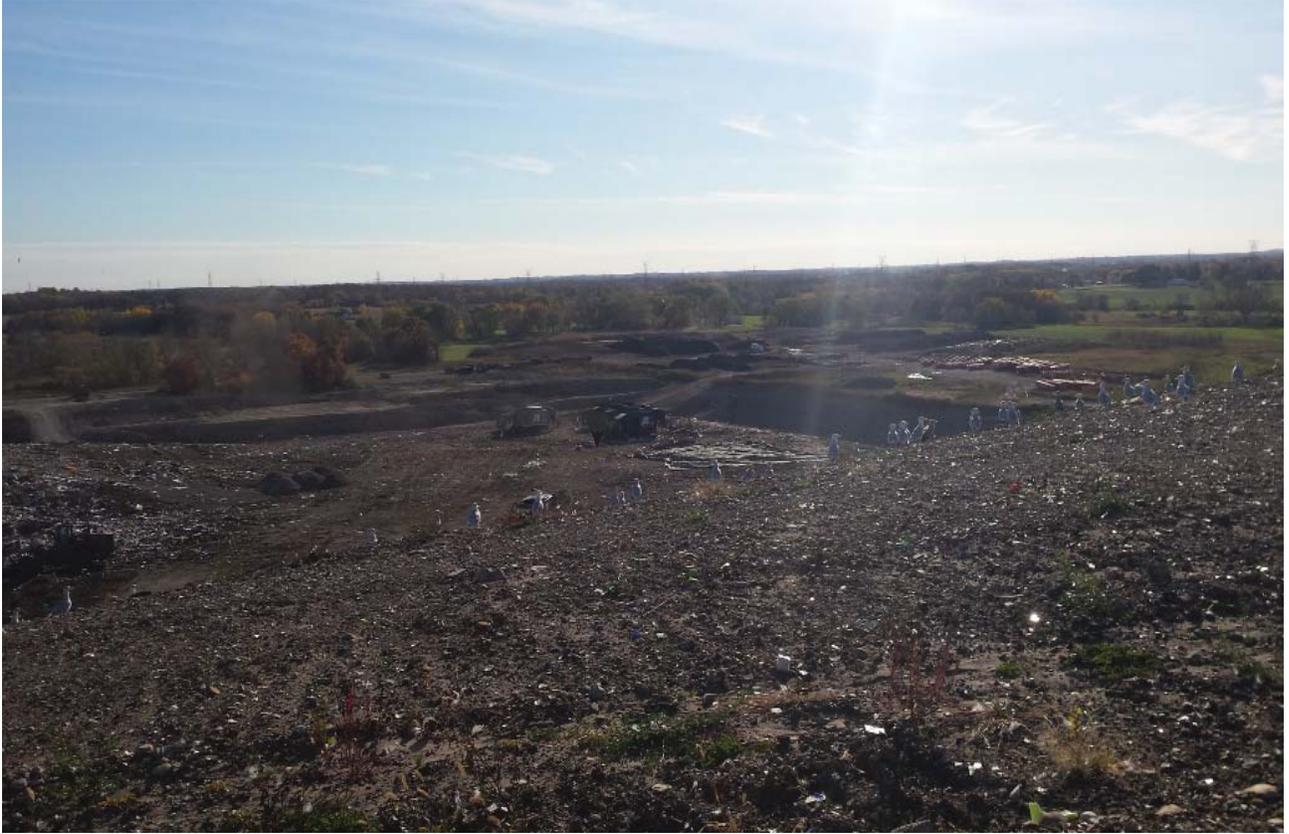
Southern view of Emerald Park

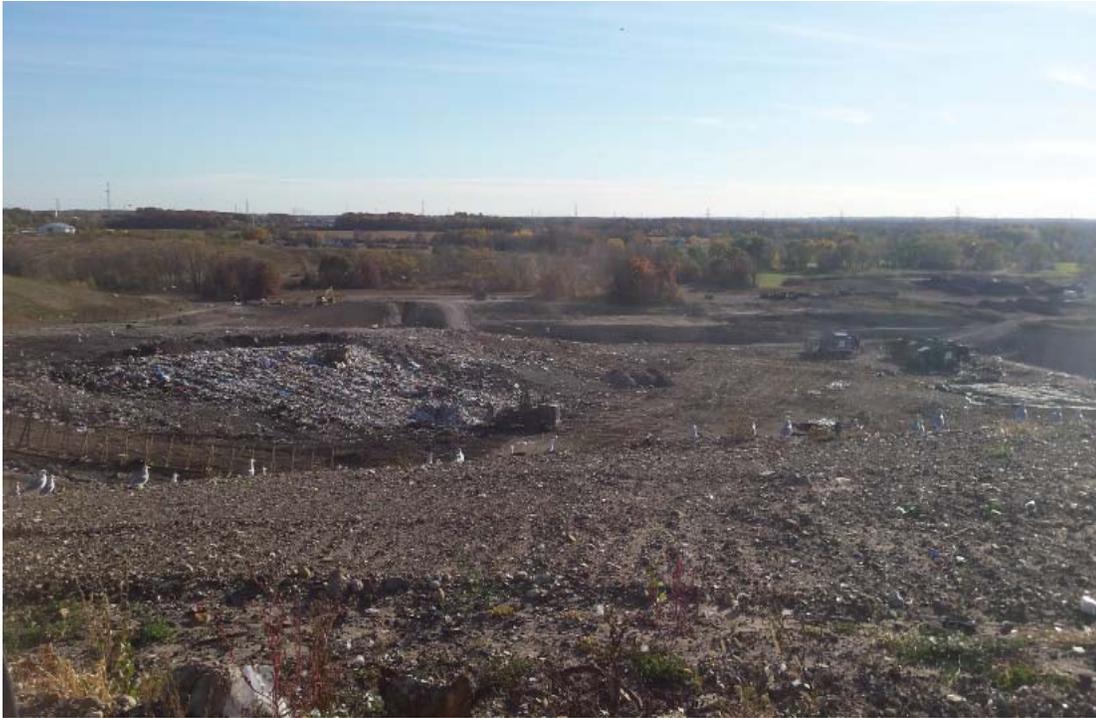
Overview of Active area

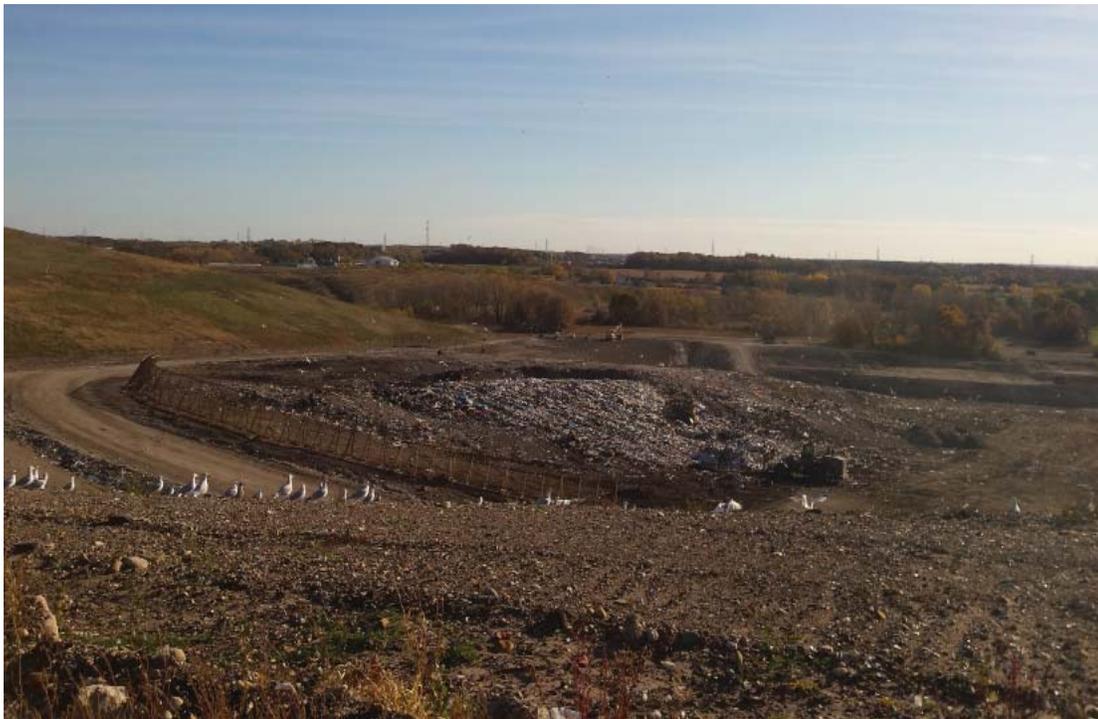
Working face viewed from the North

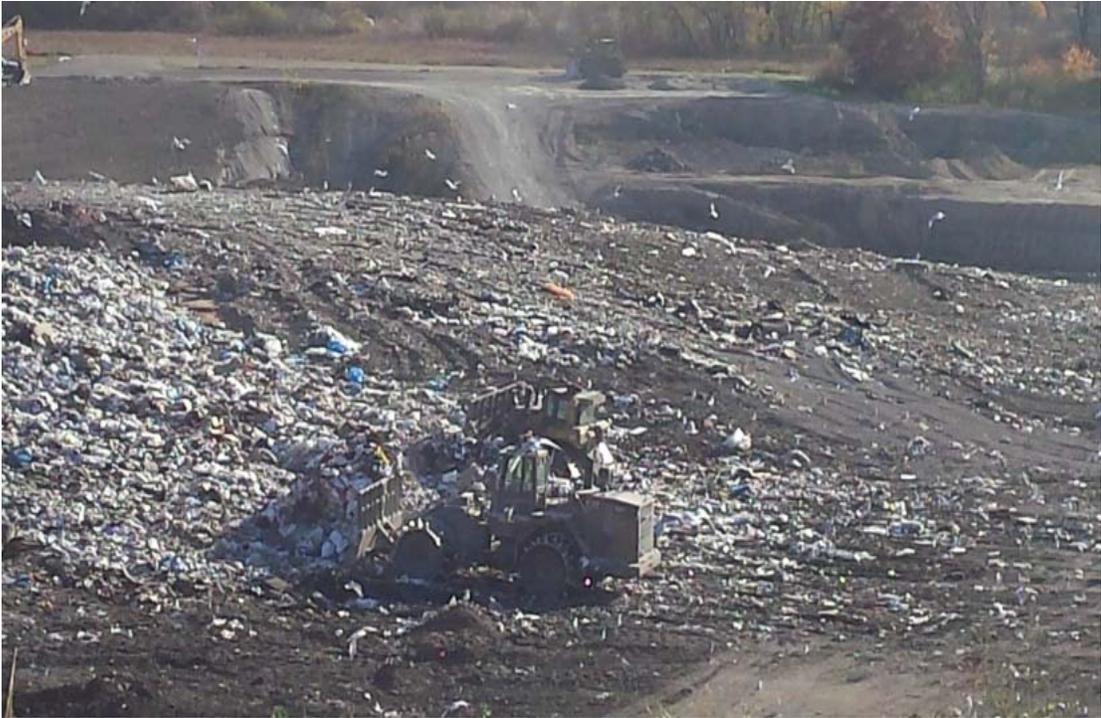
Compactor working waste upward

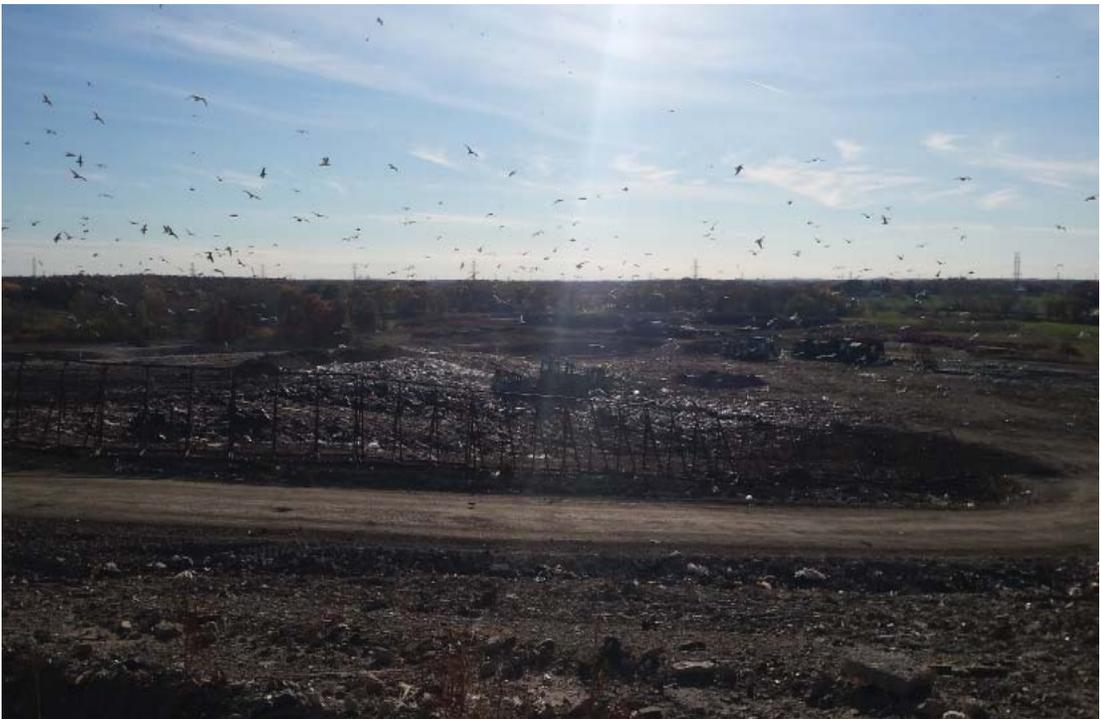
Active area

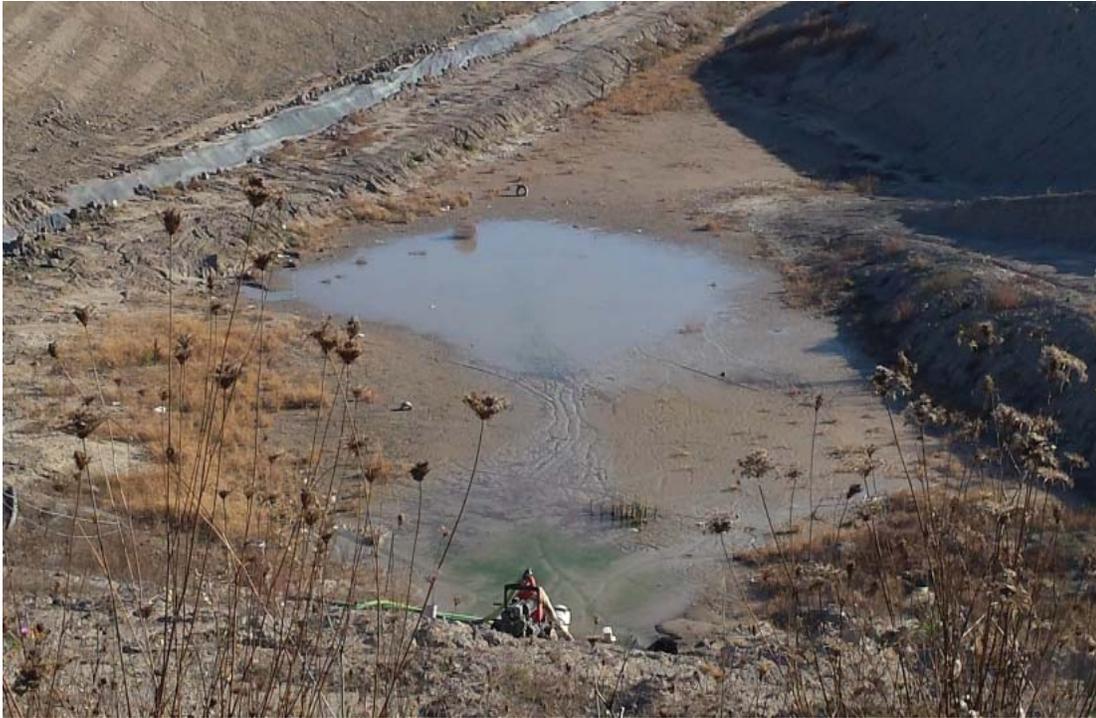
Basins nearly dry except for Basin receiving water from temp basin erosion repairs complete

Temp sed basin nearly drained. Better that tires are in the basin than in the landfill

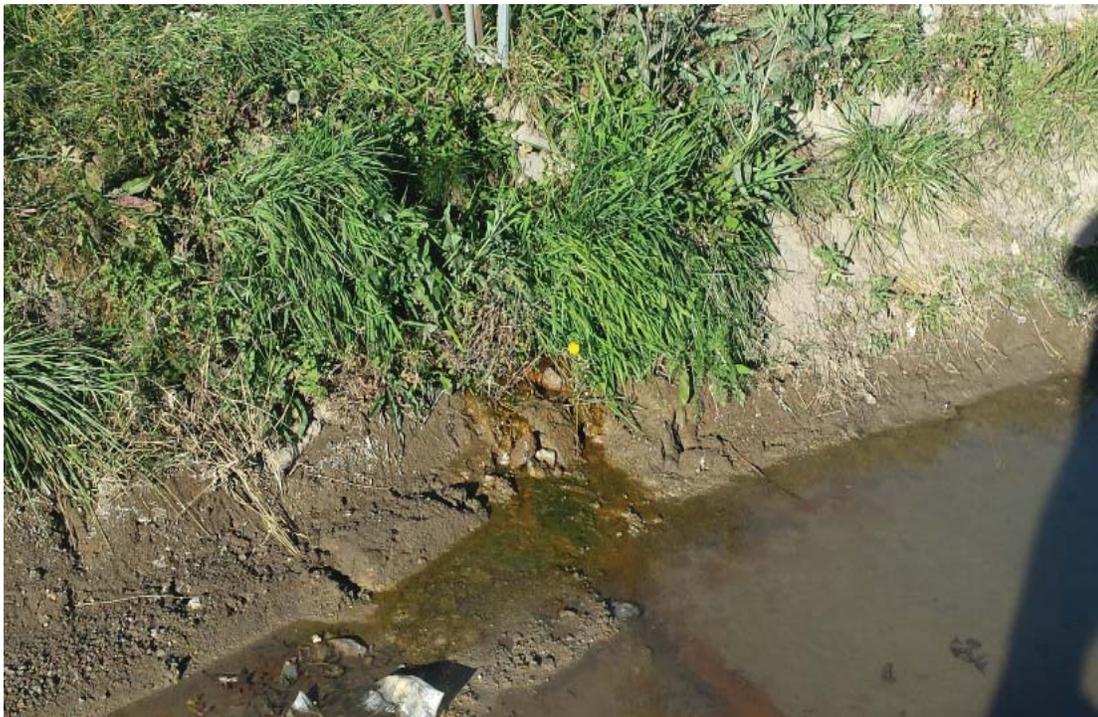
- Gradient pump output and drain area discolored with iron-colored rusty stain
- Staining only at discharge area; does not extend to ditch.

* Gradient pump out of the drains have some staining from iron. Stain only at discharge, no staining in ditch

Iron staining at toe drain and gradient pump discharge
