## Memorandum

### ADS Emerald Park Landfill Audit Summary

**To:** ADS Emerald Park Landfill Standing Committee, City of Muskego  
**FROM:** Faith Spear.  
**COPIES:** File  
**DATE:** 12/09/15  
**PROJECT NUMBER:** 1012.10030

**ADVANCED DISPOSAL SERVICES  
EMERALD PARK LANDFILL / CITY OF MUSKEGO  
AUDIT PHOTOS**

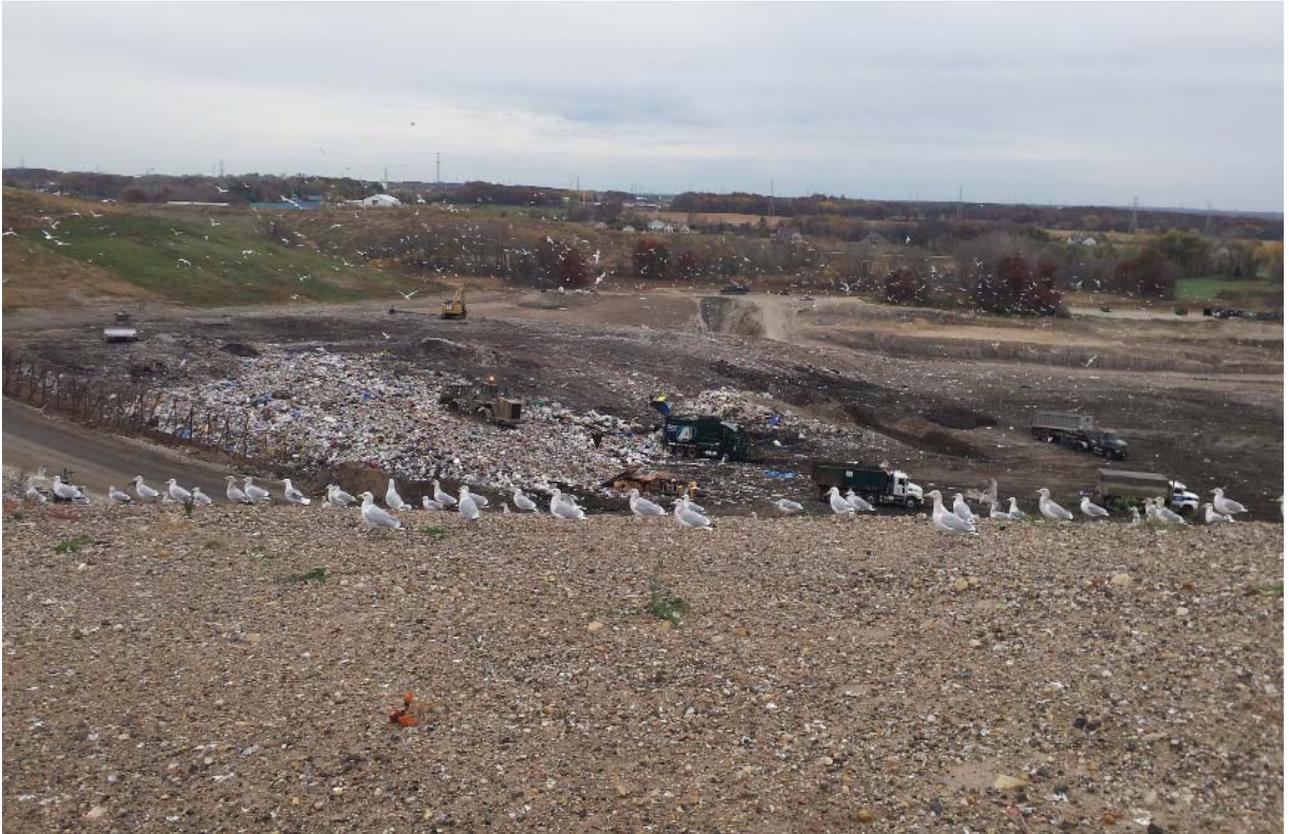
Active area viewed from the North

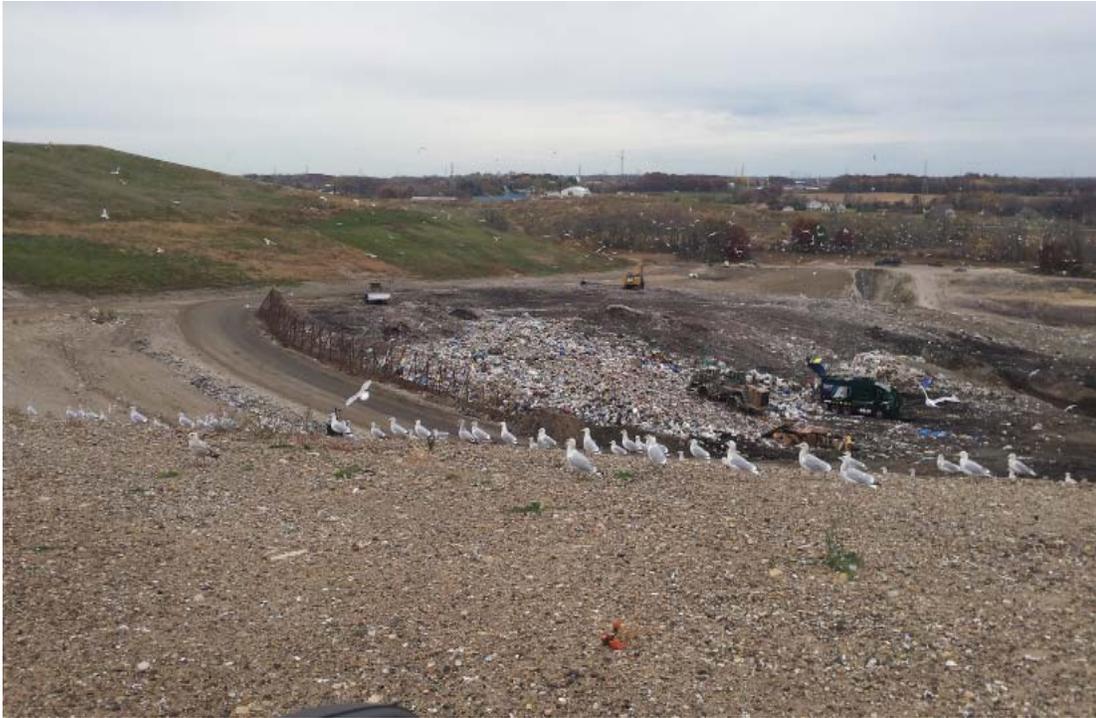
Working face against access road and Phase 6 boundary

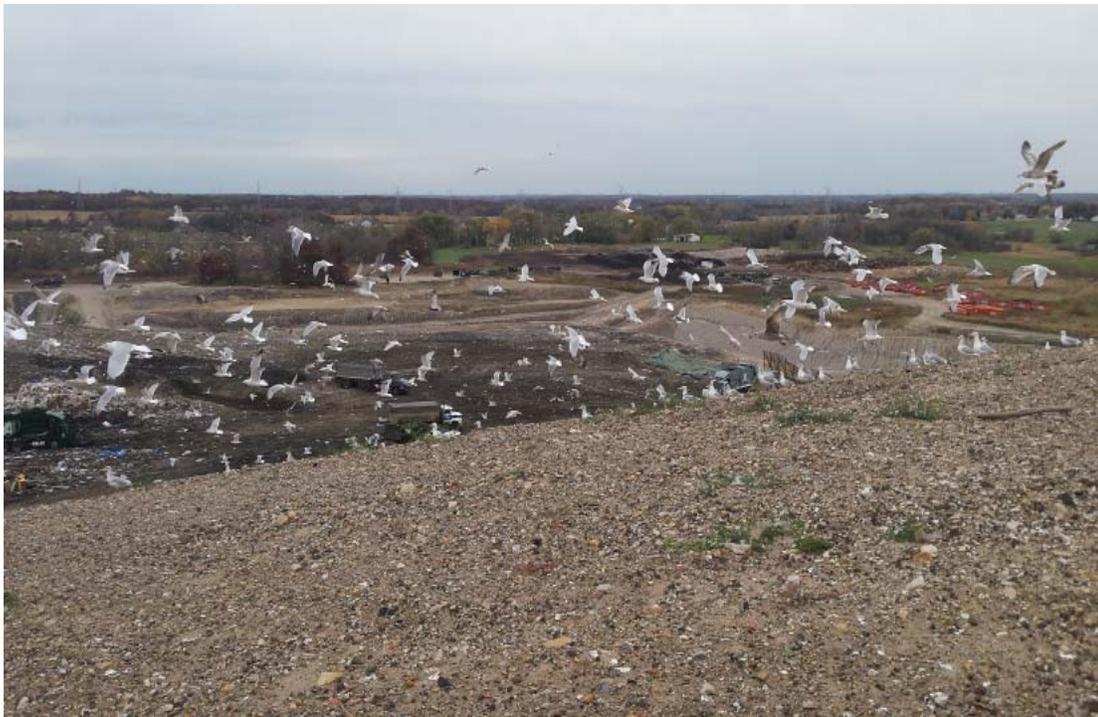
Overview of site, view obscured by birds

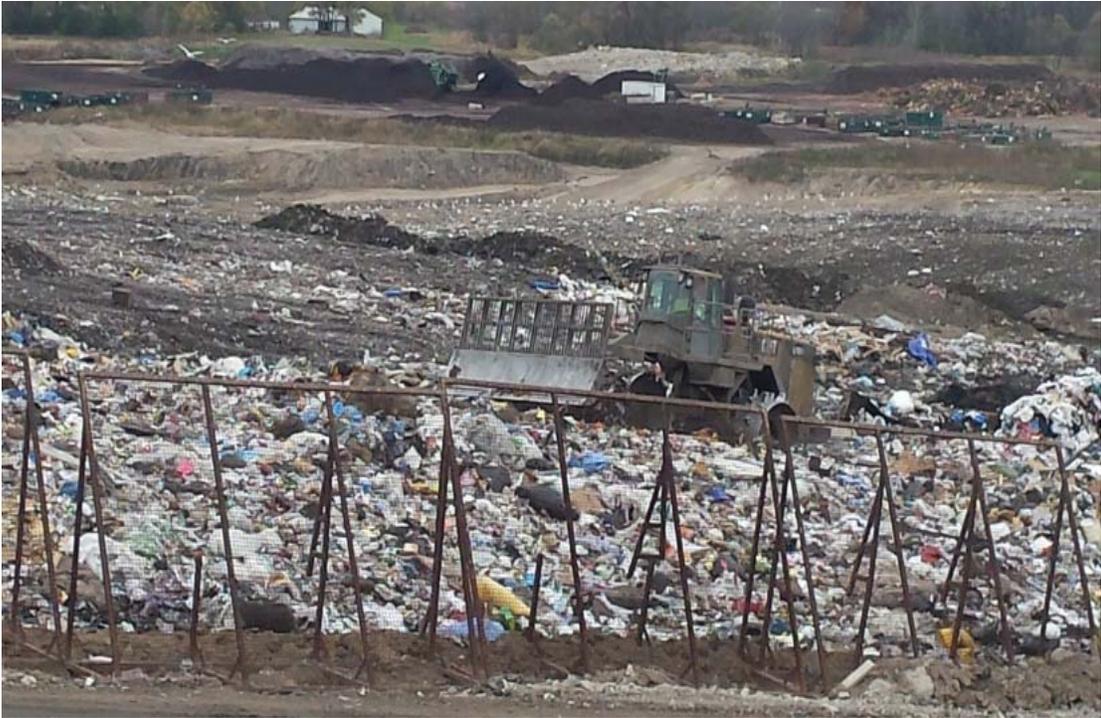
Compactor working waste upward

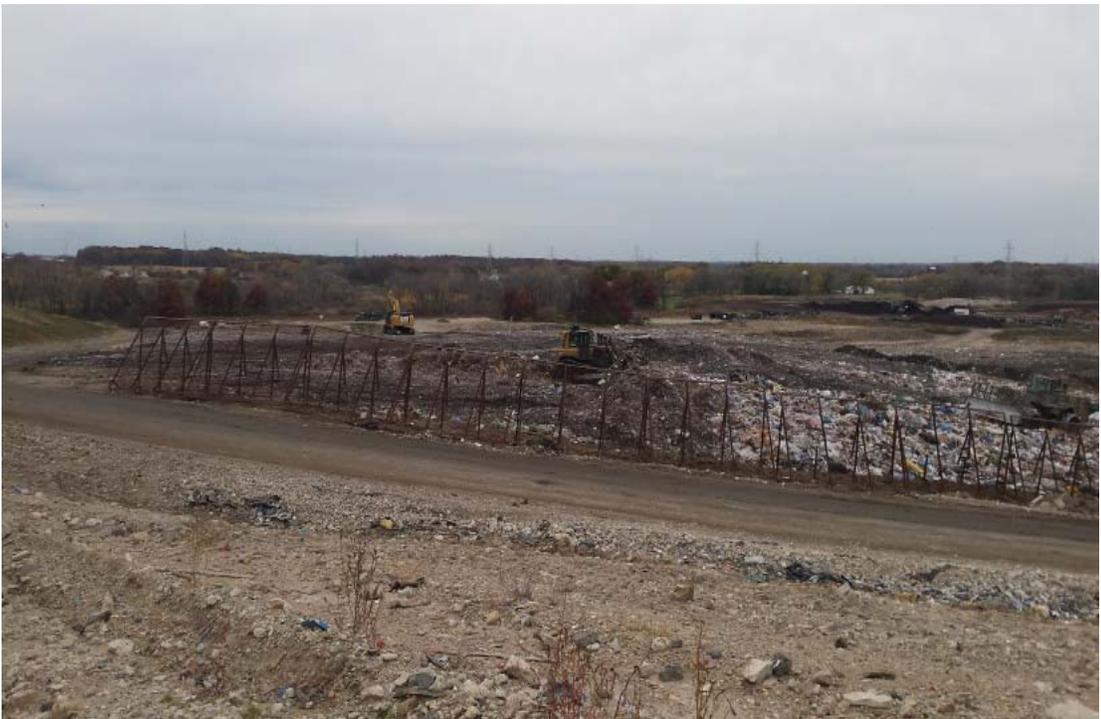
Temp fences lining access road and separating working face

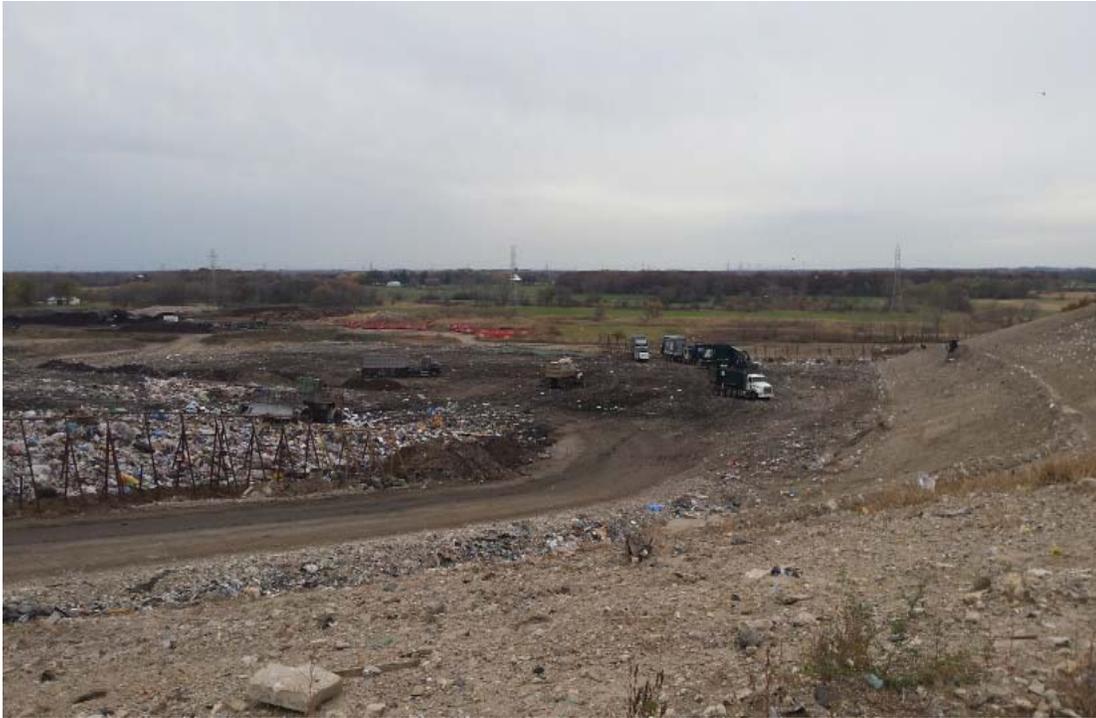
Staging and cleanout area away from working face

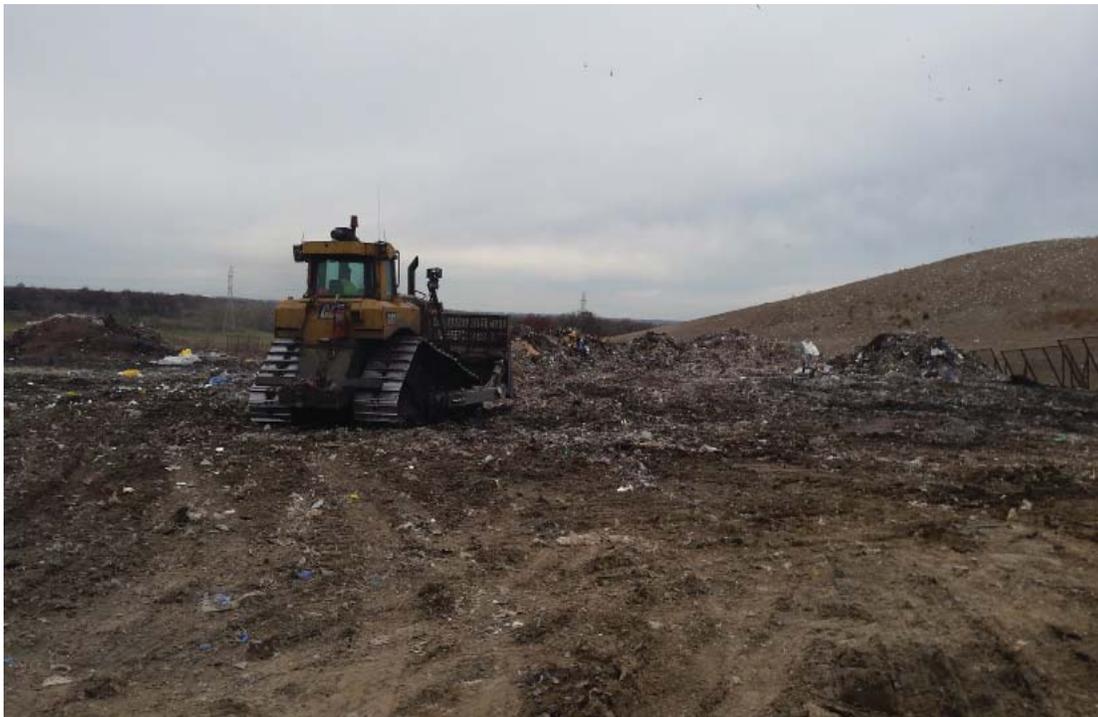
Dozer spreading cover in completed area of lift

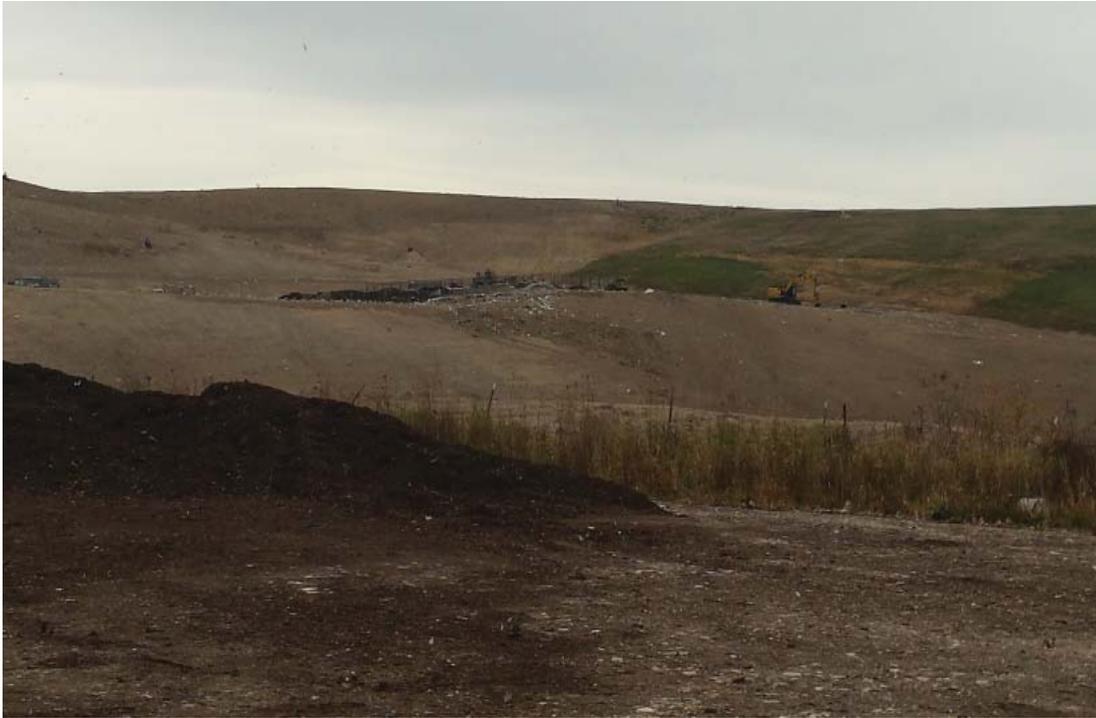
Comments:  
 Minor litter about site, mostly on West slope

Some litter at top of West slope, Phase 7, adjacent to active area

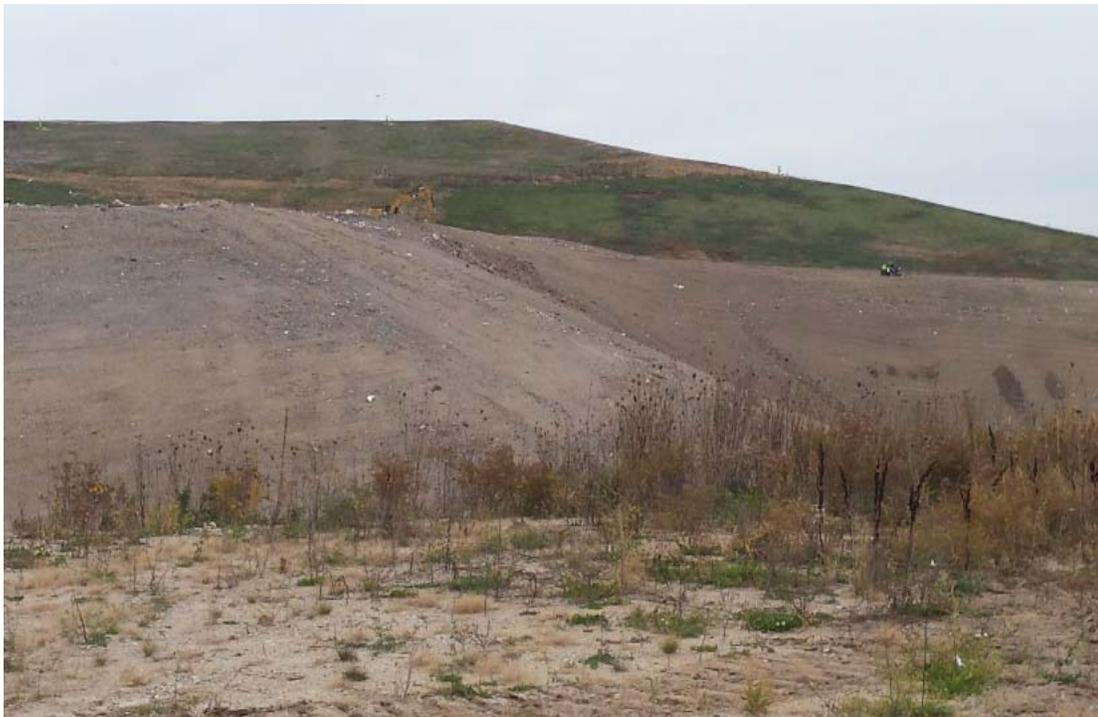
Transition from new slope work to old, existing cover in good shape

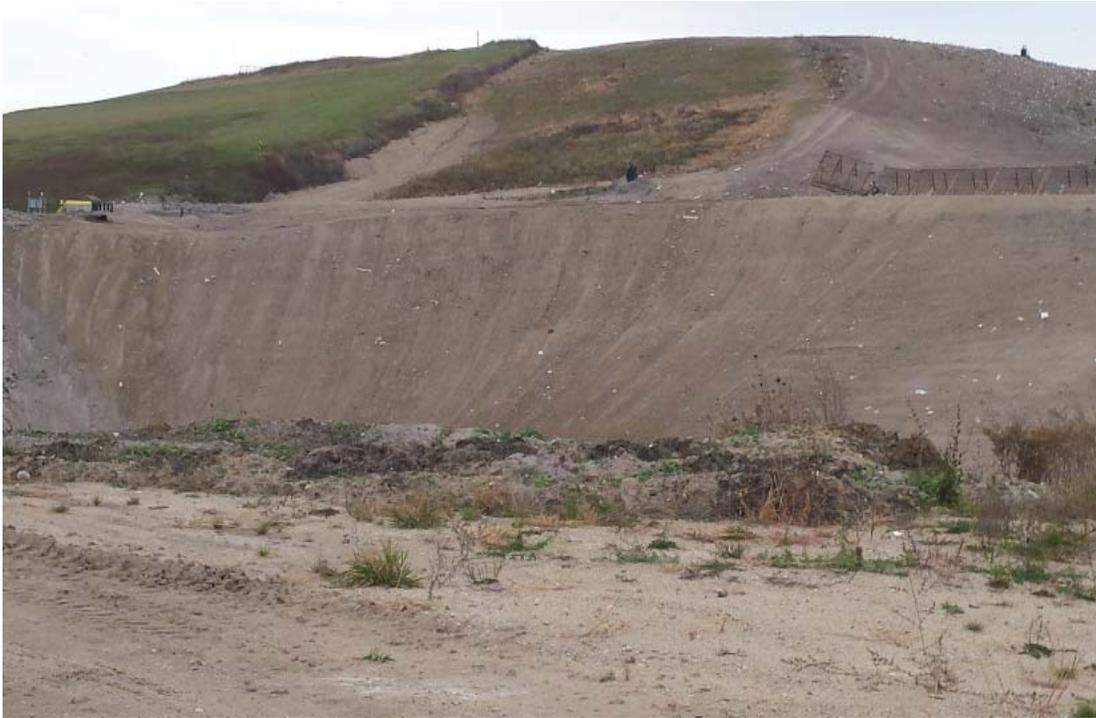
Exterior slopes, unseeded, but in excellent condition

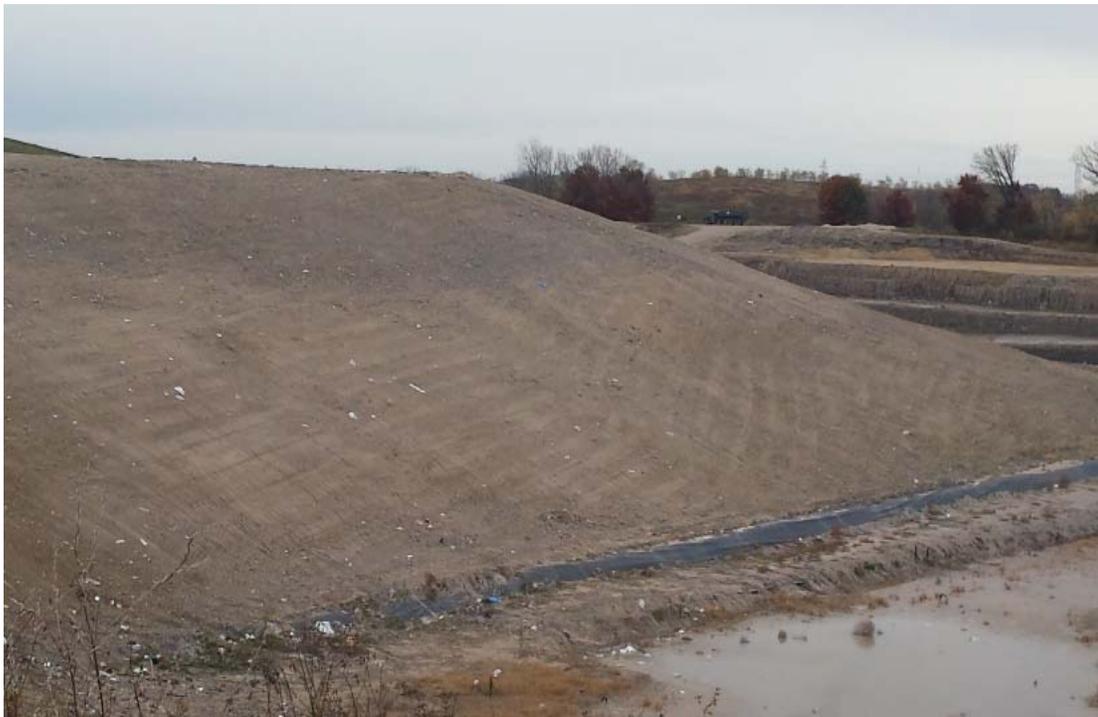
West slope of Phase 7, some litter on slope, intermediate cover in excellent shape
