### ADS Emerald Park Landfill Audit Summary

**To:** ADS Emerald Park Landfill Standing Committee, City of Muskego  
**FROM:** Faith Spear.  
**COPIES:** File  
**DATE:** 12/16/15  
**PROJECT NUMBER:** 1012.10030

**ADVANCED DISPOSAL SERVICES  
EMERALD PARK LANDFILL / CITY OF MUSKEGO  
AUDIT PHOTOS**

PROJECT NO. 1012.10030

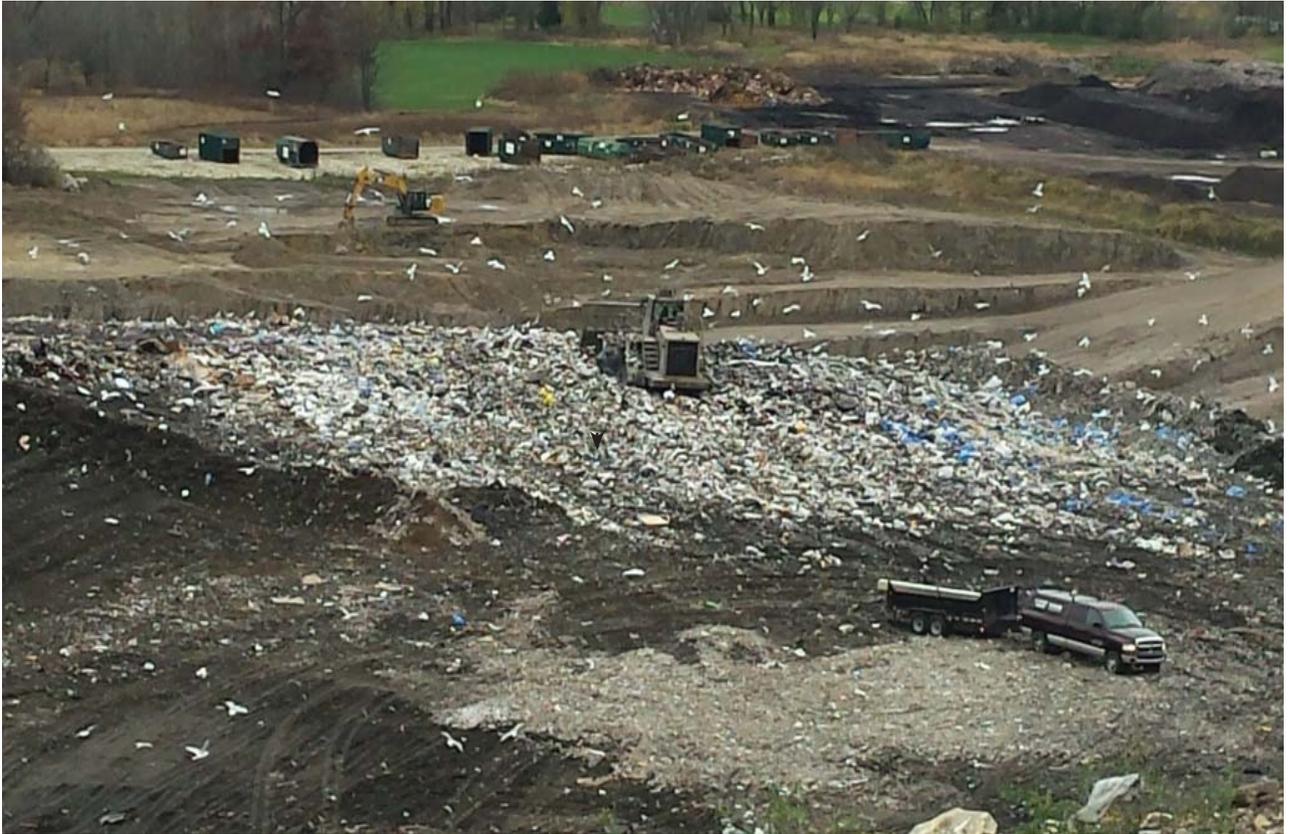
Working face in Southwest corner of Phase 7B

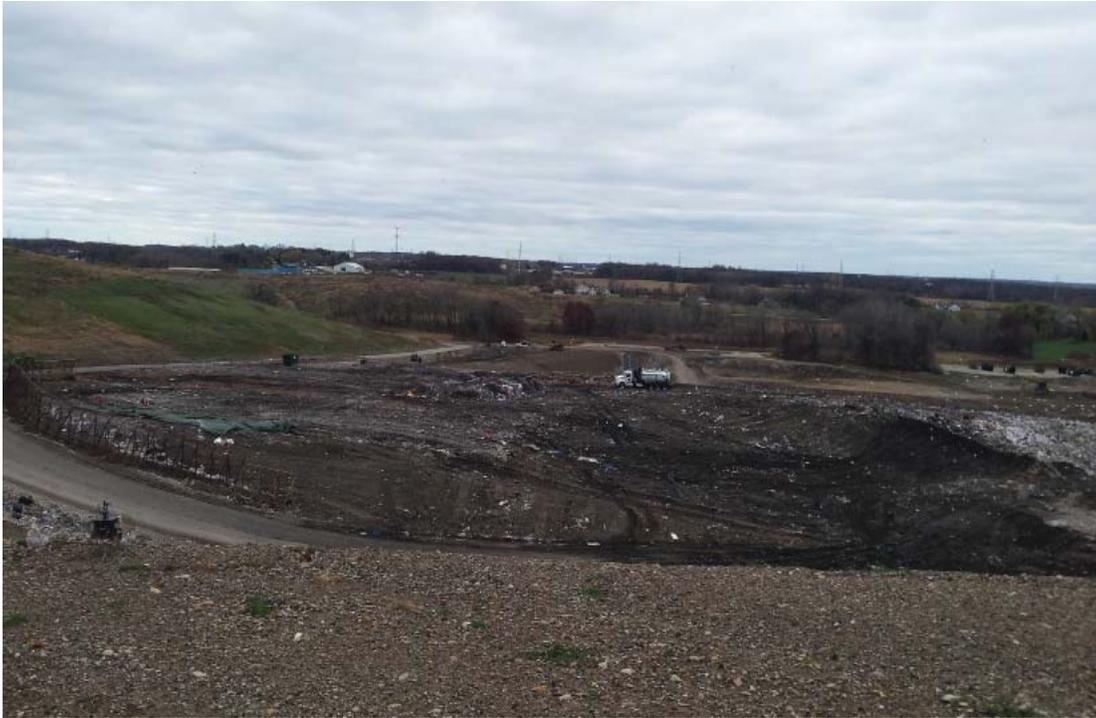
Previous working face locations very well covered

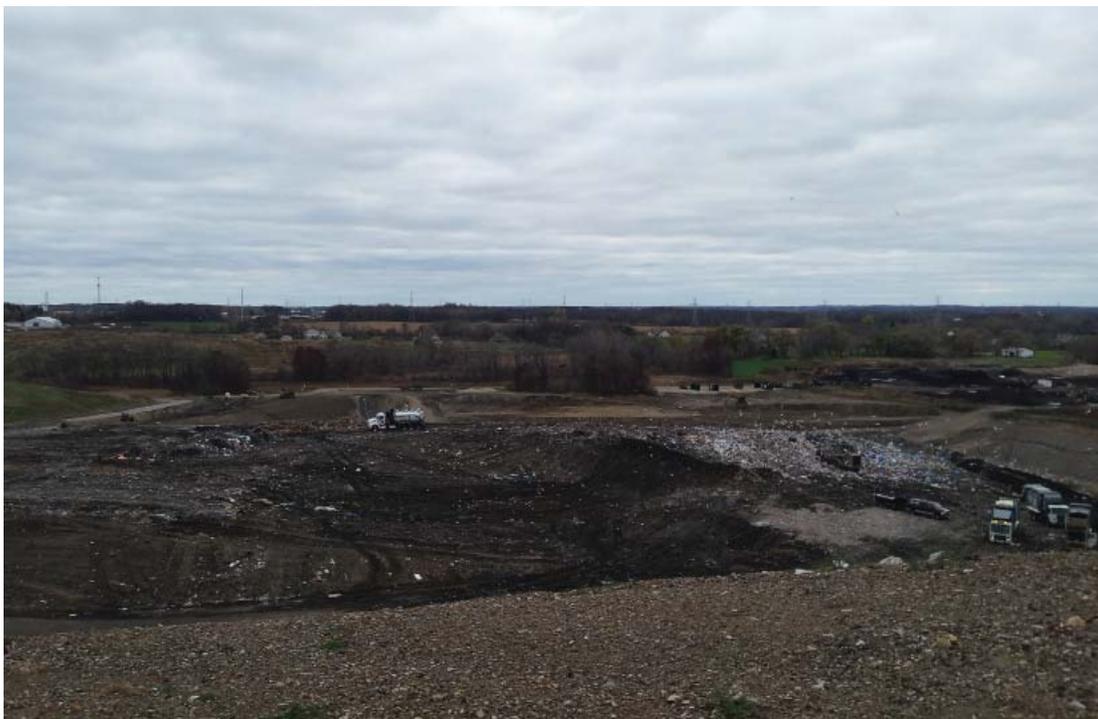
Overview of site

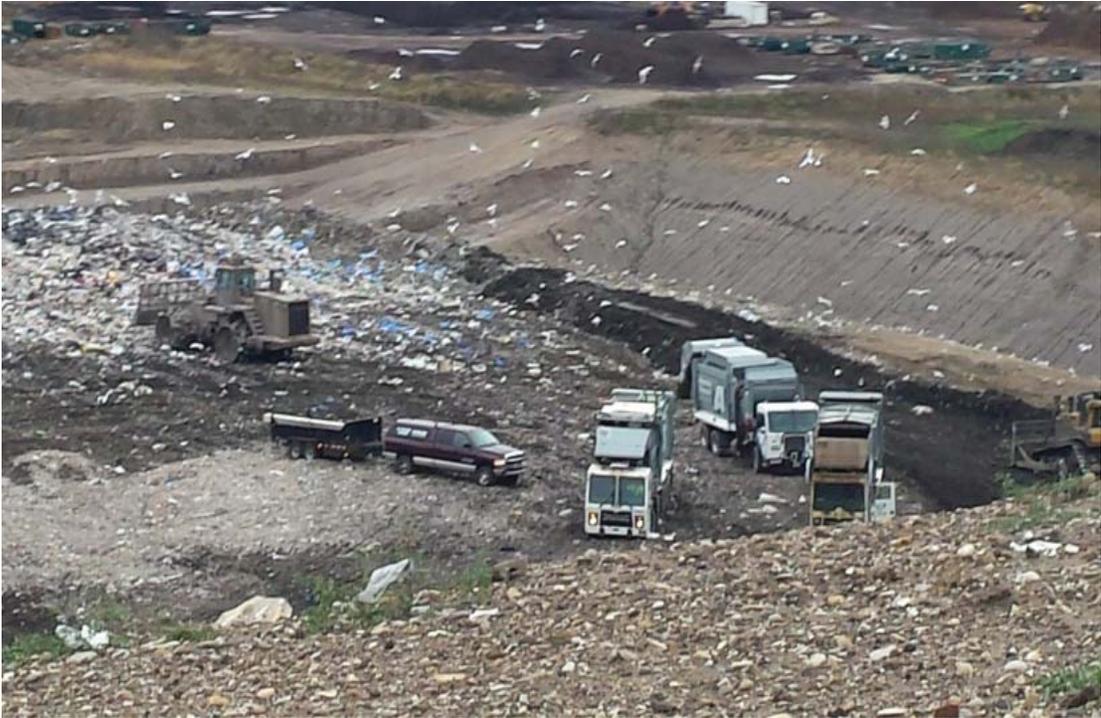
Compactor working waste upward

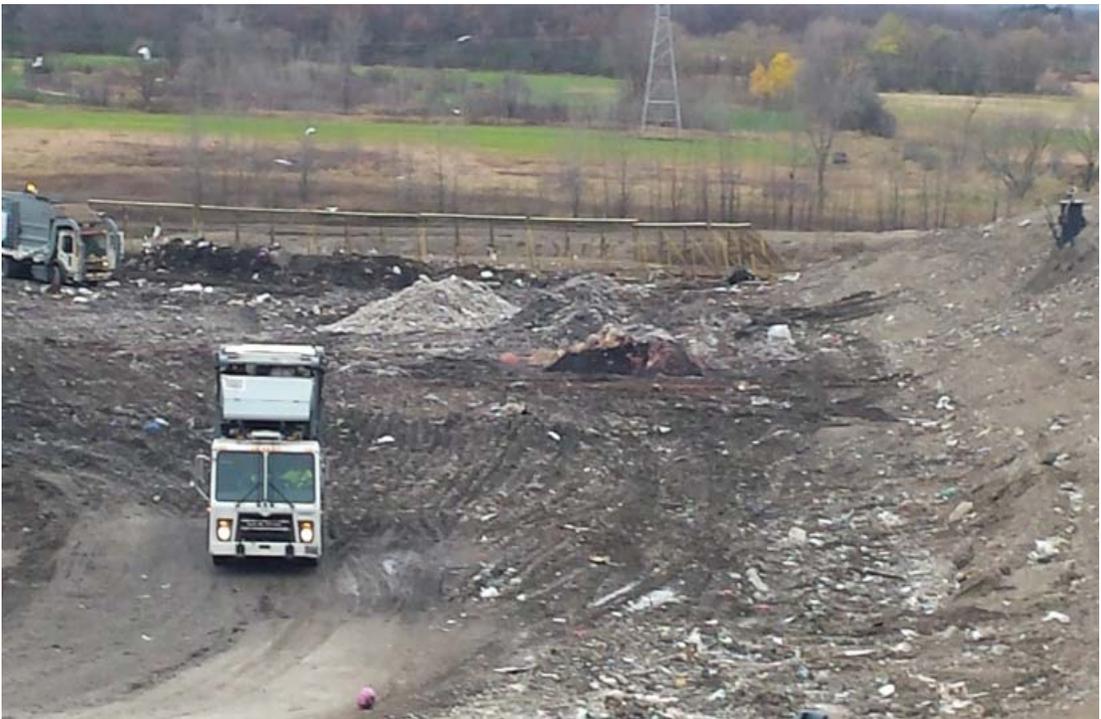
Substantial ADC stockpile in Northwest corner of Active area

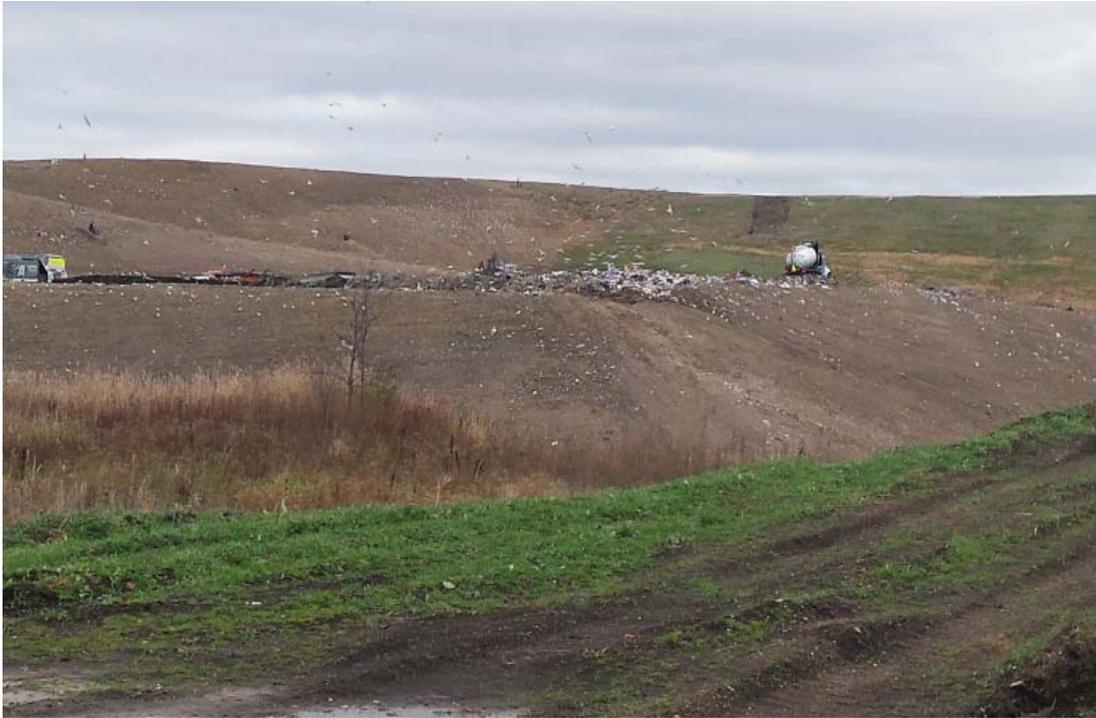
Working face with some litter

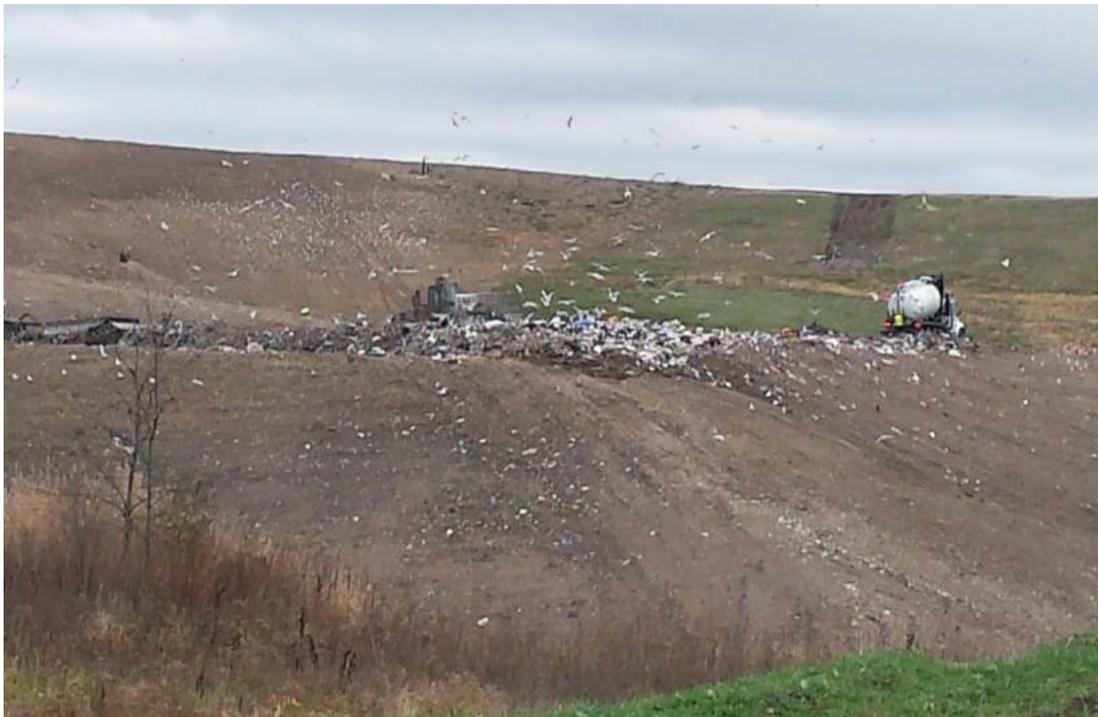
Working face at Southwest corner of Phase 7B, on both outboard slopes
