ADS Emerald Park Landfill Audit Summary

To: ADS Emerald Park Landfill Standing Committee, City of Muskego
FROM: Faith Spear.
COPIES: File
DATE: 12/19/15
PROJECT NUMBER: 1012.10030

Attached is the audit report for activities at the ADS Emerald Park Landfill for the week of November 16, 2015. The audit was performed at 3:05 PM on **November 18, 2015** by Jo Spear, Jr. in the presence of Scott Croft, Gas Well Technician.

**ADVANCED DISPOSAL SERVICES
EMERALD PARK LANDFILL / CITY OF MUSKEGO
AUDIT PHOTOS**

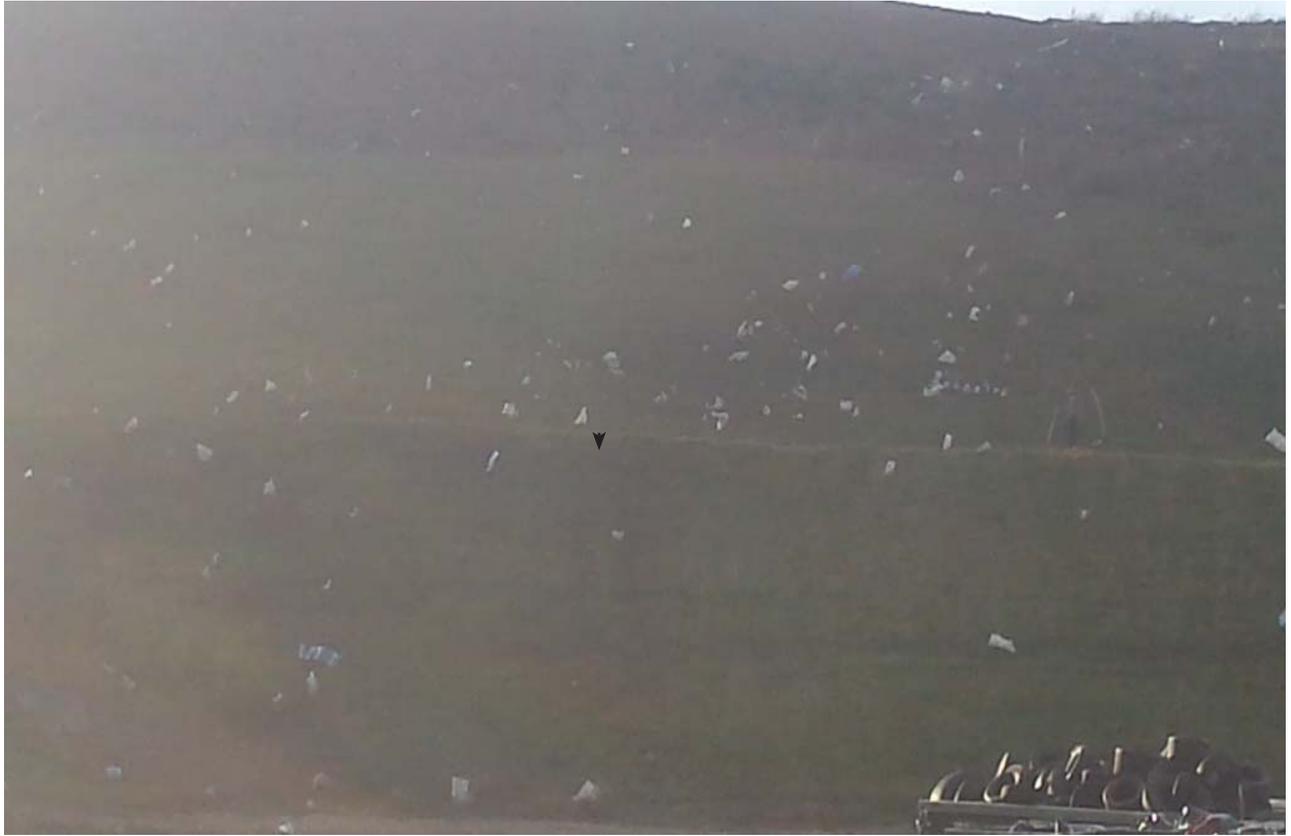
Powerful winds, Litter across site footprint.

East slope of Phases 1 - 3, heavily littered from winds.

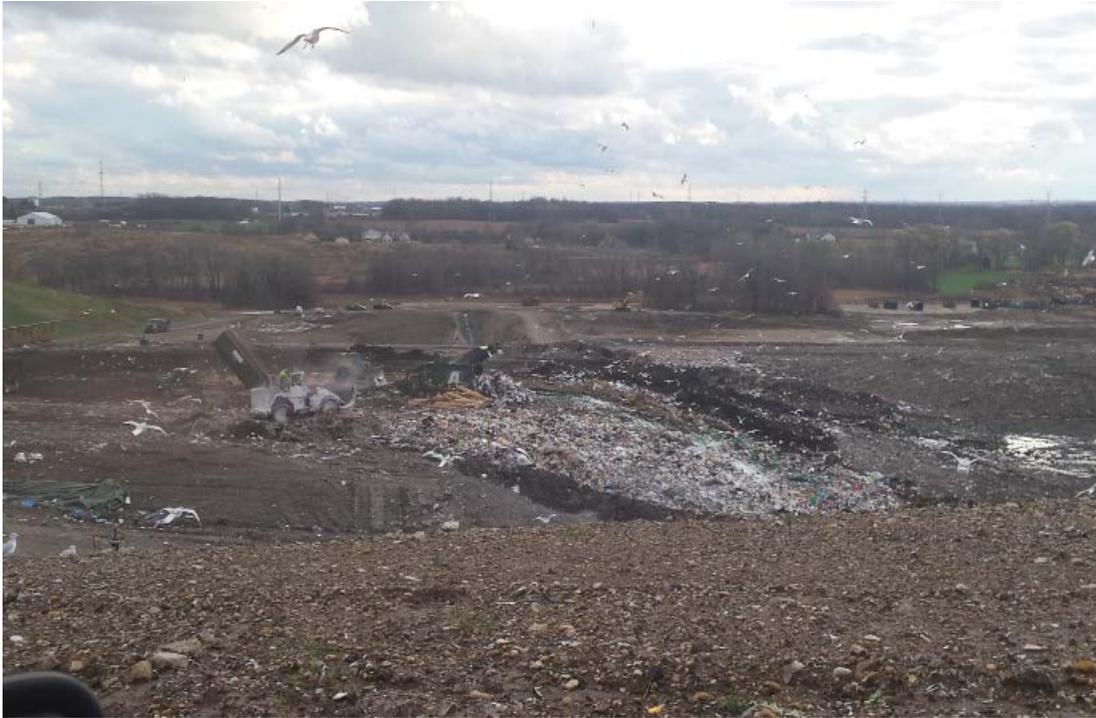
Working face

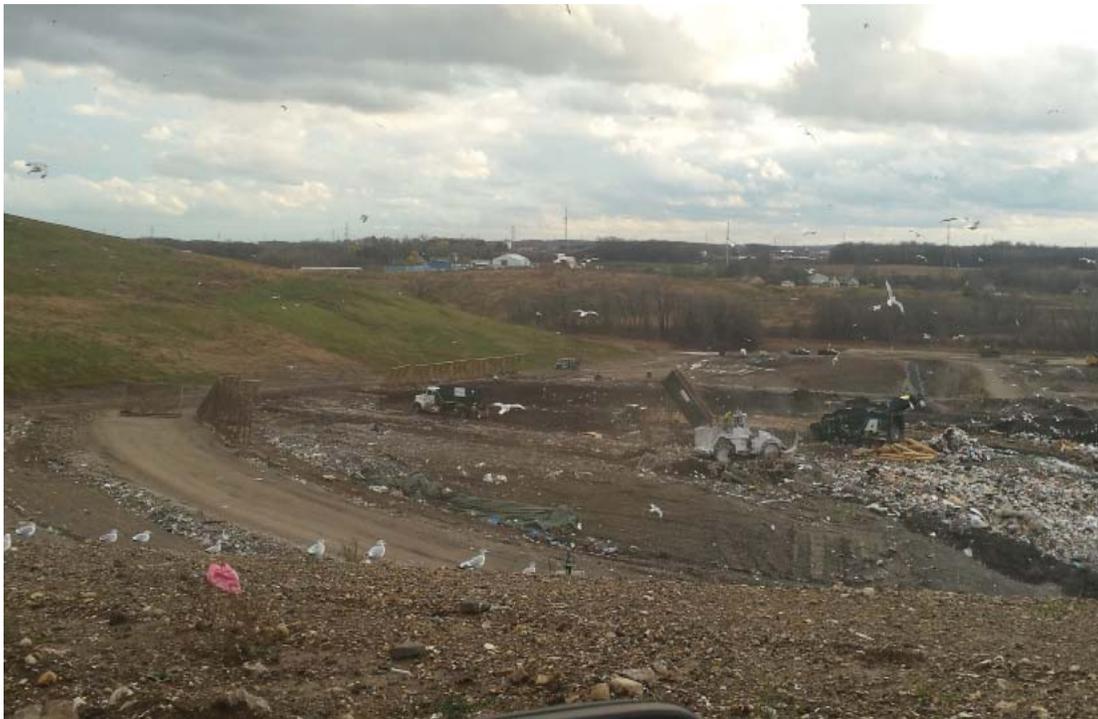
Access and Eastern section of Active Area

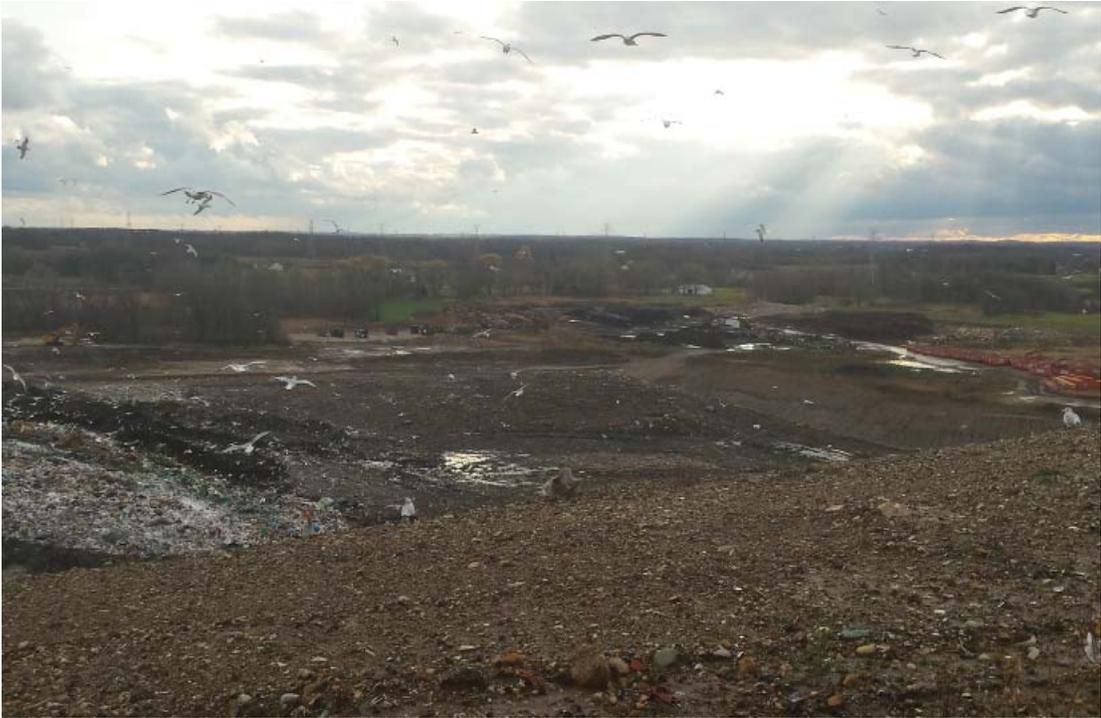
Western half of Active Area

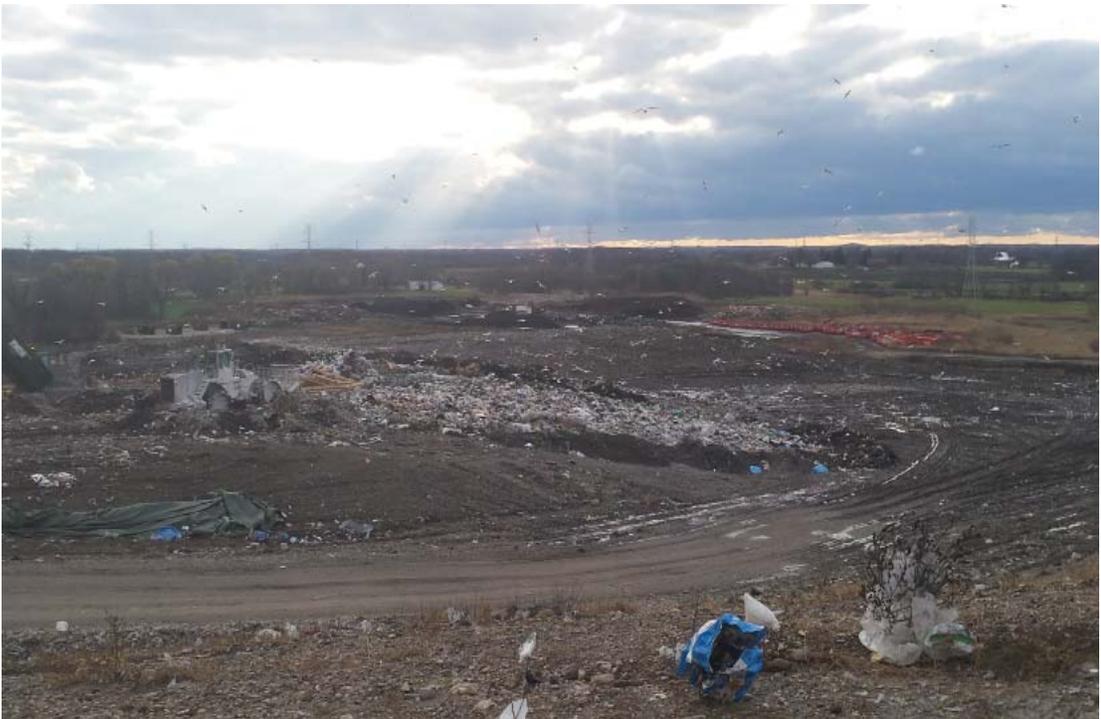
Working face in the middle of Phase 7. Location
to reduce litter impacts. No other
working faces. Liquid load tipped
during audit.

Working face in middle of Phase 7 & 7B

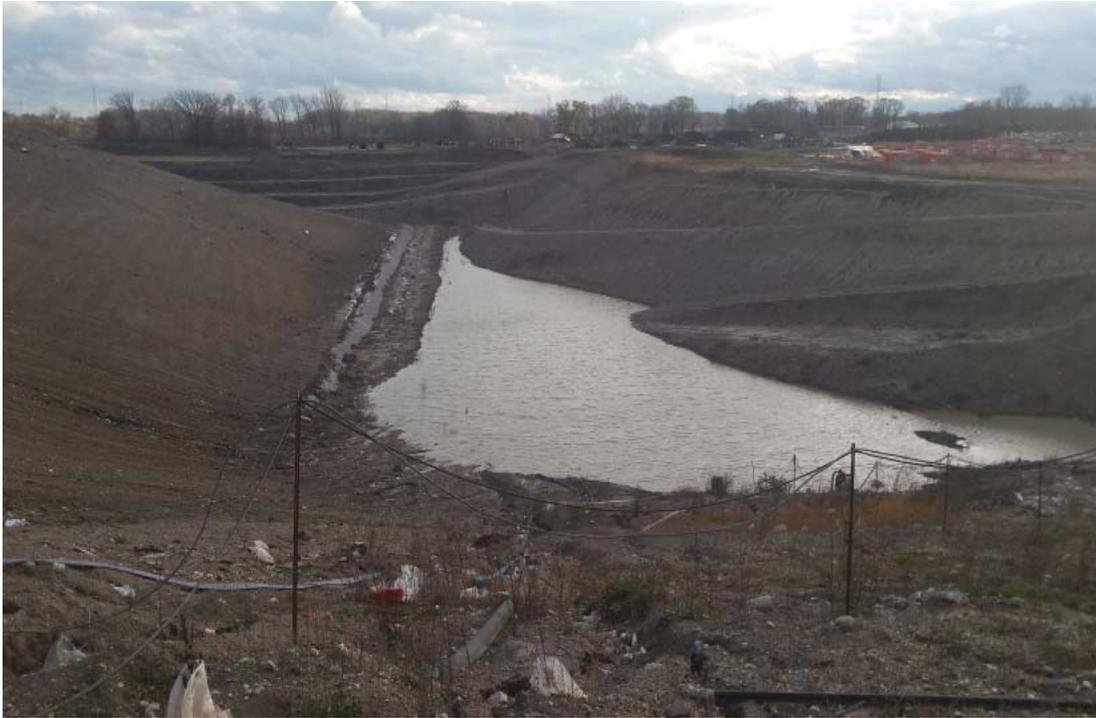
* Temp Sed Basin has free board, ~3 feet
Pumping ongoing during audit.

Temp sed basin

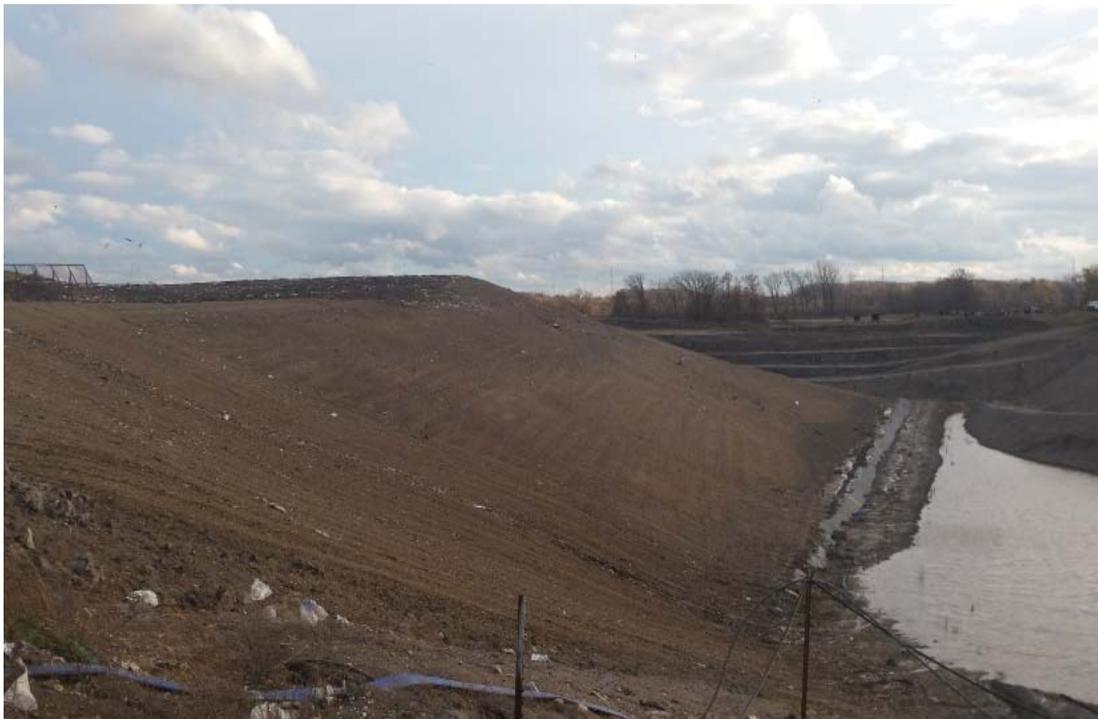
West slope of Phase 7 & 7B

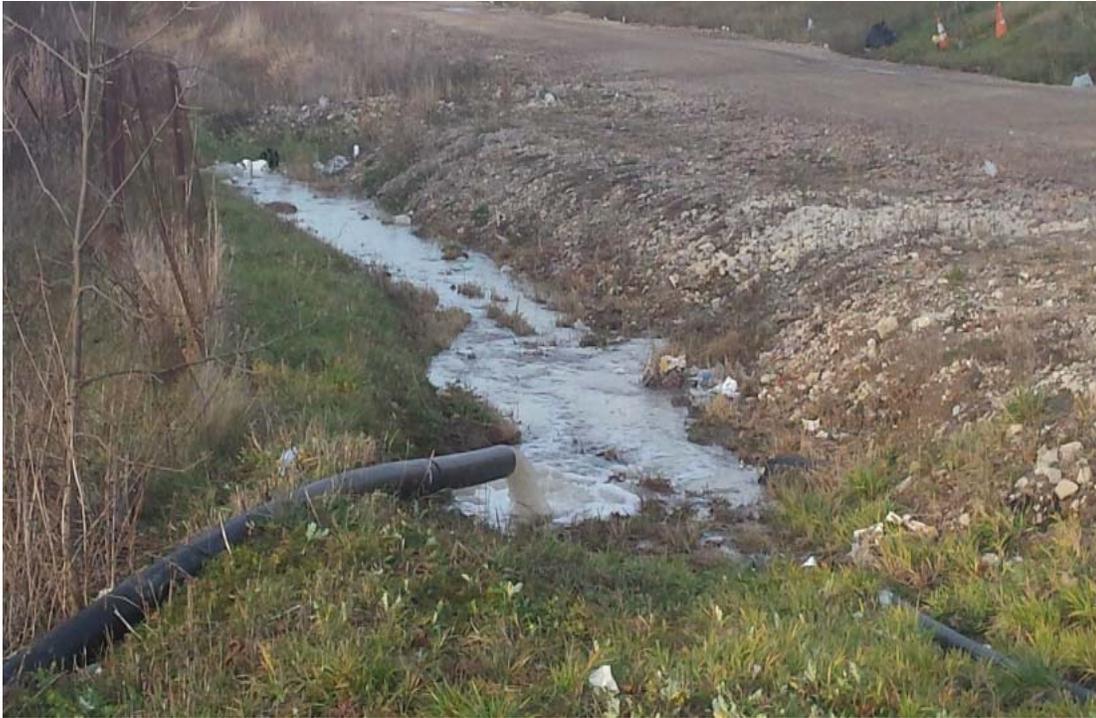
Active pumping from temp Sed. Basin to Basin #1

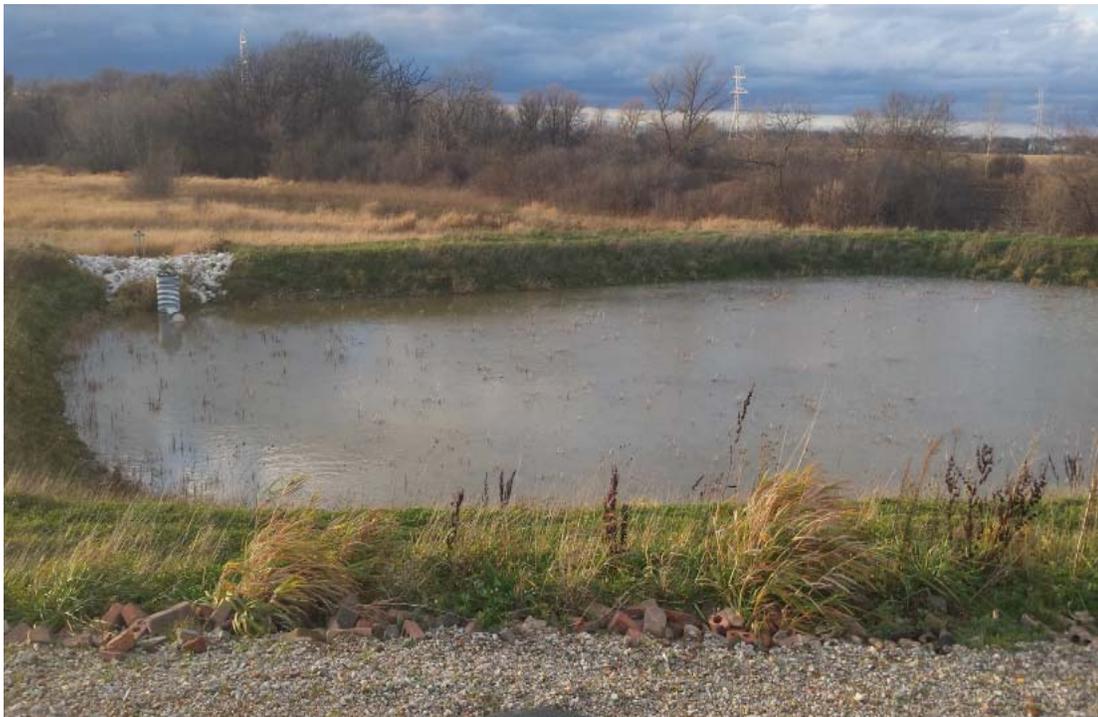
Stockpile drainage basin and outfall structure

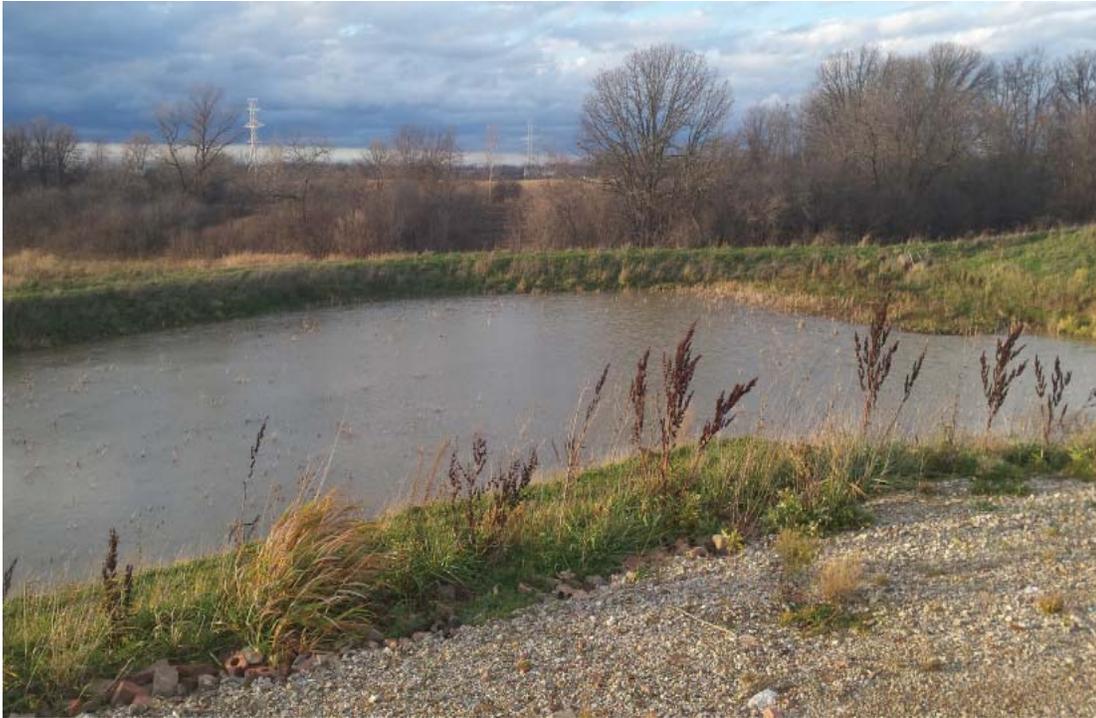
Drainage basin for Stockpiles

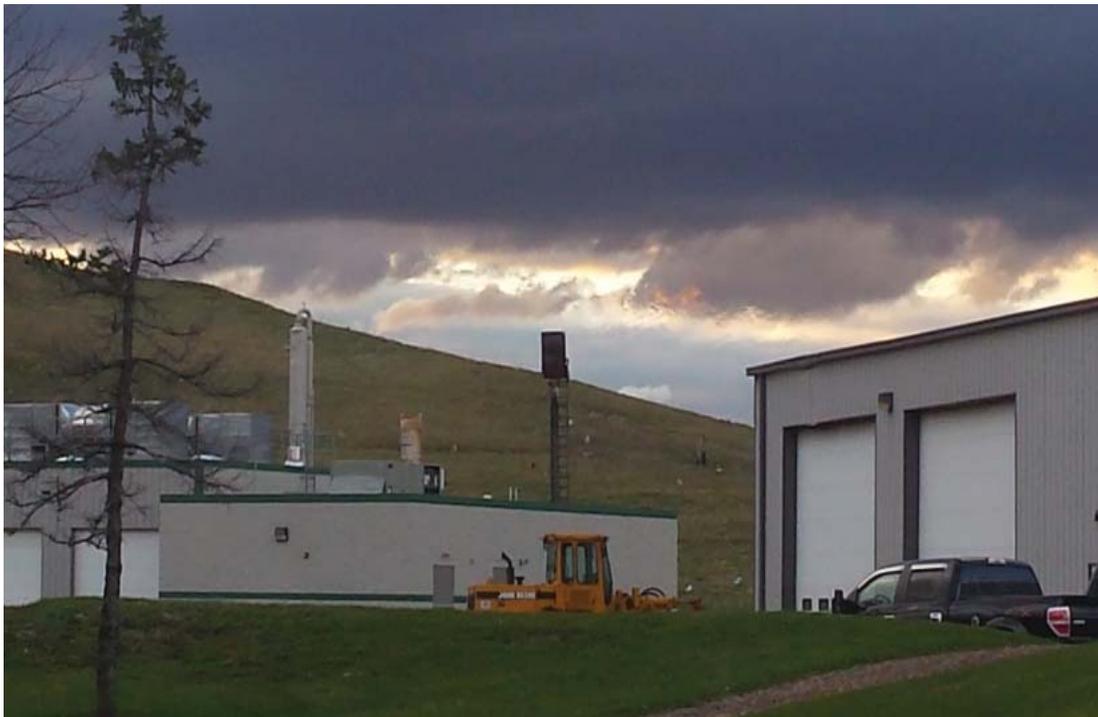
Gas delivery to begin this evening to MMSD

Flare lit while site not delivering gas to MMSD
