Memorandum

ADS Emerald Park Landfill Audit Summary

To: ADS Emerald Park Landfill Standing Committee, City of Muskego
FROM: Faith Spear.
COPIES: File
DATE: 12/29/15
PROJECT NUMBER: 1012.10030

Attached is the audit report for activities at the ADS Emerald Park Landfill for the week of December 7, 2015. The audit was performed at 10:00 AM on **December 11, 2015** by Jo Spear, Jr. in the presence of Brett Coogan, Operations Manager.

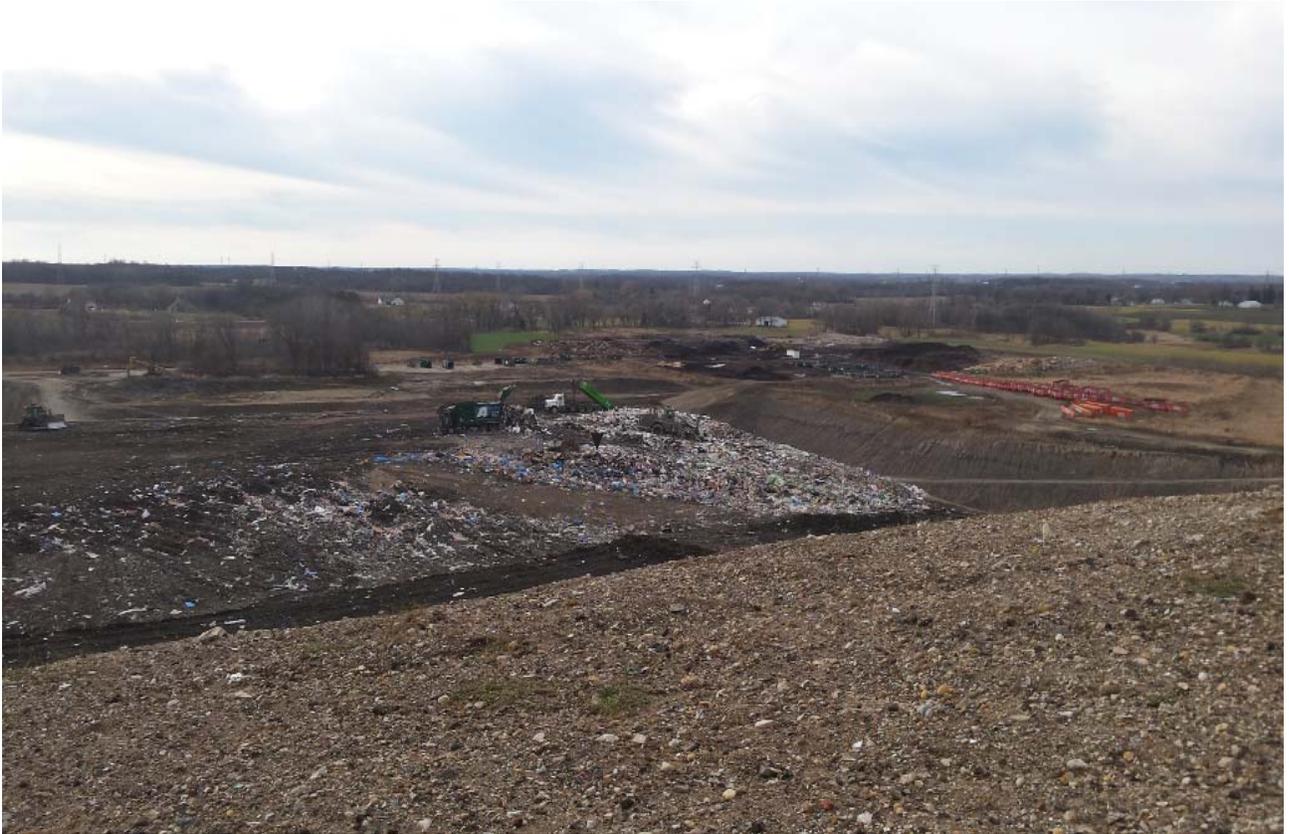
Active area and working face

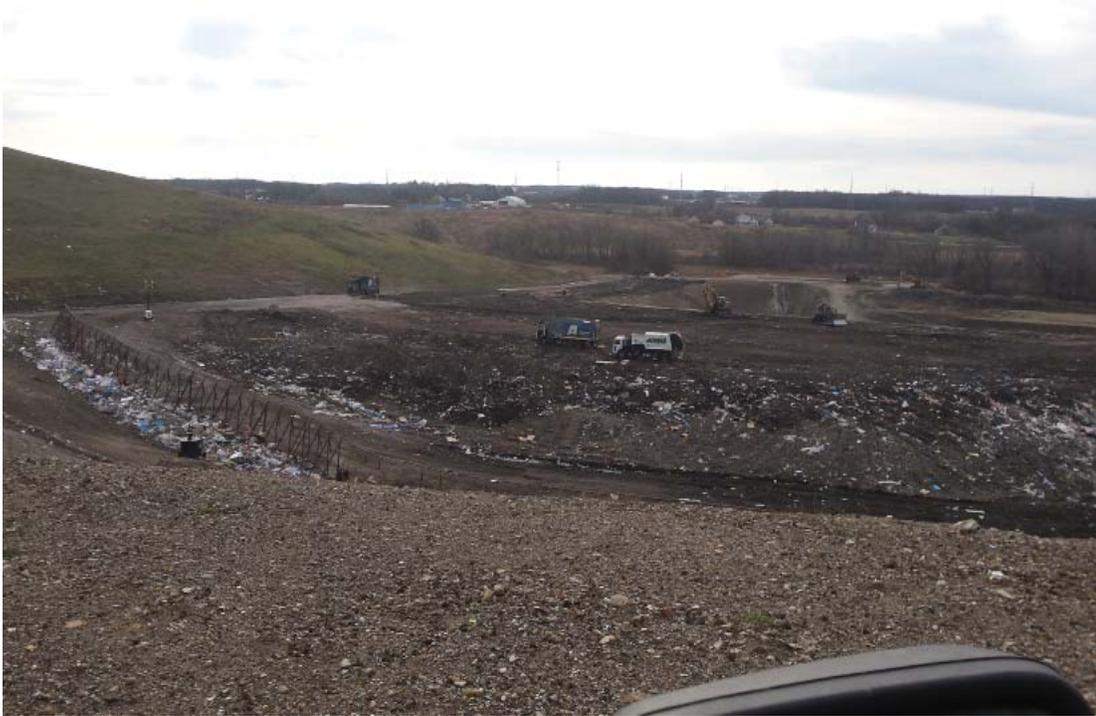
Eastern portion of active area viewed from the North

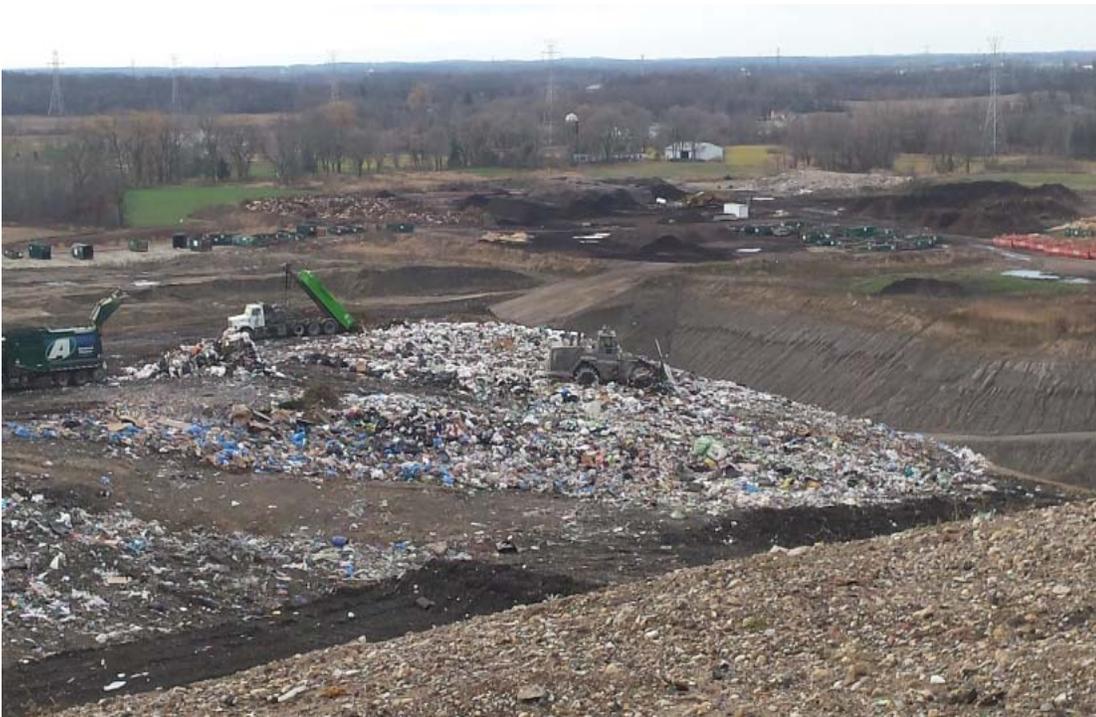
Compactor active in large working face

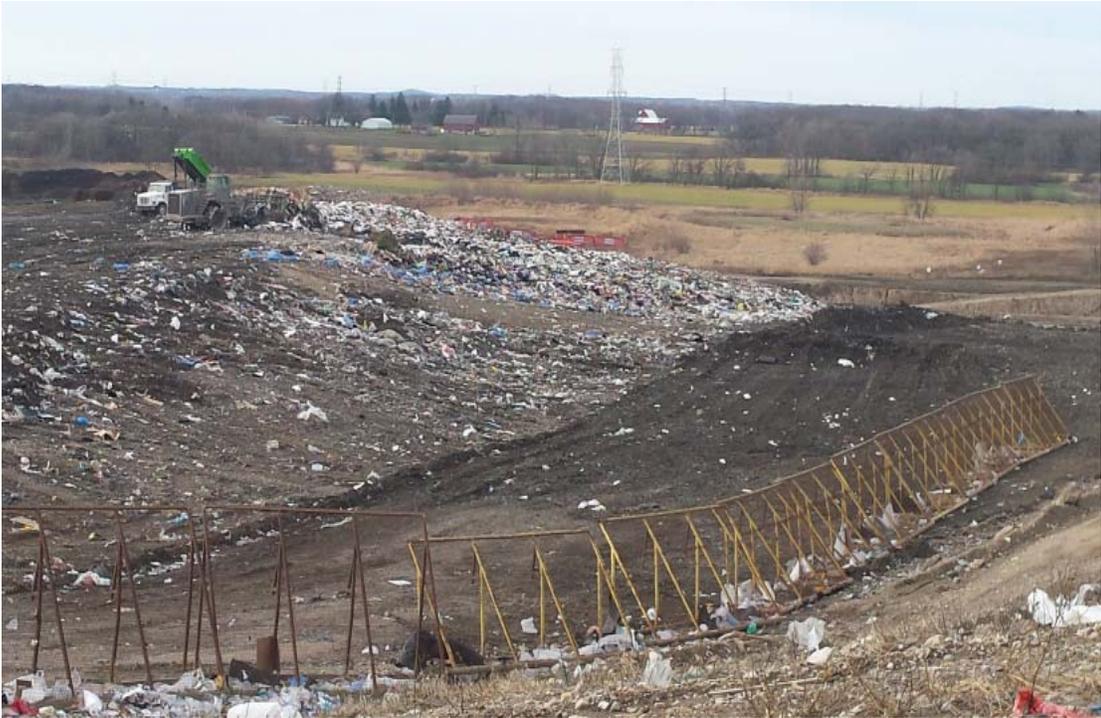
Active area outside, North, of Working face

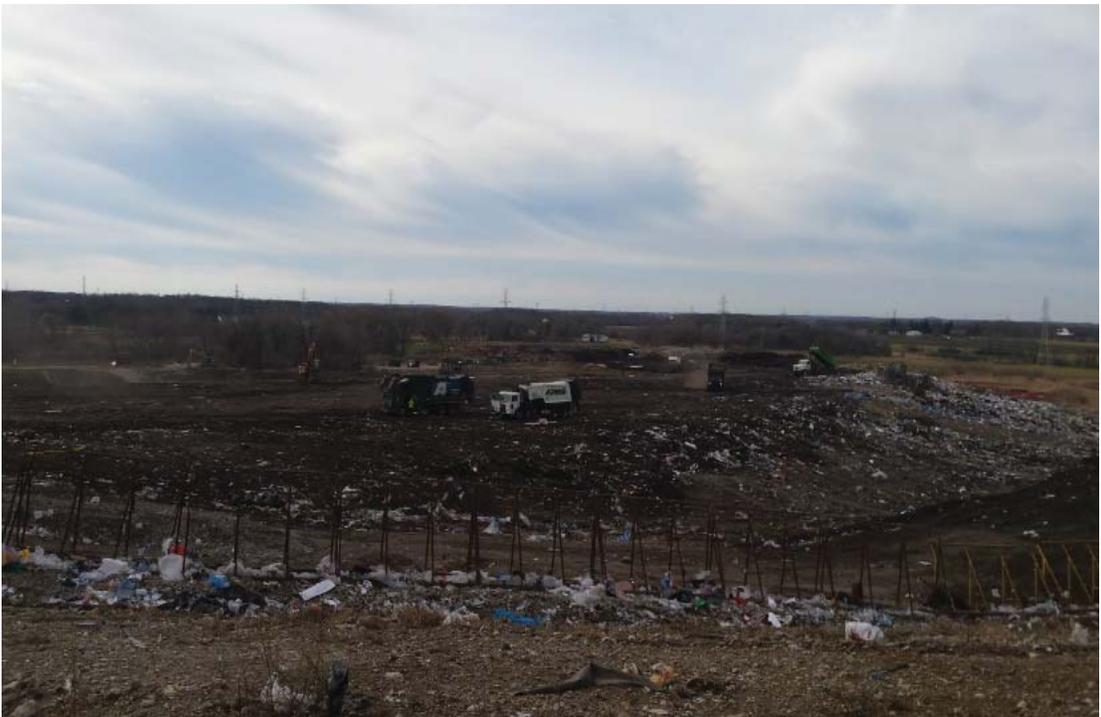
Active area, working face on the right

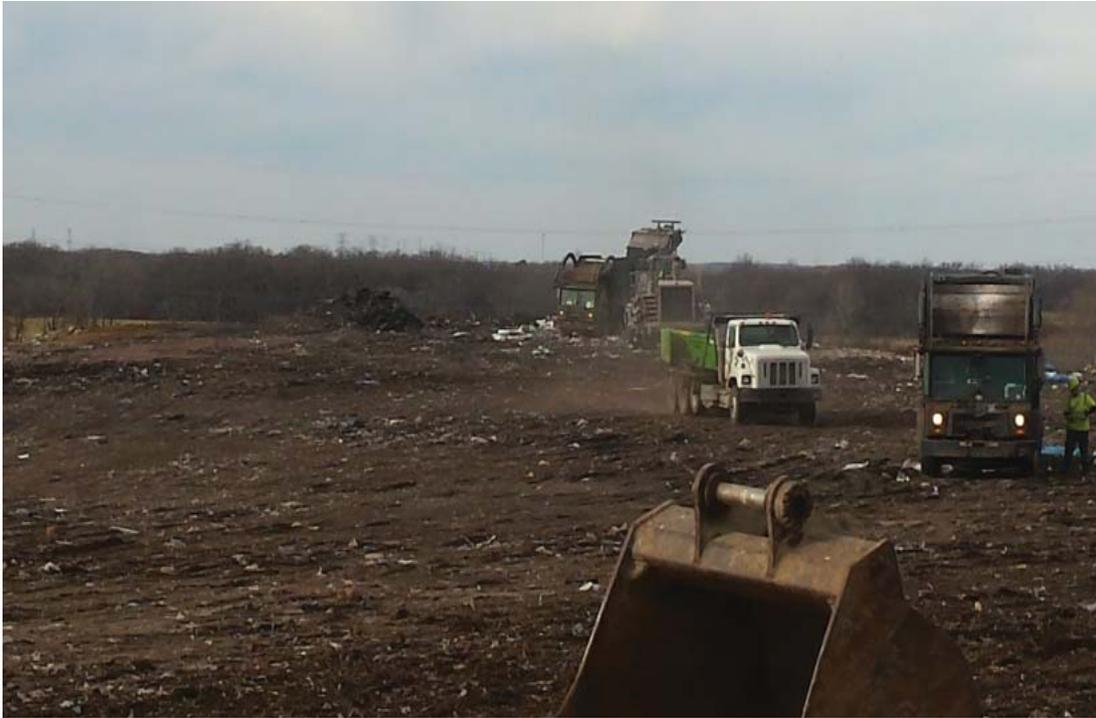
Active area viewed from the East

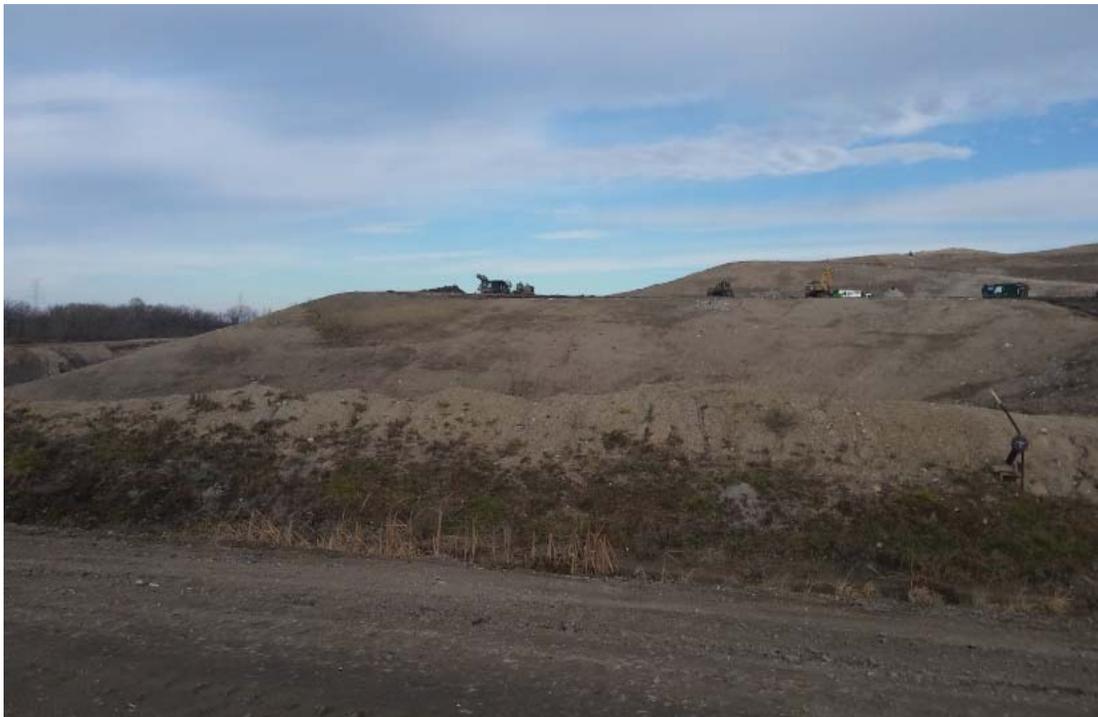
Phase 7B viewed from the South

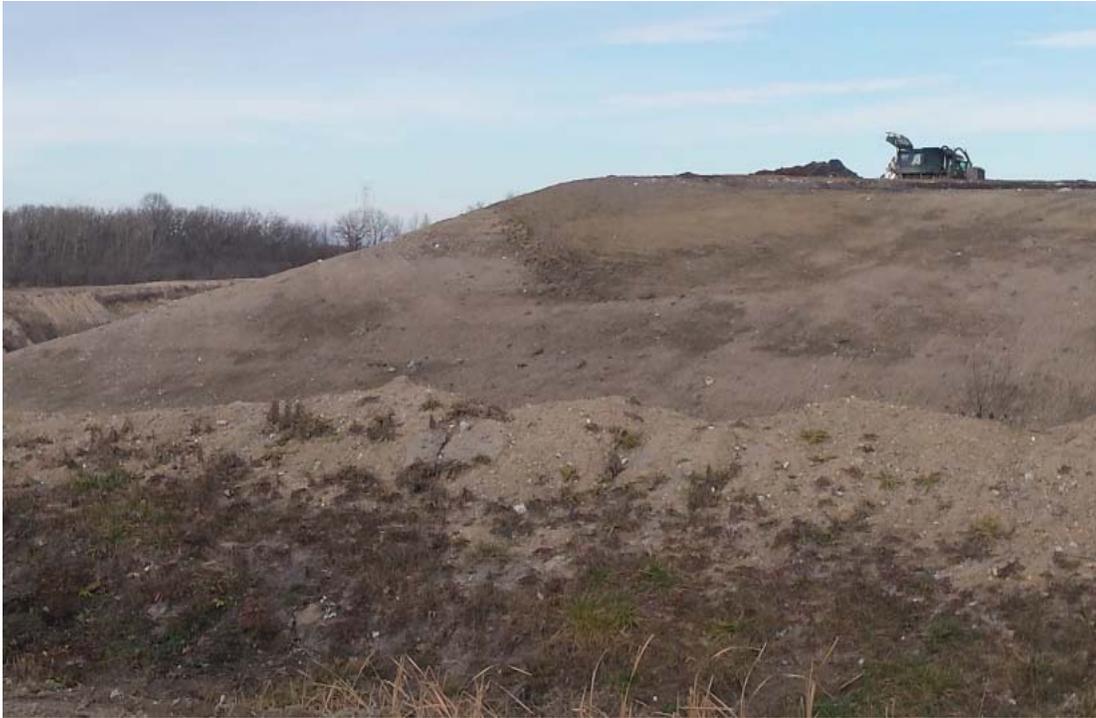
Southwest corner of Phase 7B, recently covered after waste placement

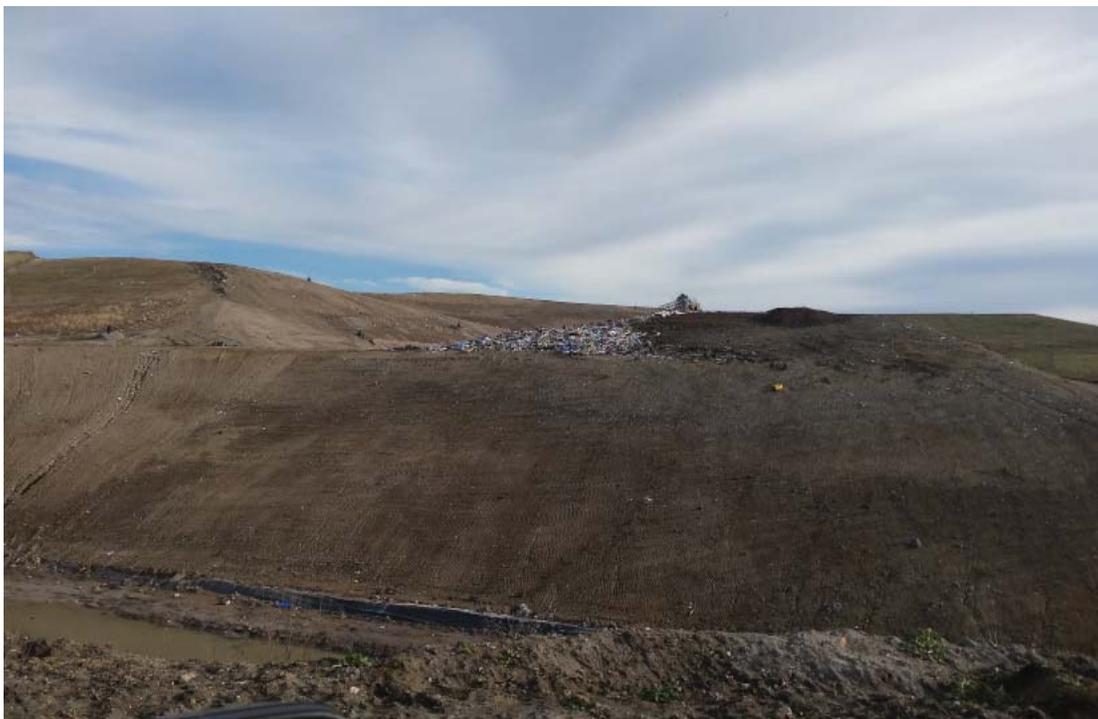
Tipping viewed from the West above and behind outboard slope

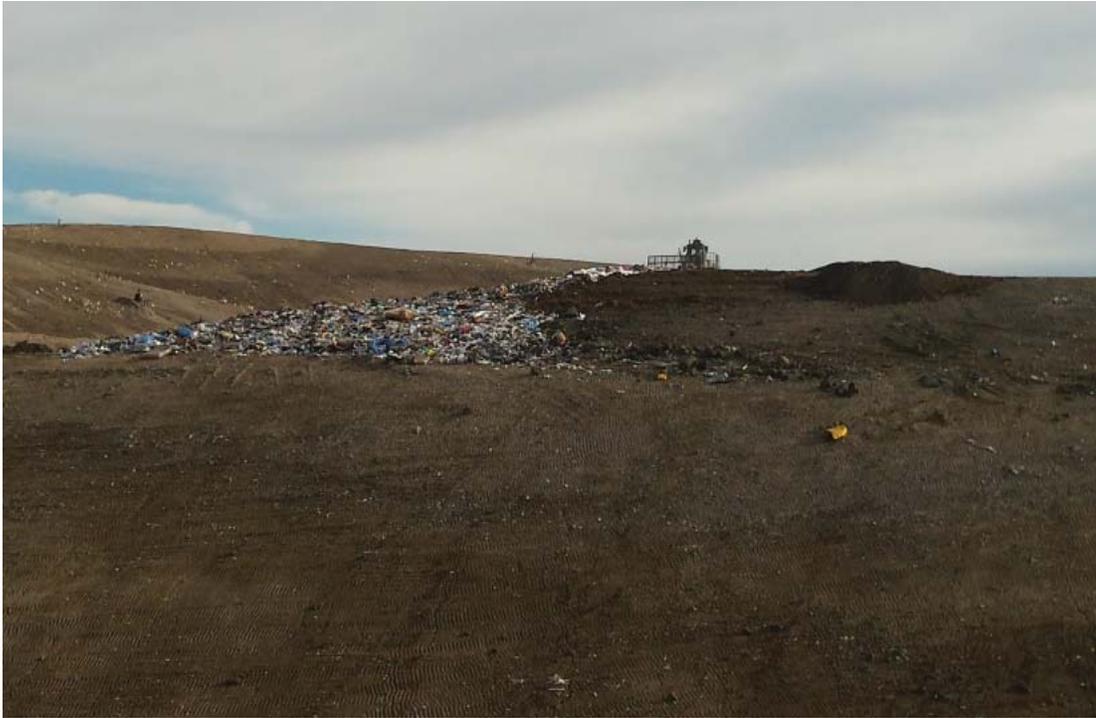
West slope of Phase 7B, cover over previous day's tipping, new tipping against slope.

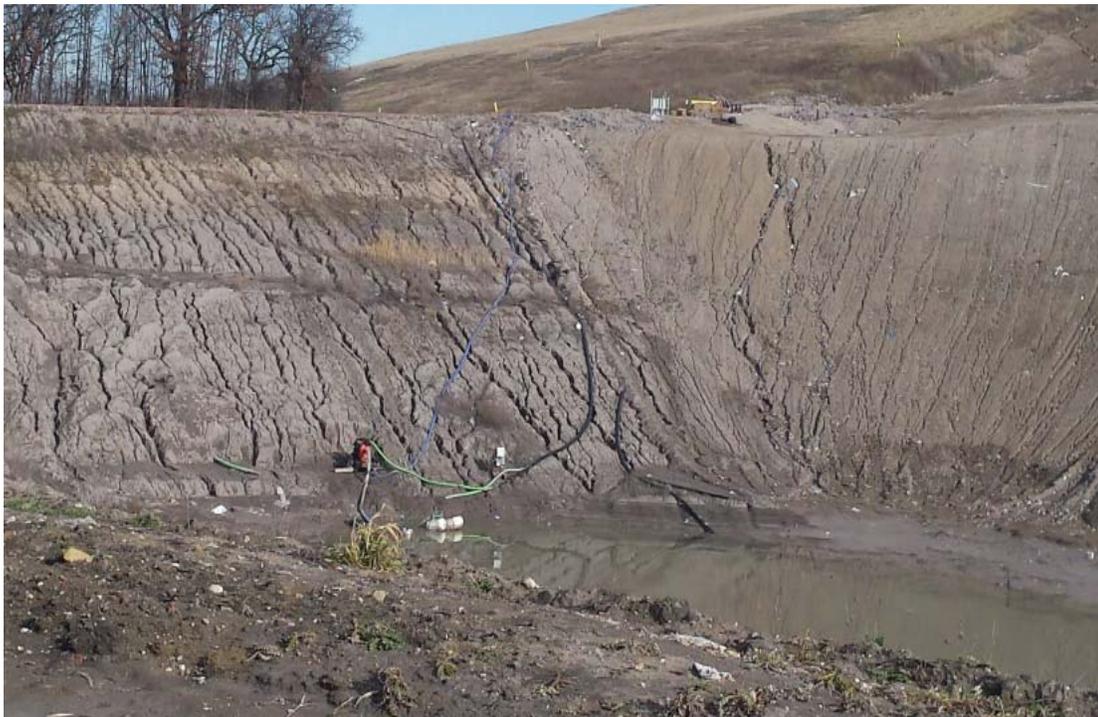
* Site still drying from storms a week ago. Too wet to repair rills. Drainage ways open enough for use. Basins draining. Temp sed basin pumped down to prep work level

Temp sed basin, pumped down after rain events, prepared for future storage
