Memorandum

ADS Emerald Park Landfill Audit Summary

To: ADS Emerald Park Landfill Standing Committee, City of Muskego
FROM: Faith Spear.
COPIES: File
DATE: 12/29/15
PROJECT NUMBER: 1012.10030

**ADVANCED DISPOSAL SERVICES
EMERALD PARK LANDFILL / CITY OF MUSKEGO
AUDIT PHOTOS**

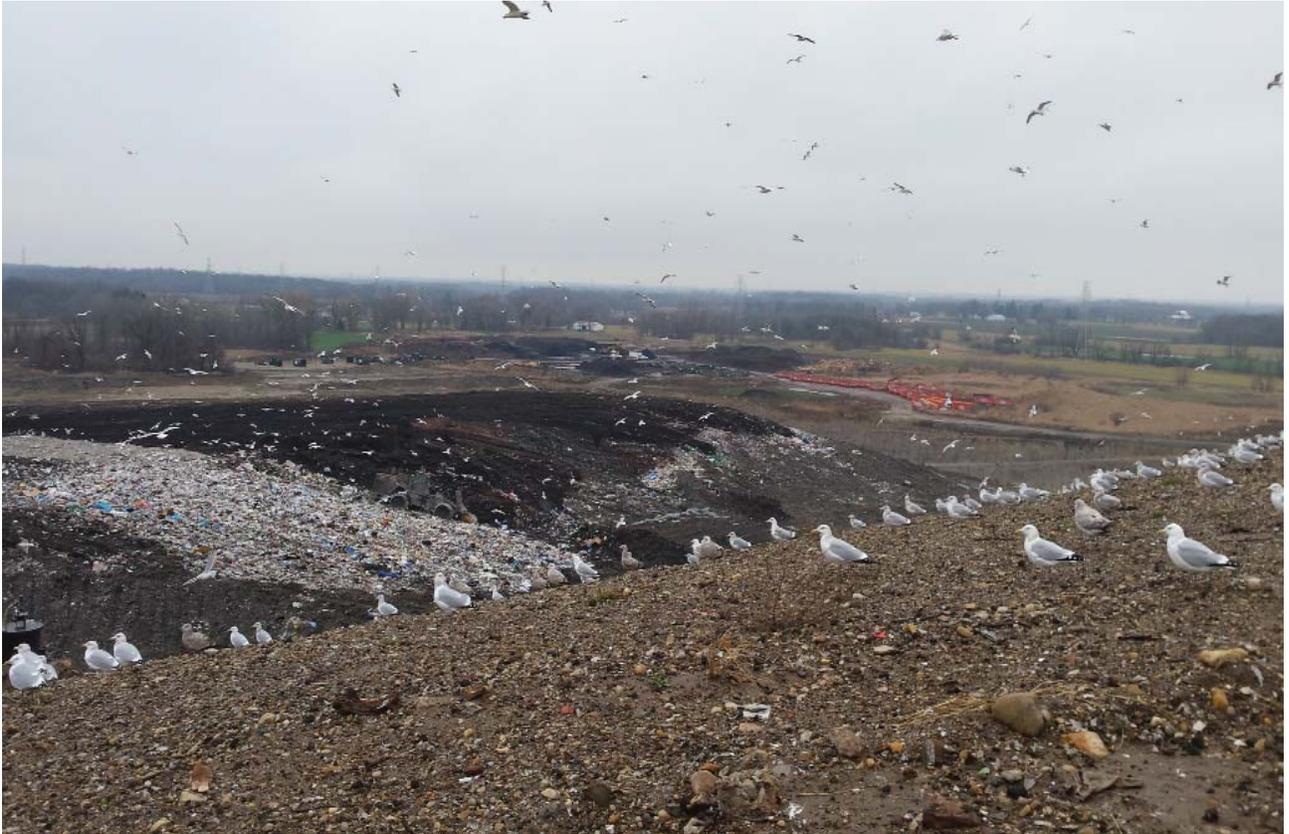
Active area and working face

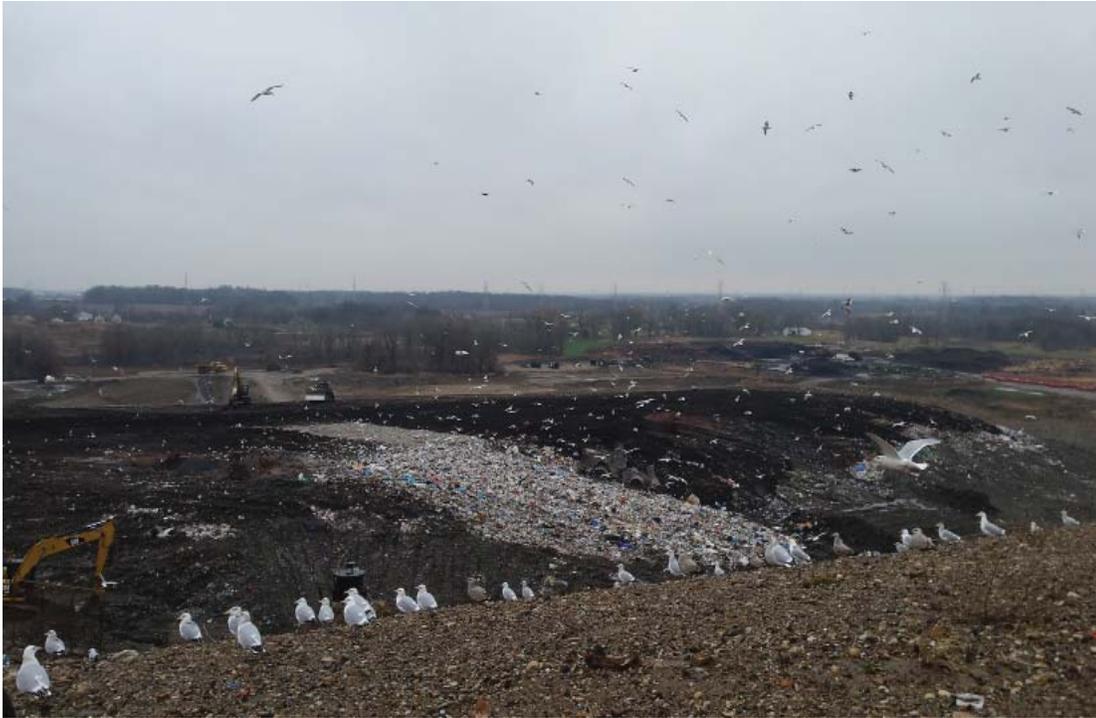
Overview of active area from the North

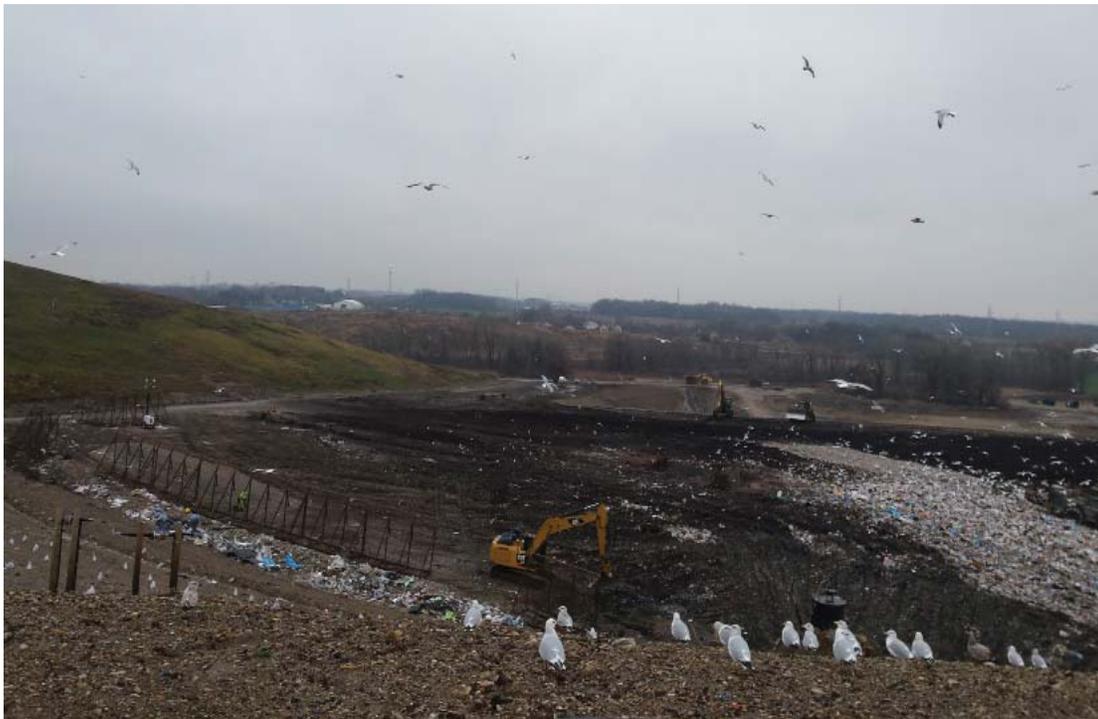
East and access to Phase 7

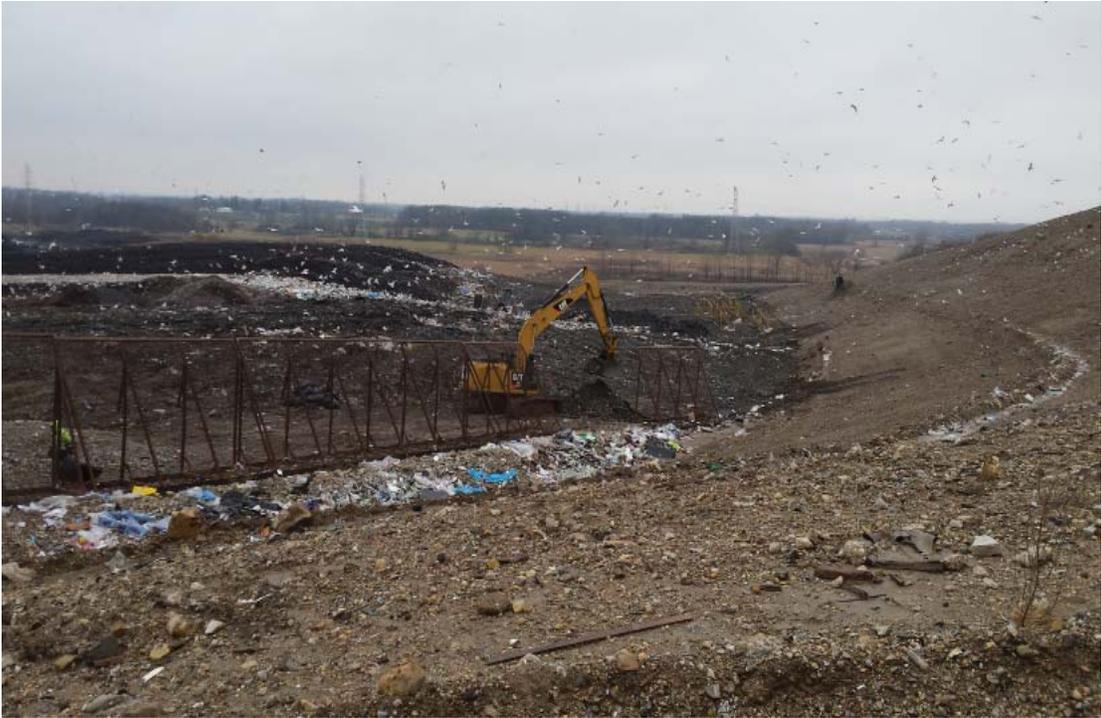
Excavator removing previously used access road

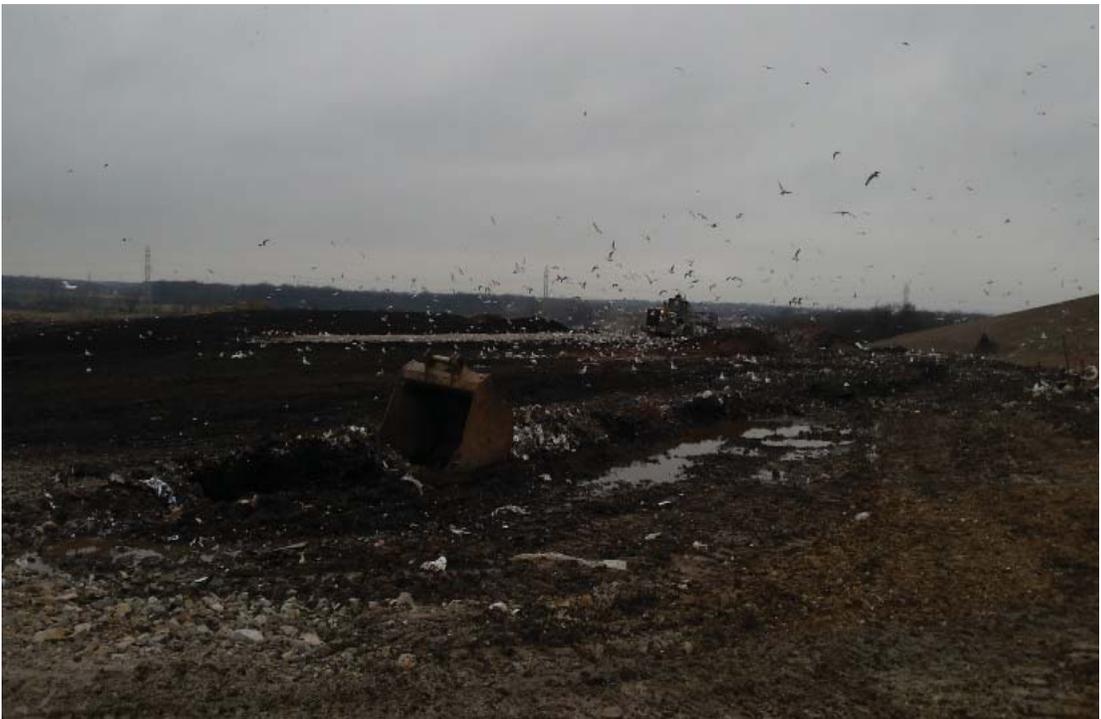
Active area, working face on the right

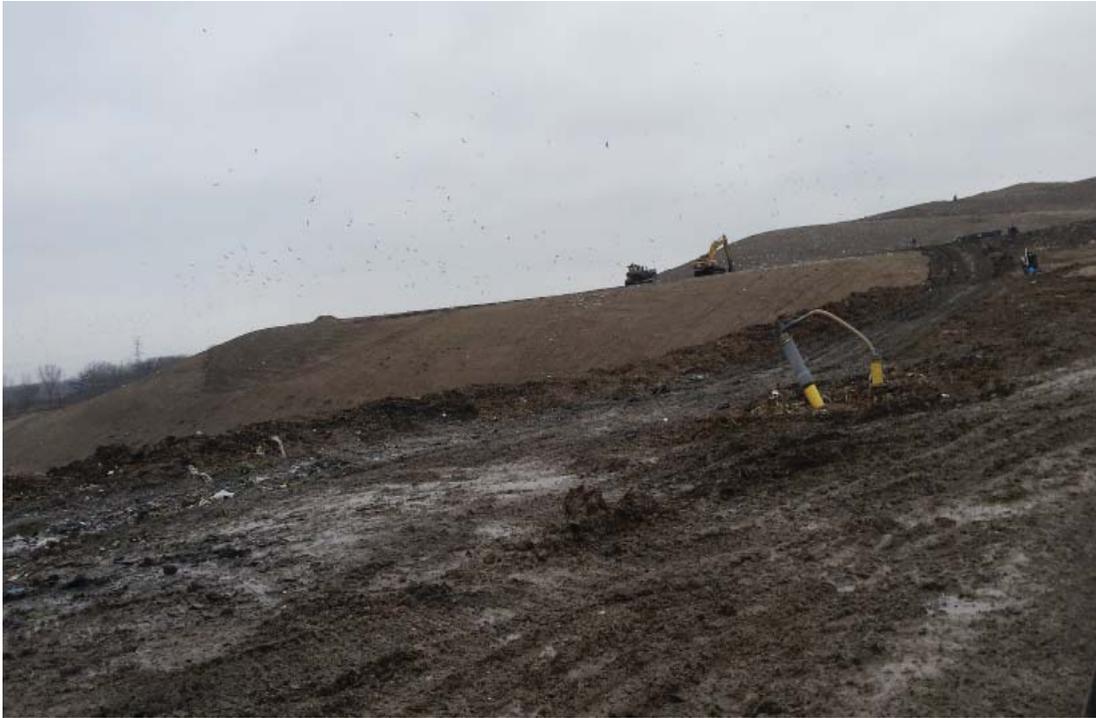
Equipment parking area with some ponding from rains. Southwest corner of Phase 6

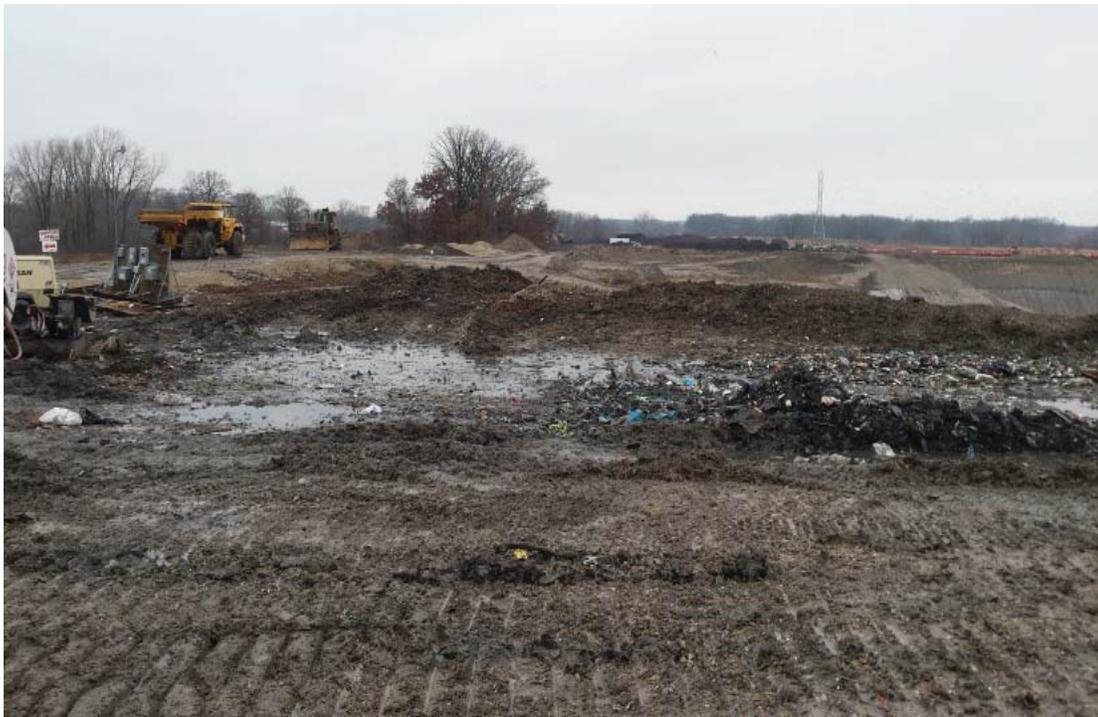
Excavation at Equipment parking to drain rain water into waste mass. Southwest corner of Phase 6

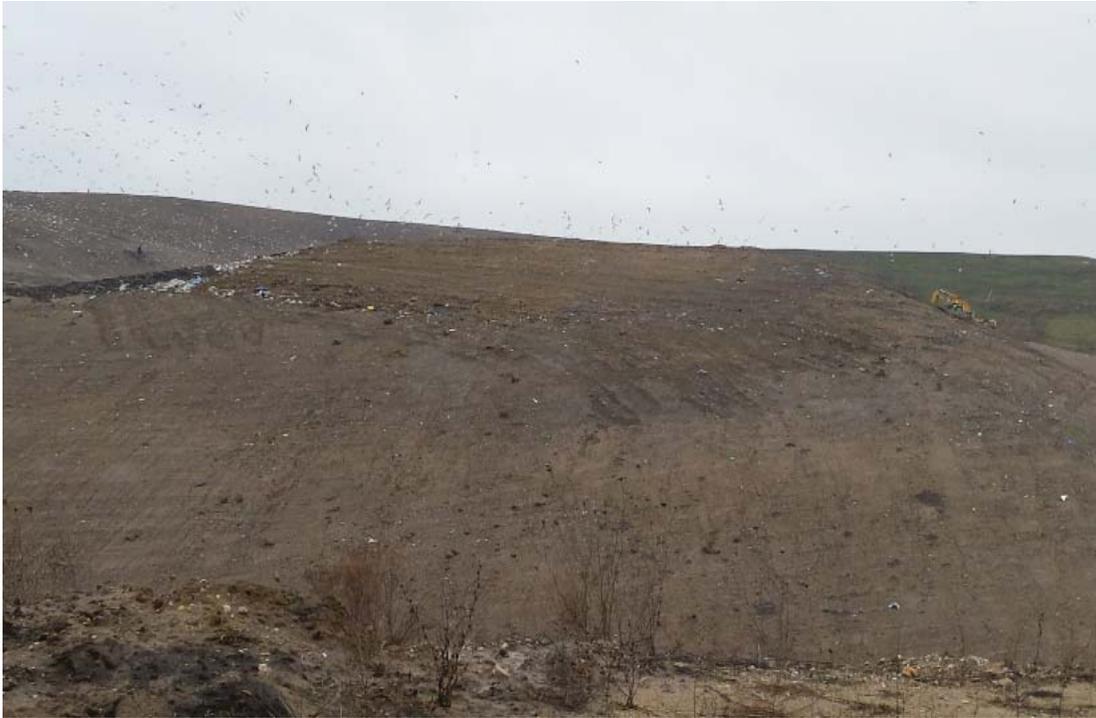
Recently covered, previous working face, at top of West slope of Phase 7B

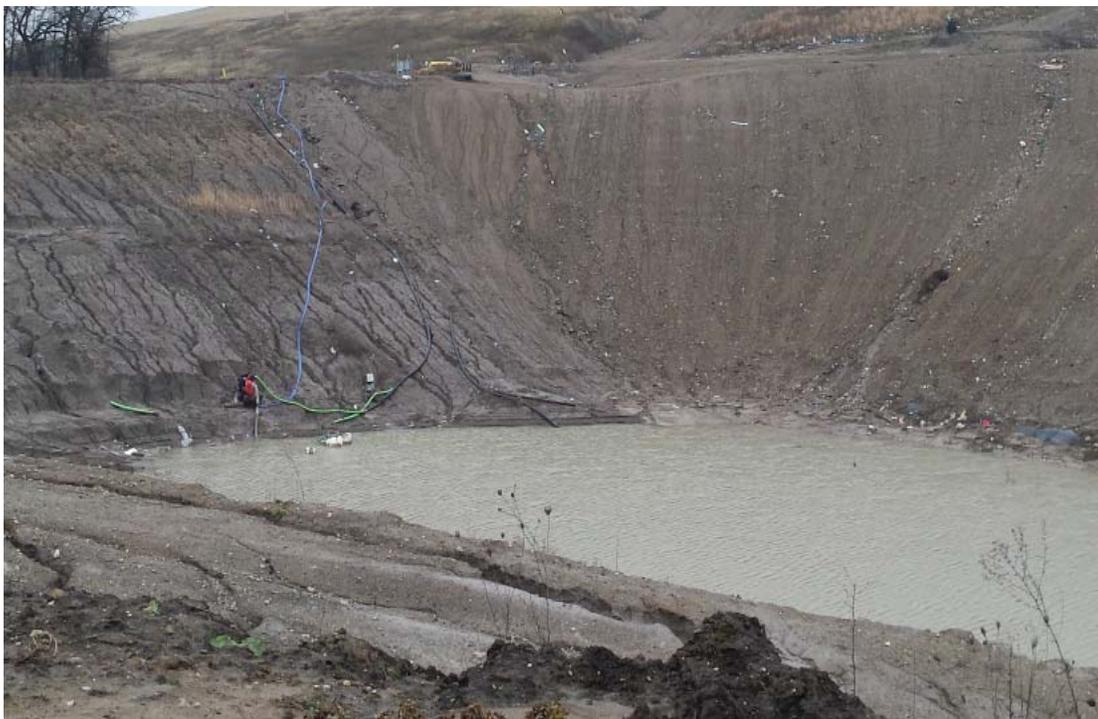
West slope of Phase 7&7B at Northwest corner, large ril, but no apparant new erosion

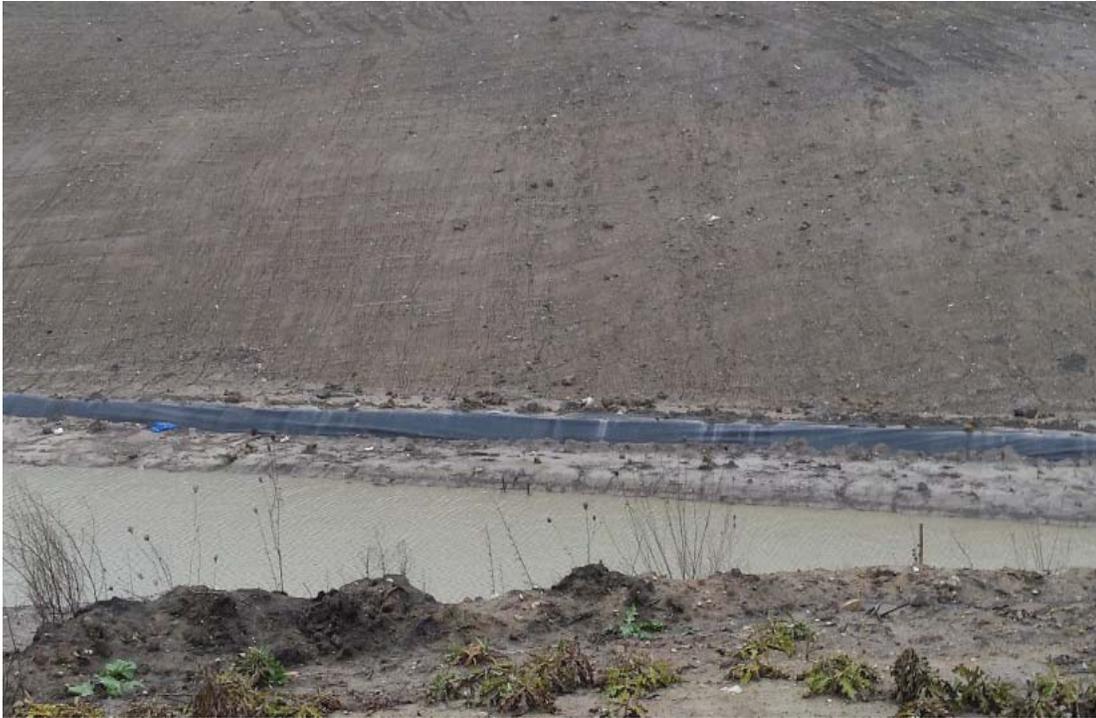
West slope of Phase 7&7B, does not appear to have additional rills

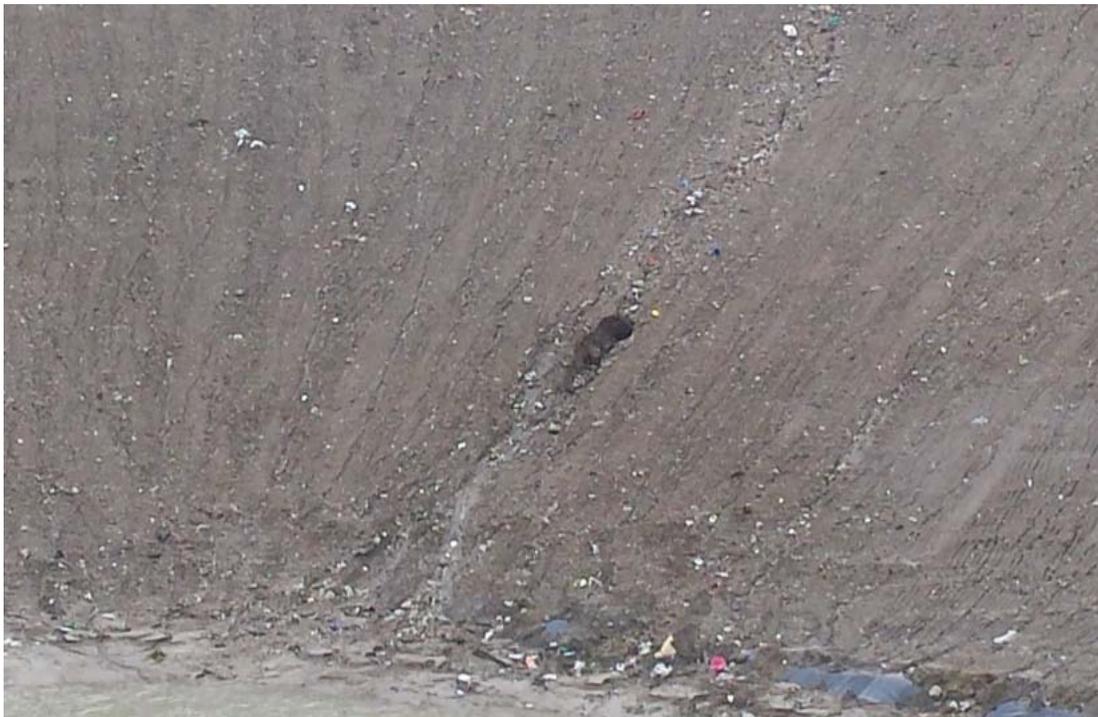
Deep rill in West slope of Phase 7&7B, no waste exposed
