ADS Emerald Park Landfill Audit Summary

To: ADS Emerald Park Landfill Standing Committee, City of Muskego
FROM: Faith Spear.
COPIES: File
DATE: 01/29/16
PROJECT NUMBER: 1012.10030

Attached is the audit report for activities at the ADS Emerald Park Landfill for the week of January 11, 2016. The audit was performed at 10:41 AM on **January 14, 2016** by Jo Spear, Jr. in the presence of Michael Hackney, General Manager.

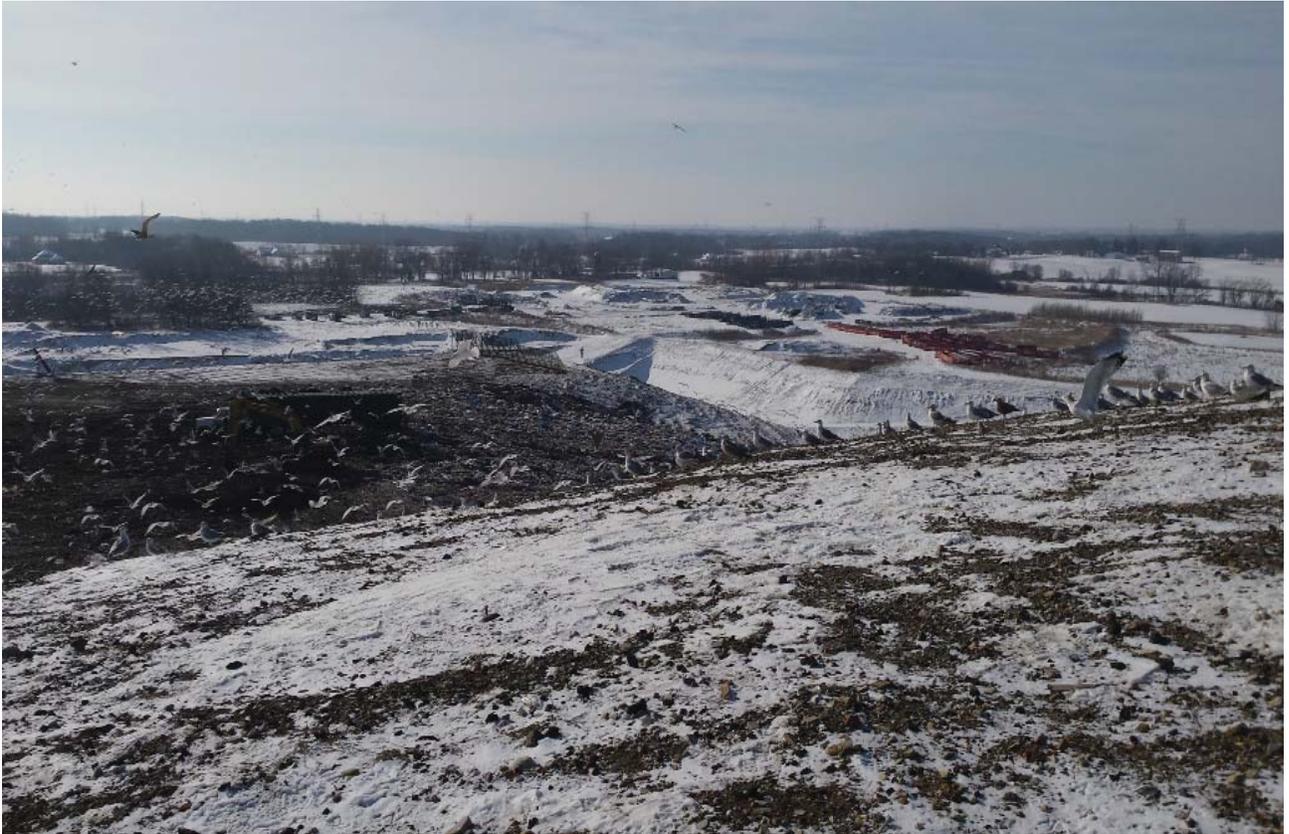
Active area and working face

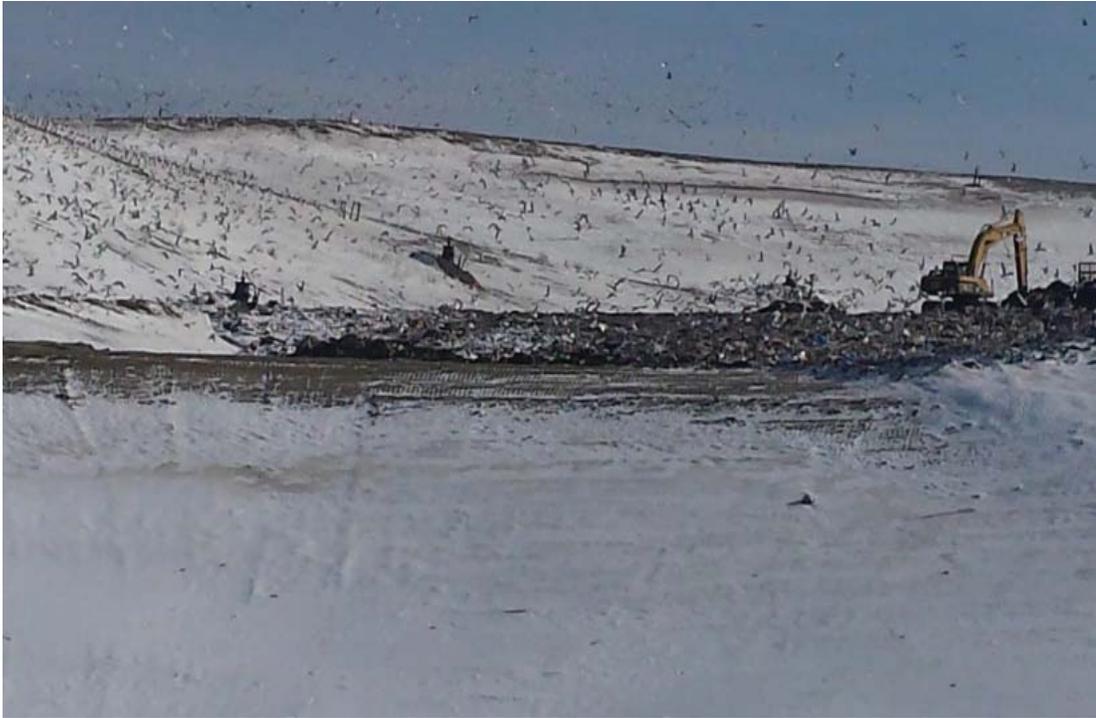
Working face at the western edge of Phase 7B Working face very broad North to South and shallow East to West Cover being recovered from previous tipping

Wide yet shallow working face on Western edge of Phase 7

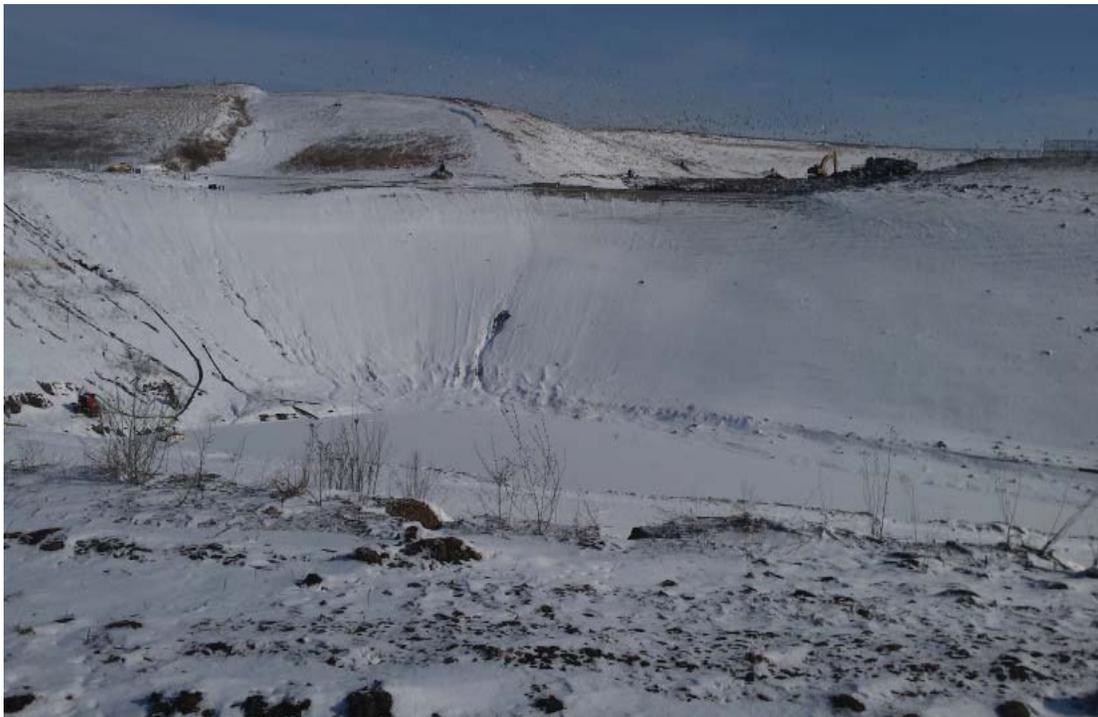
West slope of Phase 7

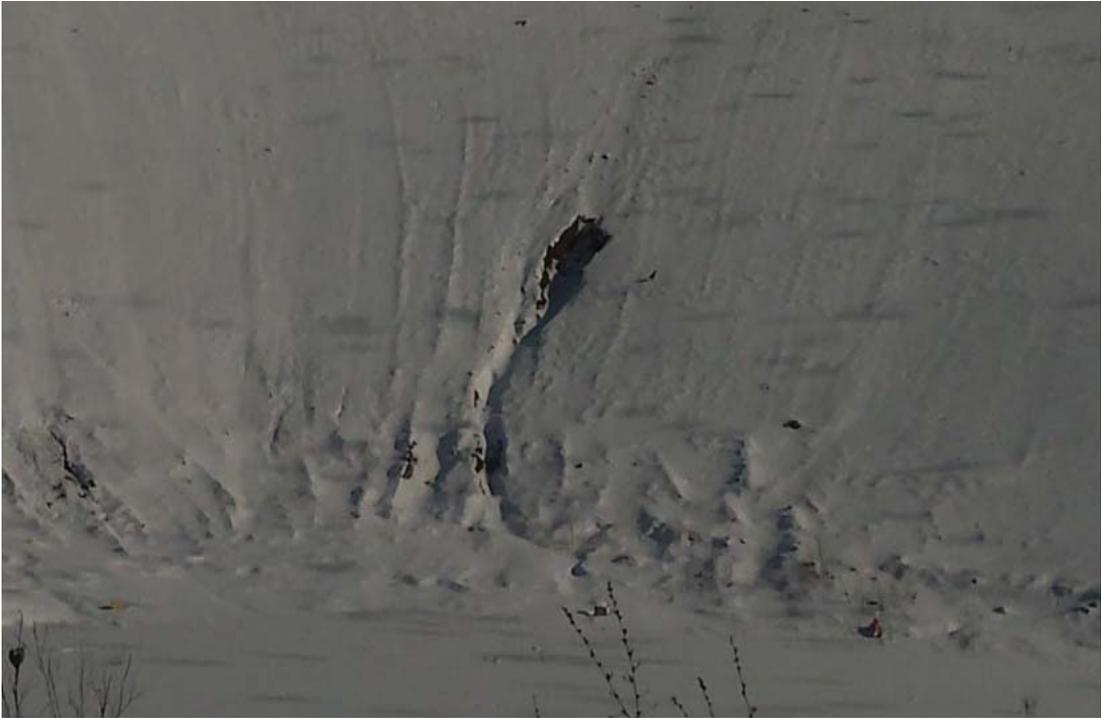
- Erosion rills visible in snow

* Temp soil basins volume very low
erosion rills visible in snow

Large ril, previously observed and not increasing in size. Ril is on West slope above Temp Sed. Basin
