Memorandum

ADS Emerald Park Landfill Audit Summary

To: ADS Emerald Park Landfill Standing Committee, City of Muskego
FROM: Faith Spear.
COPIES: File
DATE: 03/13/16
PROJECT NUMBER: 1012.10030

**ADVANCED DISPOSAL SERVICES
EMERALD PARK LANDFILL / CITY OF MUSKEGO
AUDIT PHOTOS**

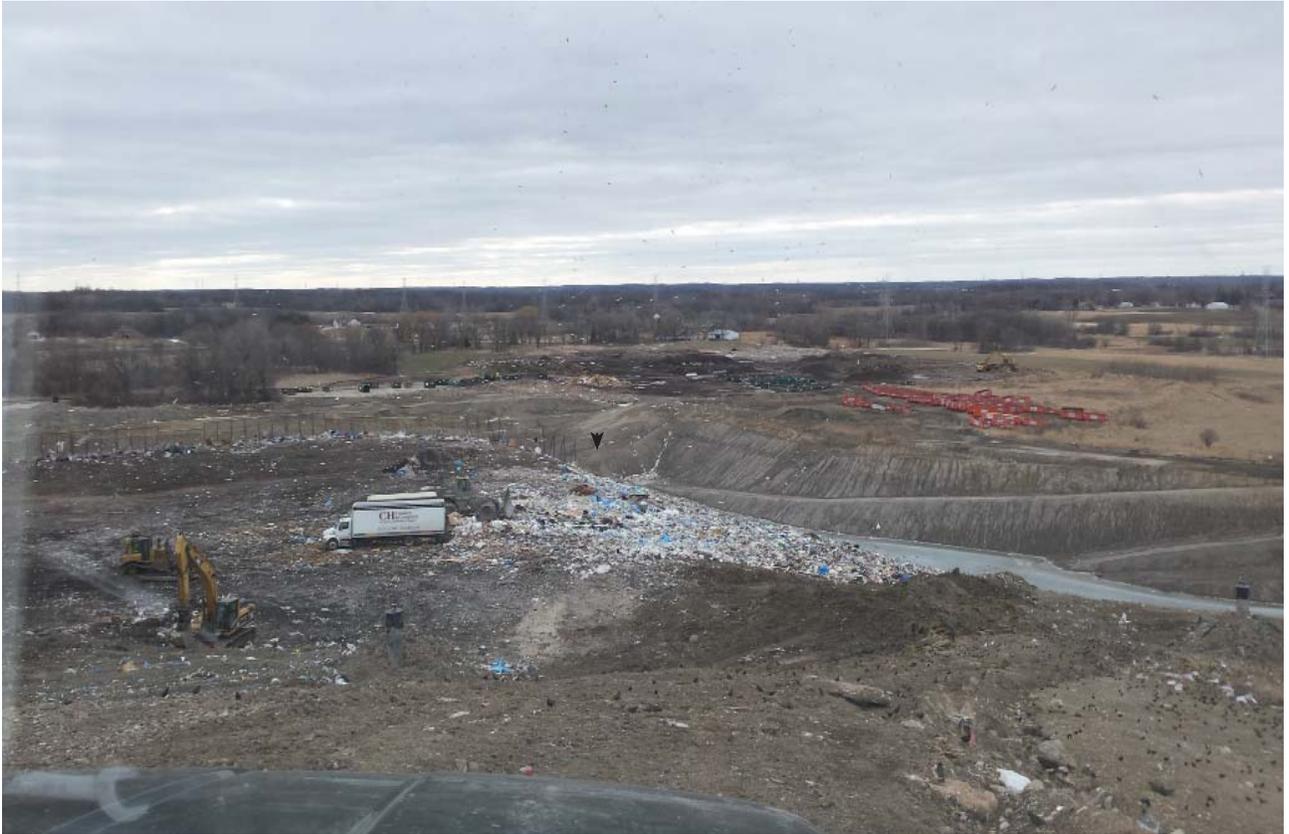
Working face viewed from North

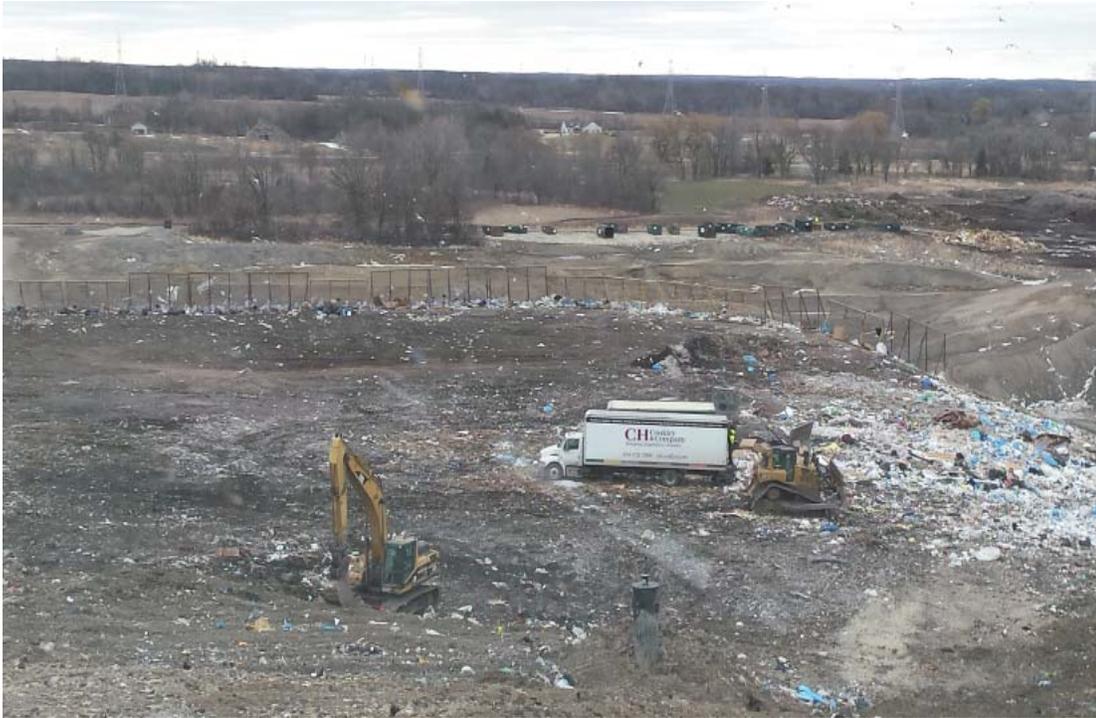
Working face on West edge of Phase 7

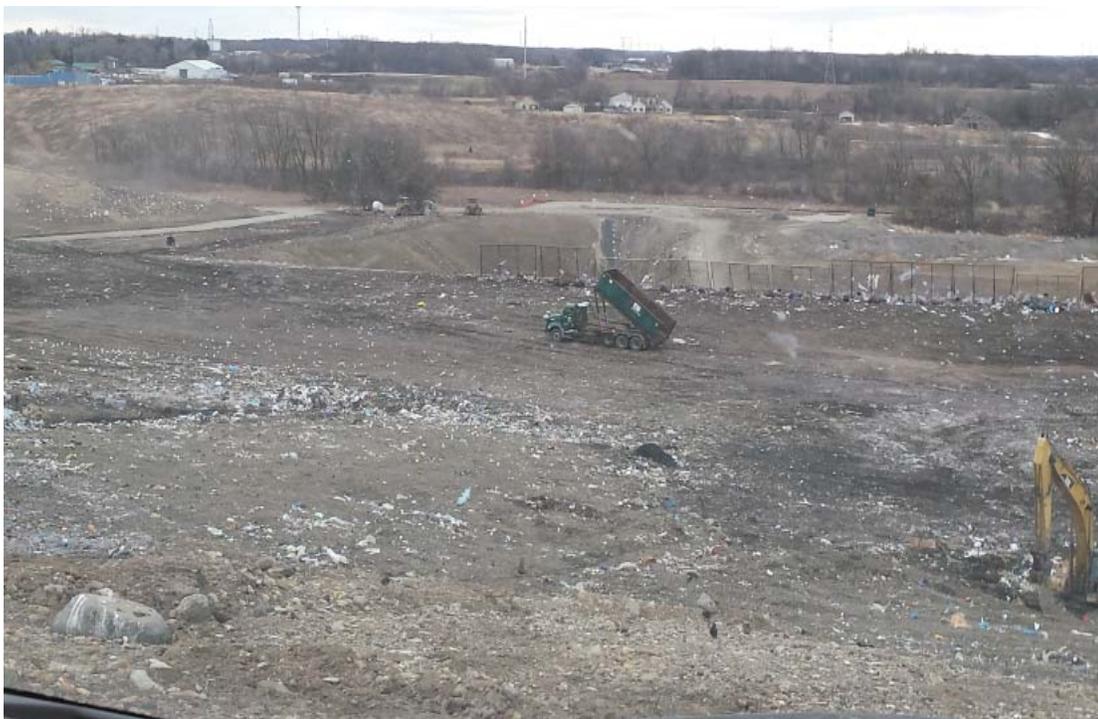
Active area viewed from the North, roll-off truck cleaning out

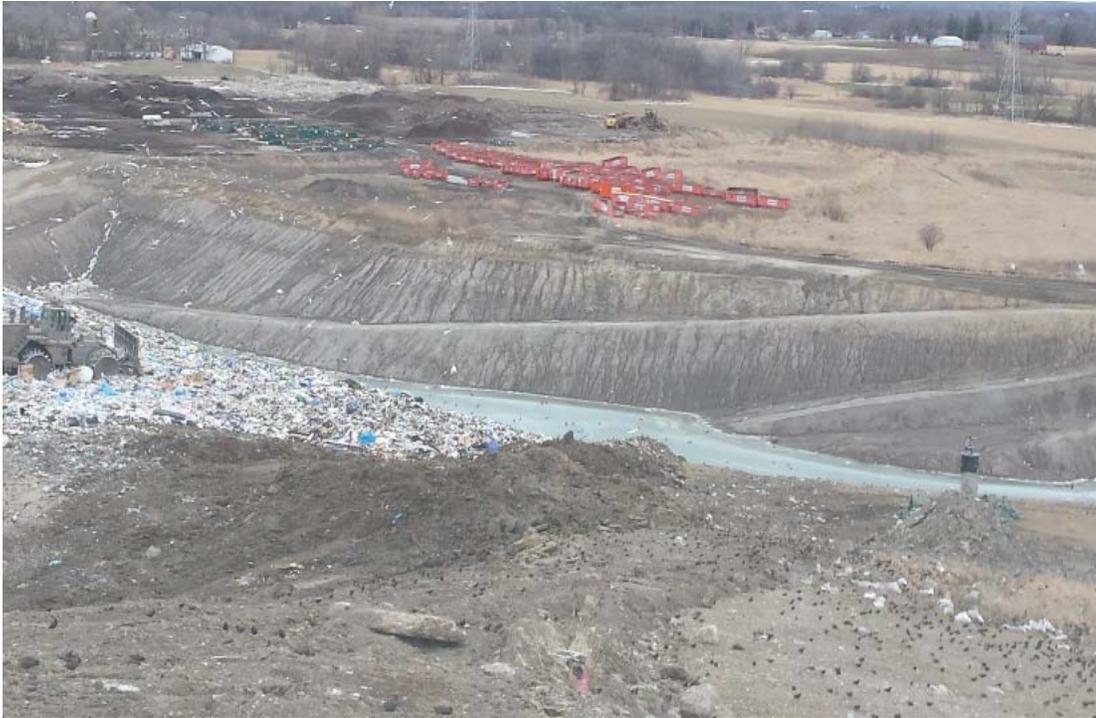
Working face and Temp sed basin viewed from Northeast

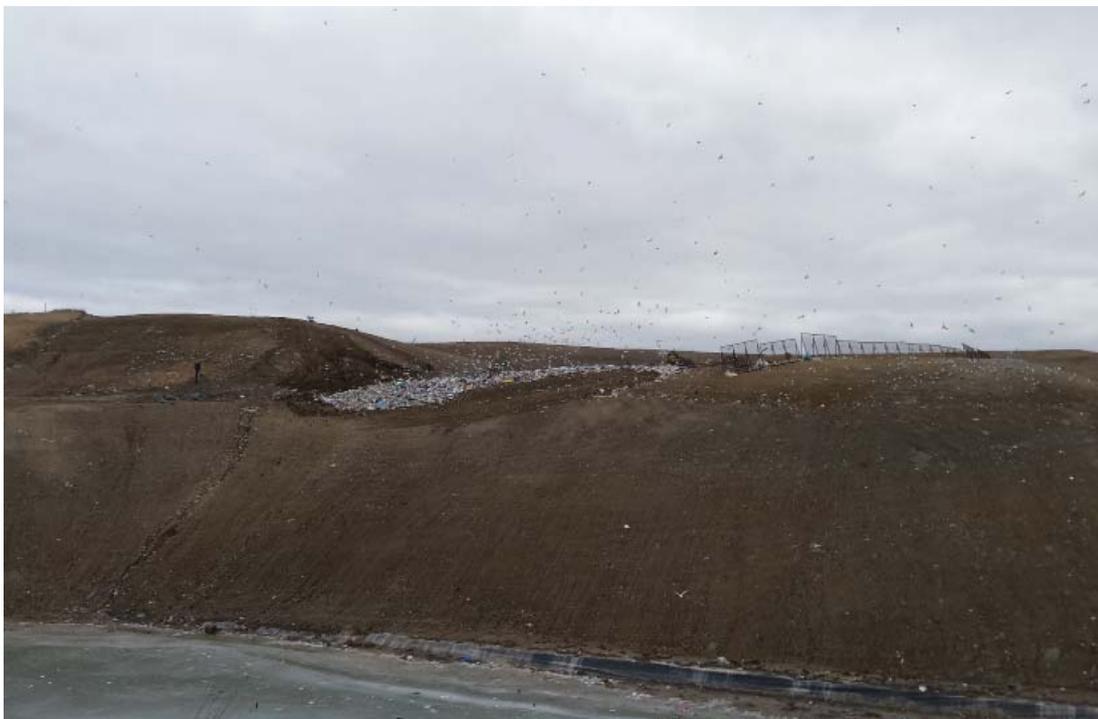
Working face viewed from Southwest

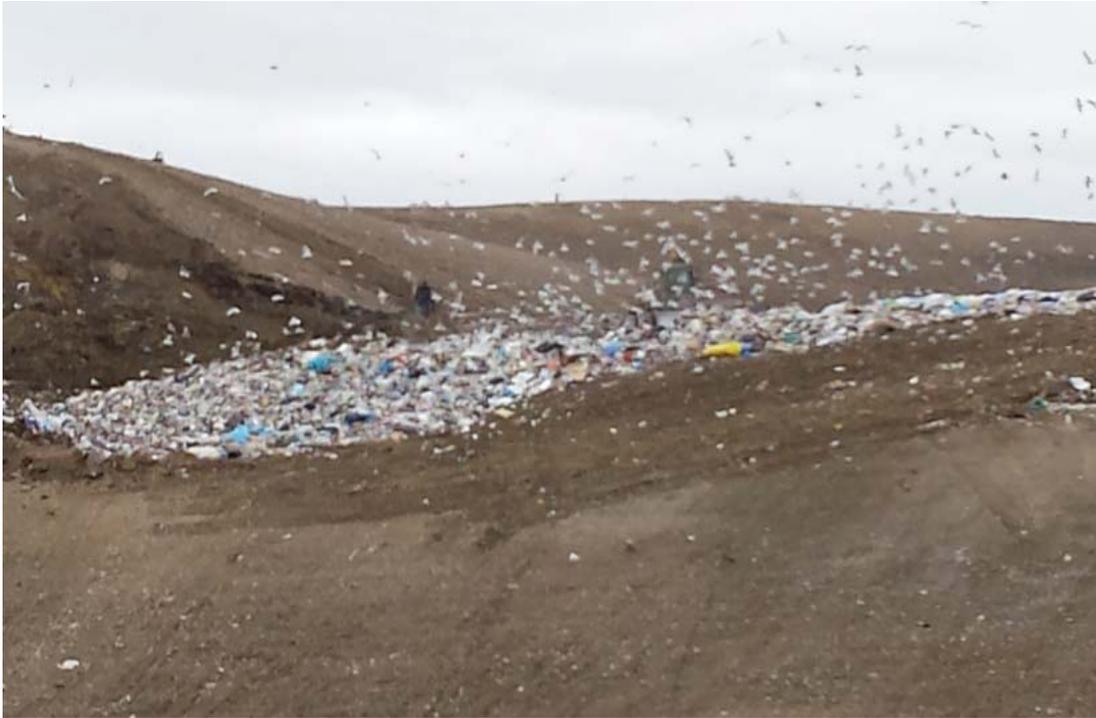
Working face viewed from West, soil stockpiled below for daily cover

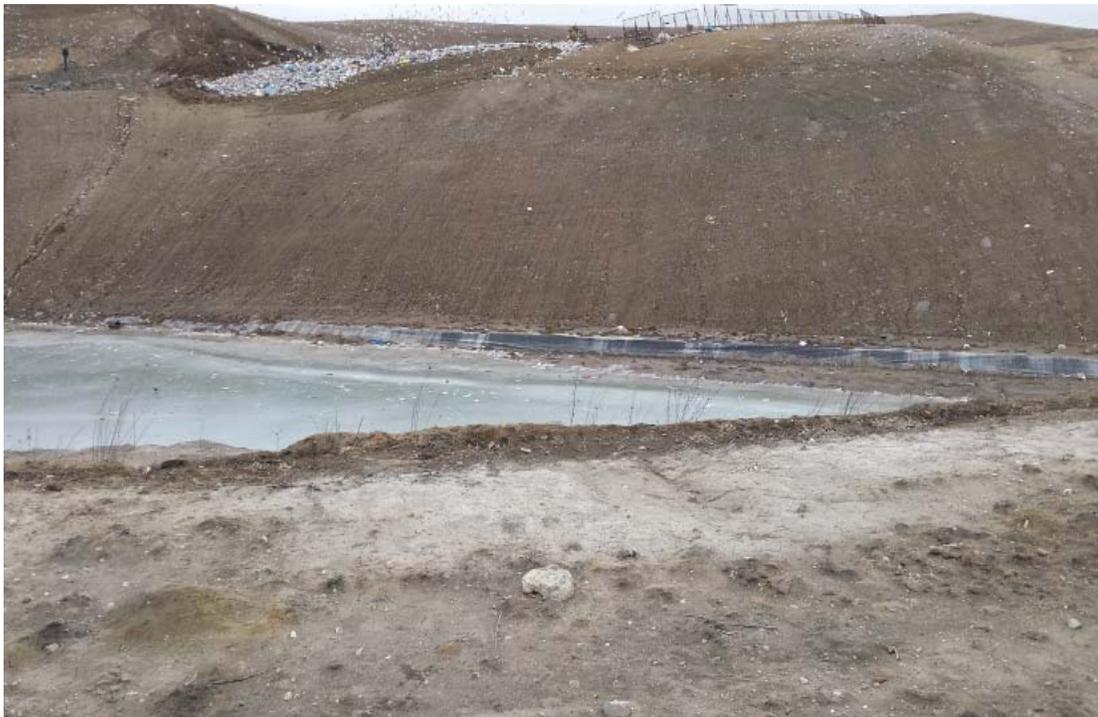
Site has experienced thaw & freeze since
last audit. Temp Sed basin pumped for 10hrs
on 2/24/16

West slope of Phase 7, pumping of Temp Sed Basin evident

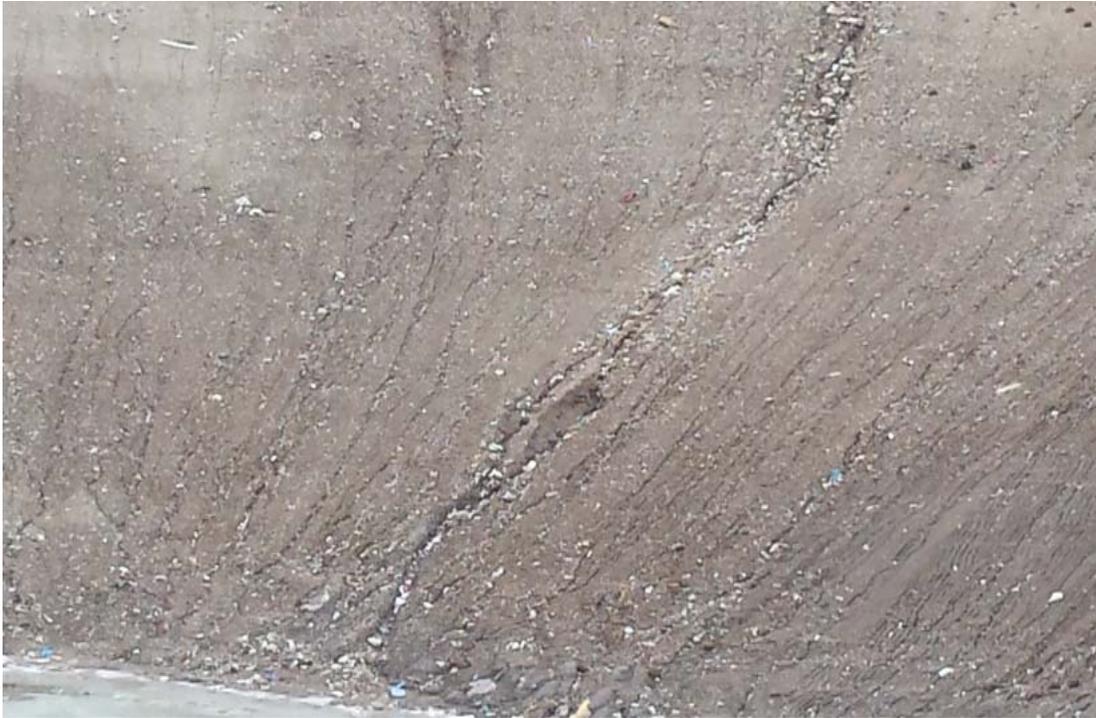
Deep ril in West slope of Phase 7, repair will have to occur in dryer conditions
