## Memorandum

### ADS Emerald Park Landfill Audit Summary

**To:** ADS Emerald Park Landfill Standing Committee, City of Muskego  
**FROM:** Faith Spear.  
**COPIES:** File  
**DATE:** 03/23/16  
**PROJECT NUMBER:** 1012.10030

**ADVANCED DISPOSAL SERVICES  
EMERALD PARK LANDFILL / CITY OF MUSKEGO  
AUDIT PHOTOS**

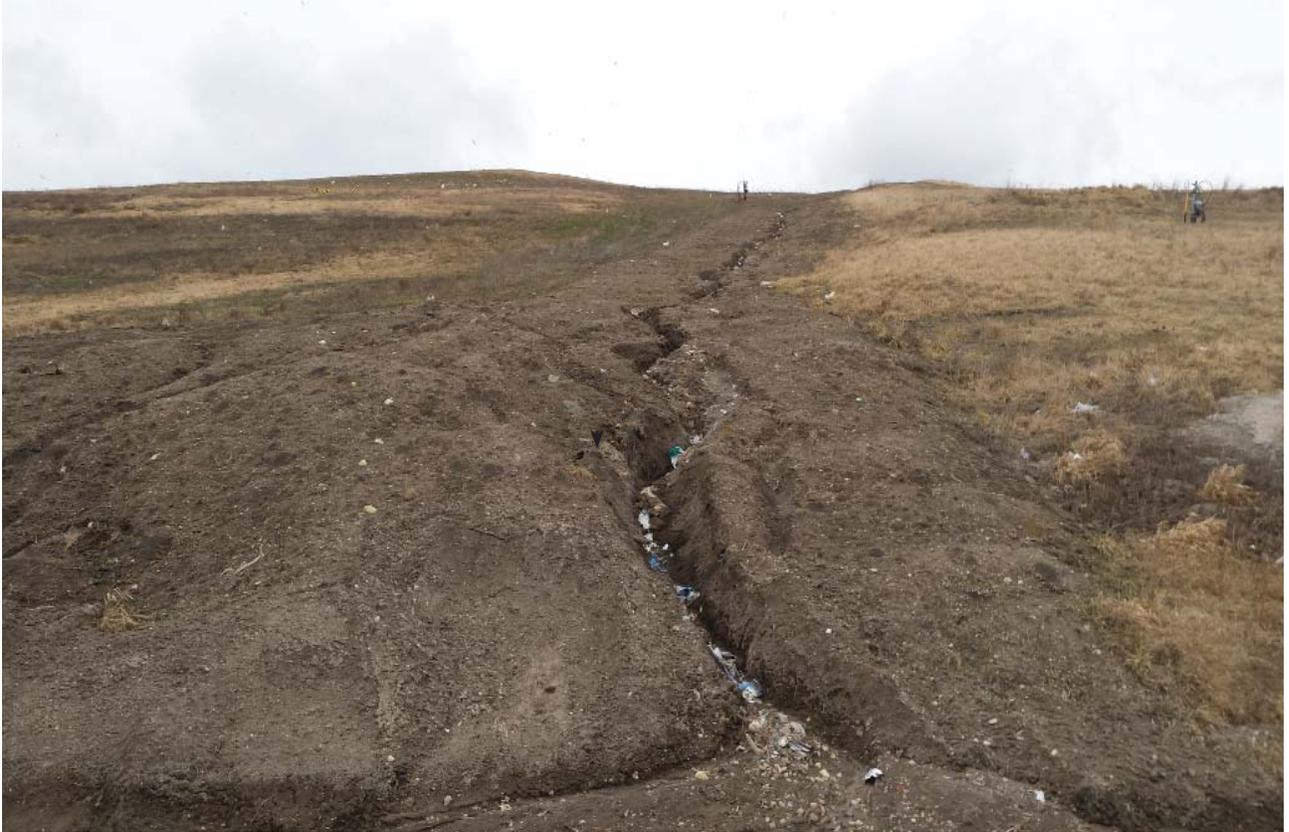
Ril at junction between Phase 6 and Closure Area III

- \* future Parkland stockpiles in good shape, some site and settings, but still good vegetative cover
- \* Site contractor for wood waste on site and grinding waste.
- \* Erosion areas identified by photos, 90 day clock for repair started.

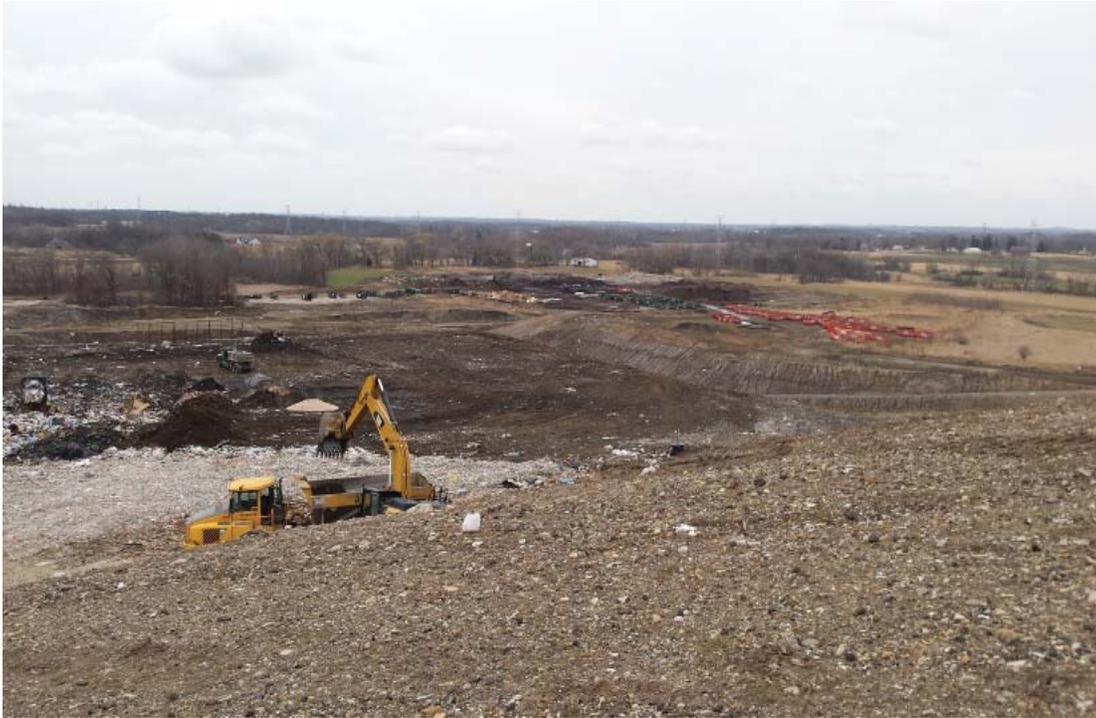
Remainder of active area, not in use during audit

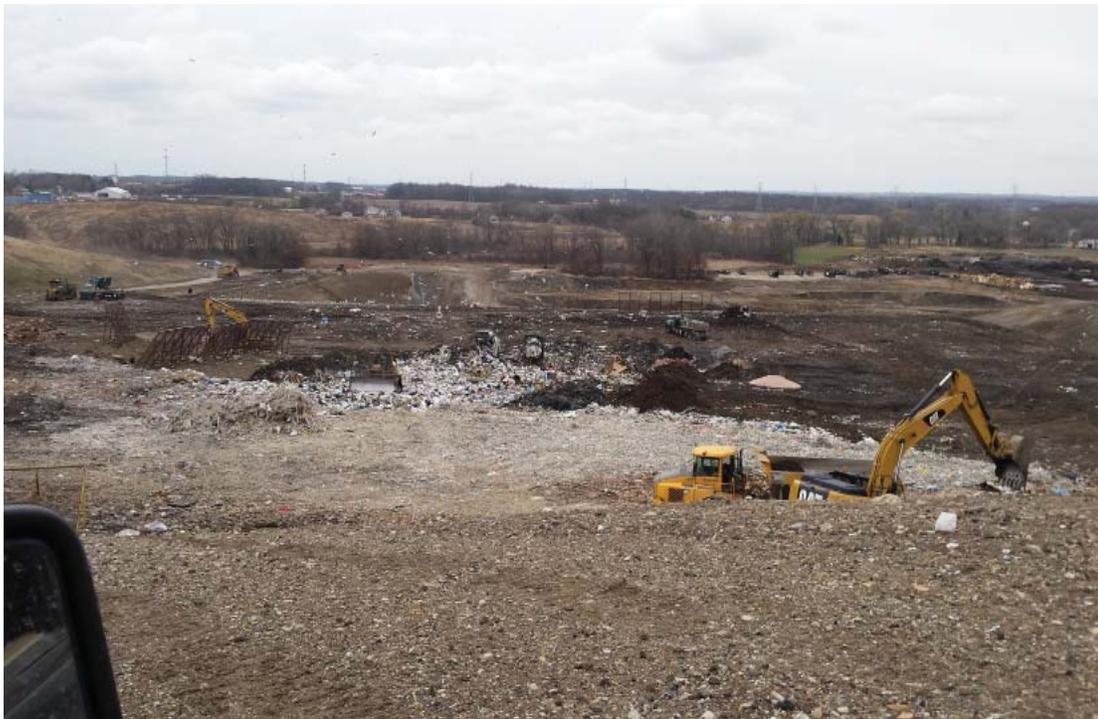
Active area viewed from the North

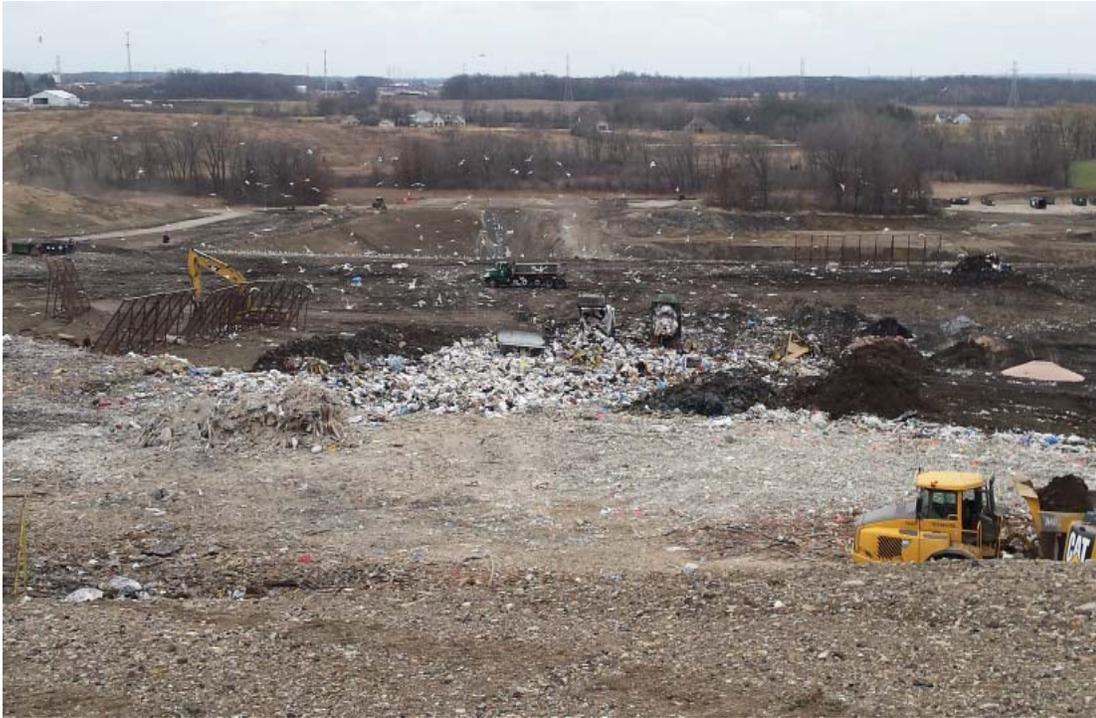
Working face

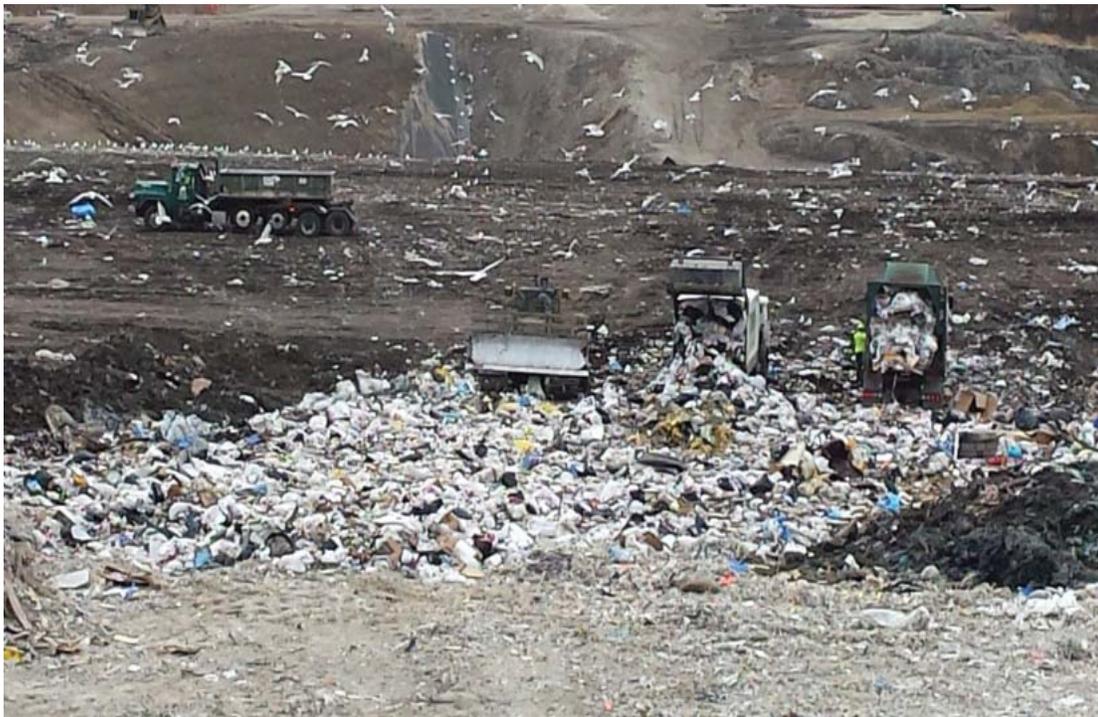
Compactor operator at lunch, dozer managing new waste

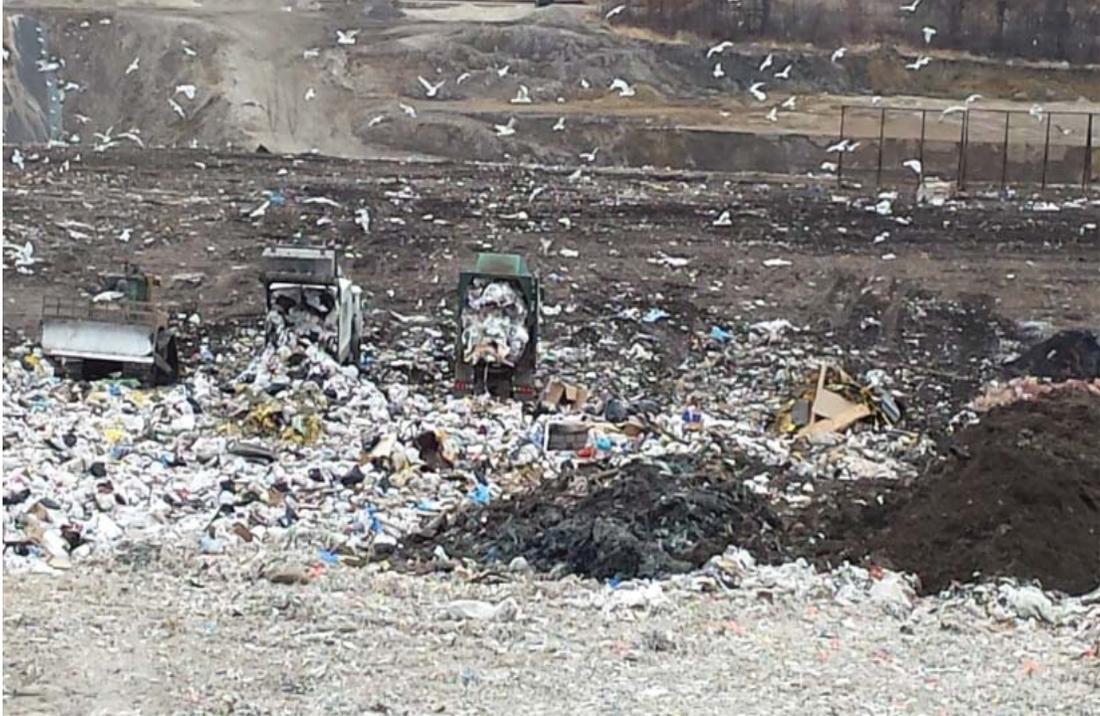
Tipping at working face

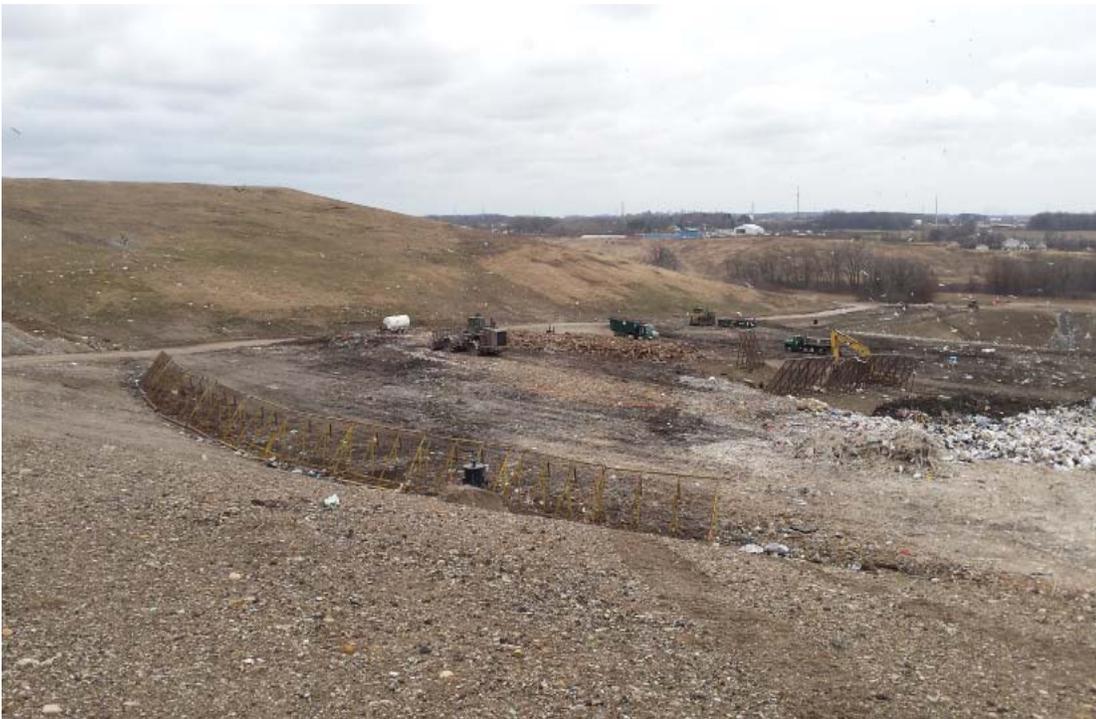
Active area viewed from the North

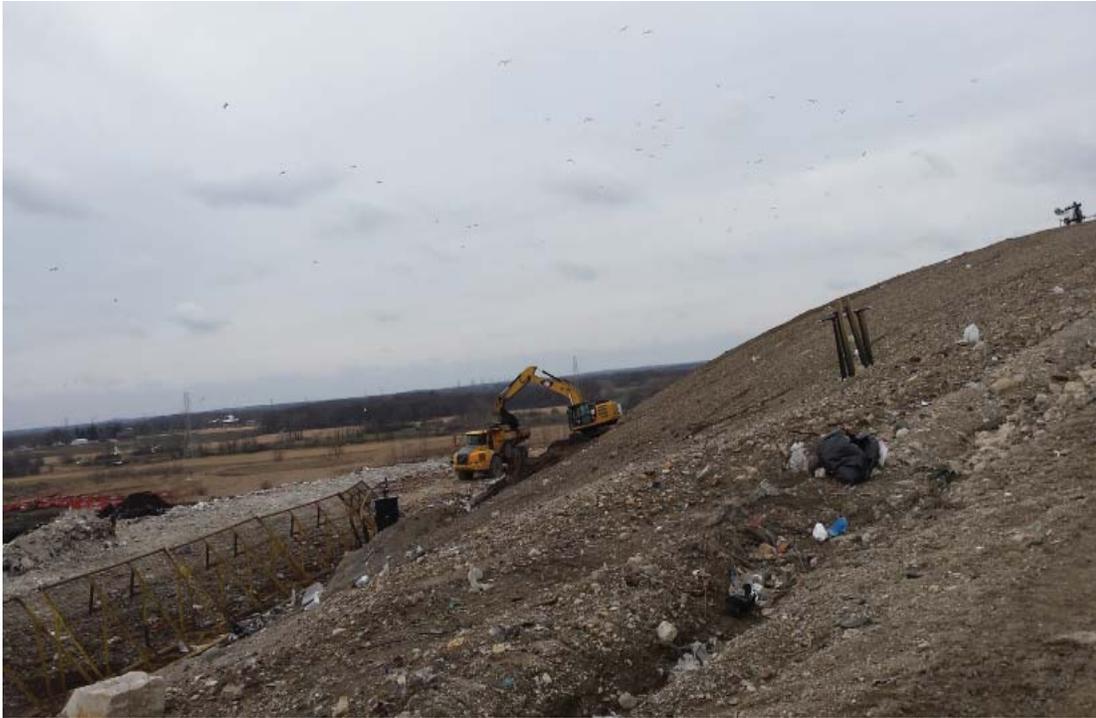
Excavator recovering soils from slope for daily cover.

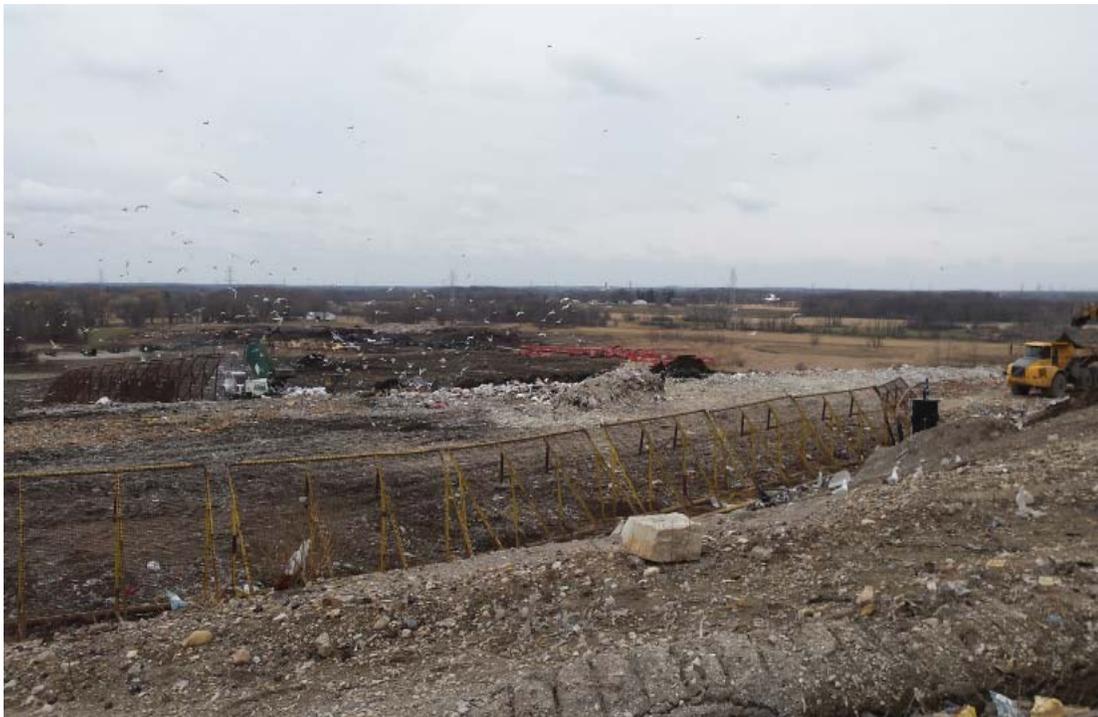
Working face viewed from the North

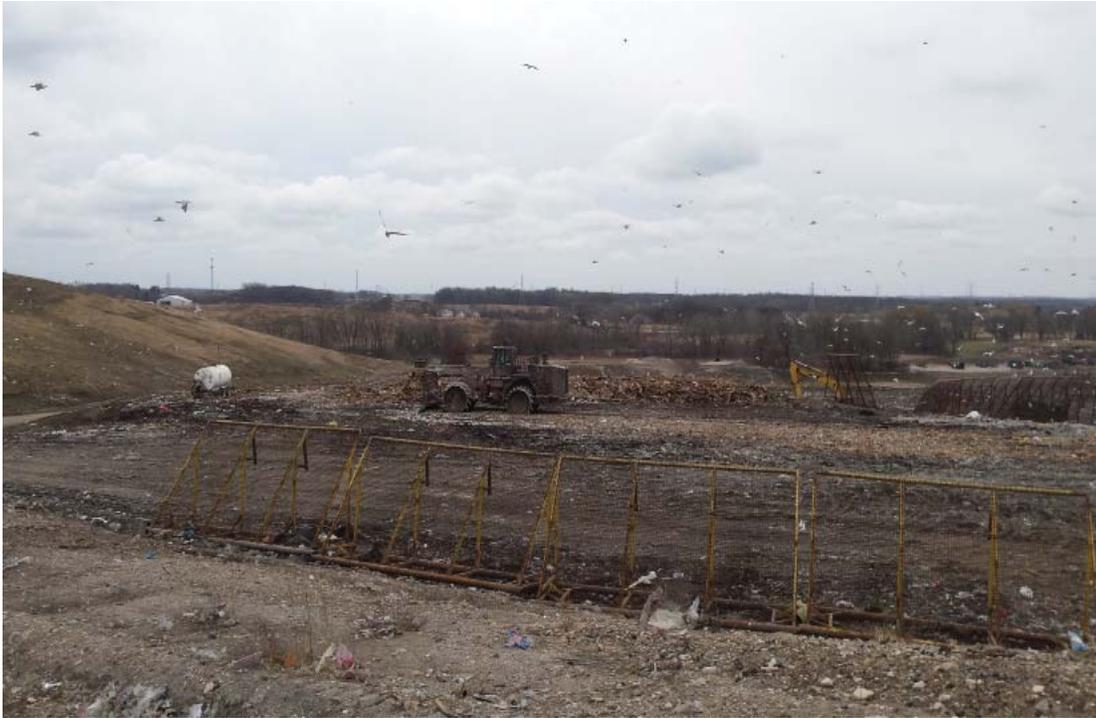
Active area and access to working face. Material stockpiled to make travel-ways

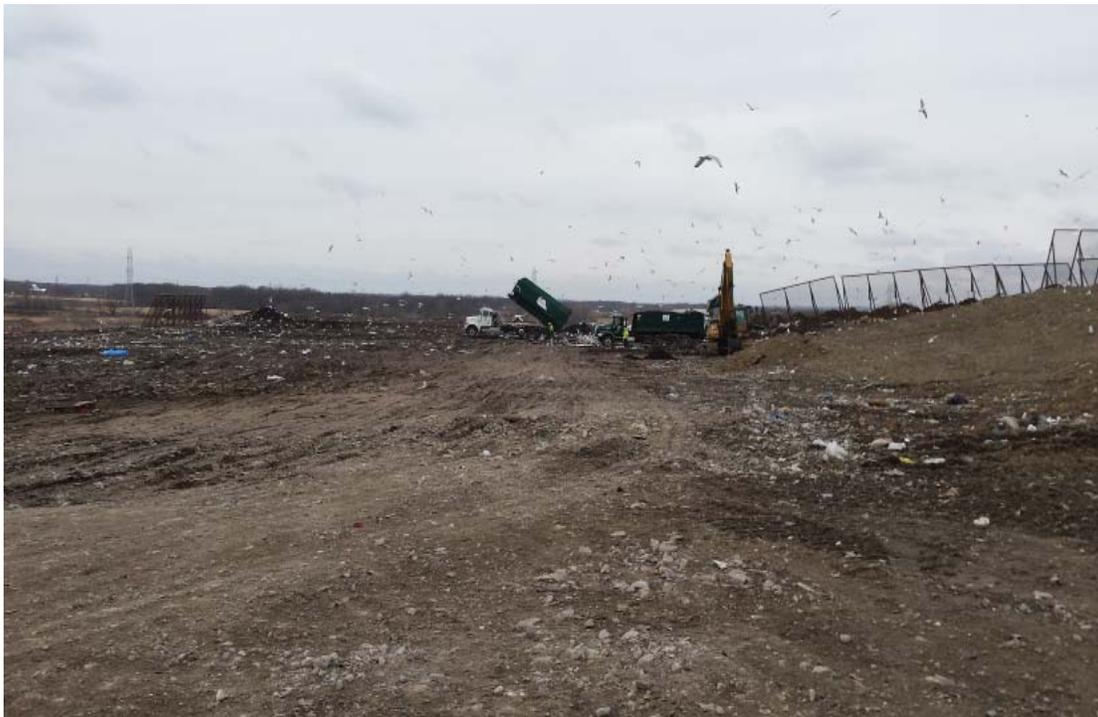
Working face viewed from the East

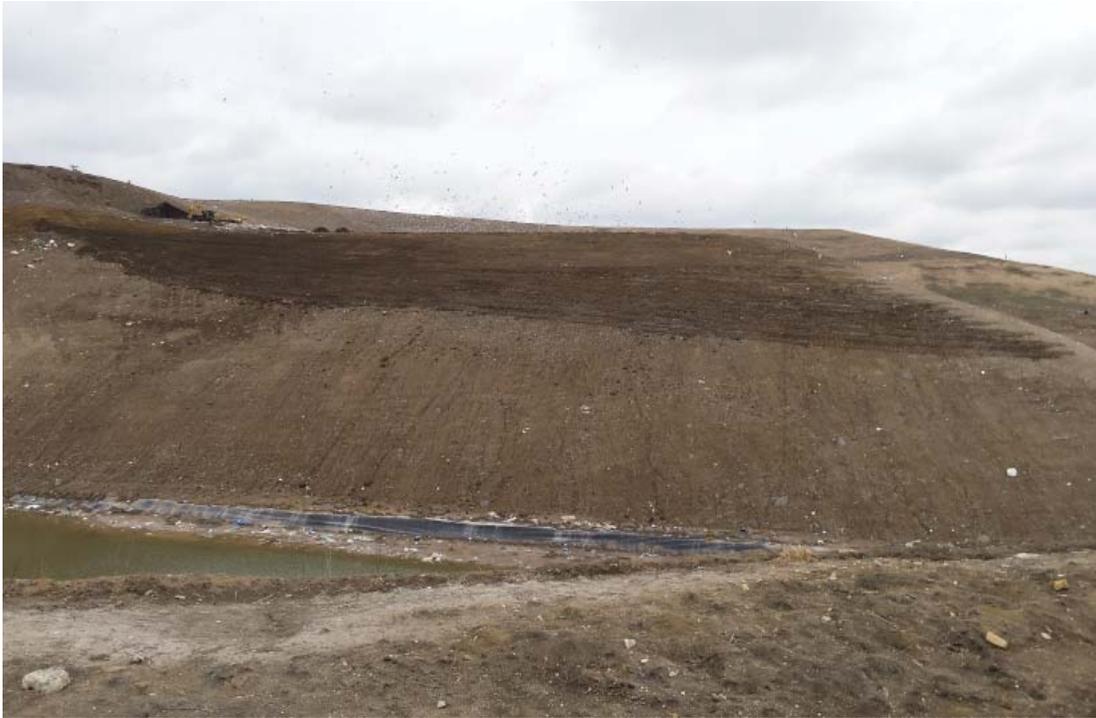
West slope of Phase 7 with new intermediate cover at top of slope

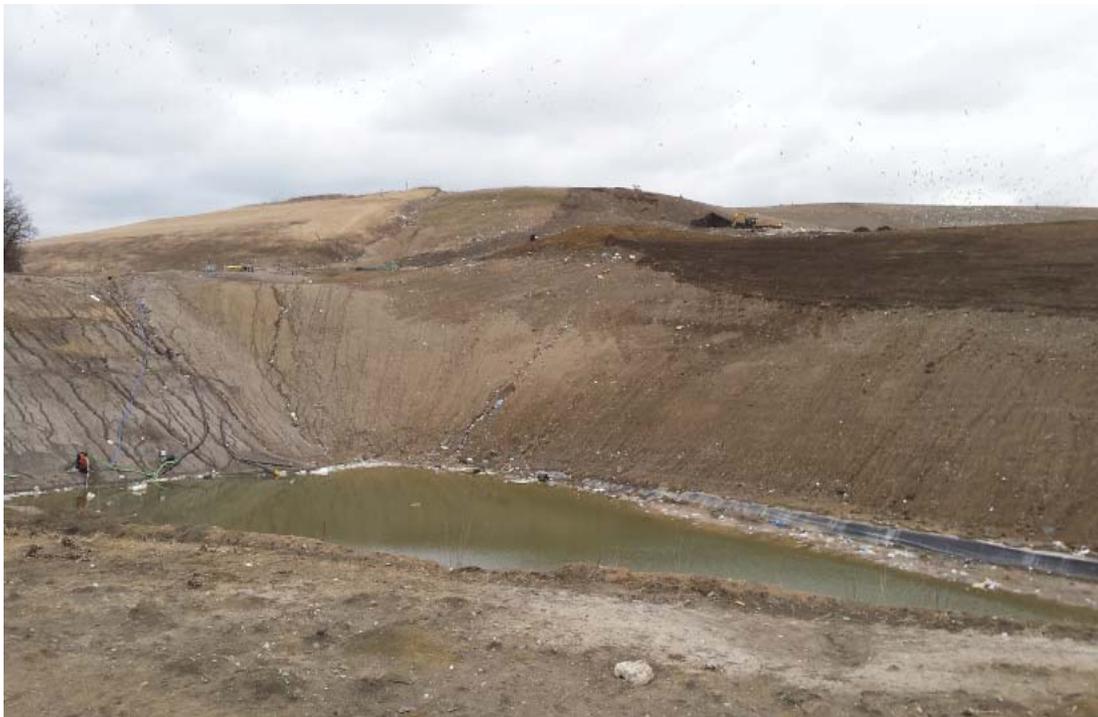
Overview of Landfill footprint viewed from Southwest

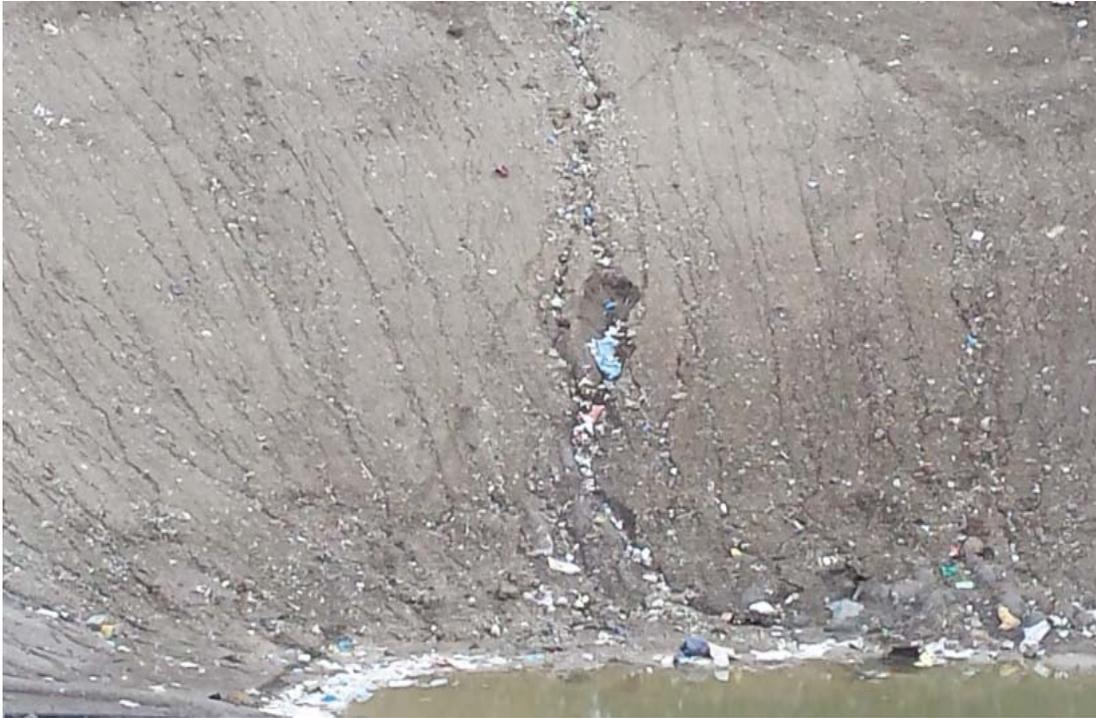
Large ril in Phase 7 West slope, trash within is litter not flagging or exposed waste.

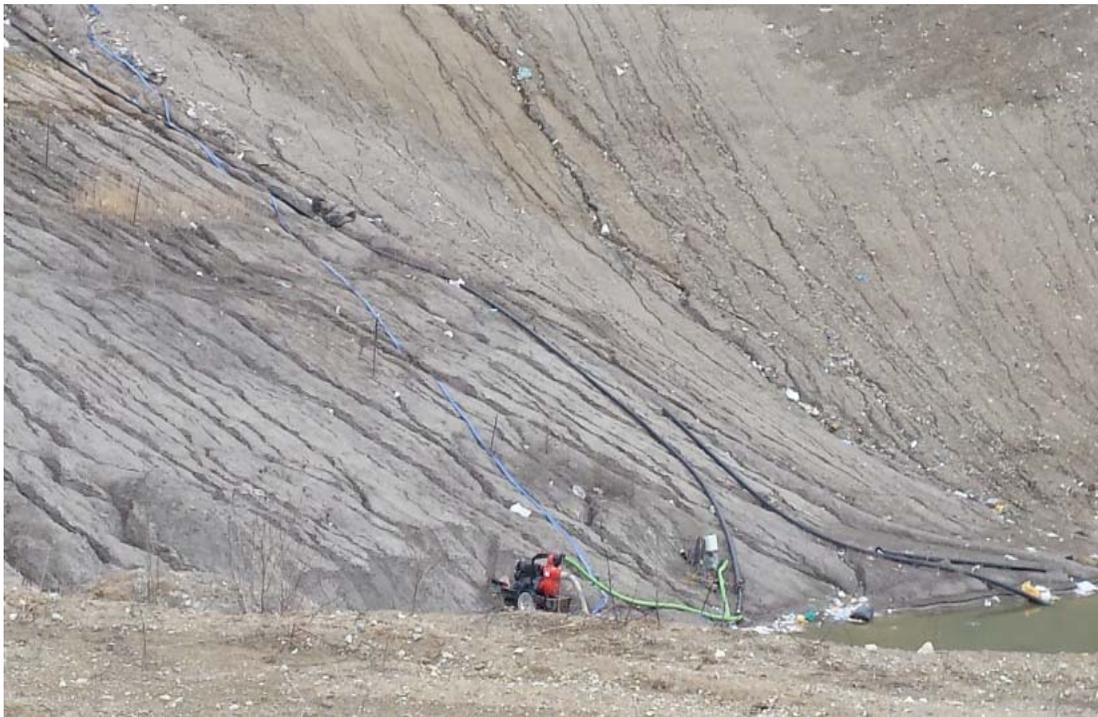
West slope of Phase 7, draining into temp sed basin

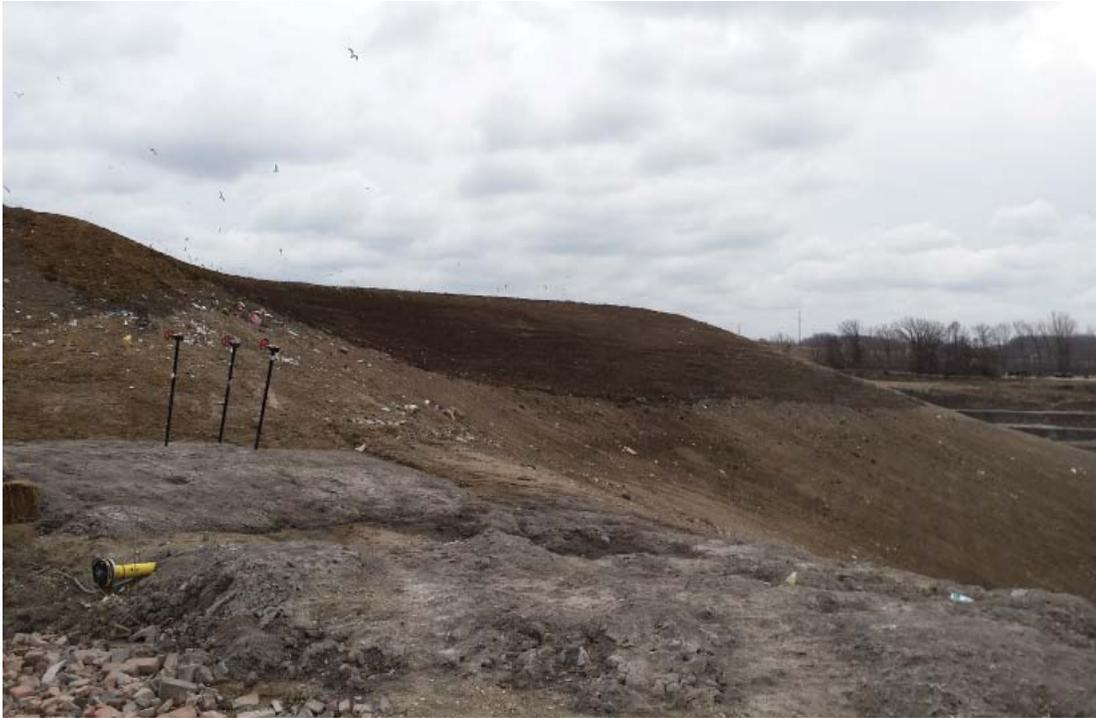
New intermediate cover at top of slope, Phase 7 West slope
