Memorandum

ADS Emerald Park Landfill Audit Summary

To: ADS Emerald Park Landfill Standing Committee, City of Muskego
FROM: Faith Spear.
COPIES: File
DATE: 05/13/16
PROJECT NUMBER: 1012.10030

Attached is the audit report for activities at the ADS Emerald Park Landfill for the week of March 20. The audit was performed at 3:20 PM on **March 24, 2016**, by Jo Spear, Jr. in the presence of Scott Croft, Gas Well Technician.

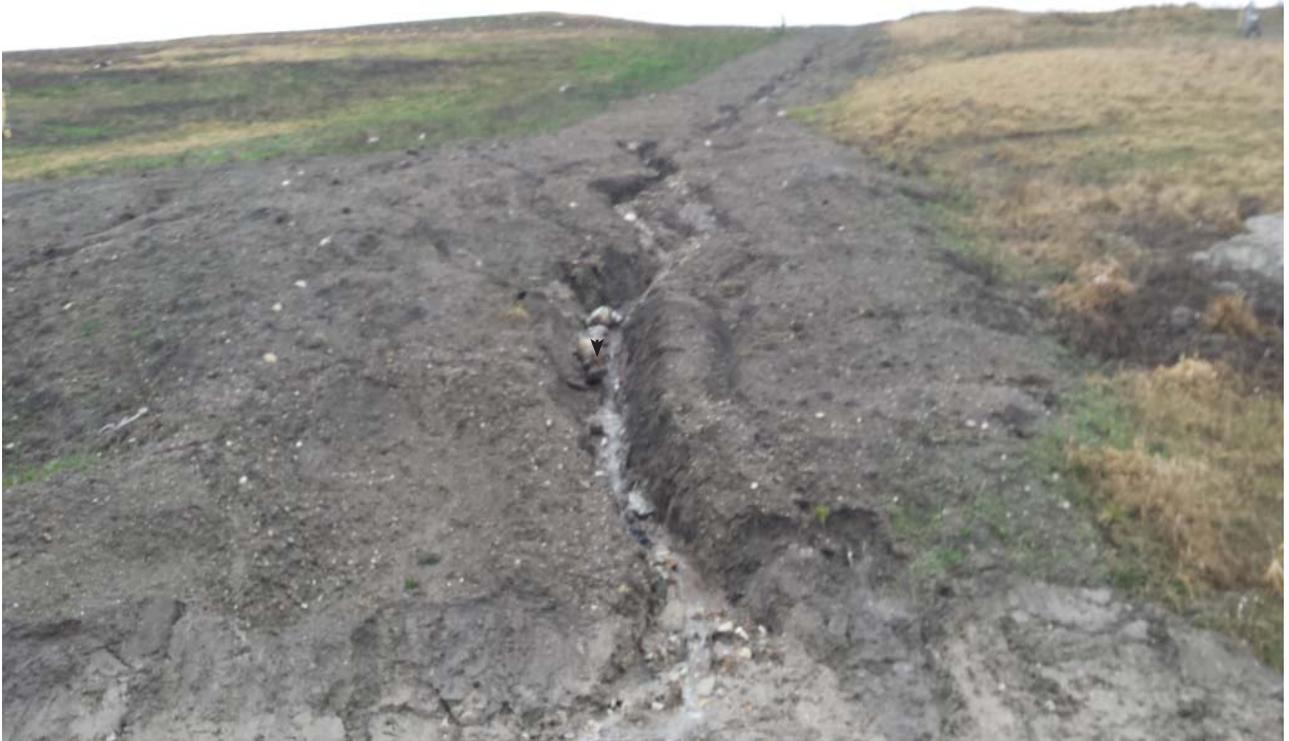
Continuous rains with possible snow tonight
additional erosion in phase 5/6. Ditches cleaned
today and yesterday

Junction between Phases 5 & 6, closure area III to the East, right. Repairs expected in dry conditions

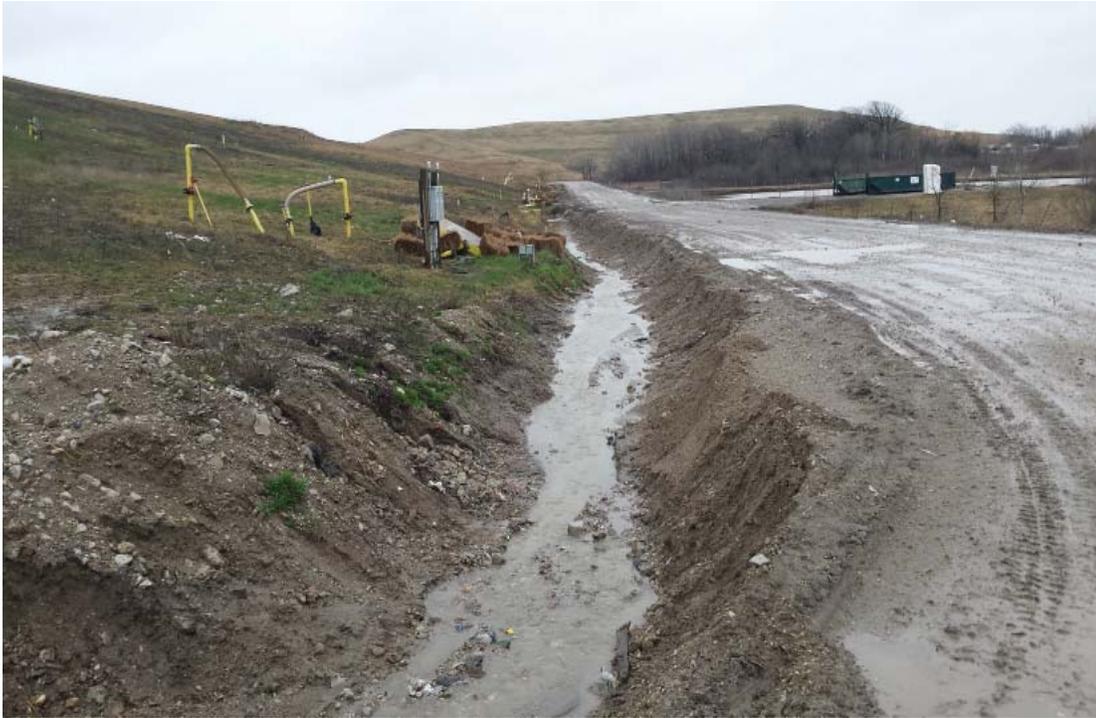
Ditch cleaned along toe of Phase 5&6 South slope

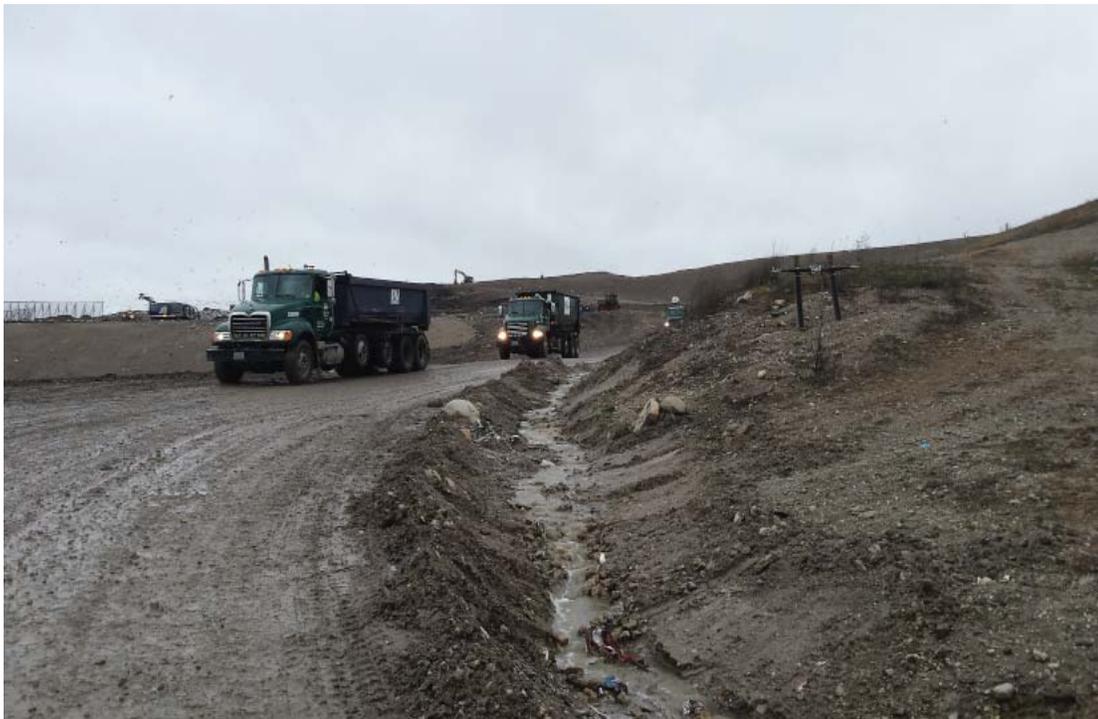
Ditch cleaned along toe of Phase 6 West slope

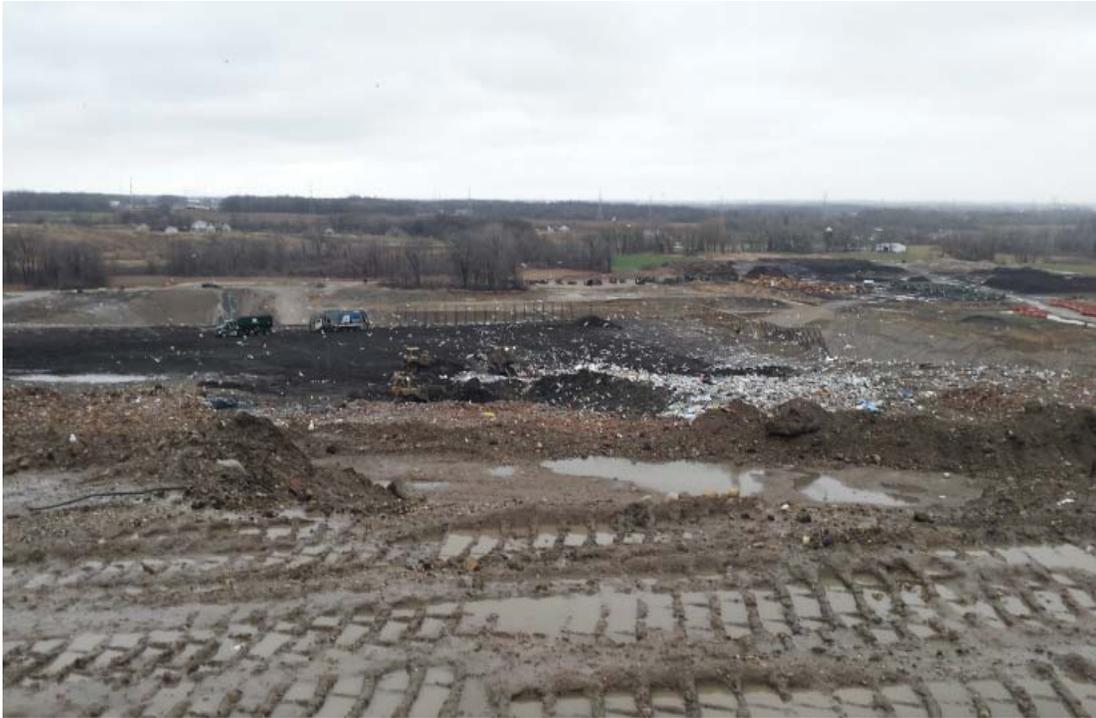
Overview of the active area

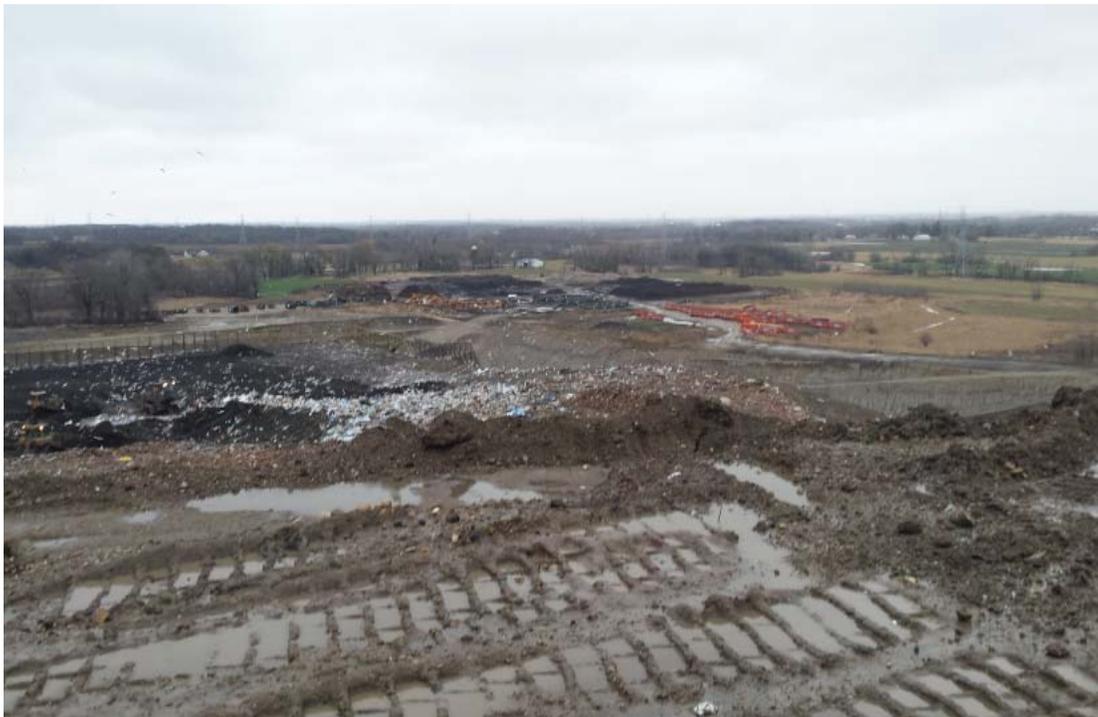
Working face viewed from above and North

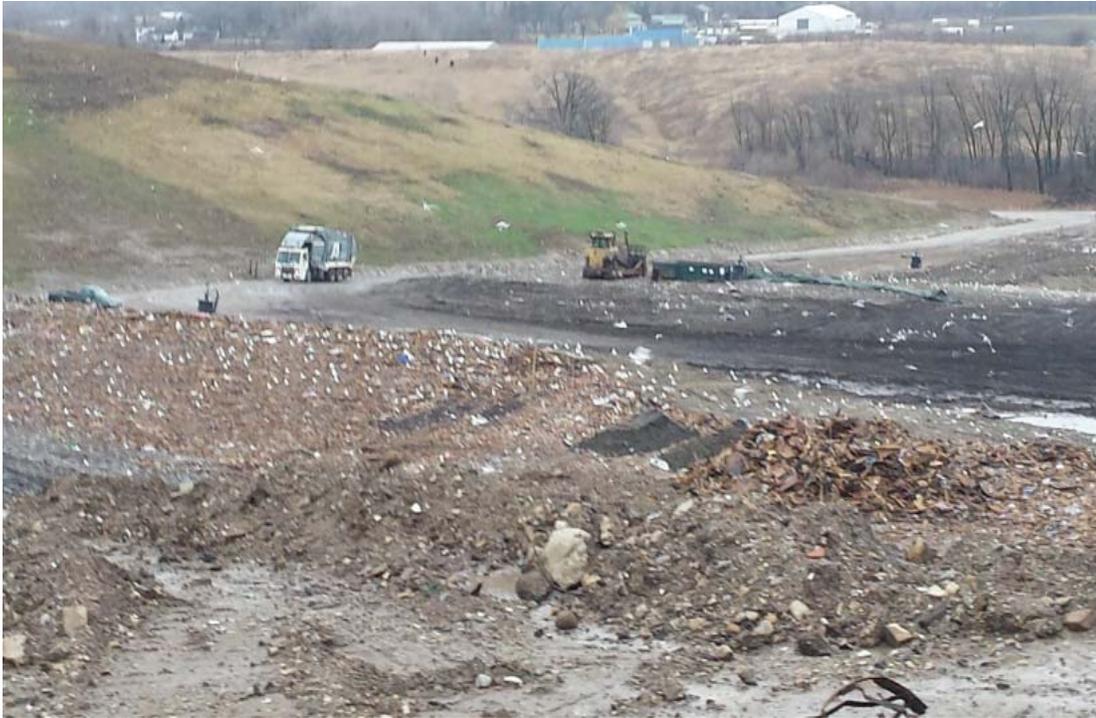
Active area approach

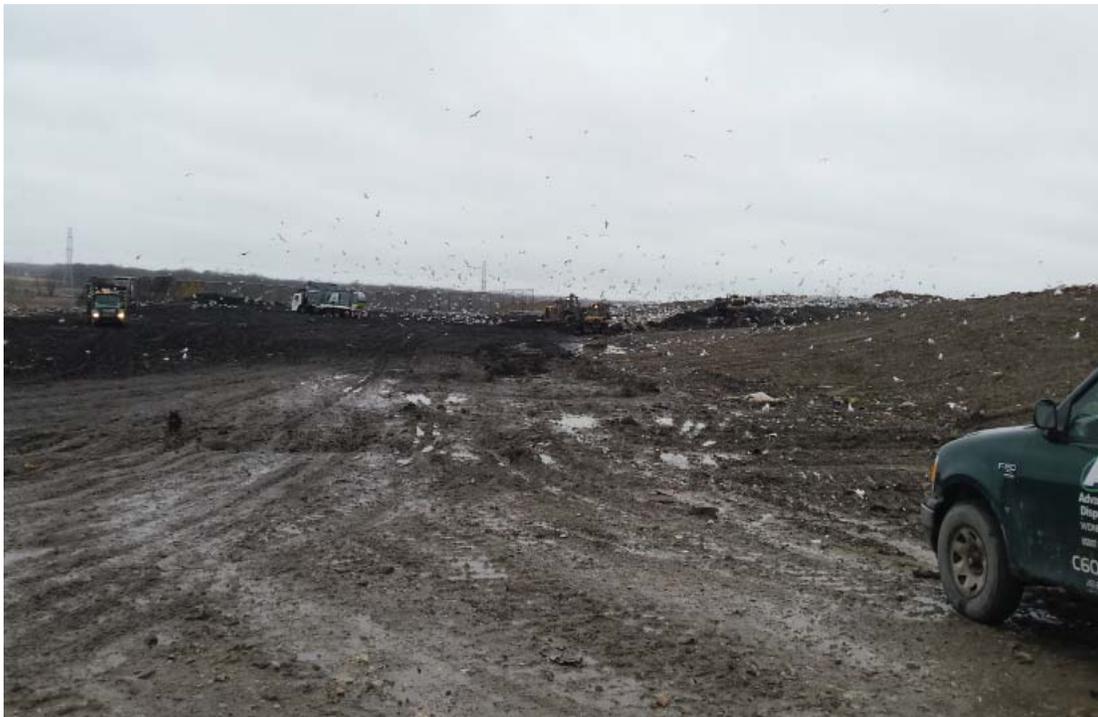
Active area viewed from the East

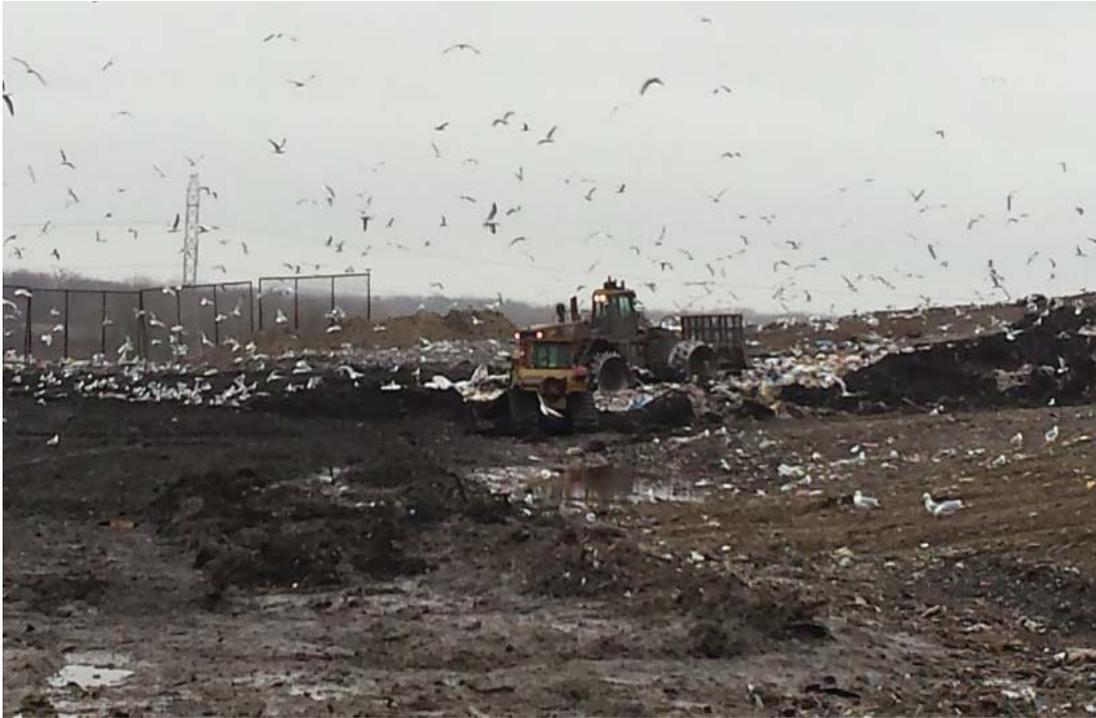
Compactor working waste placement, dozers covering waste after placement

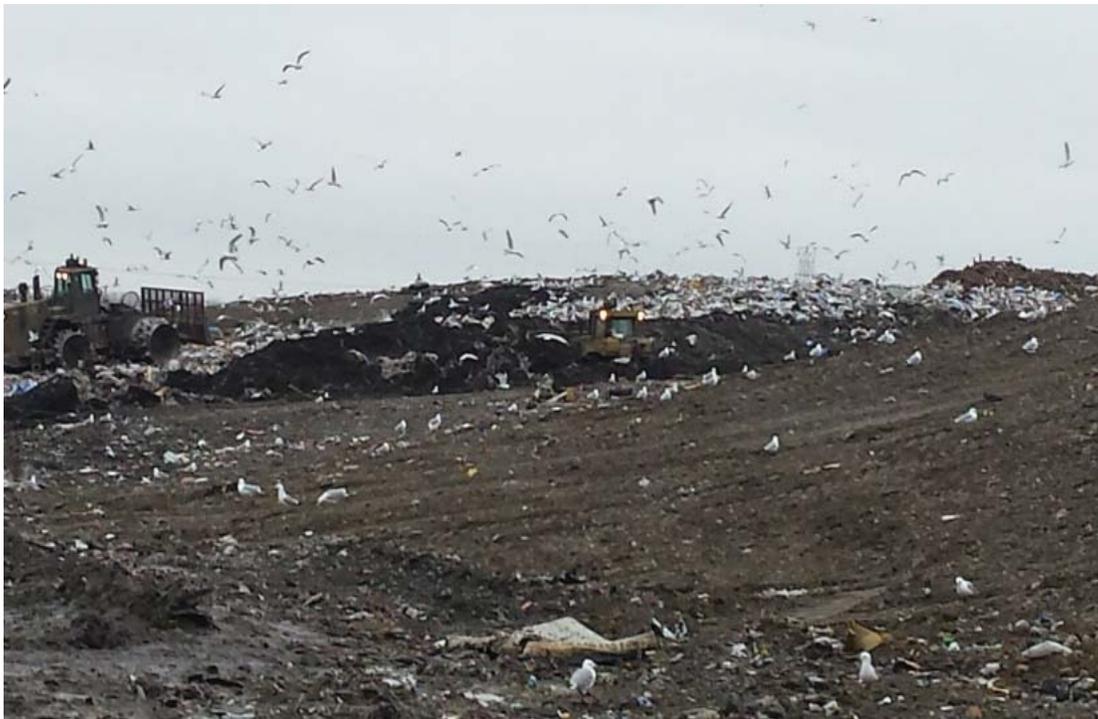
Working face, long and thin, laid out North South in the center of Phase 7.

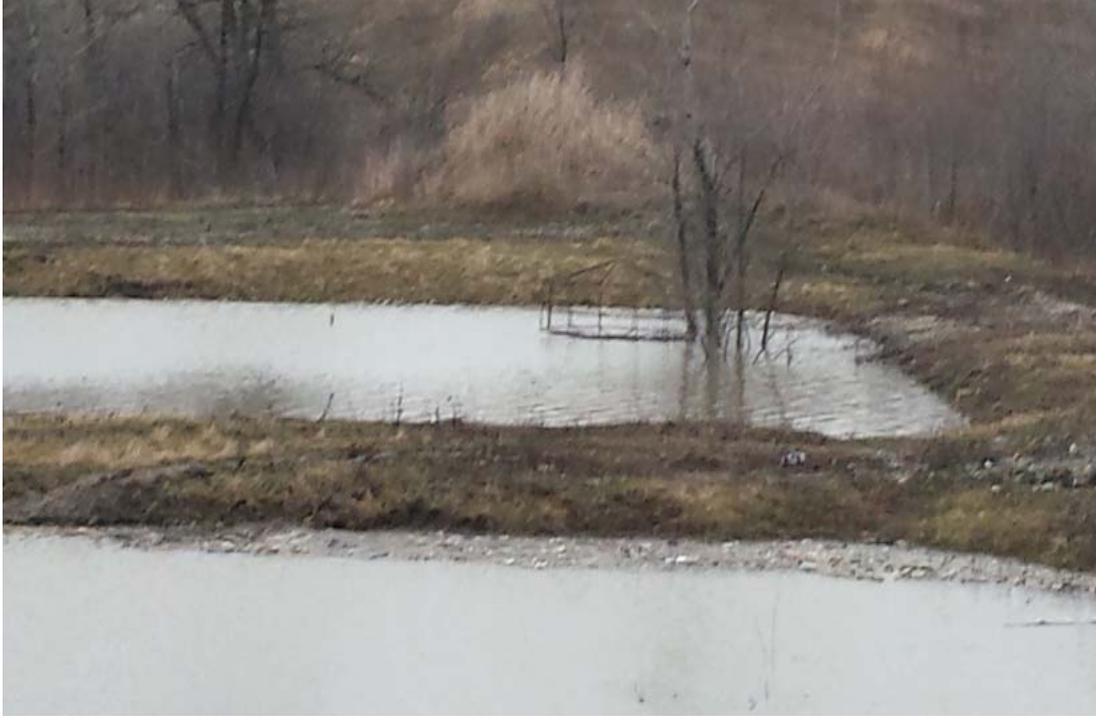
* Temp Sed Basin 2-1' Freeboard & being pumped overnight.

Basin #2, elevation higher than the top of control structure. Other Basins have freeboard
