Memorandum

ADS Emerald Park Landfill Audit Summary

To: ADS Emerald Park Landfill Standing Committee, City of Muskego
FROM: Faith Spear.
COPIES: File
DATE: 05/12/16
PROJECT NUMBER: 1012.10030

**ADVANCED DISPOSAL SERVICES
EMERALD PARK LANDFILL / CITY OF MUSKEGO
AUDIT PHOTOS**

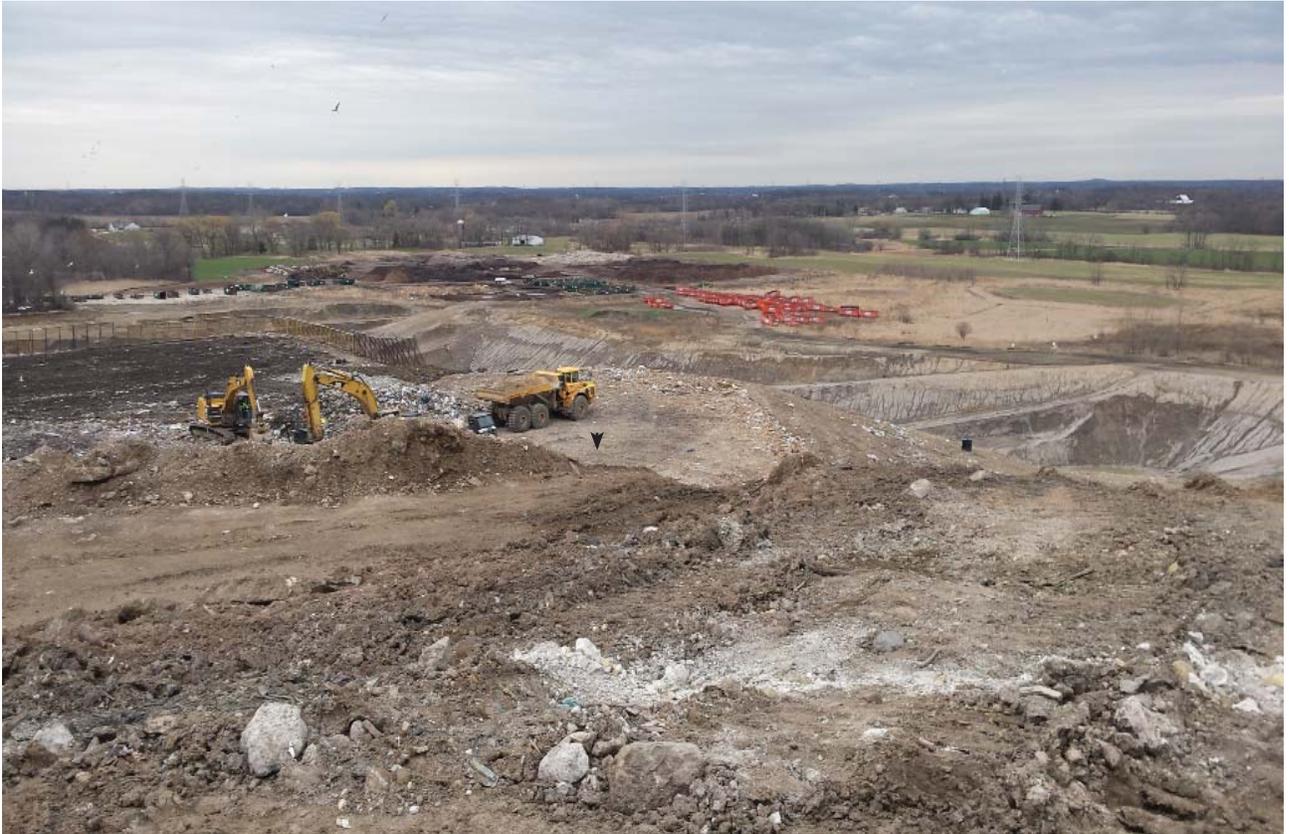
Well raising ongoing during audit

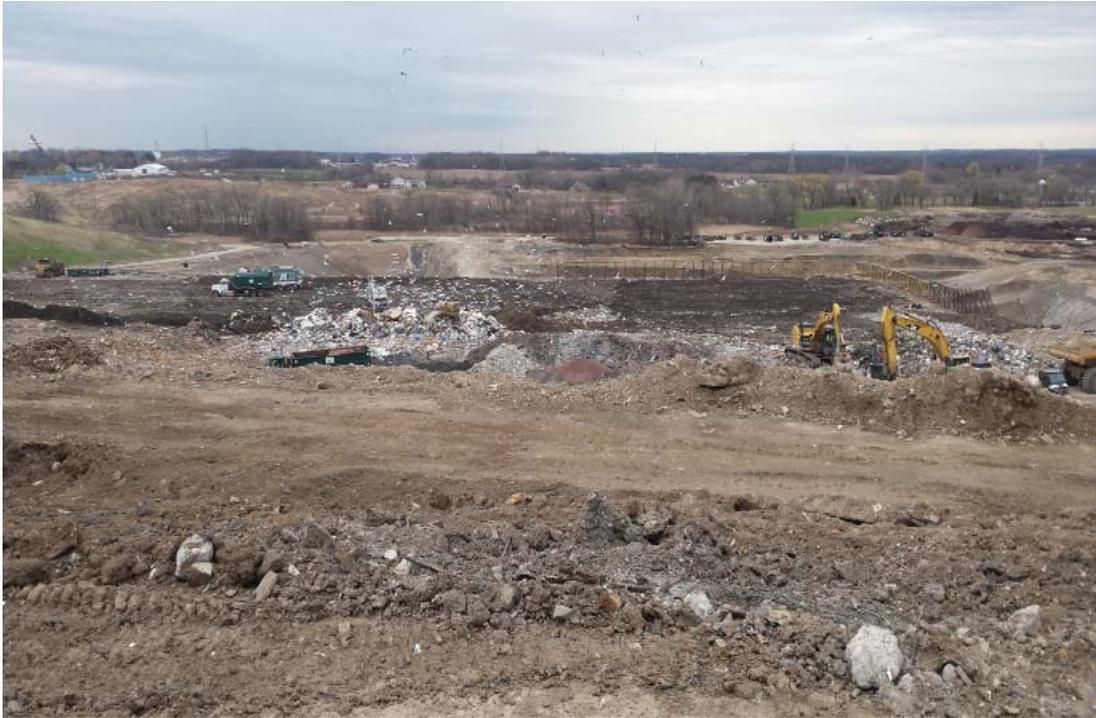
Active area viewed from the North

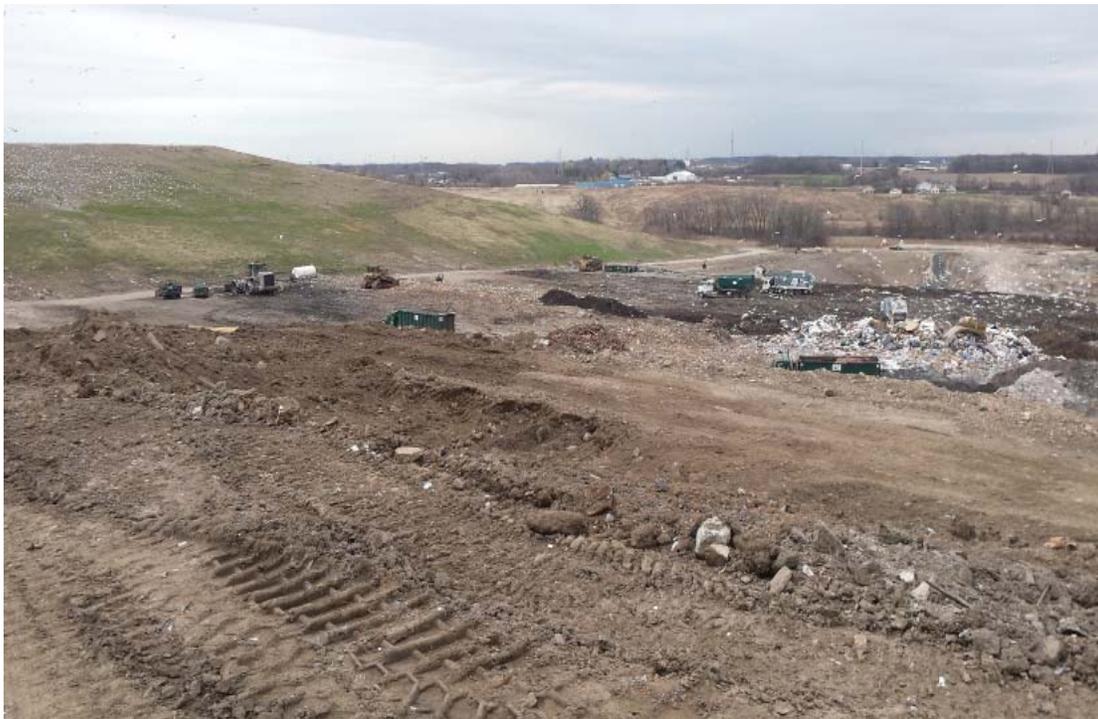
Active area viewed from the Northwest

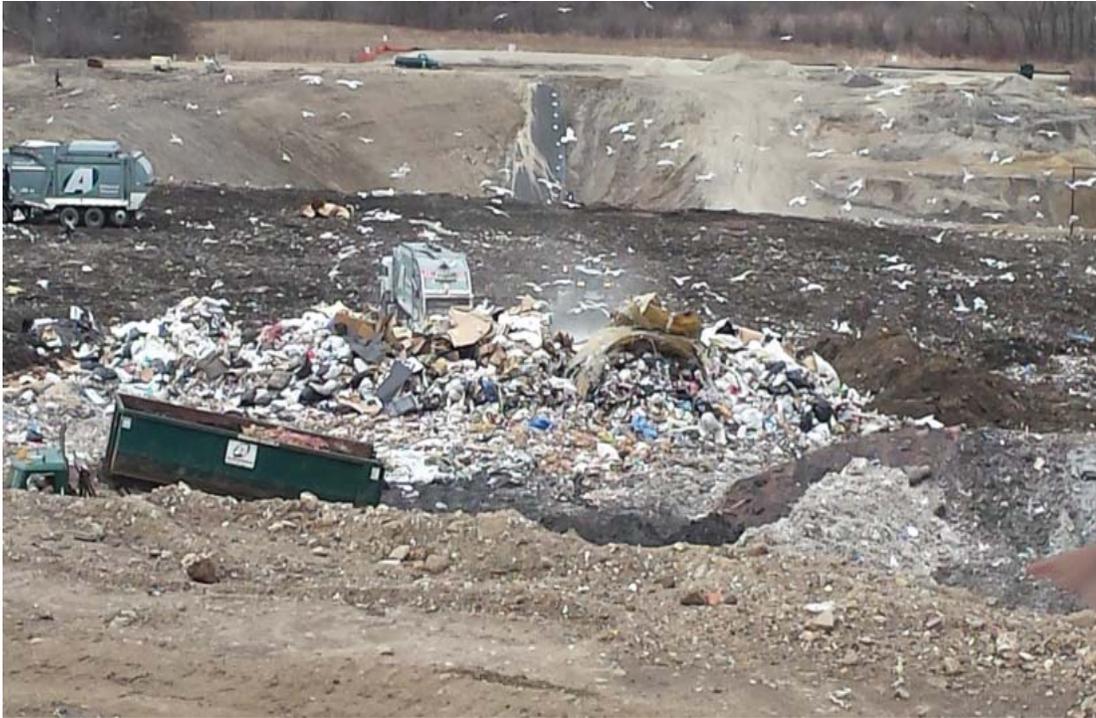
Overview of the working face from the North

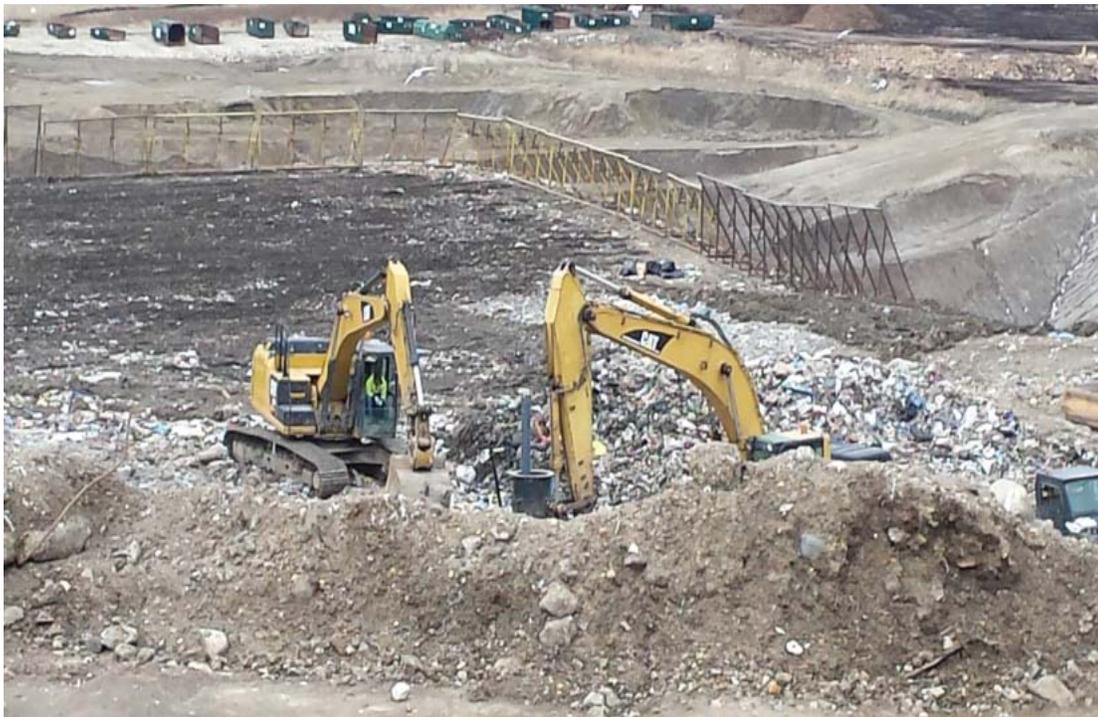
* Well being elevated during audit in Northwest corner of Phase 7

Equipment being used to raise cason style gas well

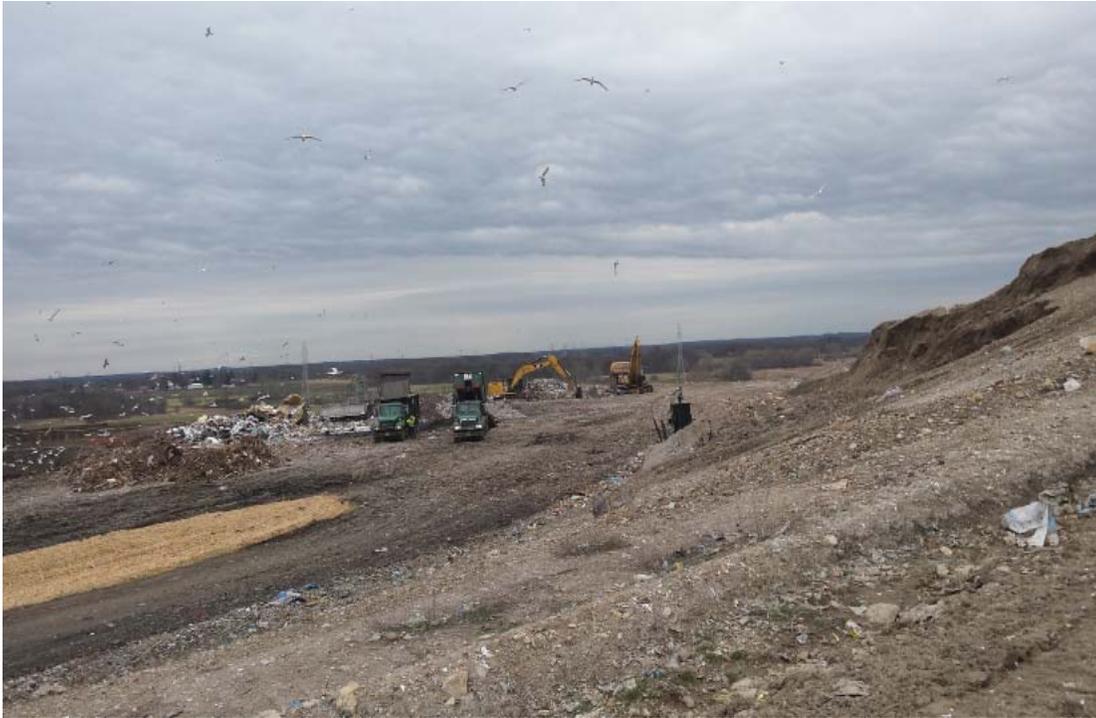
Active area approach

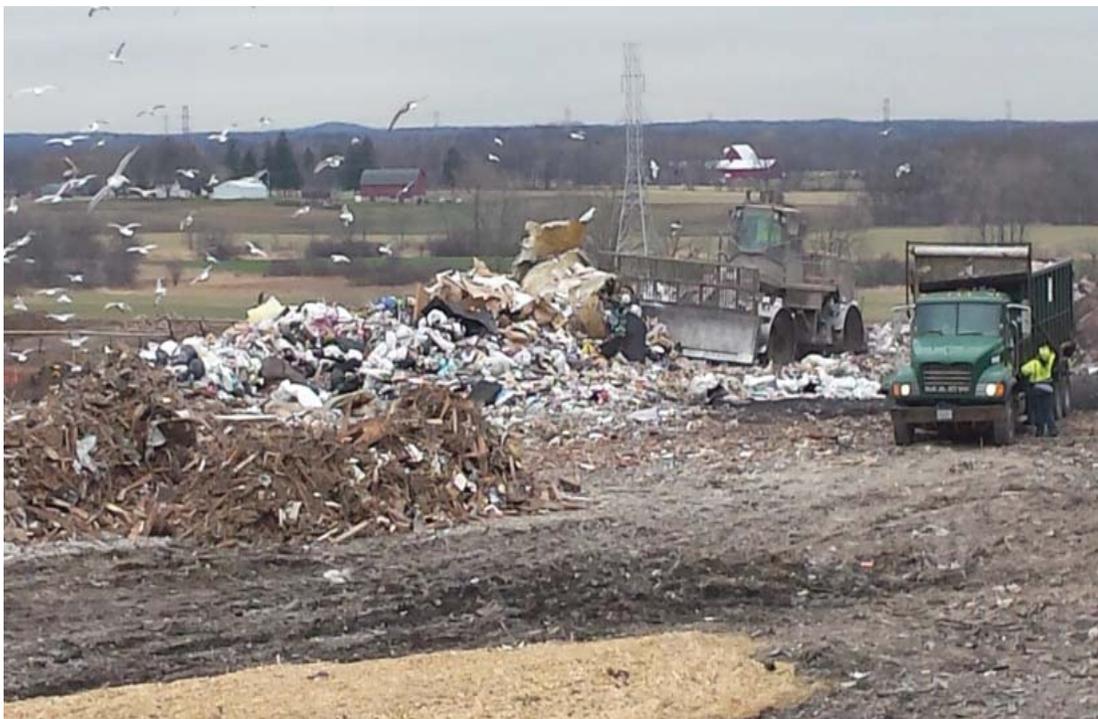
C&D materials stockpiled for use at end of day, daily cover support

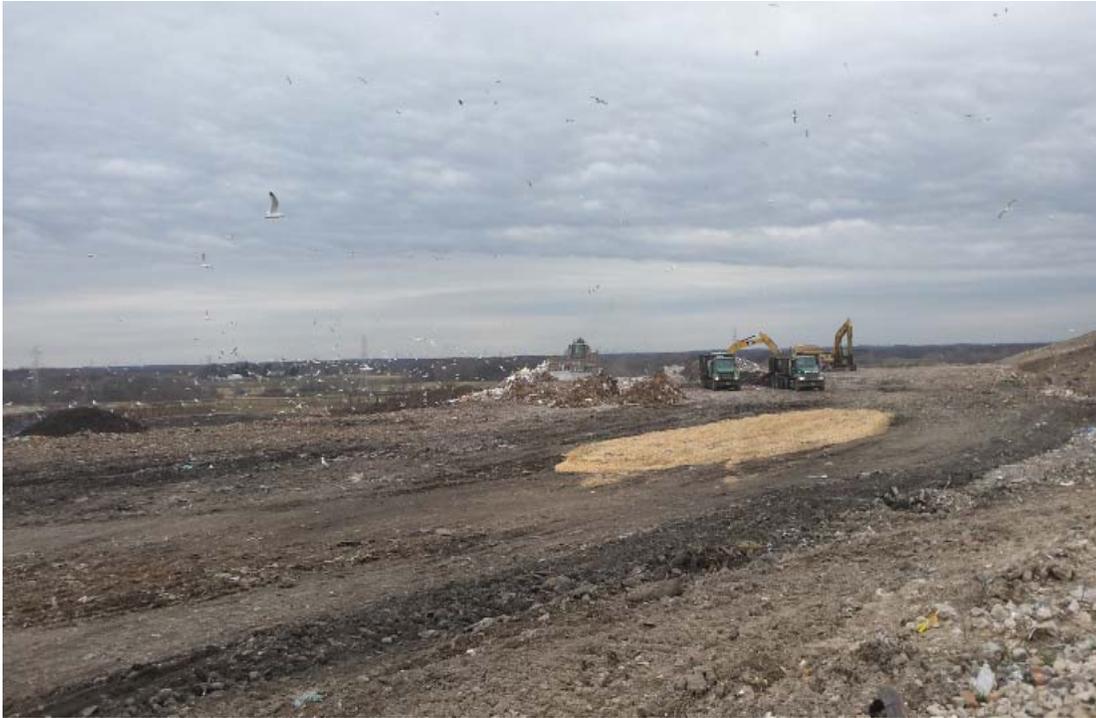
Working face viewed from the West, wood seconds/chipped wood, being used for travelway stabilization

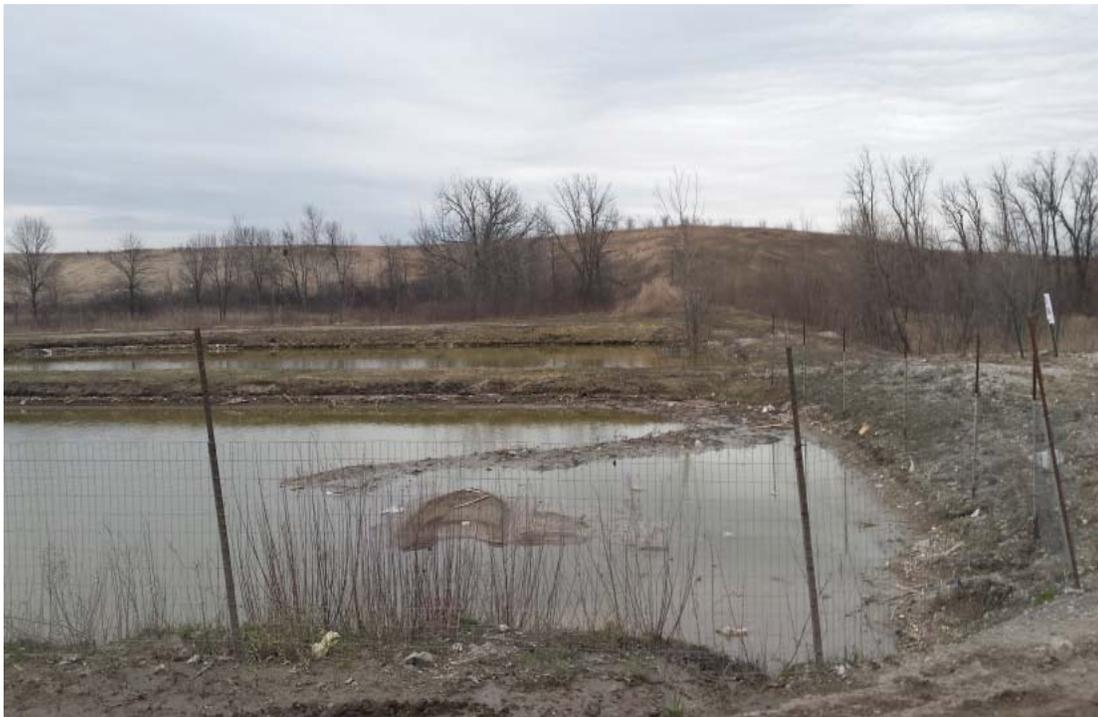
Basins draining, Basin 2 at 1' freeboard, other basins well drained.

Basin #2, some draining since last audit

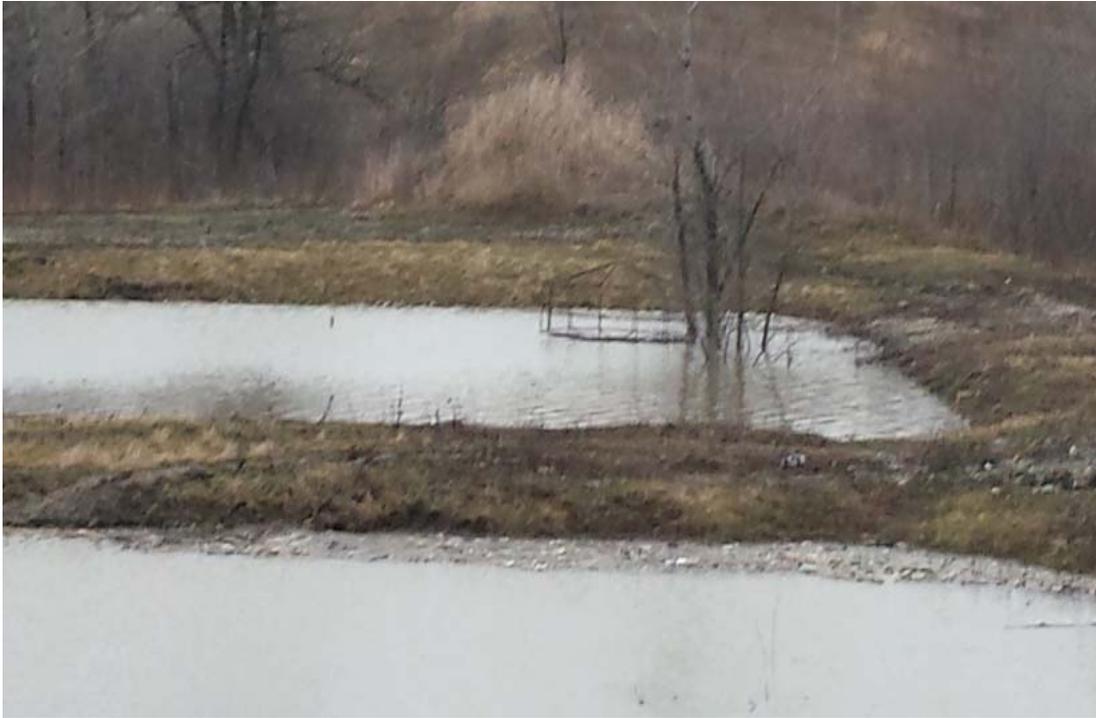
Basin #2, elevation higher than the top of control structure. Other Basins have freeboard
