## Memorandum

### ADS Emerald Park Landfill Audit Summary

**To:** ADS Emerald Park Landfill Standing Committee, City of Muskego  
**FROM:** Faith Spear.  
**COPIES:** File  
**DATE:** 06/13/16  
**PROJECT NUMBER:** 1012.10030

**ADVANCED DISPOSAL SERVICES  
EMERALD PARK LANDFILL / CITY OF MUSKEGO  
AUDIT PHOTOS**

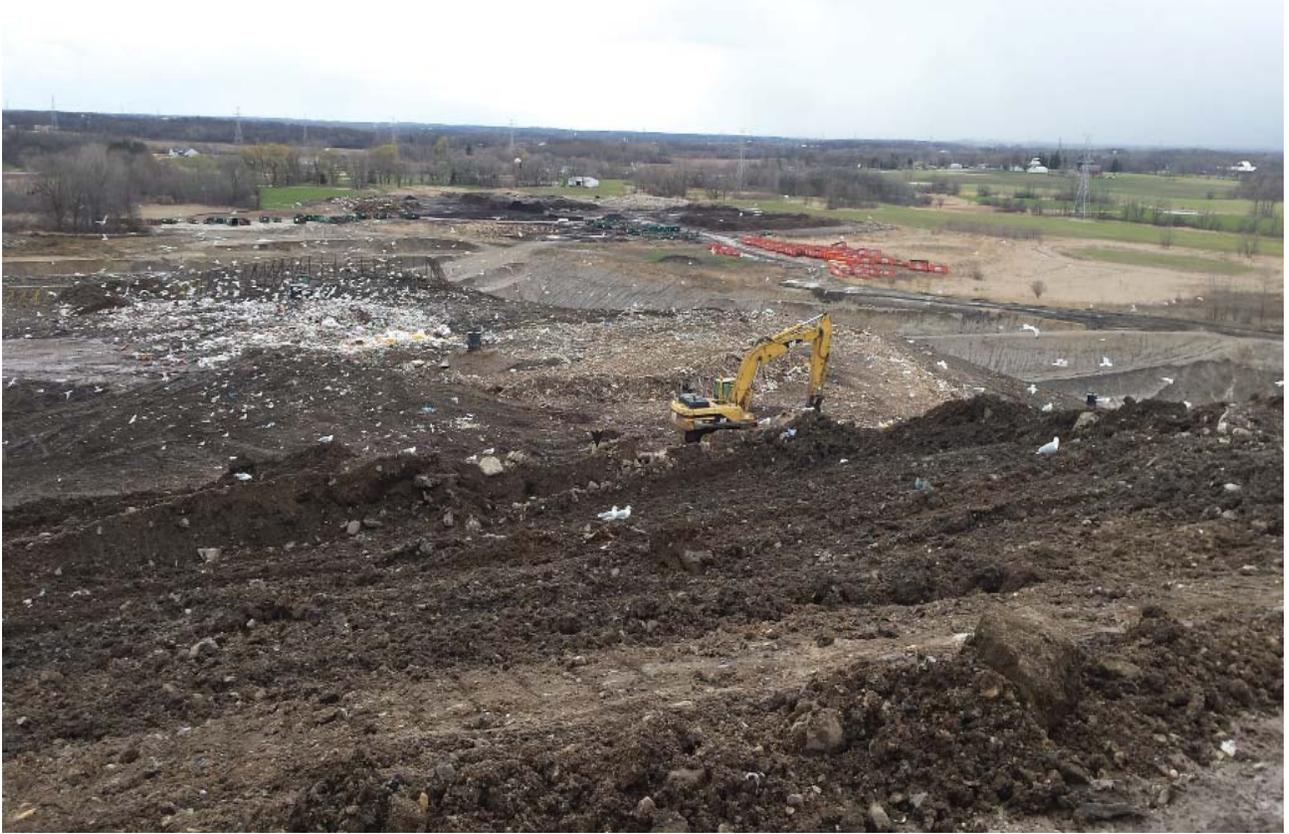
Working face, visible by bird location.

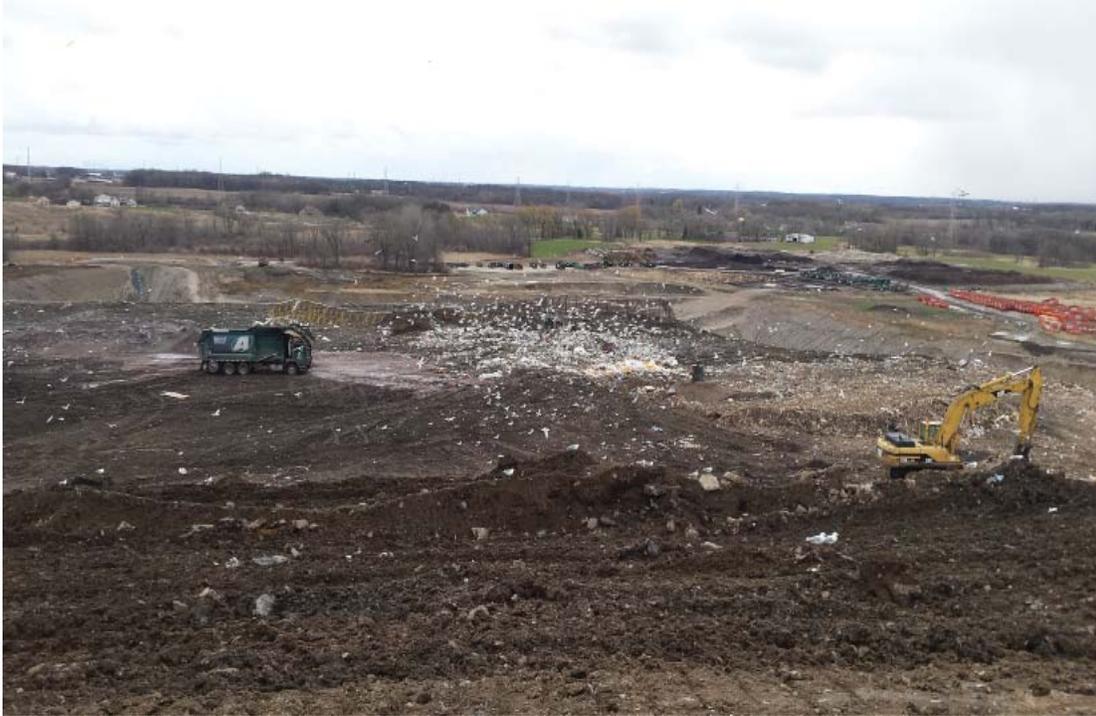
Active area viewed from the North

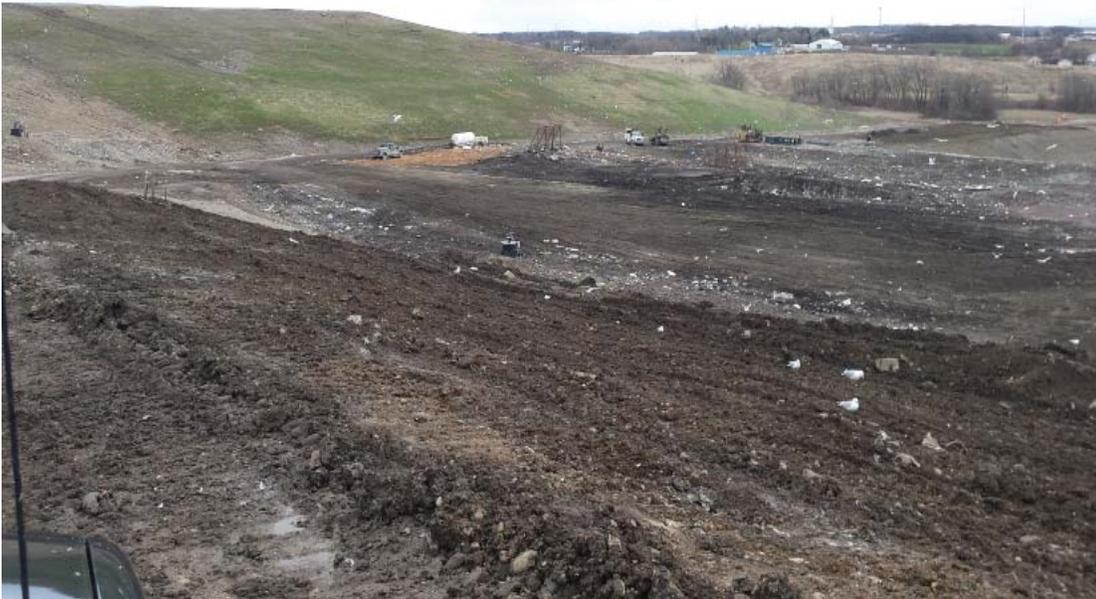
Active area viewed from the Northwest

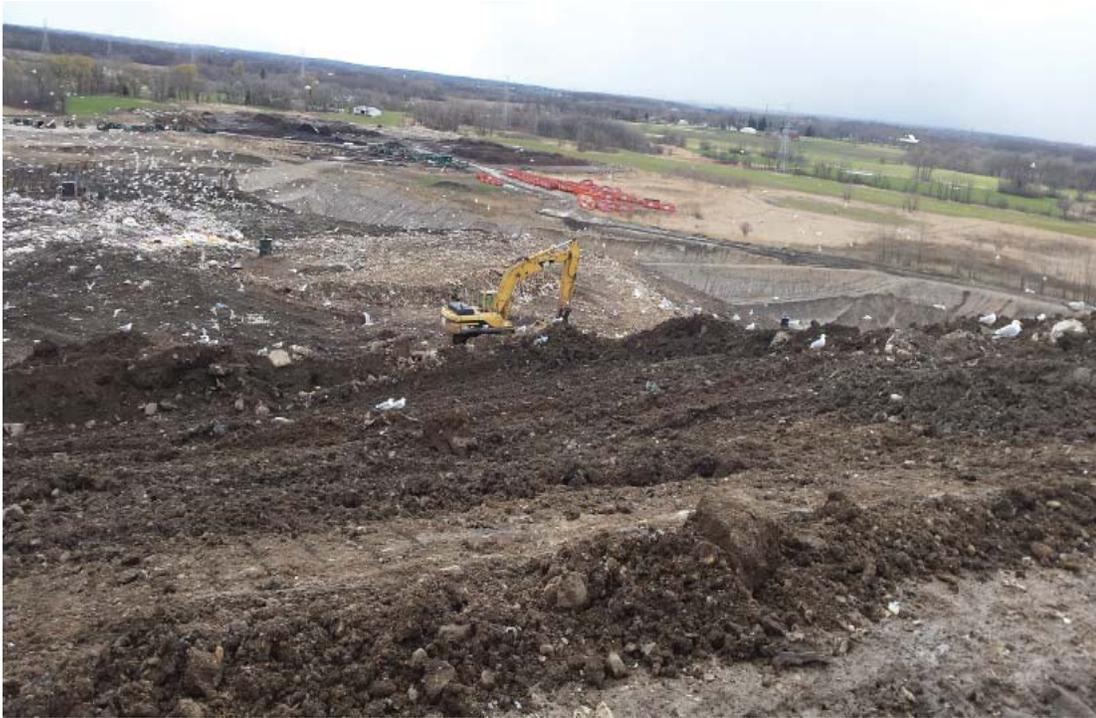
View of Active area from North

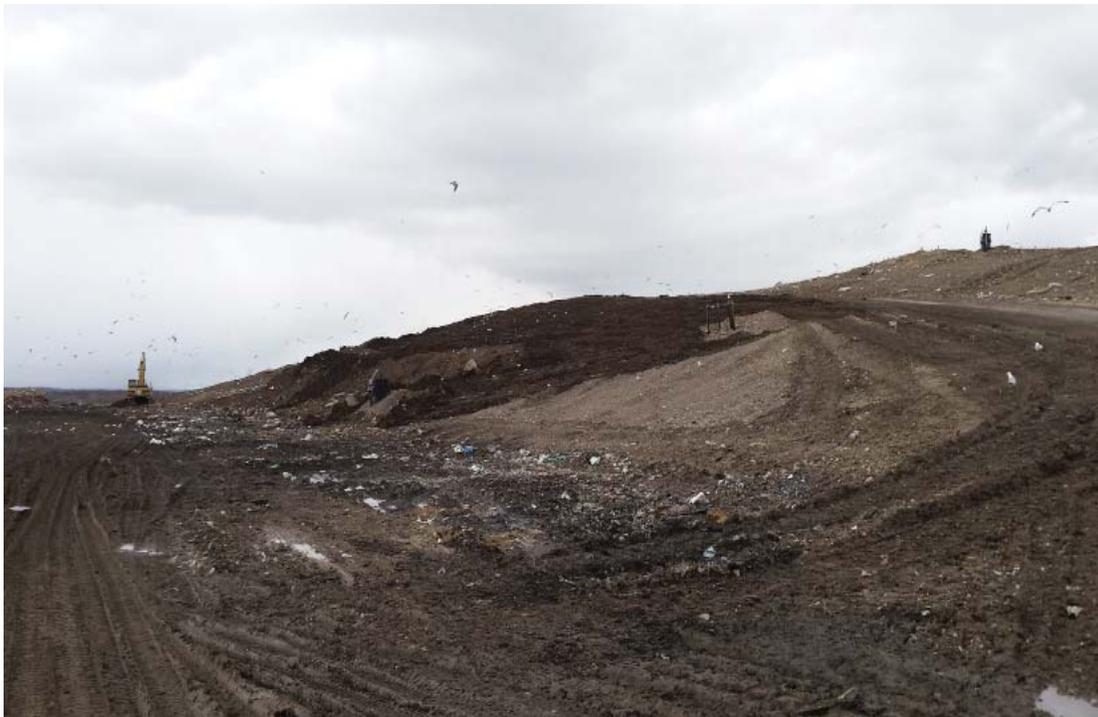
South slope/transition Phase 7 to 3

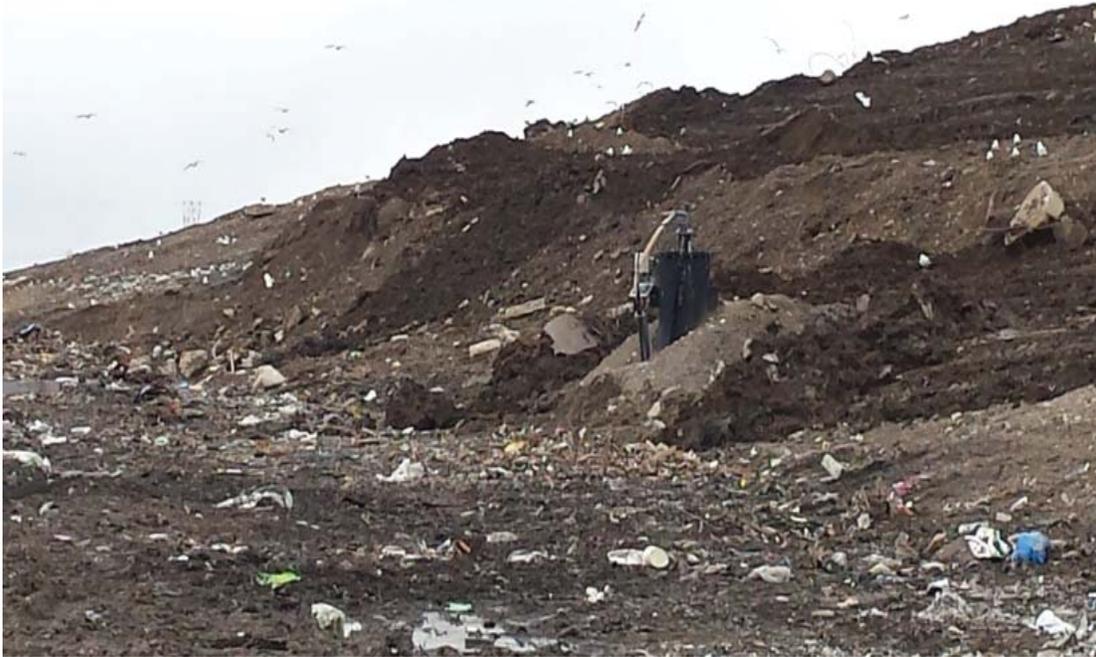
Working face on west edge of Phase 7  
Working East ward. Soils used along  
Phase 3 South slope for cover are nearly  
used. Soil from Phase 5/6 top being  
used for cover

South slope of Phase 3, excavated soils used for cover

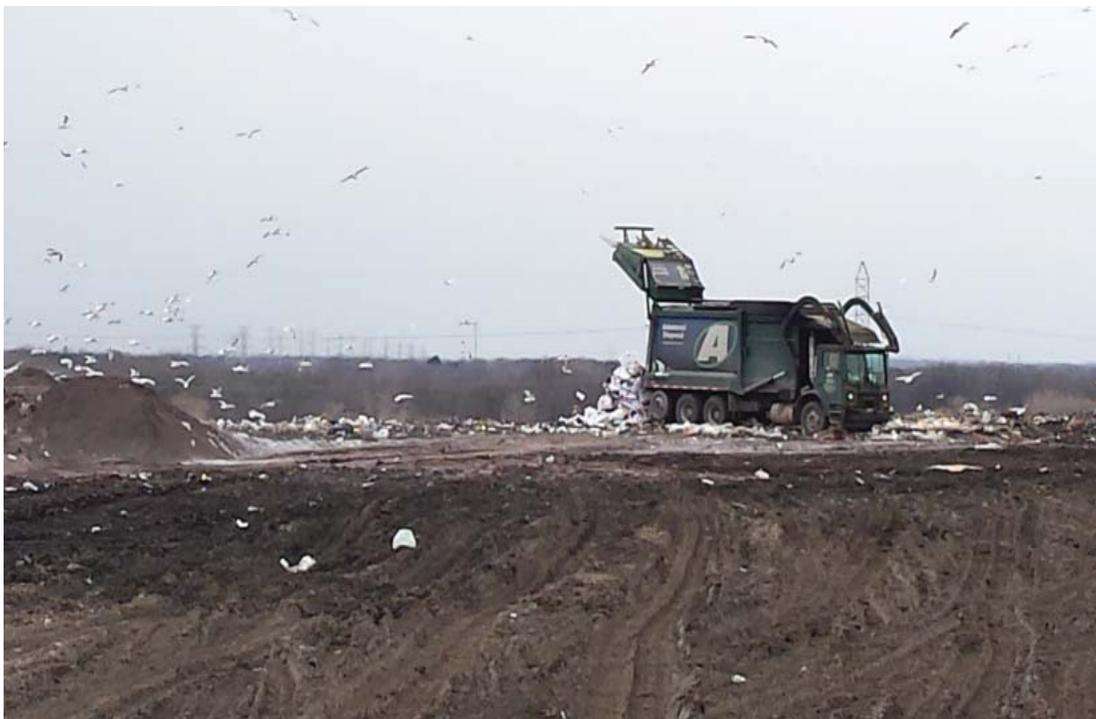
Working face, truck active tipping

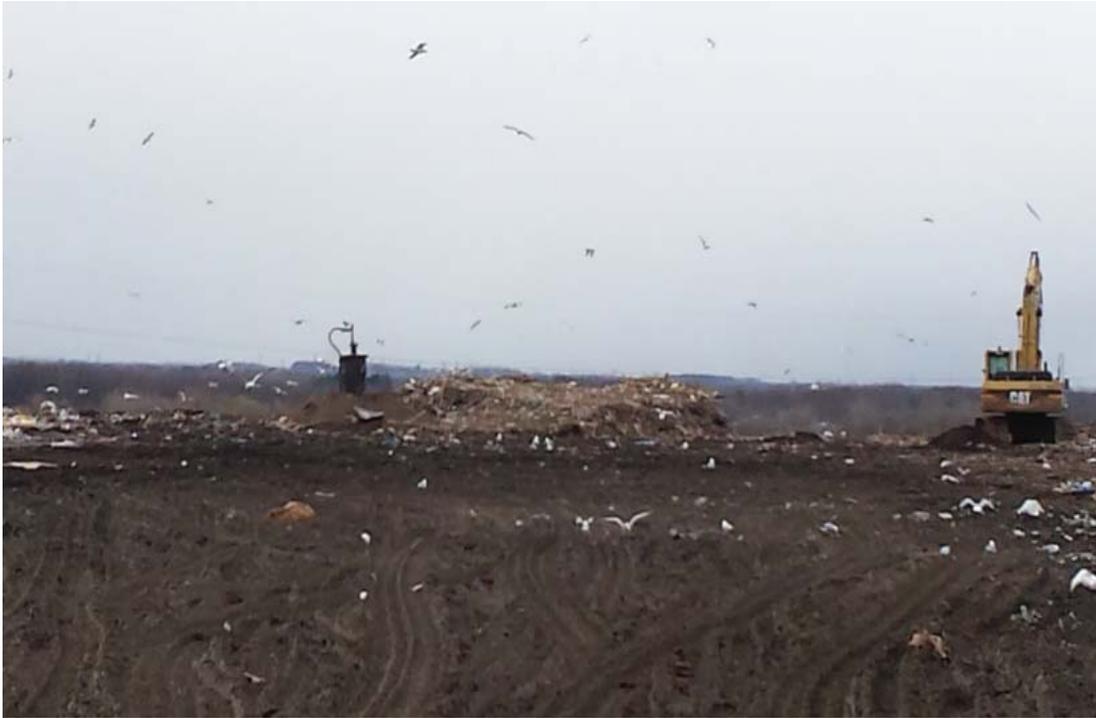
Working face viewed from East

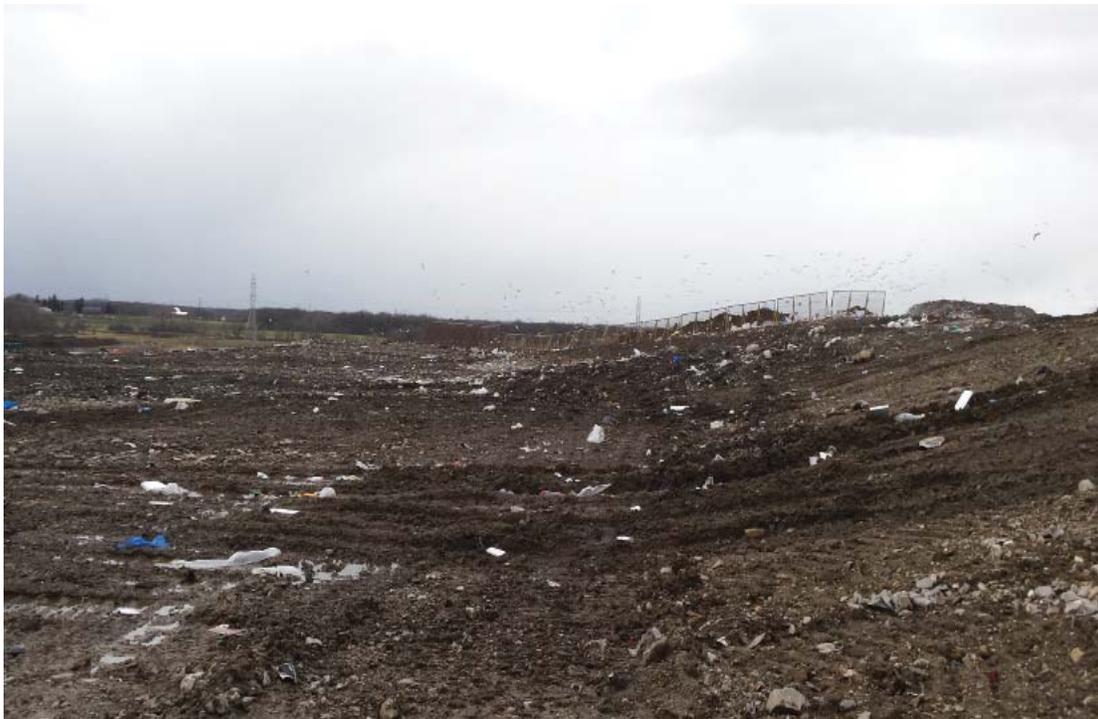
Active area viewed from East

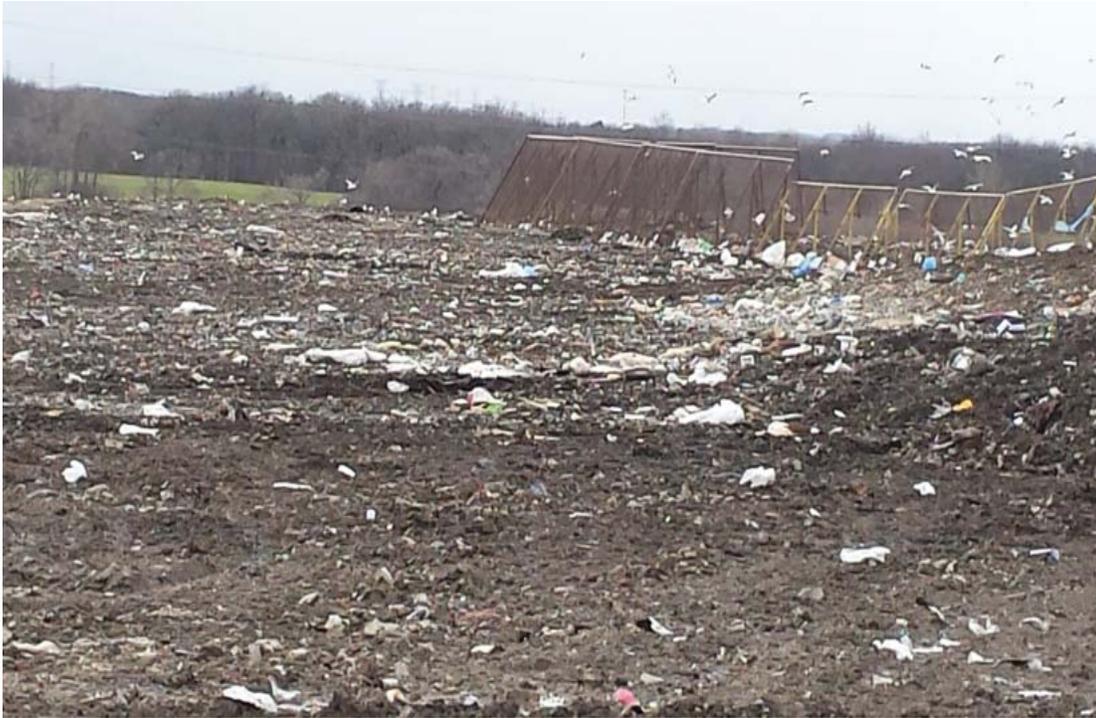
Litter on slopes & active area

Active area outside mobil litter fences, very windy.

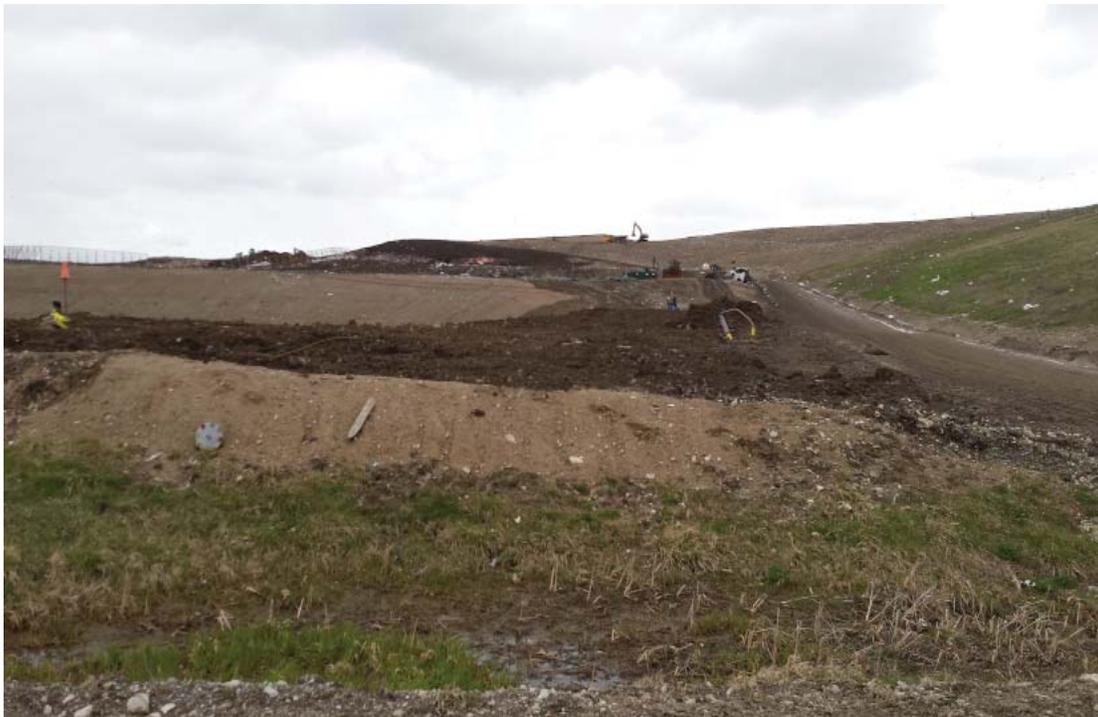
Active area viewed from the South, equipment area raised by soil to reduce ponding and better access

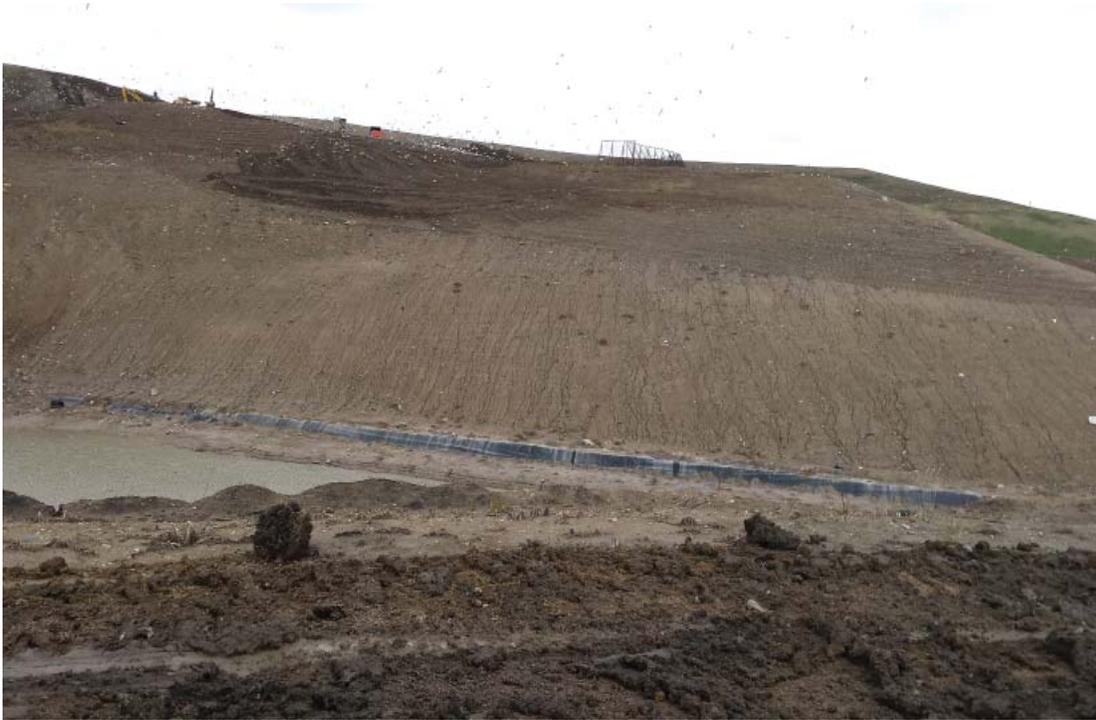
Swamp events since last audit, Basins high due to weather, Ditches clean erosion to be repaired when slopes dry

West slope of Phase 7, minor erosion over winter

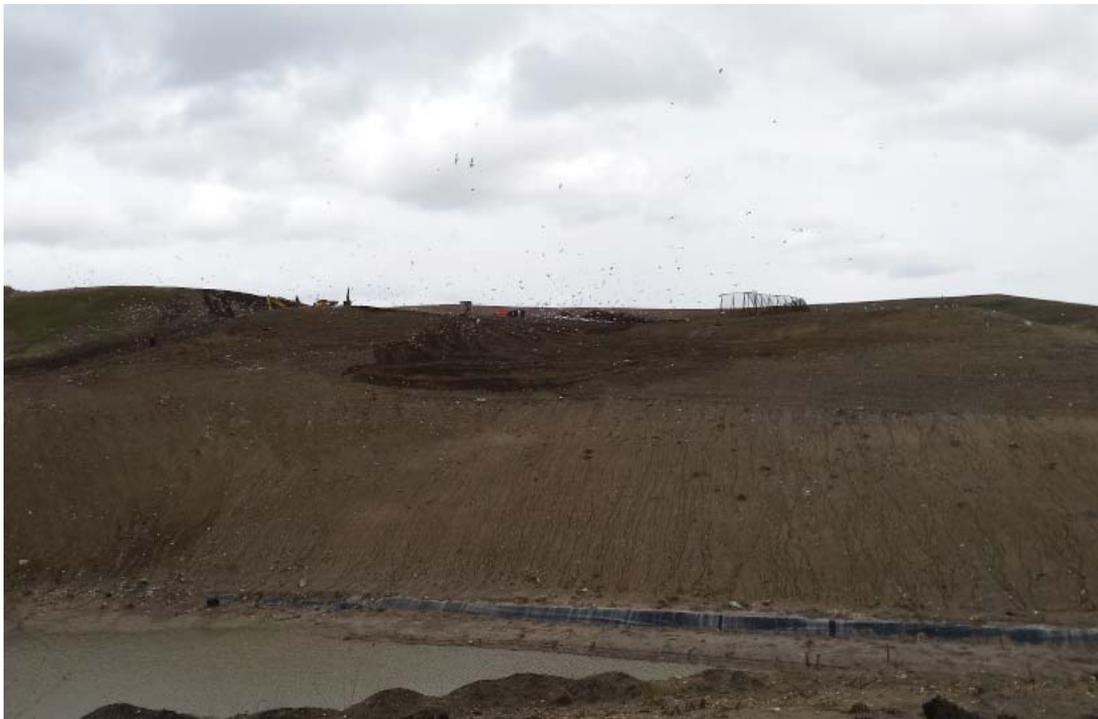
West slope of Phase 7

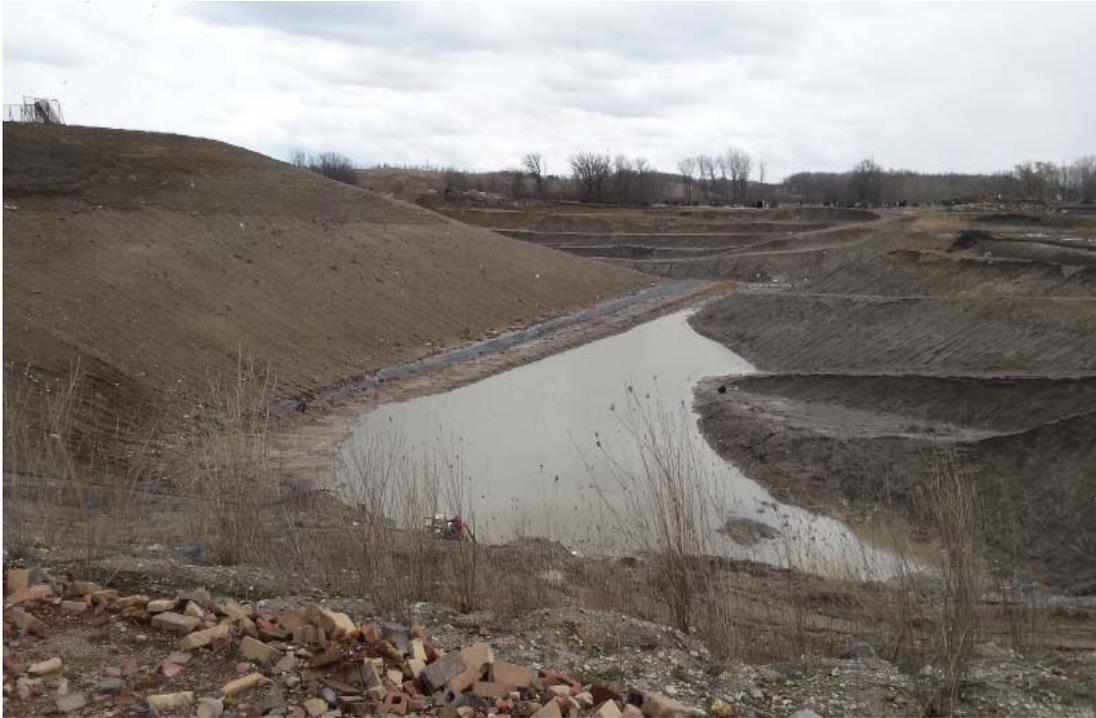
Temp sed basin

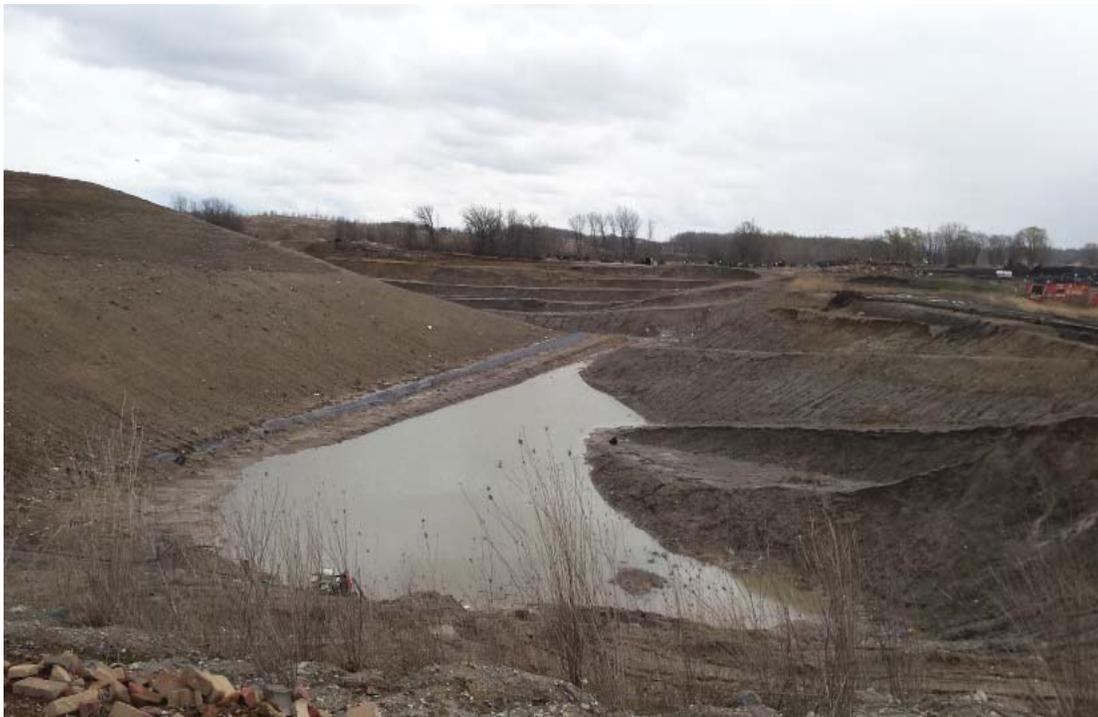
\* Temp sed basin being drained by electric 4" pump, hard wired for use. Six inch pump, gas powered, available at need.

Temp sed basin being drained by electrical 4" pump
