ADS Emerald Park Landfill Audit Summary

To: ADS Emerald Park Landfill Standing Committee, City of Muskego
FROM: Faith Spear.
COPIES: File
DATE: 06/15/16
PROJECT NUMBER: 1012.10030

Attached is the audit report for activities at the ADS Emerald Park Landfill for the week of April 17, 2016. The audit was performed at 1:40 PM on **April 21, 2016** by Jo Spear, Jr. in the presence of Brett Coogan, Operations Manager.

**ADVANCED DISPOSAL SERVICES
EMERALD PARK LANDFILL / CITY OF MUSKEGO
AUDIT PHOTOS**

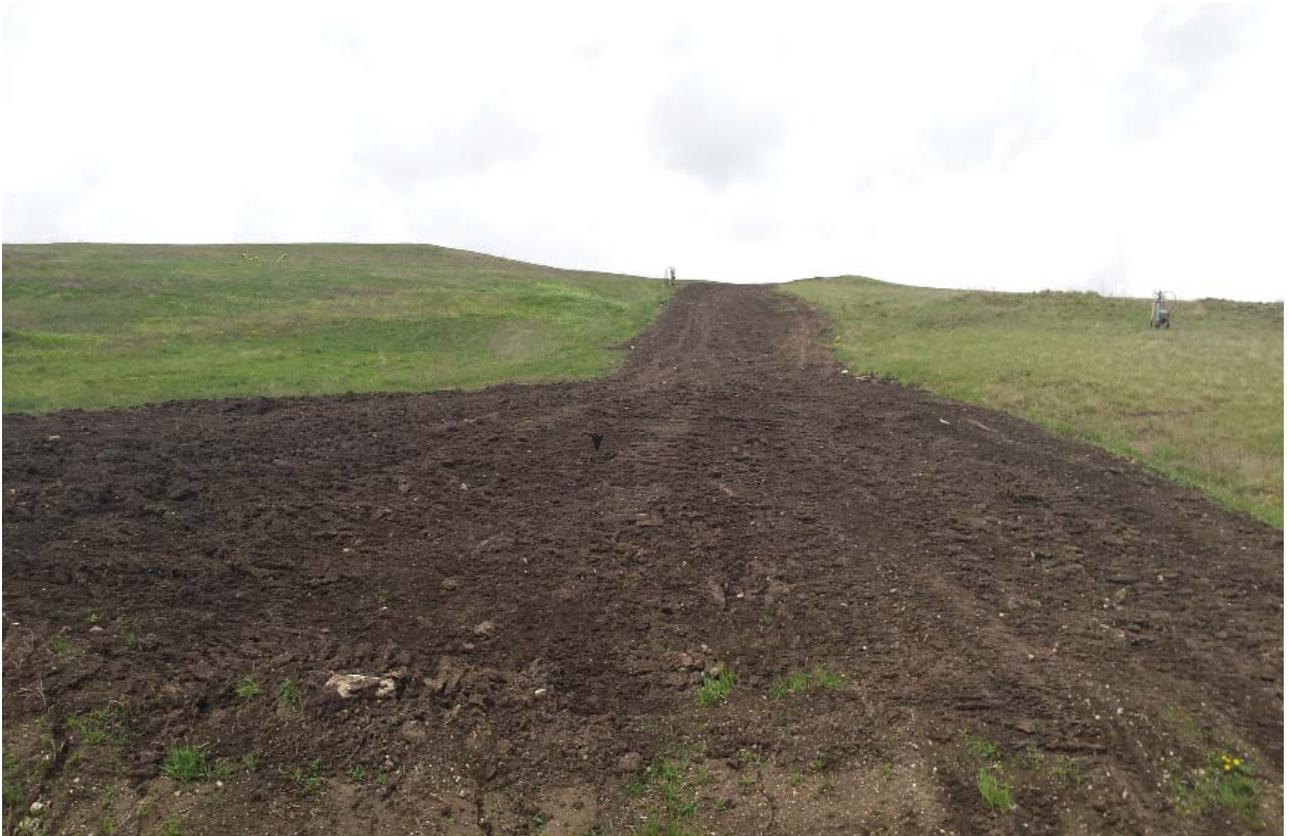
- Rills and erosion identified in previous audits have been repaired
 - Smoothed and patched with additional soils moved with dozers
 - Junction of Phases 5 & 6 and West slope of Phase 7 are considerable improved

Large ril on South slope of Phase 5/6 junction repaired with soil. Downslope flume placement expected this spring/summer

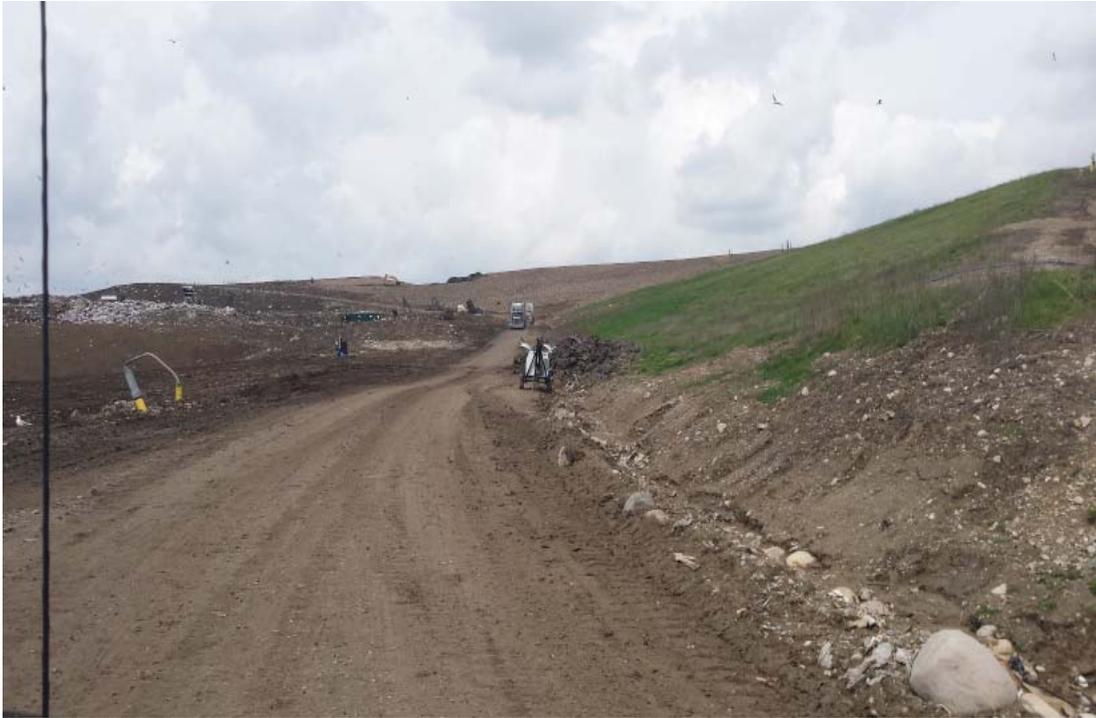
Access to active area

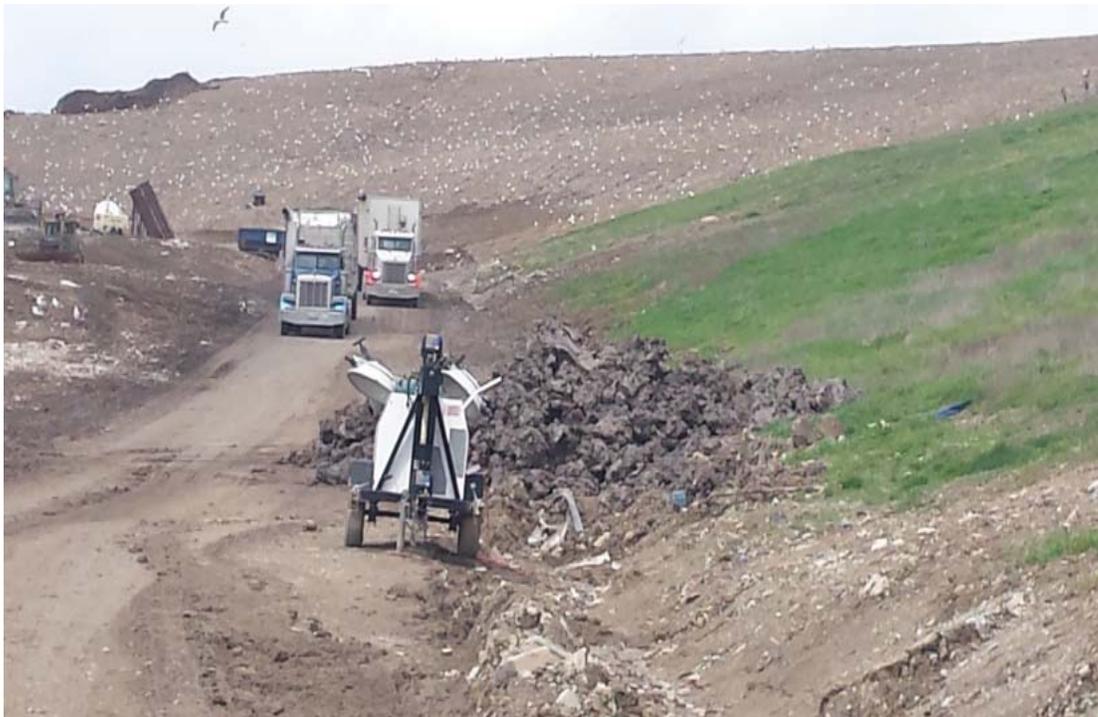
- Ditch lines on Phase 6 West slope have been cut down to waste depth and relined with clay
 - Clay liners will be shaped for better drainage

Ditch cleaning along West slope of Phase 6

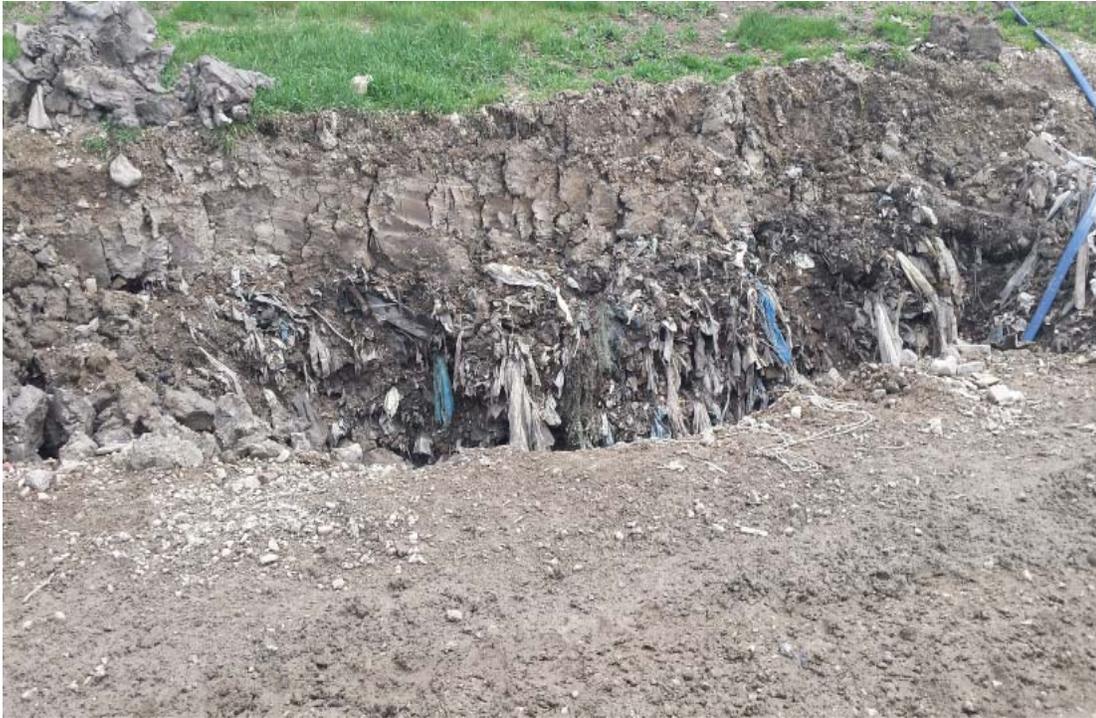
Excavation of drainage ditches, backfill with clay and compacted to create flow path

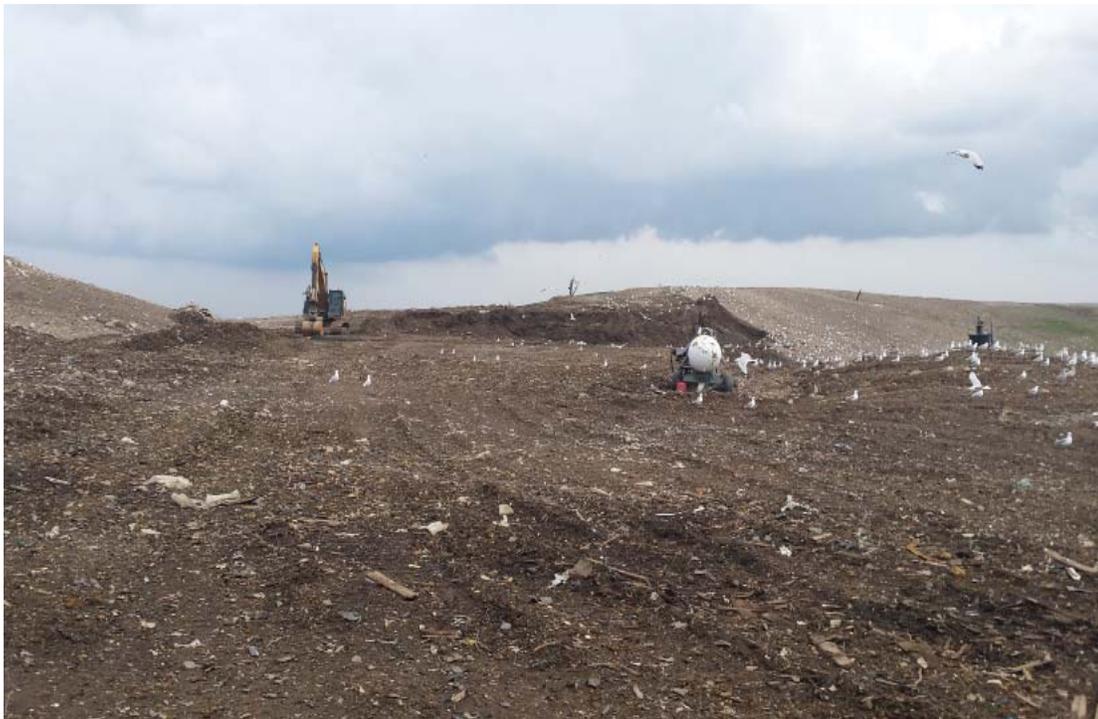
Soil on top of Phase 5/6 being excavated for cover

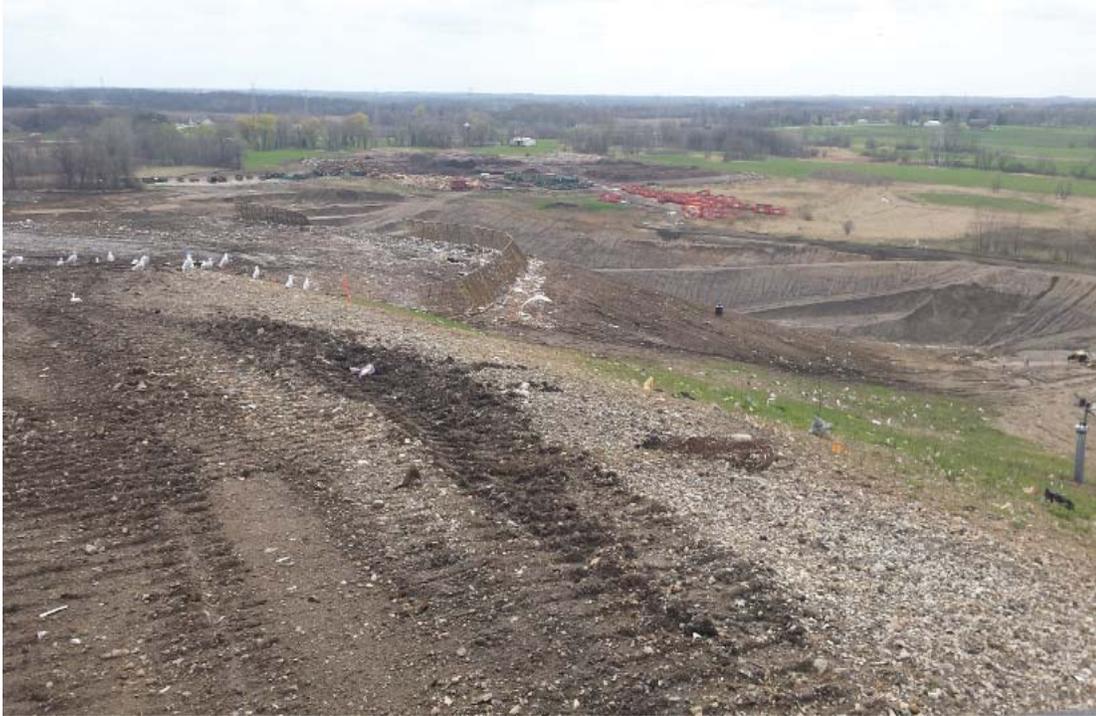
Overview of the West slopes of landfill

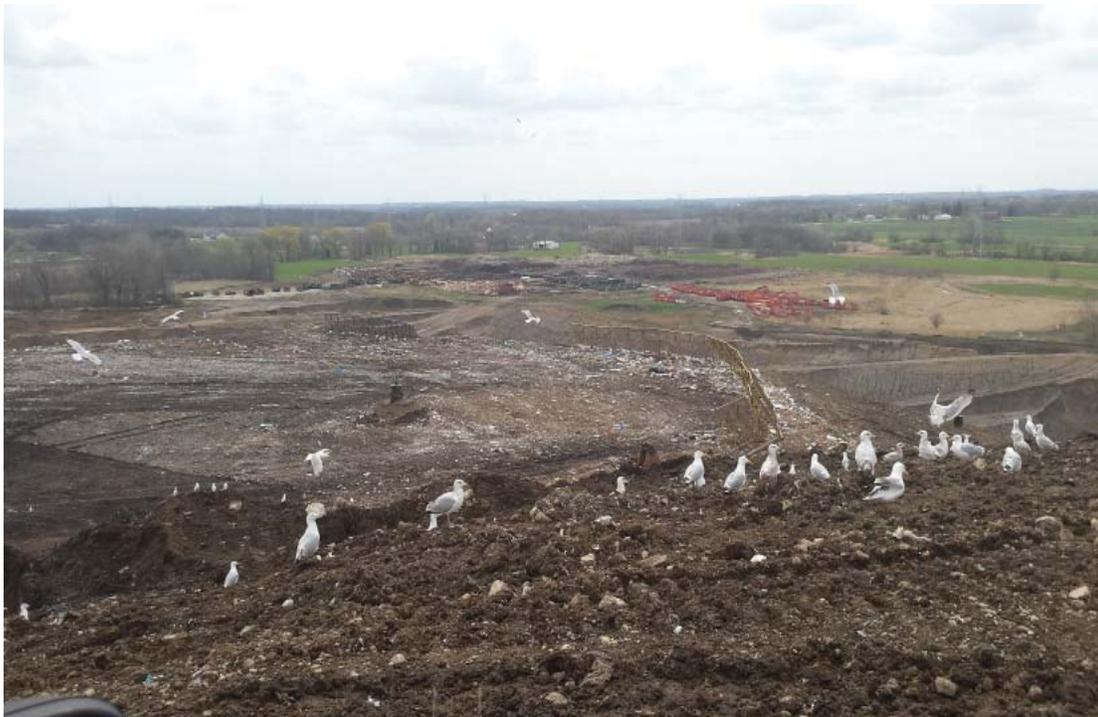
West edge of Phase 7

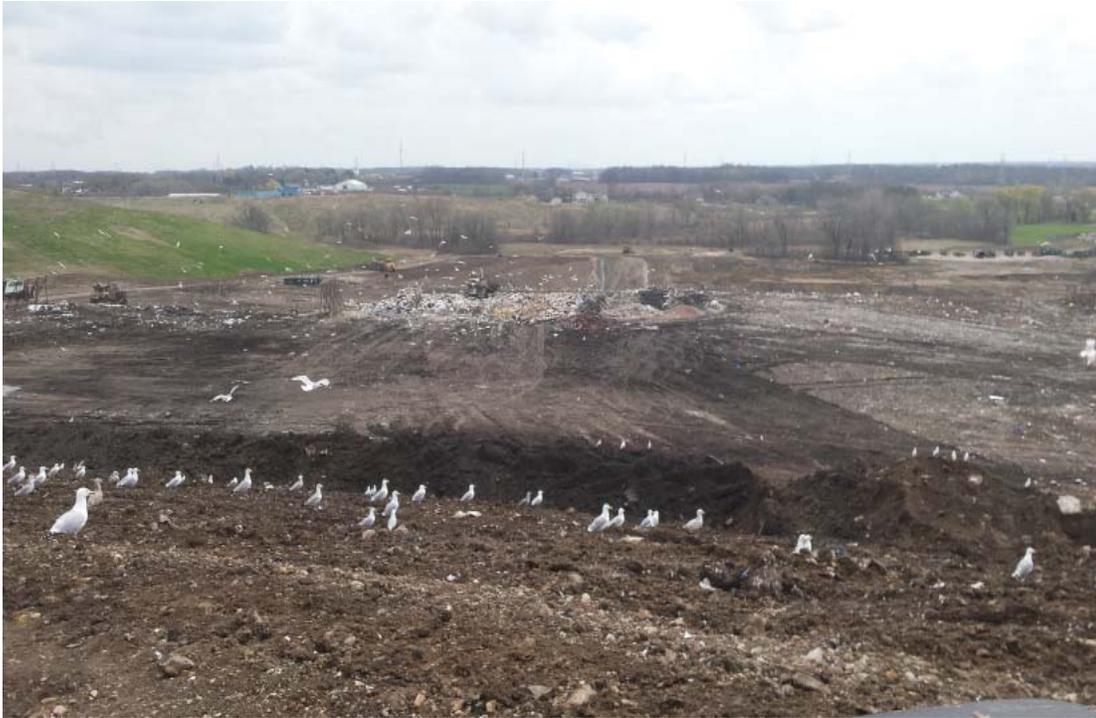
Working face in middle of South edge of Phase 7

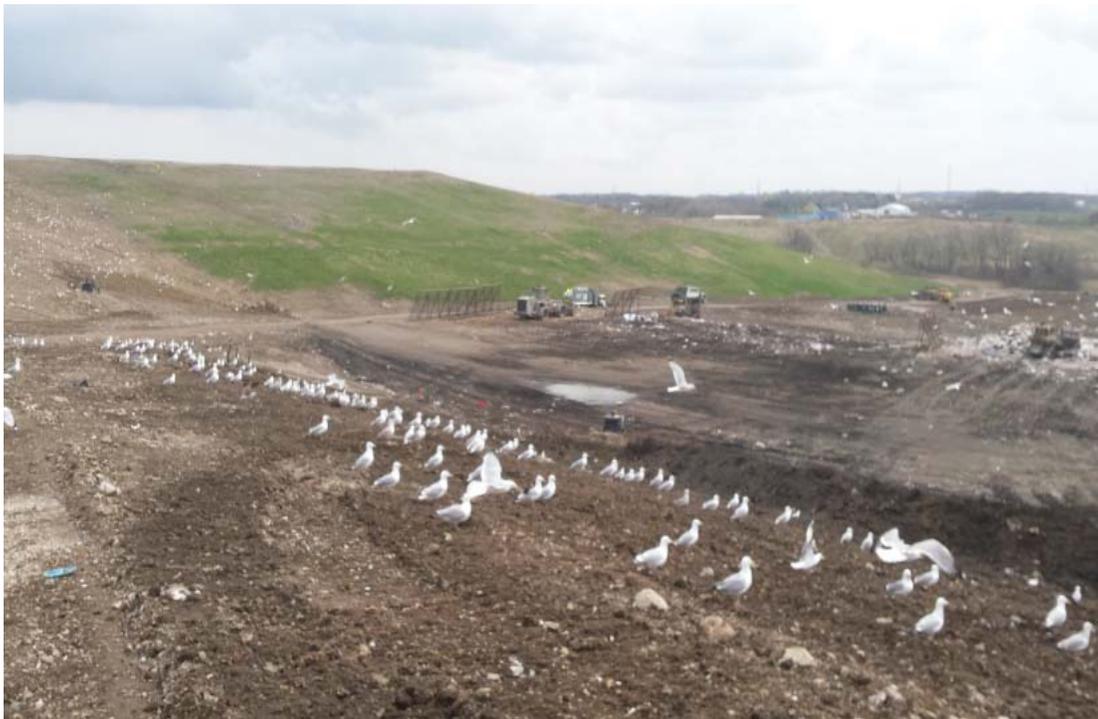
East edge of Phase 7

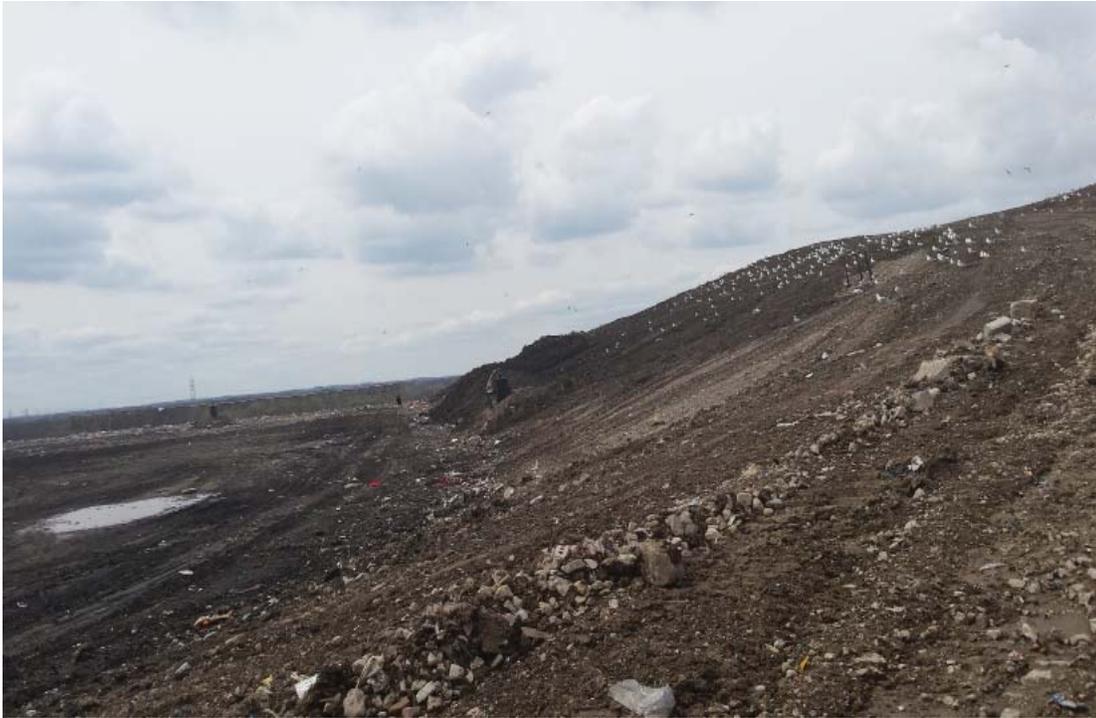
South slope of Phase 3 being excavated for cover soils

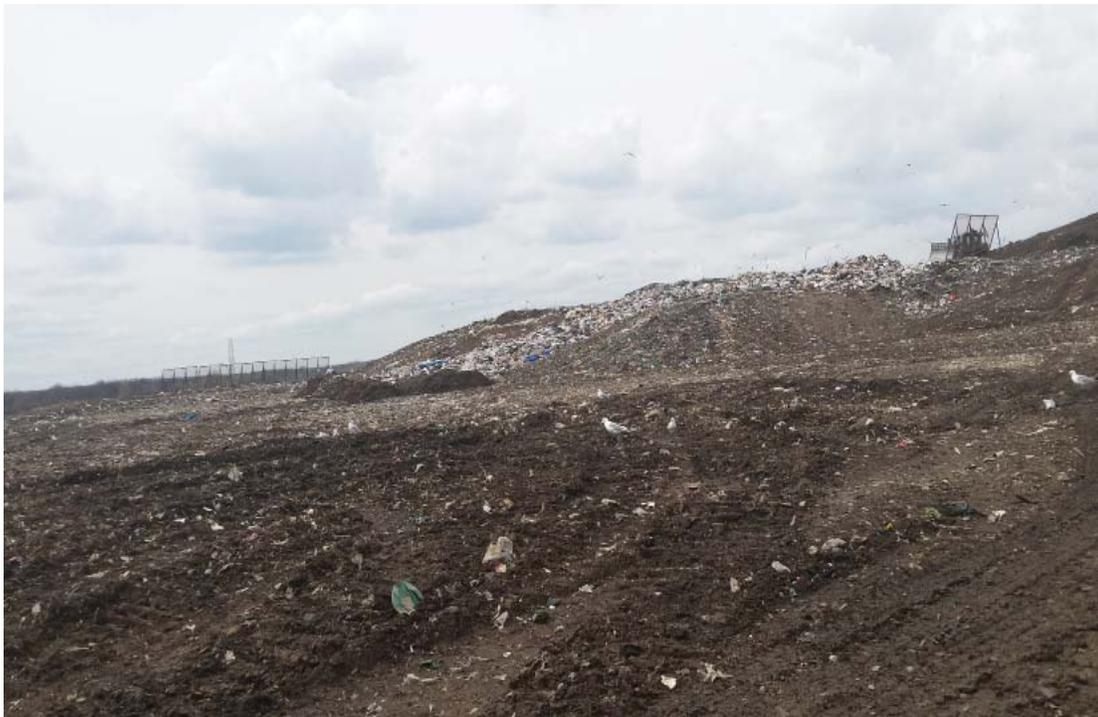
Southeast of active area, stock pile of wood waste for development of travel-way over active area

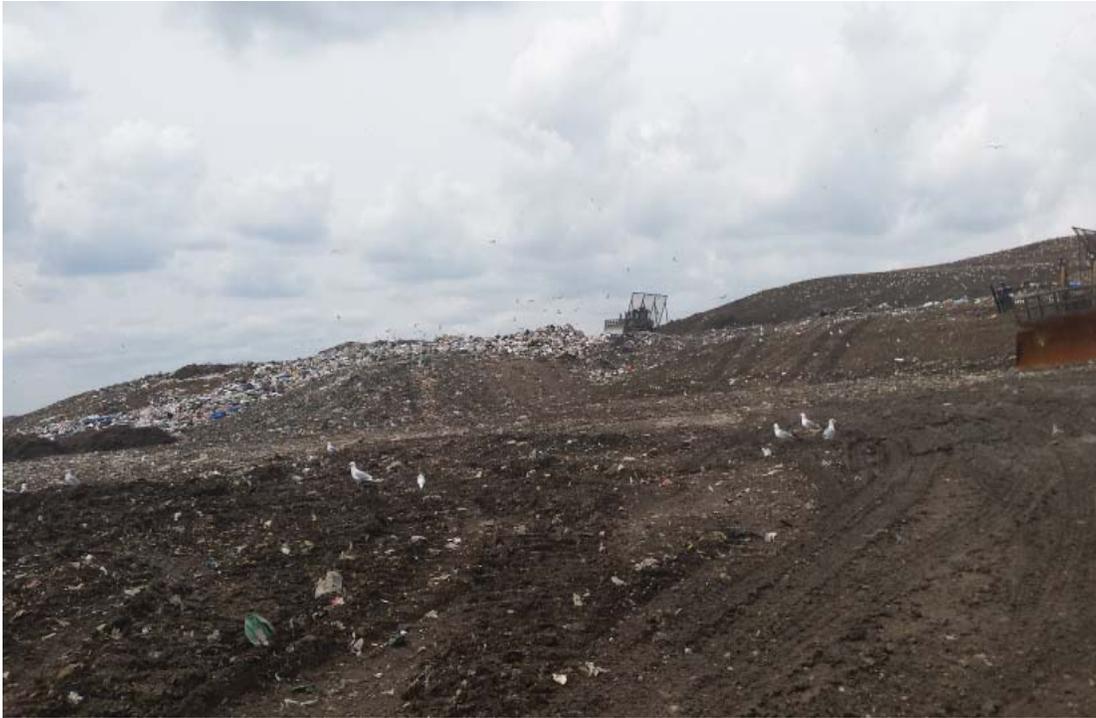
Active area viewed from Southeast

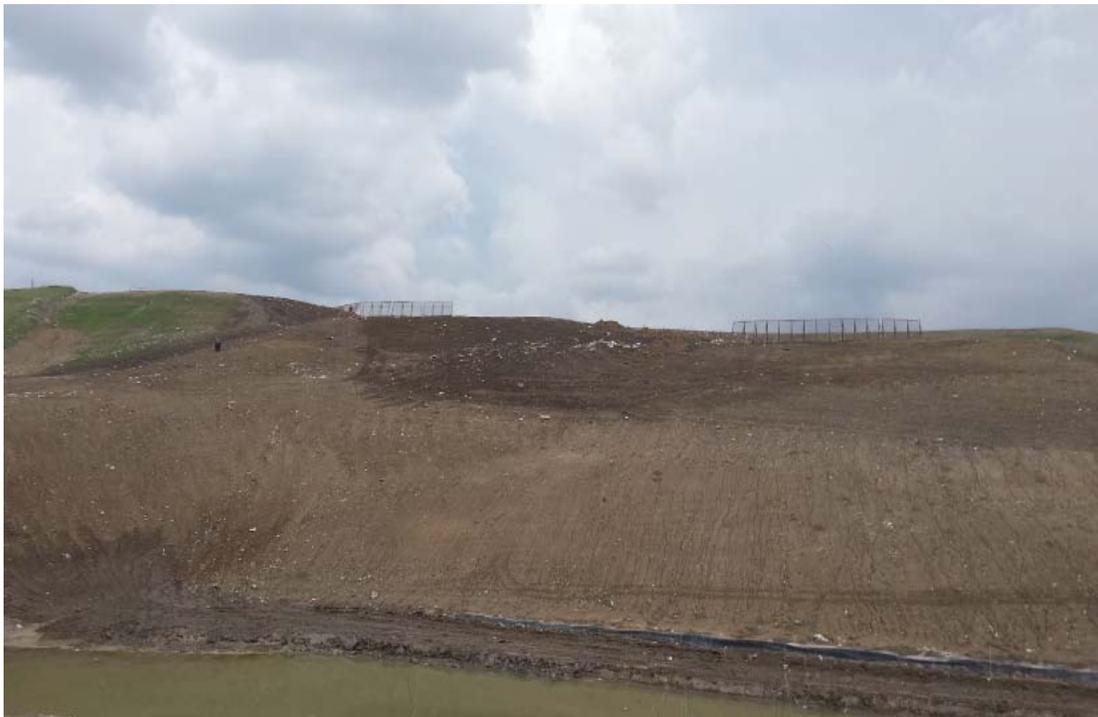
West slope of Phase 7, new intermediate cover placement

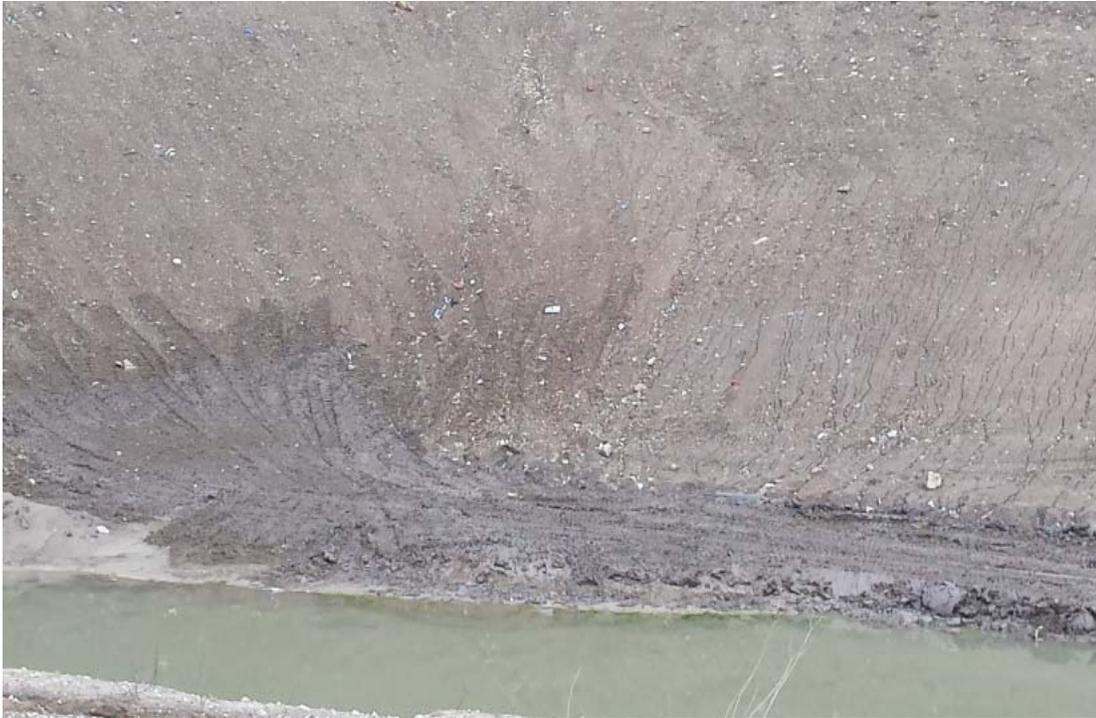
* Rills and erosion previously identified in audits repaired by dozers and additional soils. Especially, the junction of ~~Phase 6 & 7~~ 5 & 6 and West slope of Phase 7

Rils repaired on West slope of Phase 7, previous ril quite deep and wide

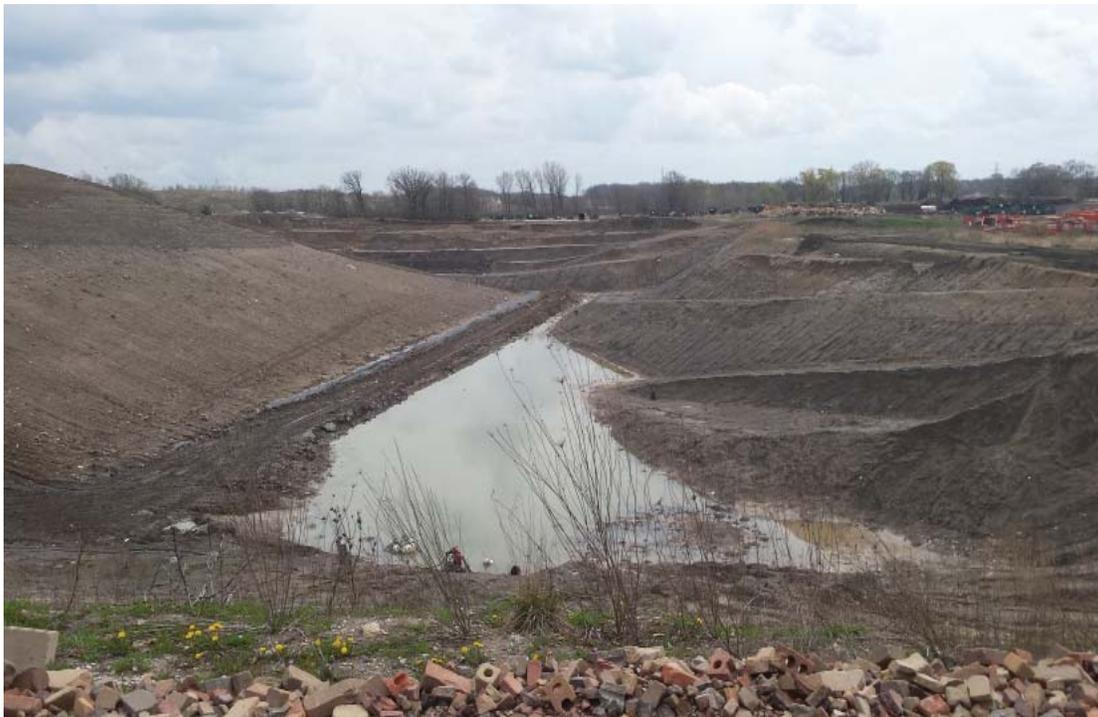
- Temporary sediment basin has been pumped into Basin #1

Temp sed basin pumped down into Basin #1
