ADS Emerald Park Landfill Audit Summary

To: ADS Emerald Park Landfill Standing Committee, City of Muskego
FROM: Faith Spear.
COPIES: File
DATE: 06/15/16
PROJECT NUMBER: 1012.10030

Attached is the audit report for activities at the ADS Emerald Park Landfill for the week of April 24, 2016. The audit was performed at 12:20 PM on **April 26, 2016** by Jo Spear, Jr. in the presence of Scot Croft, Landfill Technician.

**ADVANCED DISPOSAL SERVICES
EMERALD PARK LANDFILL / CITY OF MUSKEGO
AUDIT PHOTOS**

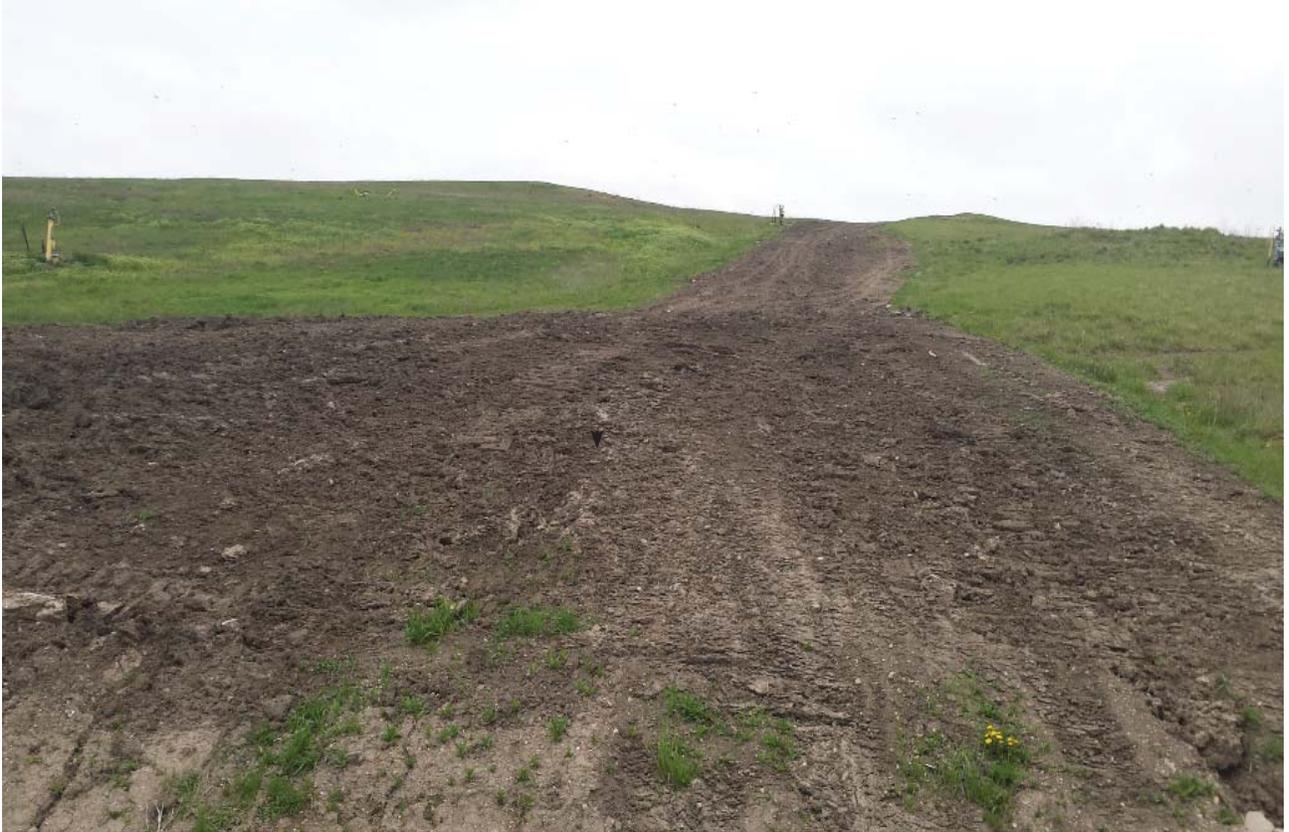
Basins draining RIL repairs showing some growth where seeded

Repaired Ril at South slope of Phase 5 and 6 junction

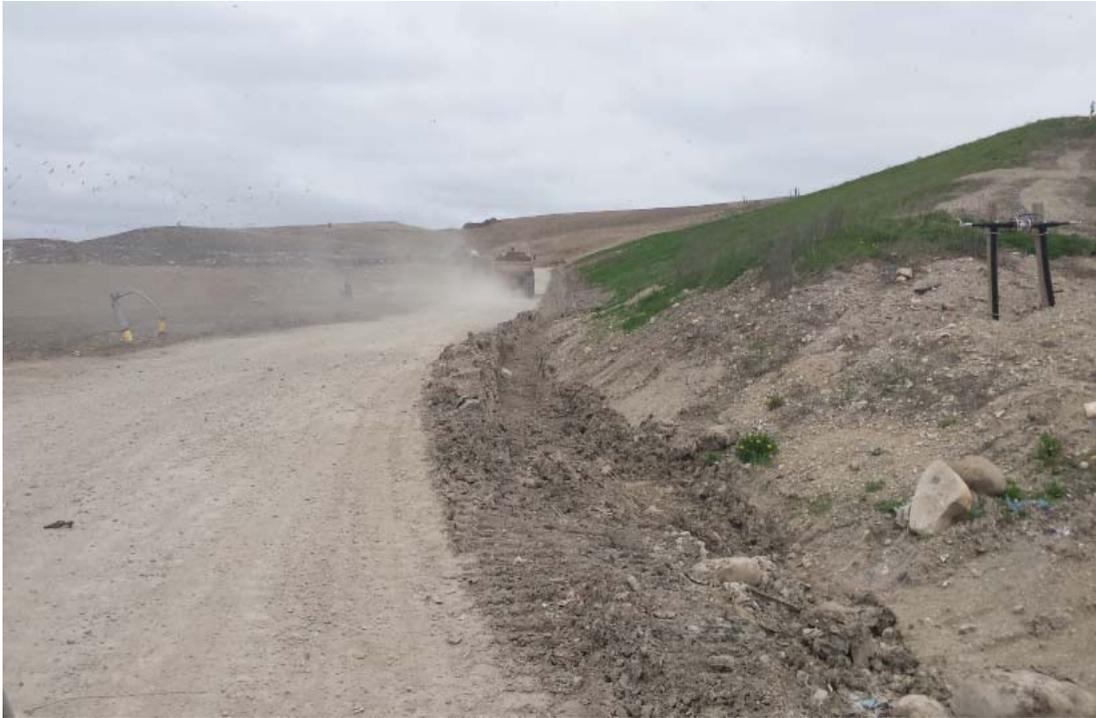
* Ditch line completed along East edge of Access Road through Phase 6/7

Access road to active area, ditch refilling and grading completed

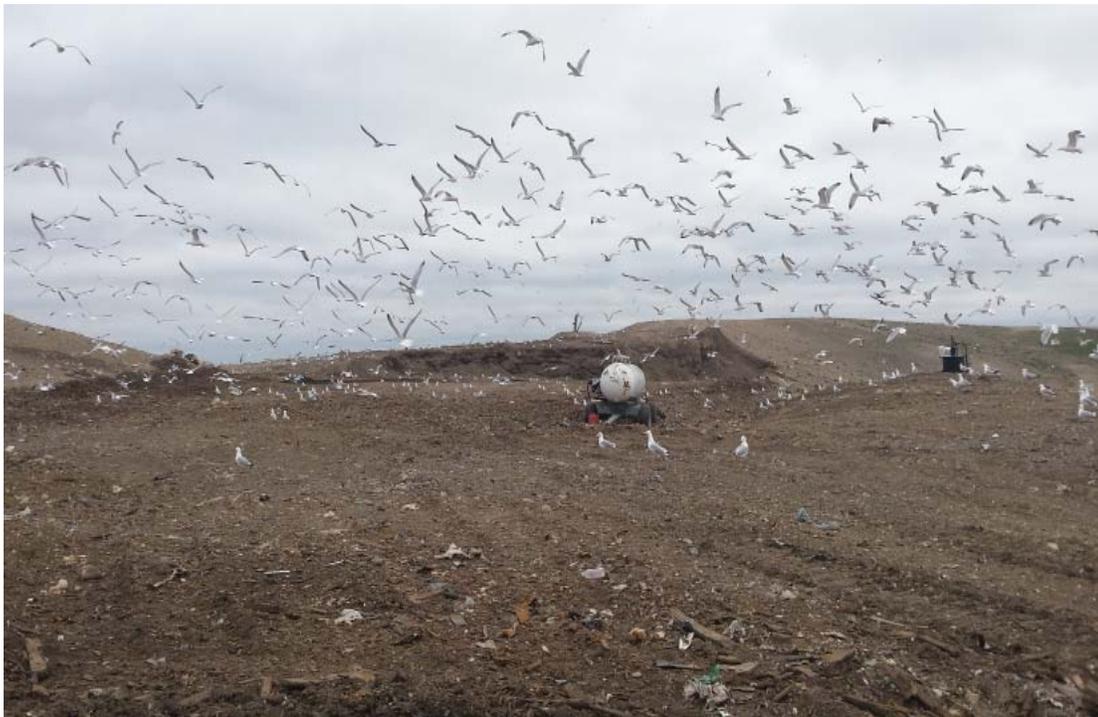
Top of Phases 3,4,5, and 6; soil being excavated for daily cover

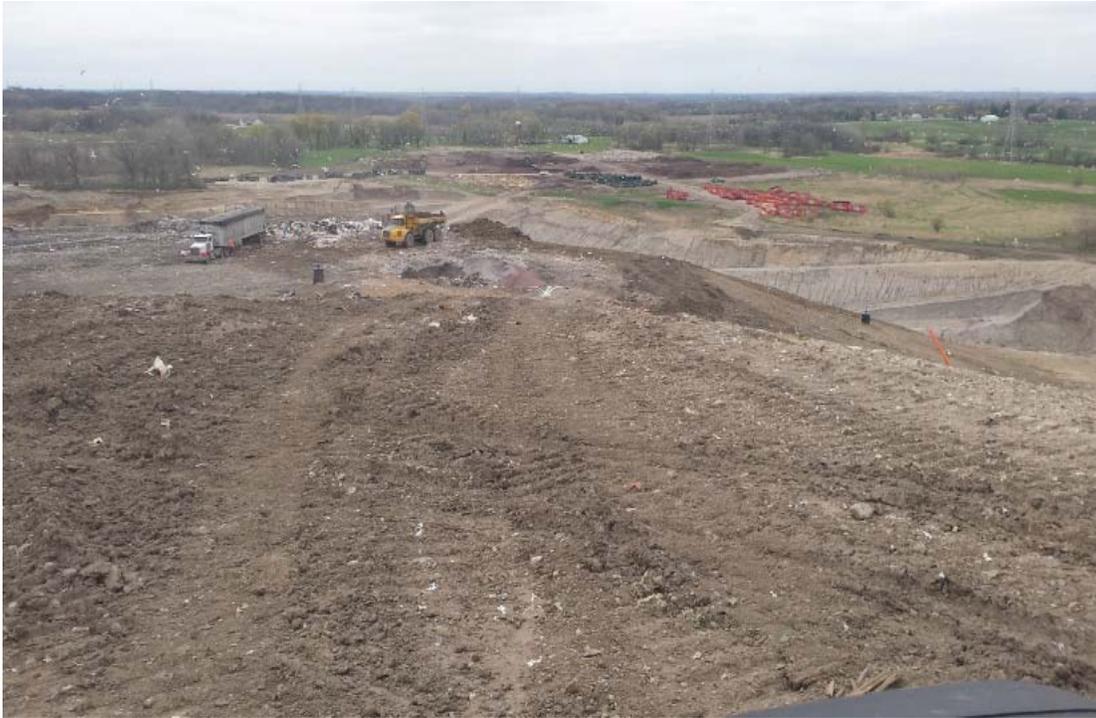
Working face in Southwest corner of Phase 7

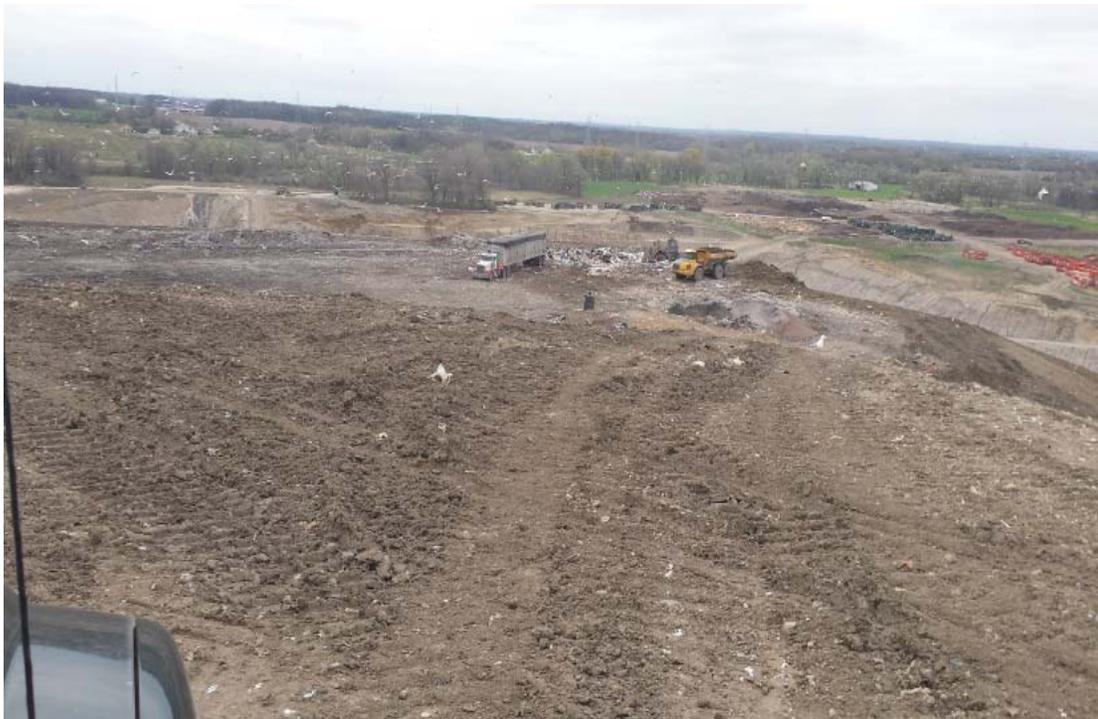
Working face in Southwest corner of Phase 7

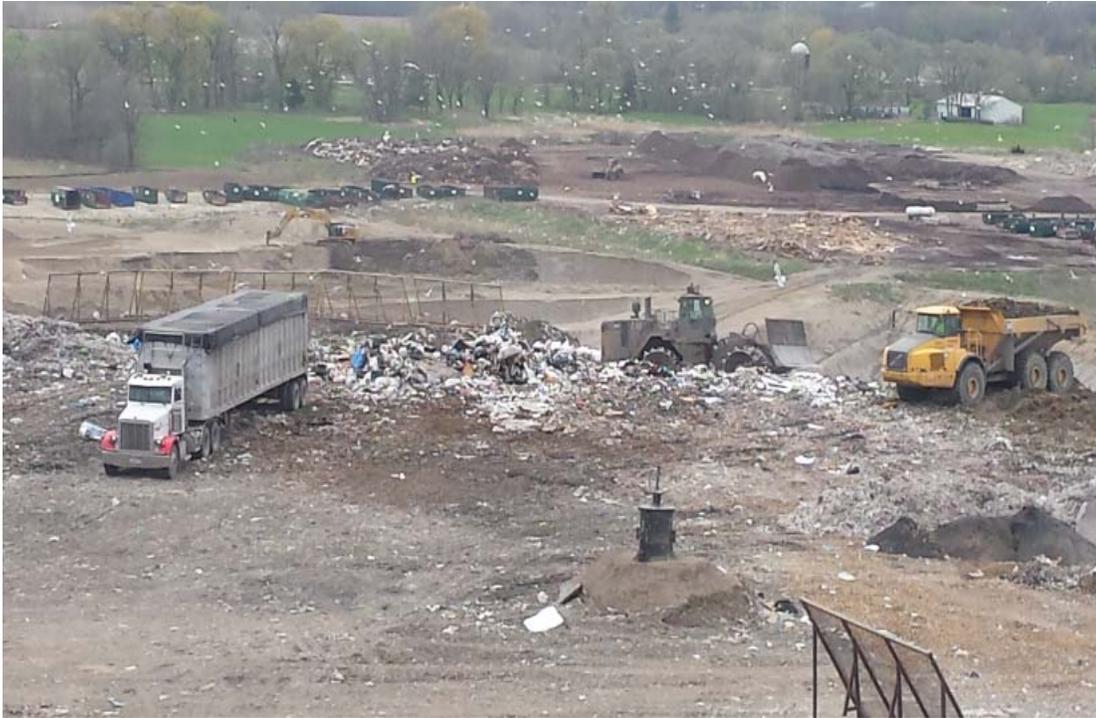
Working face

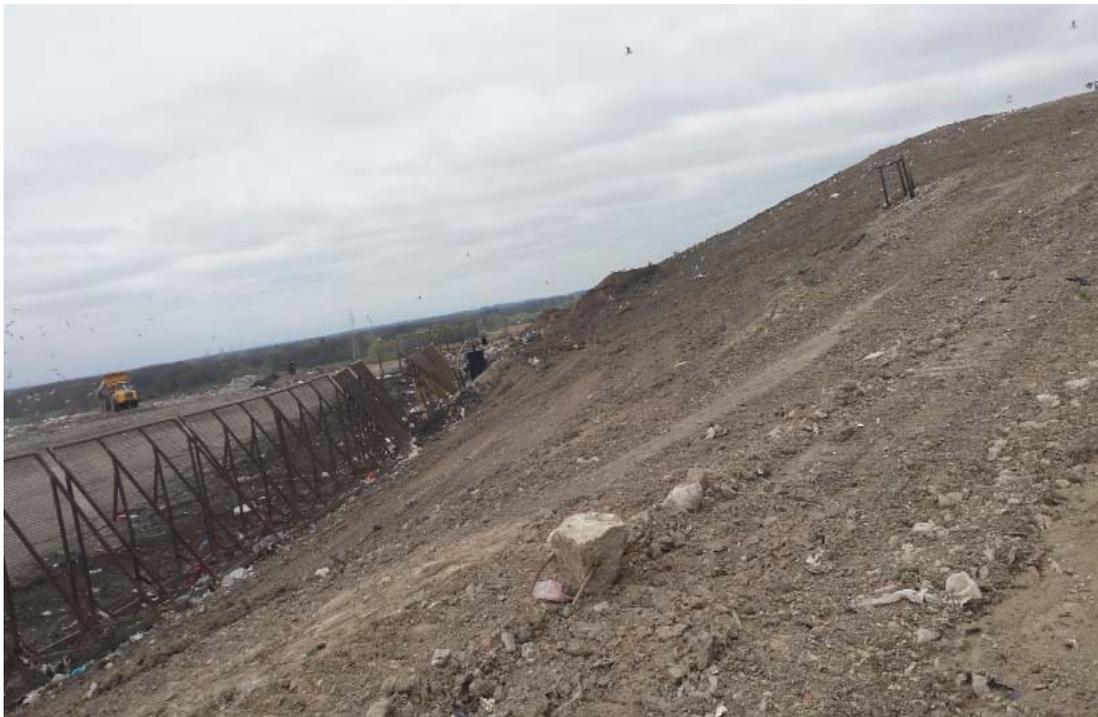
South slope of Phase 3, being reshaped as soil is used for cover

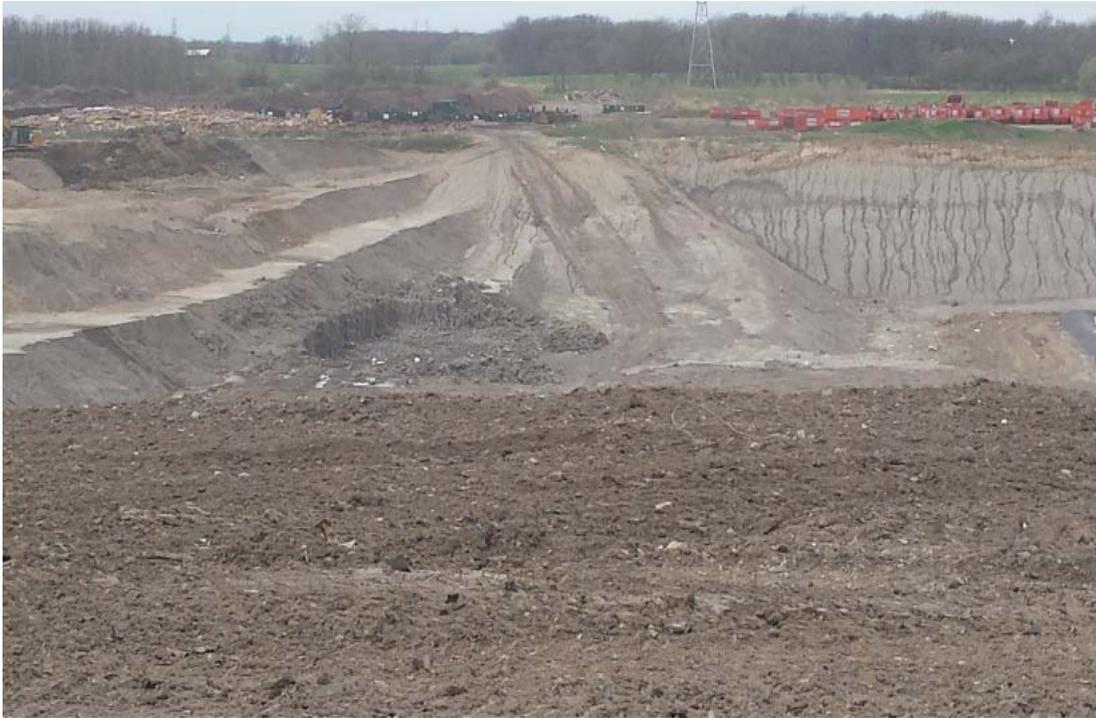
Future Phase 8 excavation for intermediate cover placement

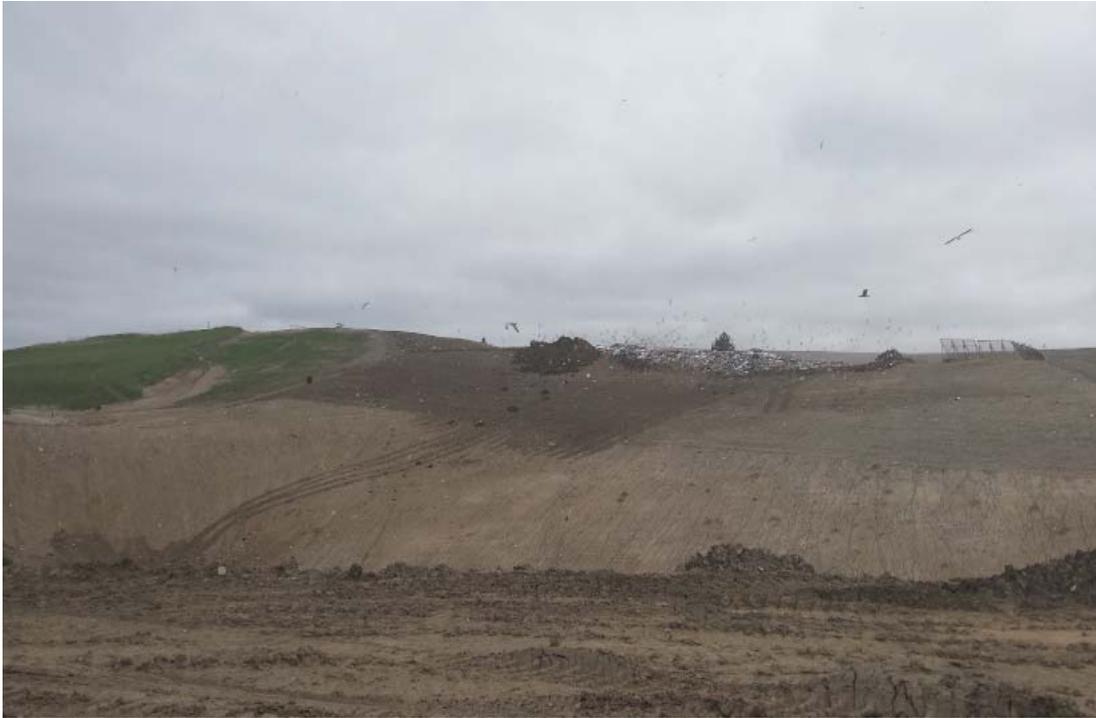
* Outboard slope soil placement, intermediate cover, on West slope of Phase 7/7B clays from site

West slope of Phase 7, additional cover soils placed

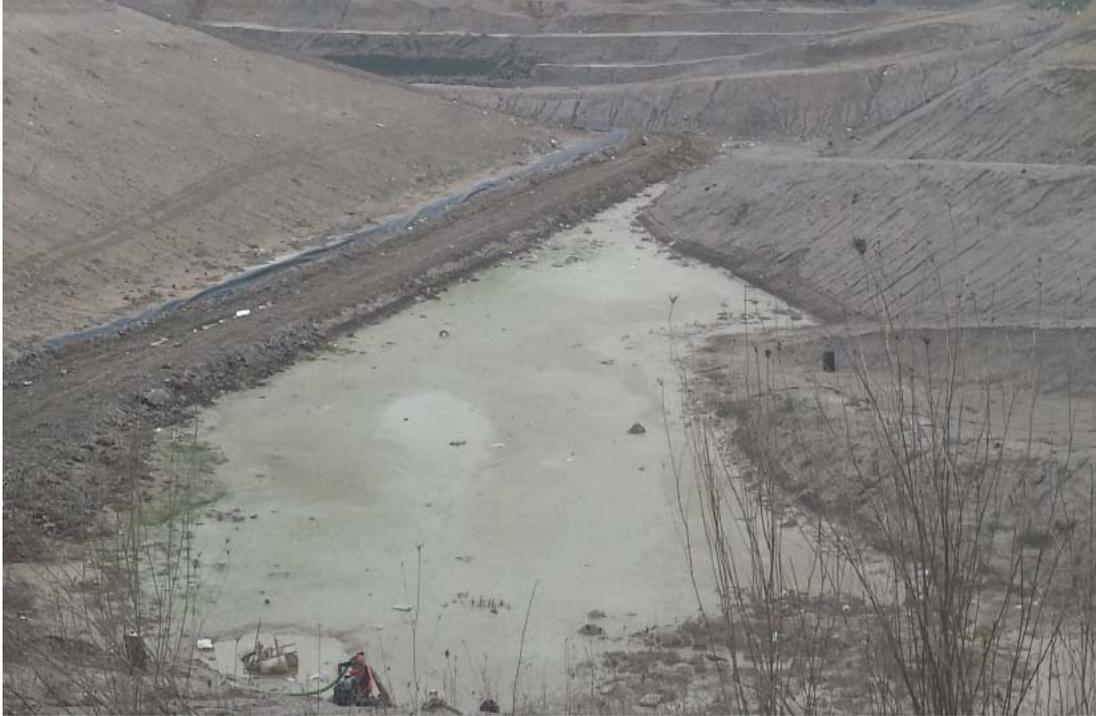
Temp sed basin, nearly drained

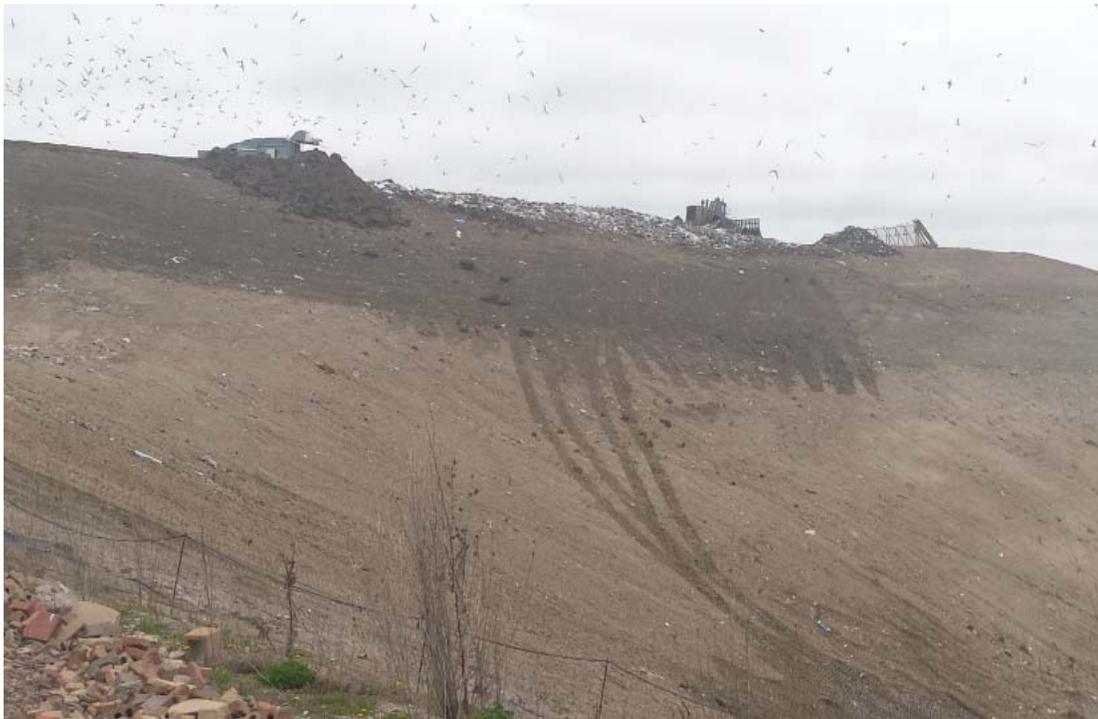
Additional soils placed on West slope of Phase 7/7B
