ADS Emerald Park Landfill Audit Summary

To: ADS Emerald Park Landfill Standing Committee, City of Muskego
FROM: Faith Spear.
COPIES: File
DATE: 06/23/16
PROJECT NUMBER: 1012.10030

Attached is the audit report for activities at the ADS Emerald Park Landfill for the week of May 1, 2016. The audit was performed at 11:05 AM on **May 6, 2016** by Jo Spear, Jr. in the presence of Brett Coogan, Operations Manager.

**ADVANCED DISPOSAL SERVICES
EMERALD PARK LANDFILL / CITY OF MUSKEGO
AUDIT PHOTOS**

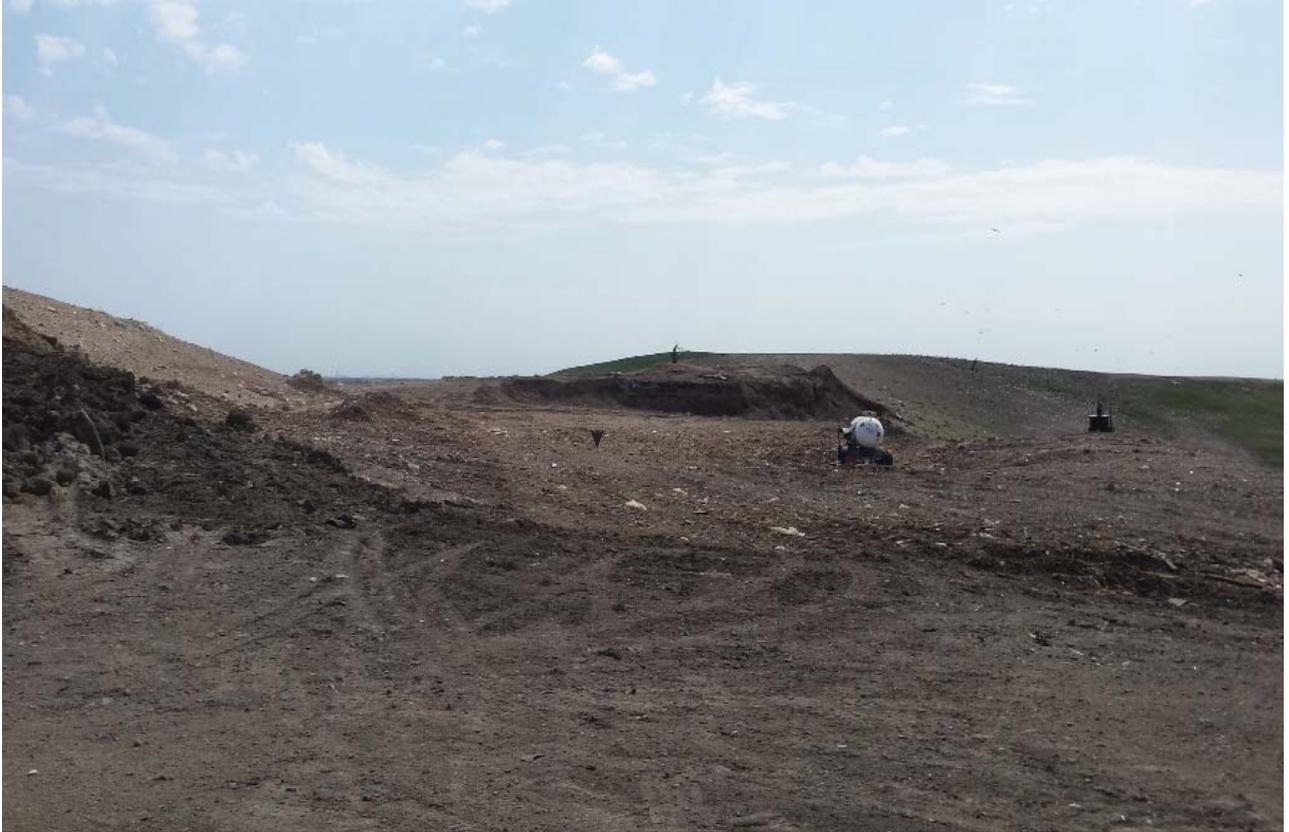
Top of Phases 3, 4, and 5. Soil being used to bring phases up to final grades.

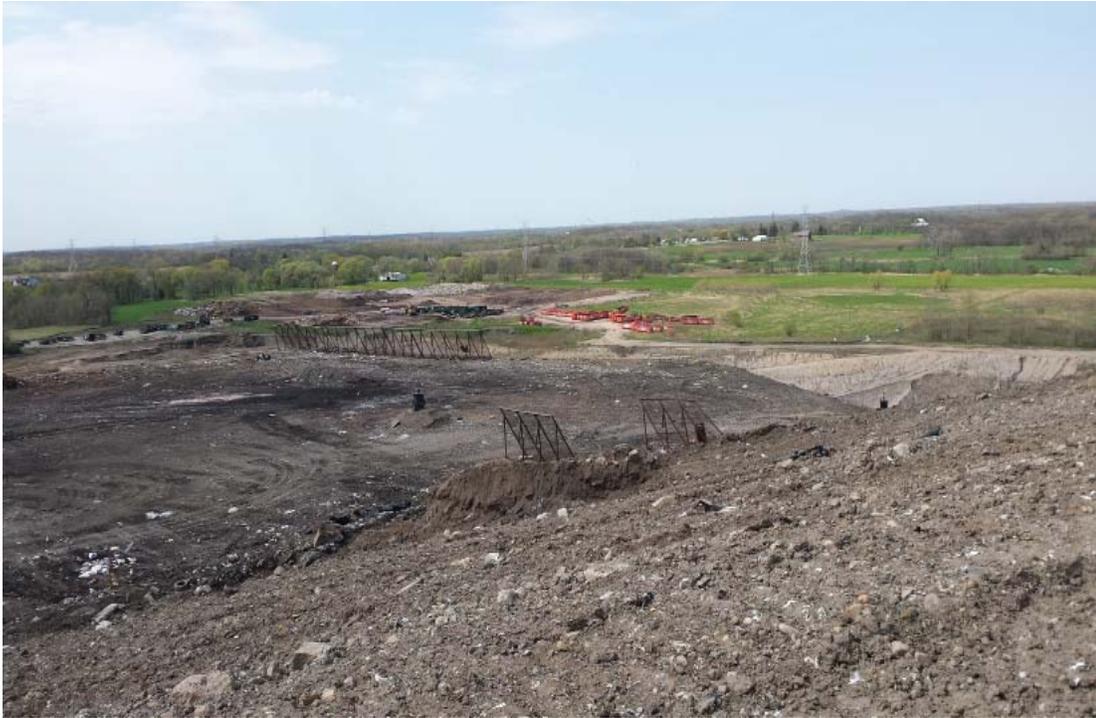
Western half of Active area

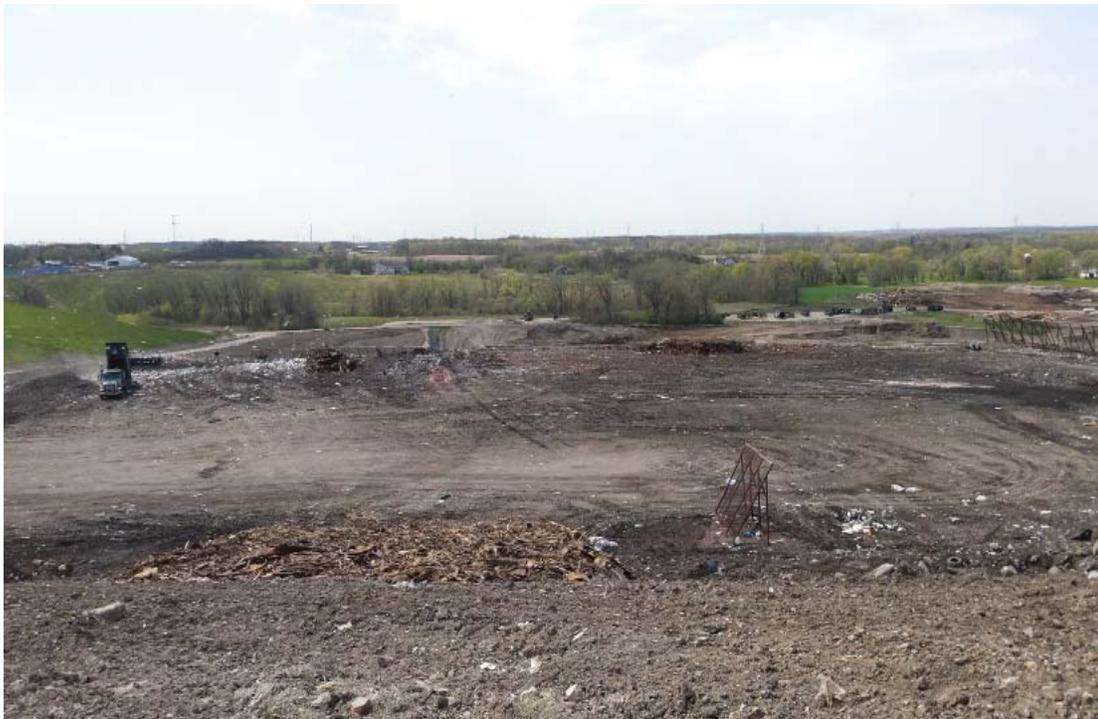
Active area

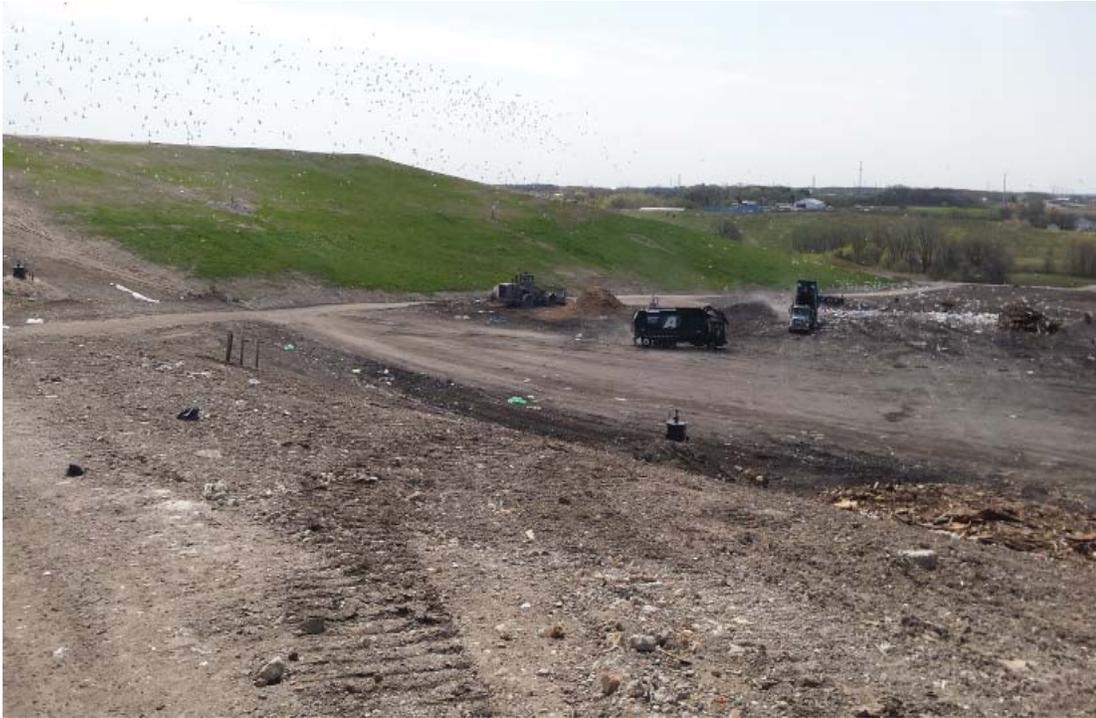
Active area and access

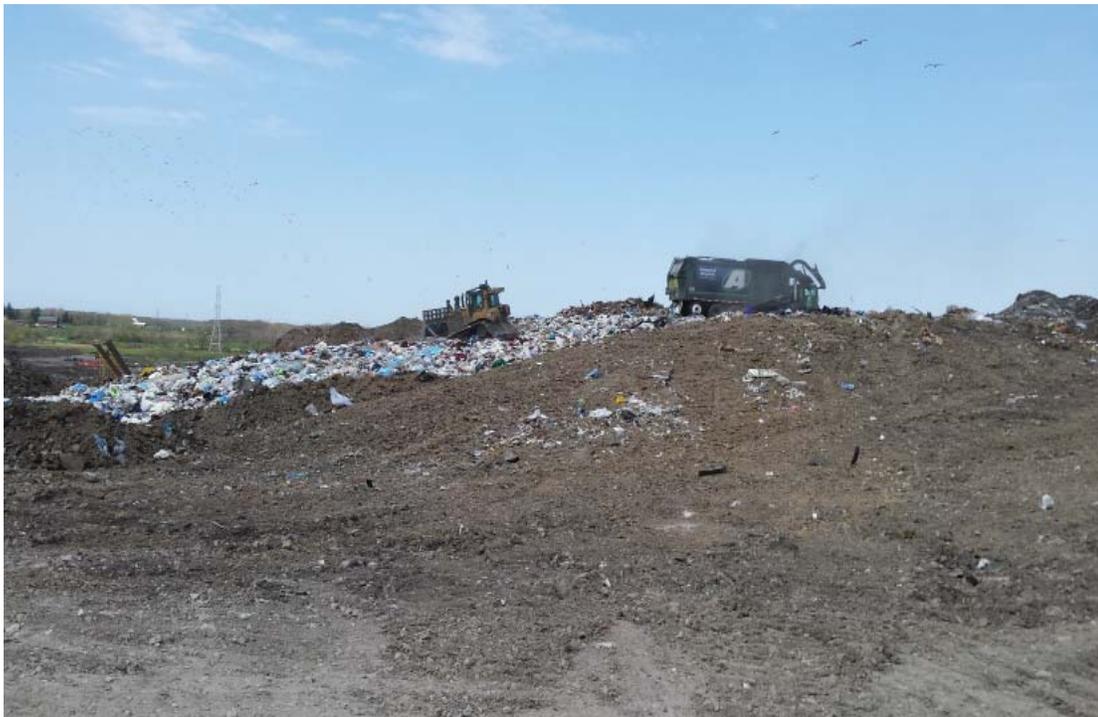
Working face on South slope of Phase 7B

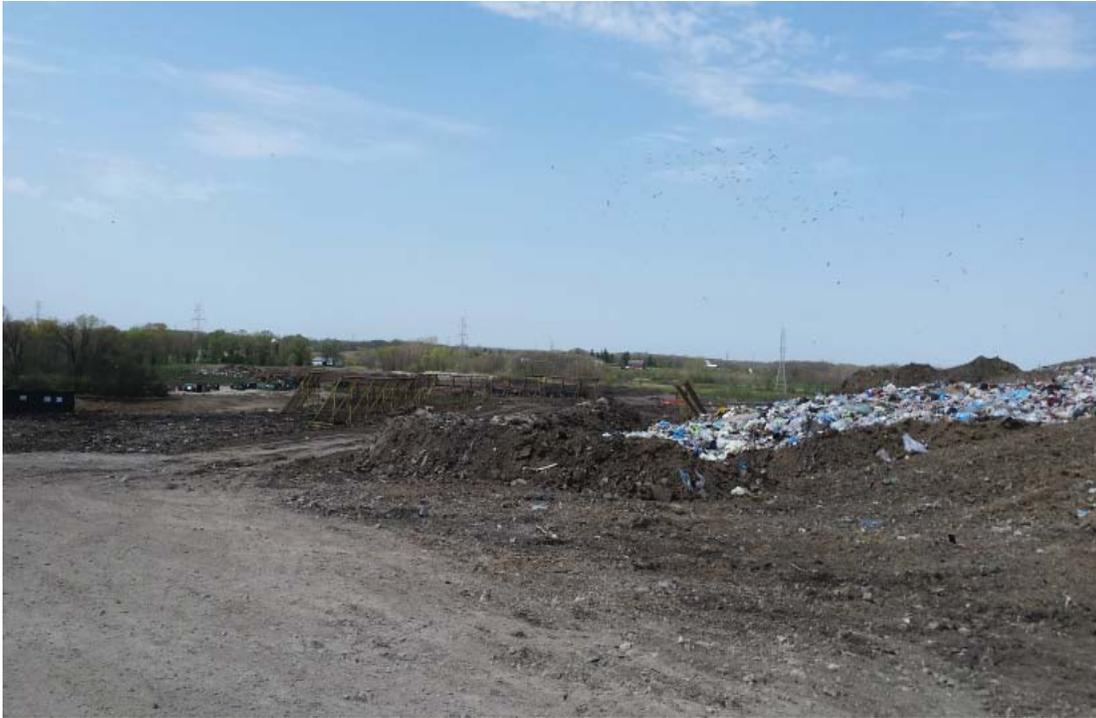
Working face

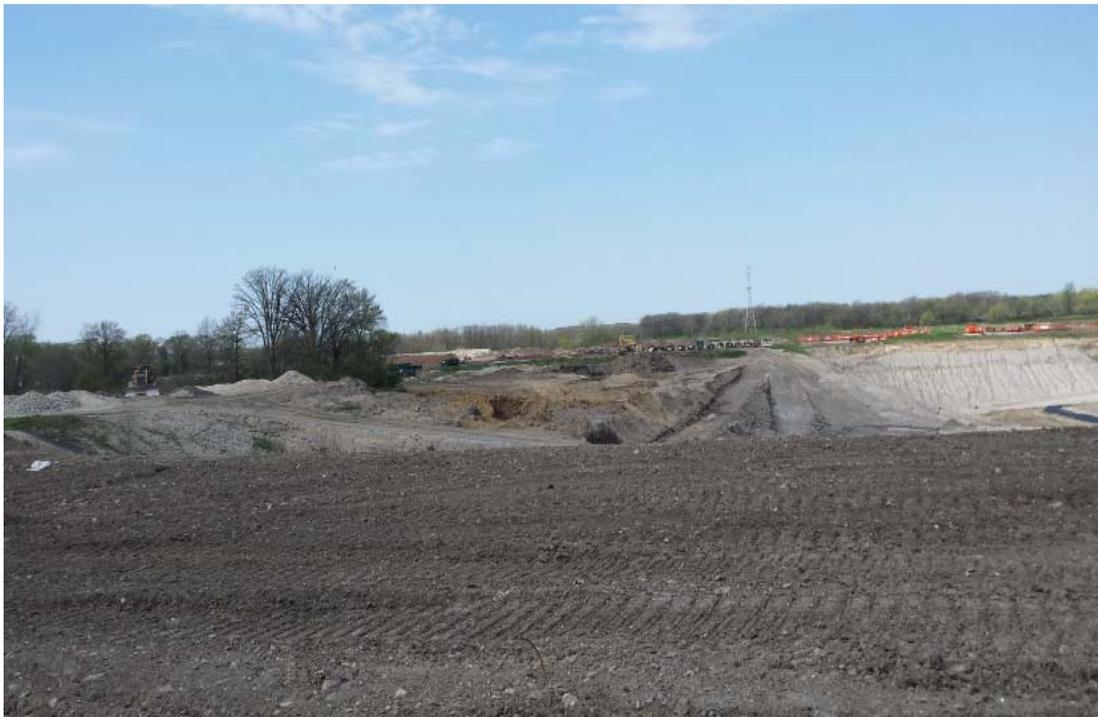
Excavation of future Phase 8

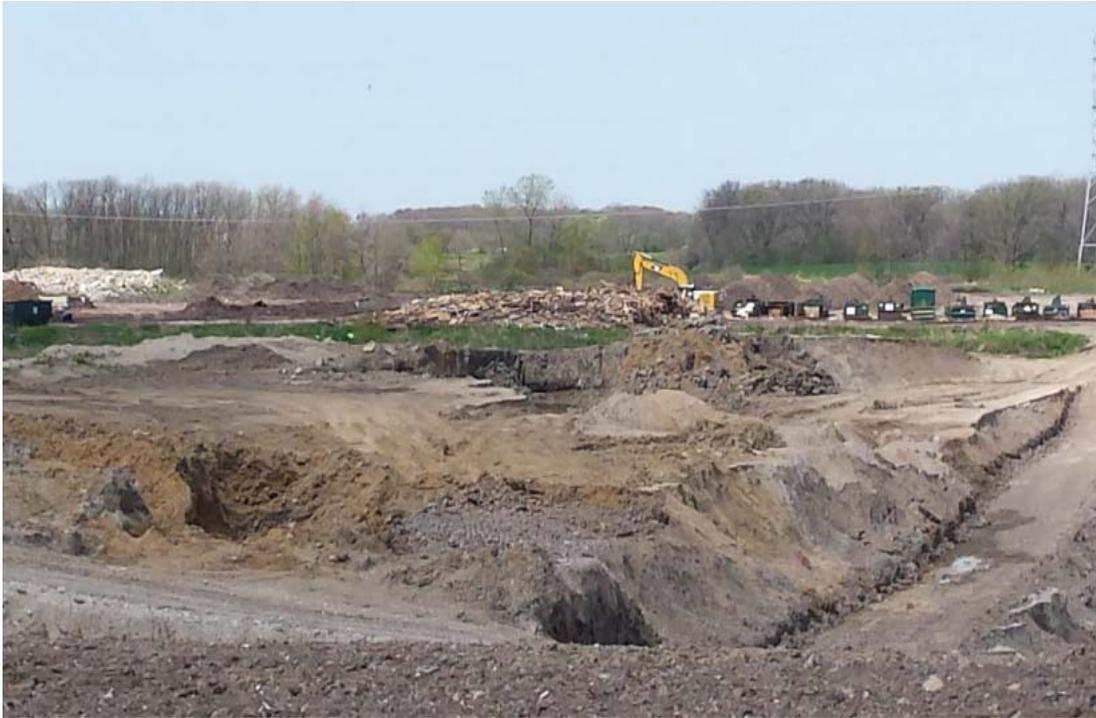
Future Phase 8 excavation for intermediate cover placement

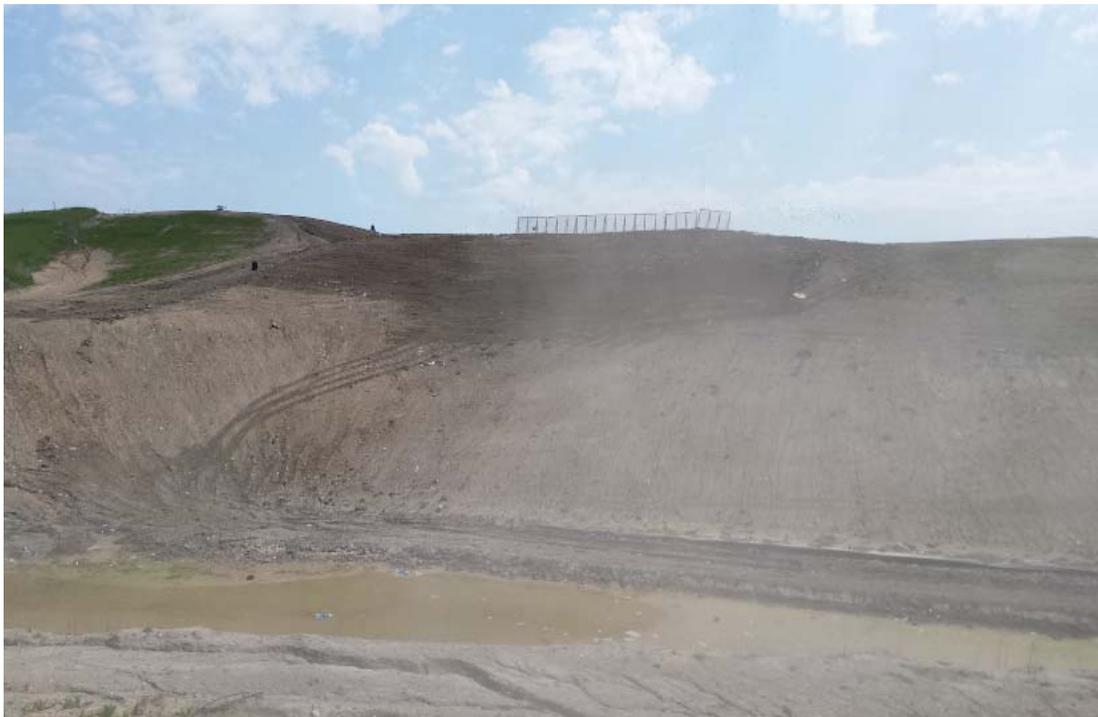
Phase 7, West edge over temp sed basin. Some rills, but in good shape

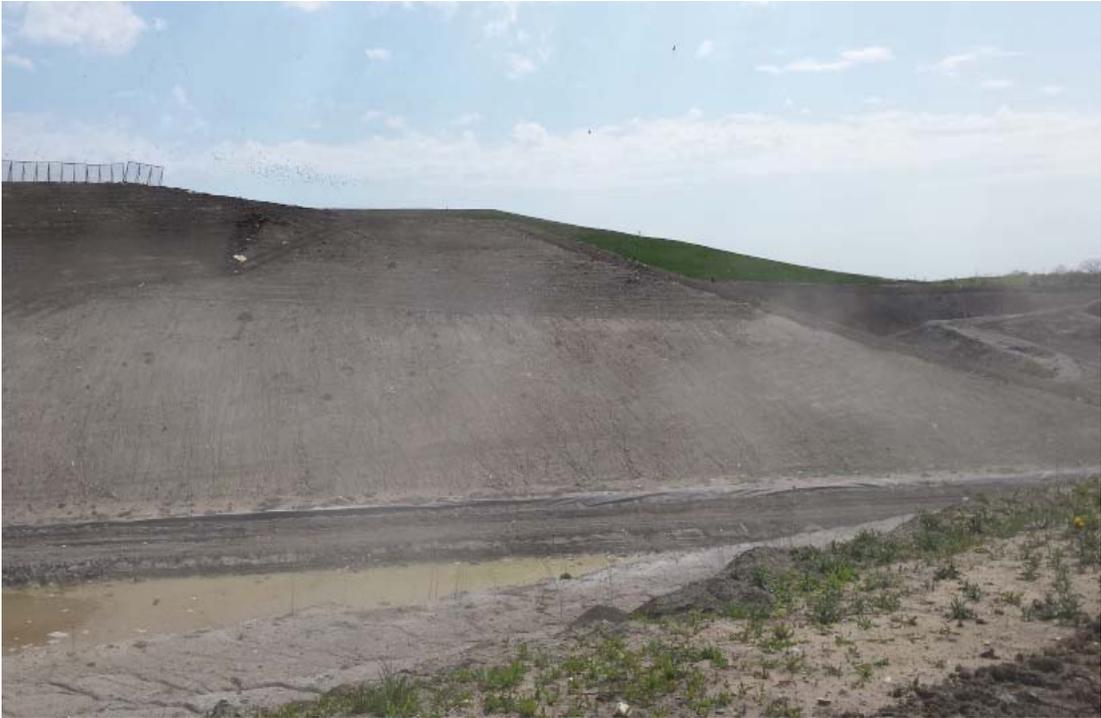
West Slope of Phase 7, cover conditions show rills, but in good shape

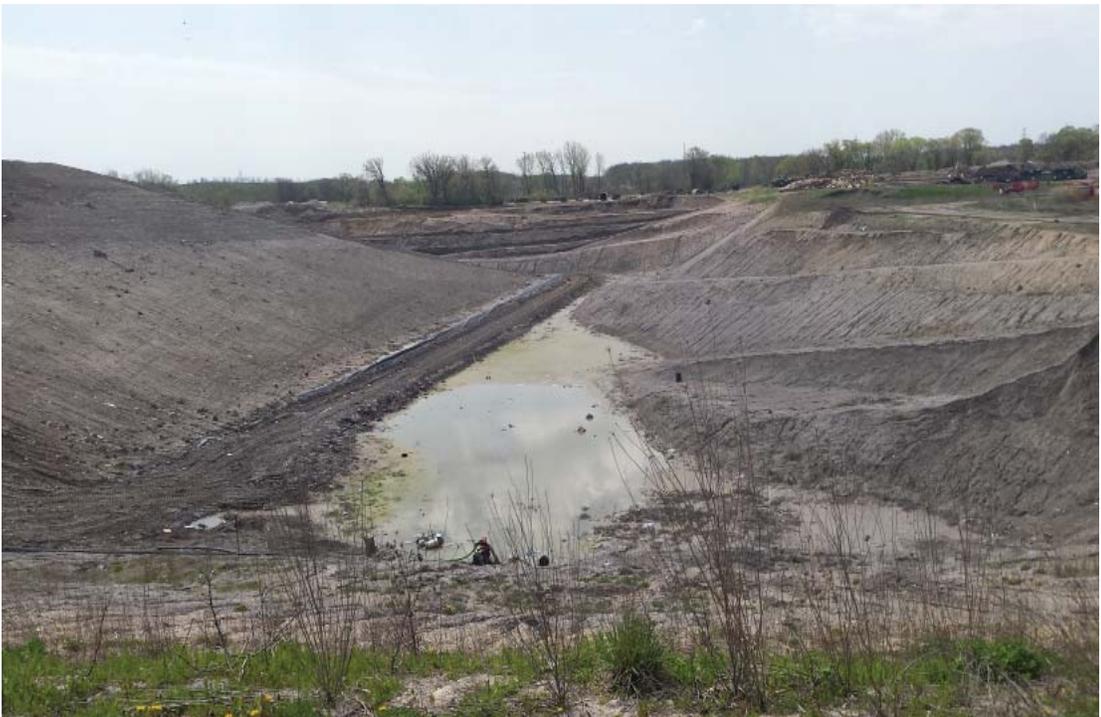
Temp sed basin pumped down, into Basin #1
