ADS Emerald Park Landfill Audit Summary

To: ADS Emerald Park Landfill Standing Committee, City of Muskego
FROM: Faith Spear.
COPIES: File
DATE: 06/22/16
PROJECT NUMBER: 1012.10030

**ADVANCED DISPOSAL SERVICES
EMERALD PARK LANDFILL / CITY OF MUSKEGO
AUDIT PHOTOS**

PROJECT NO. 1012.10030

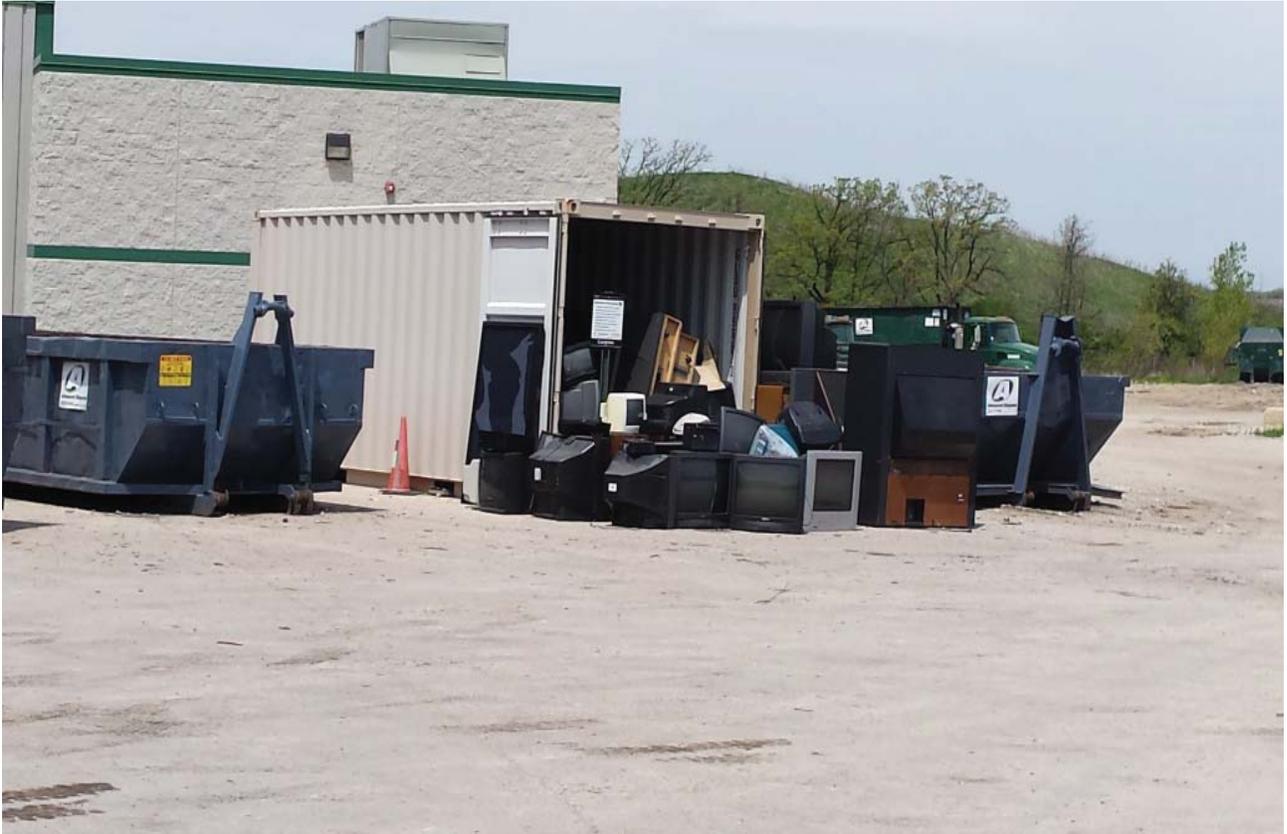
E-Waste Container full, site active during audit

Overflow of E-waste in Resi-drop-off yard

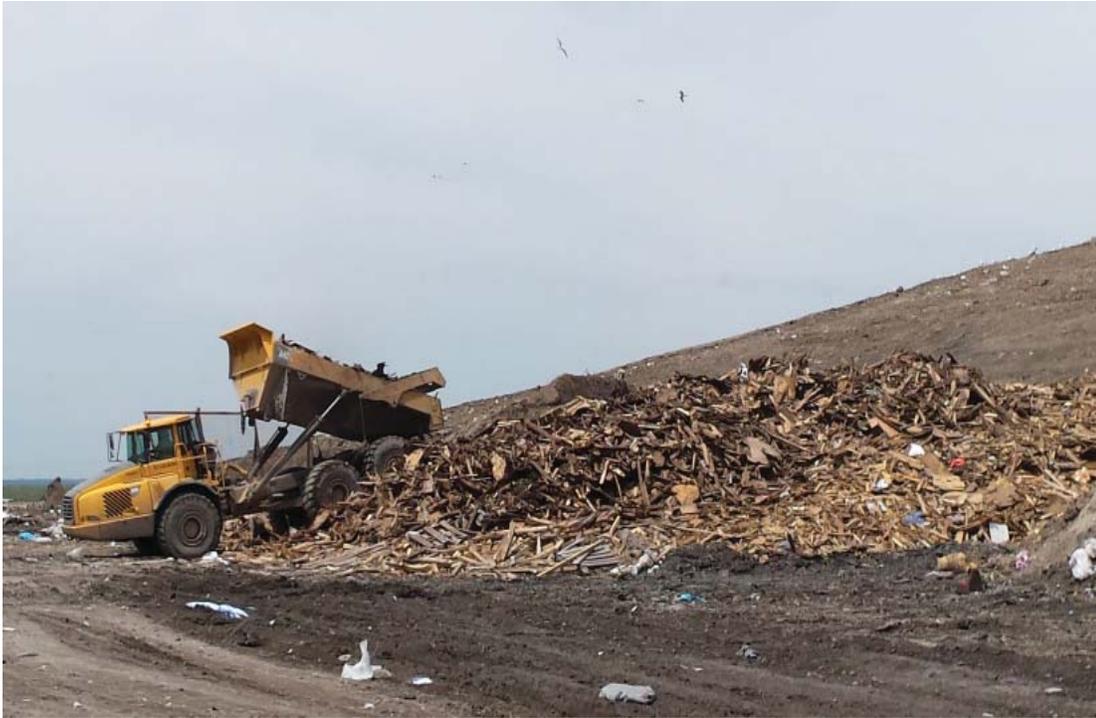
Stockpiling of wood for travelway use

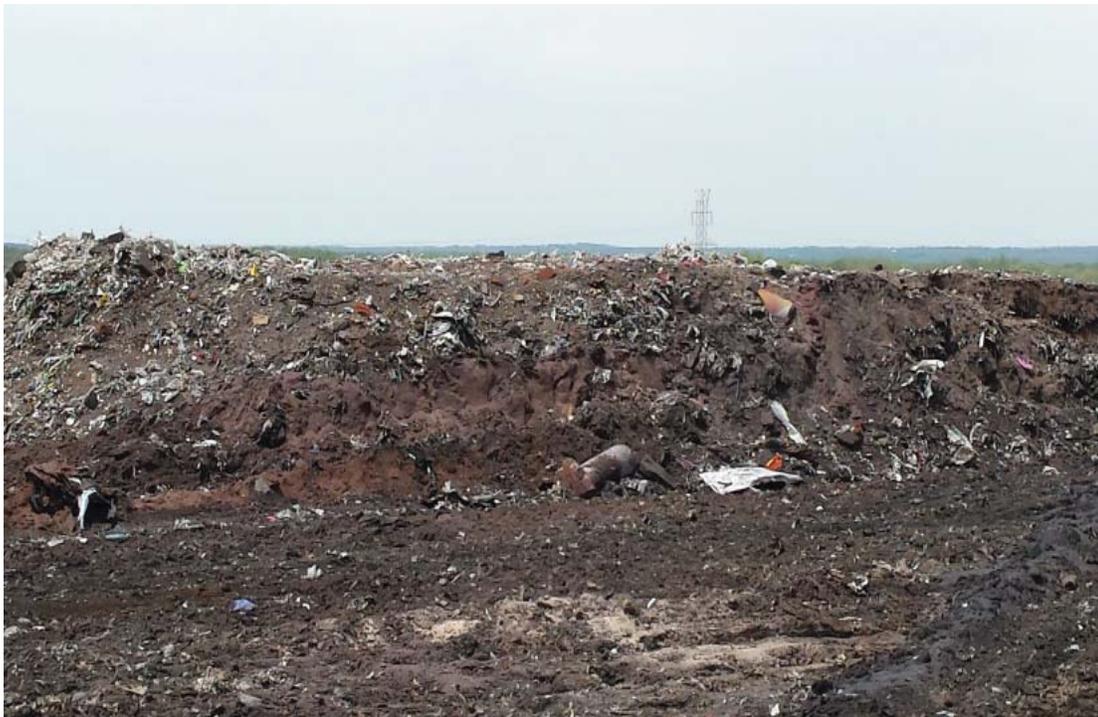
recover soils and sands for cover

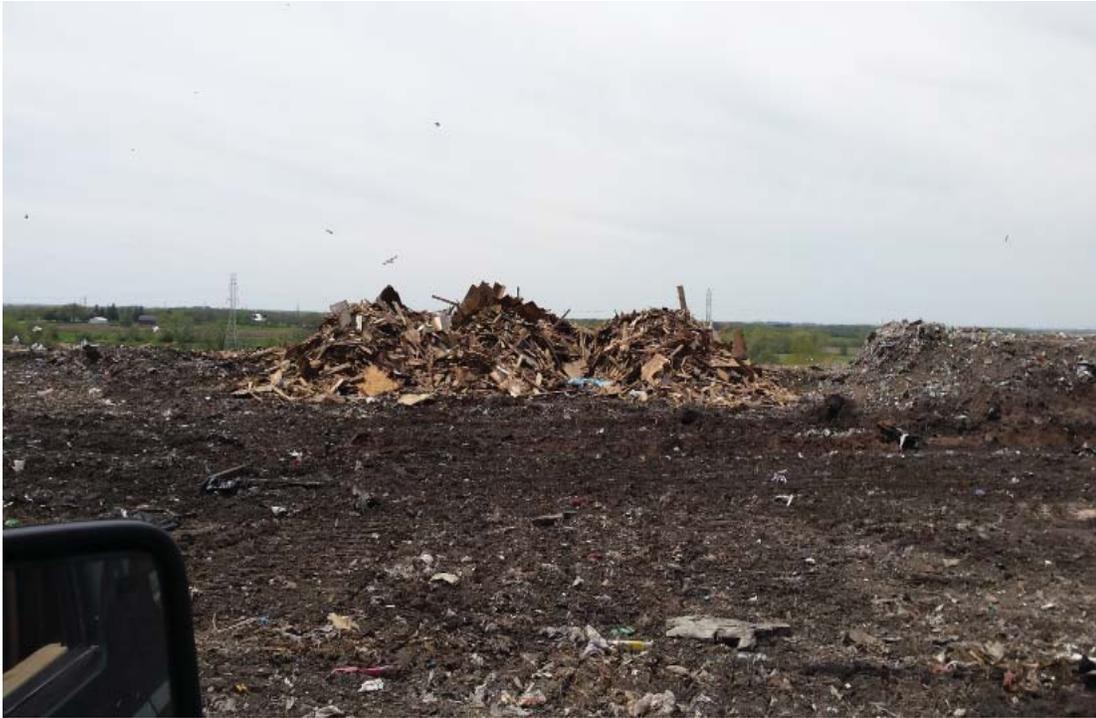
Wood stockpiled for use on travelways

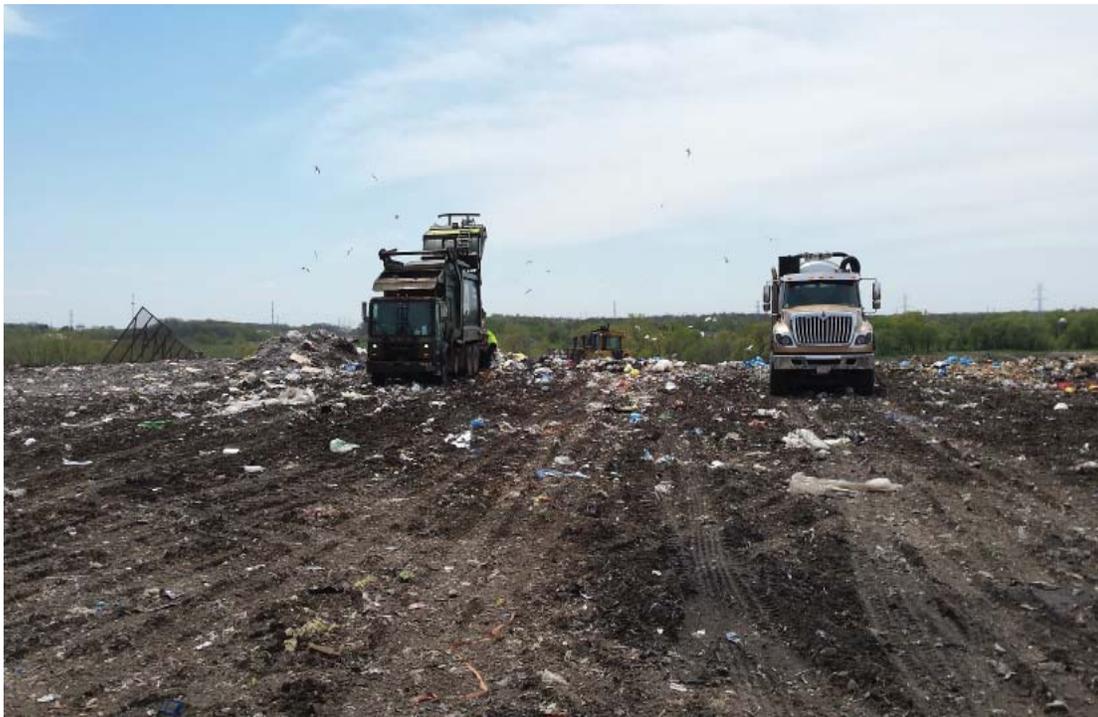
Tipping trucks above working face

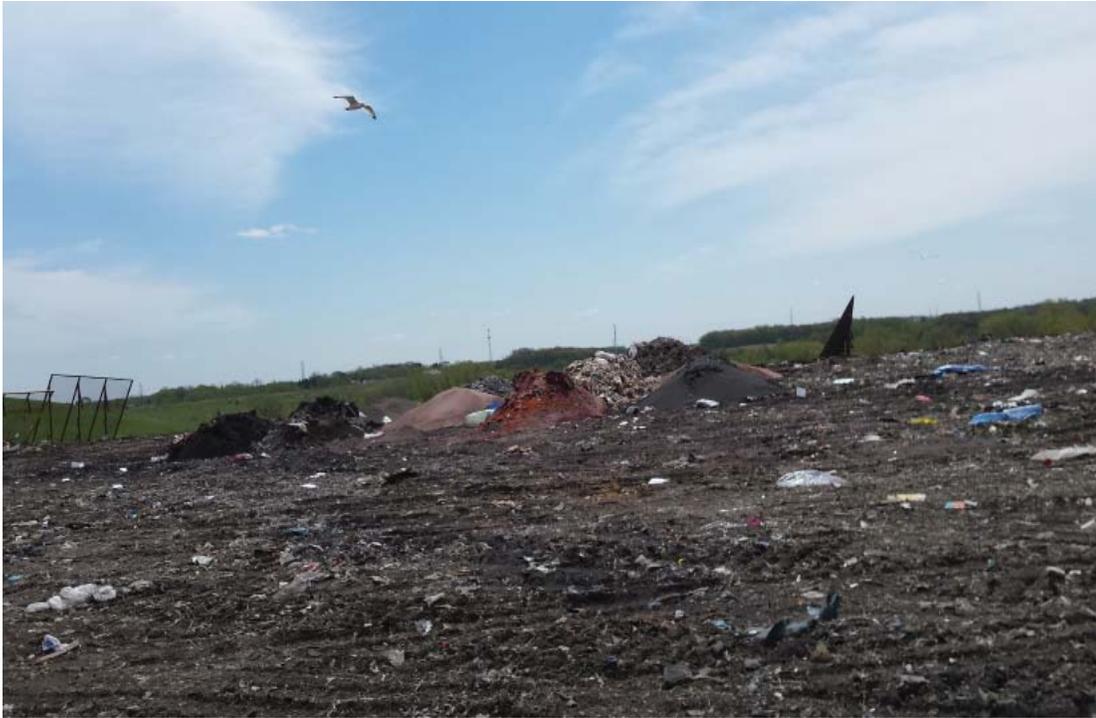
Foundry sands stockpiled for use as cover

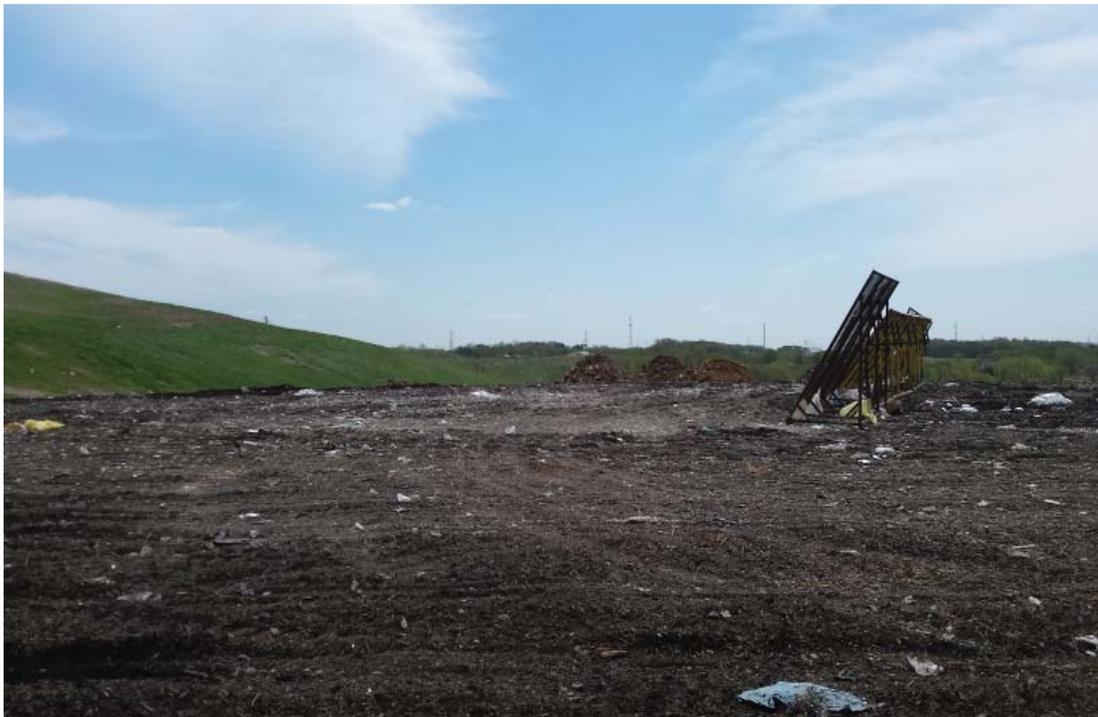
Active area

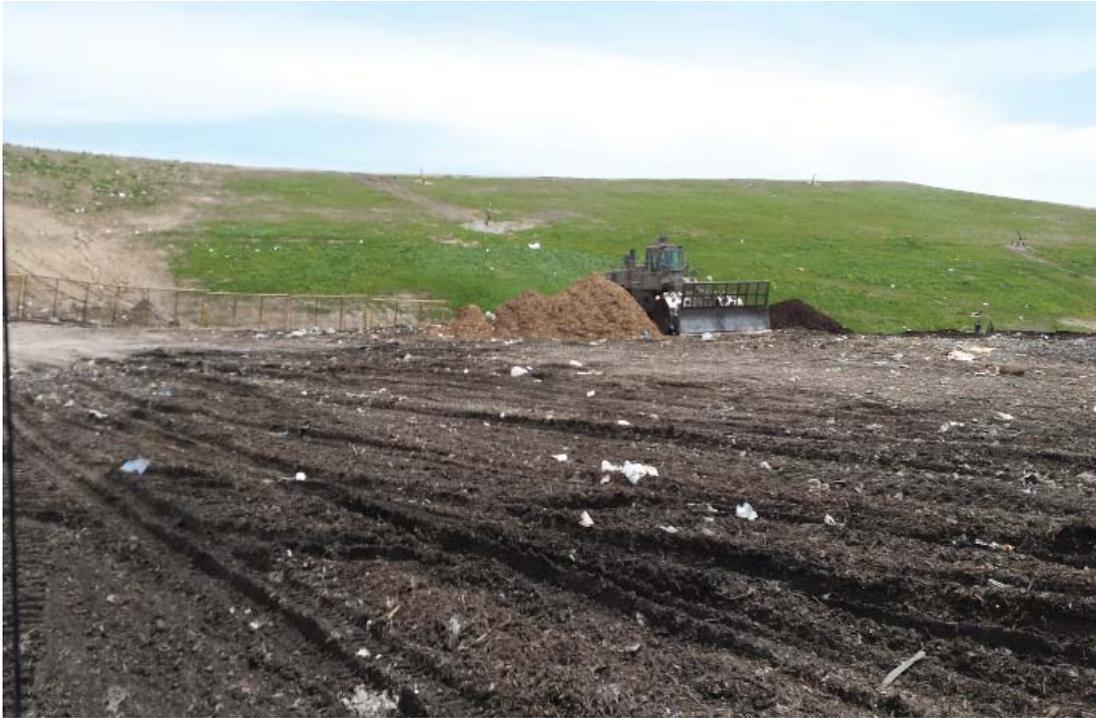
Active area viewed from center to East

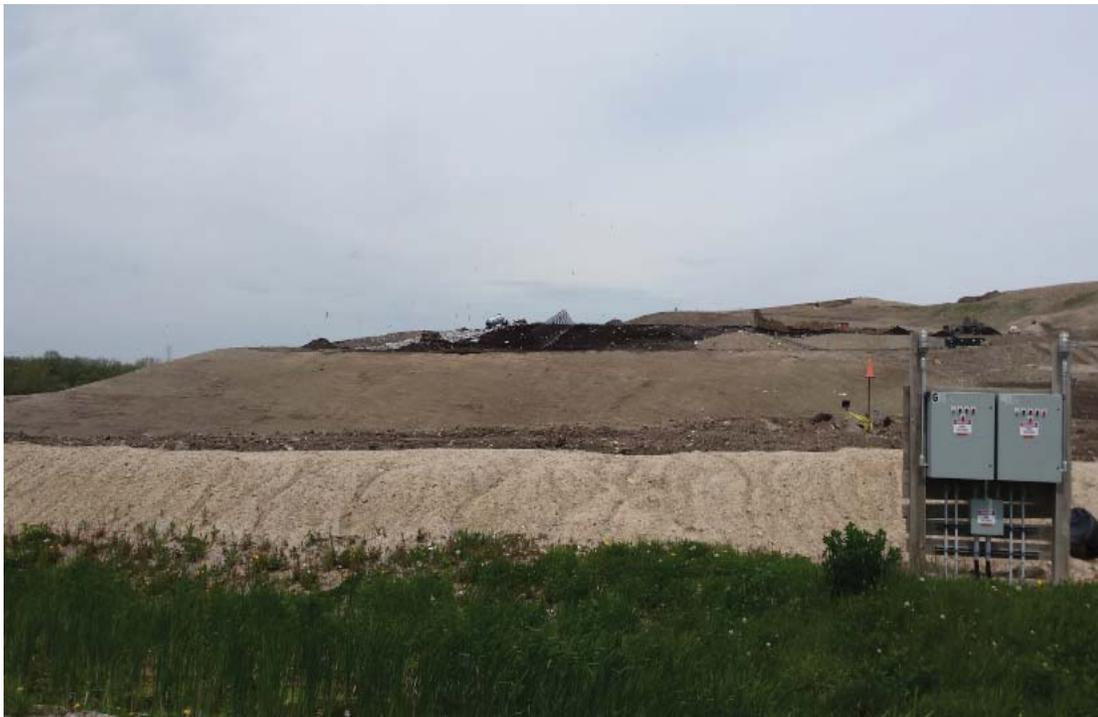
Overview of Phase 7 and 7B from the Southeast

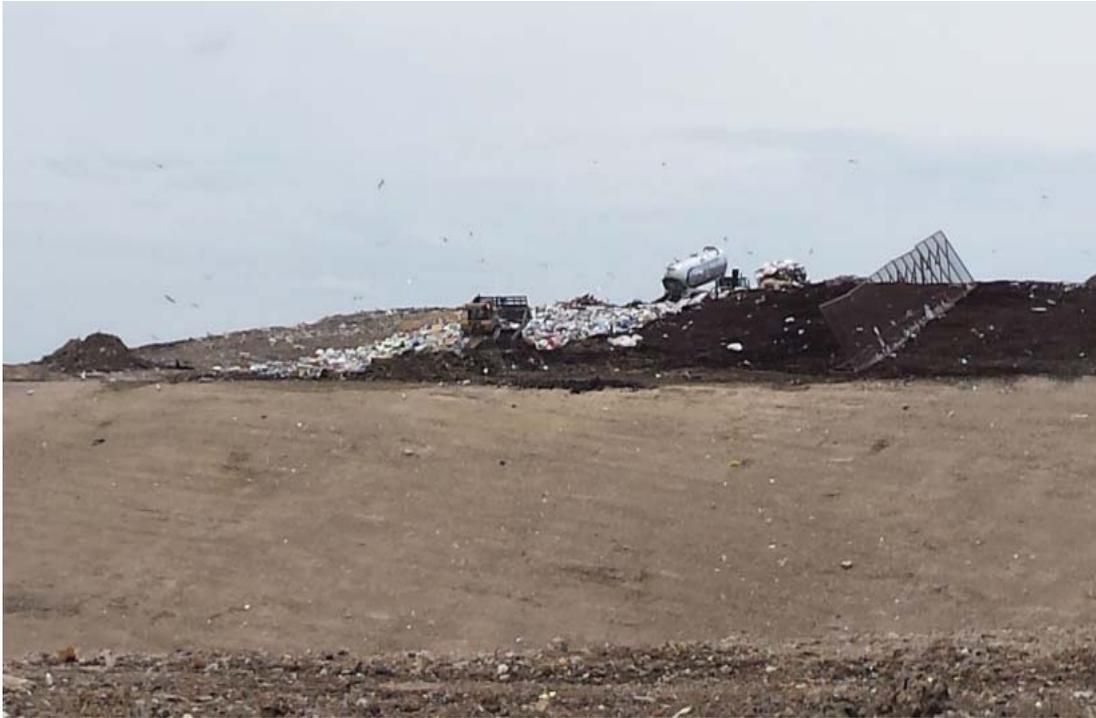
Working face in Southwest corner of Phase 7

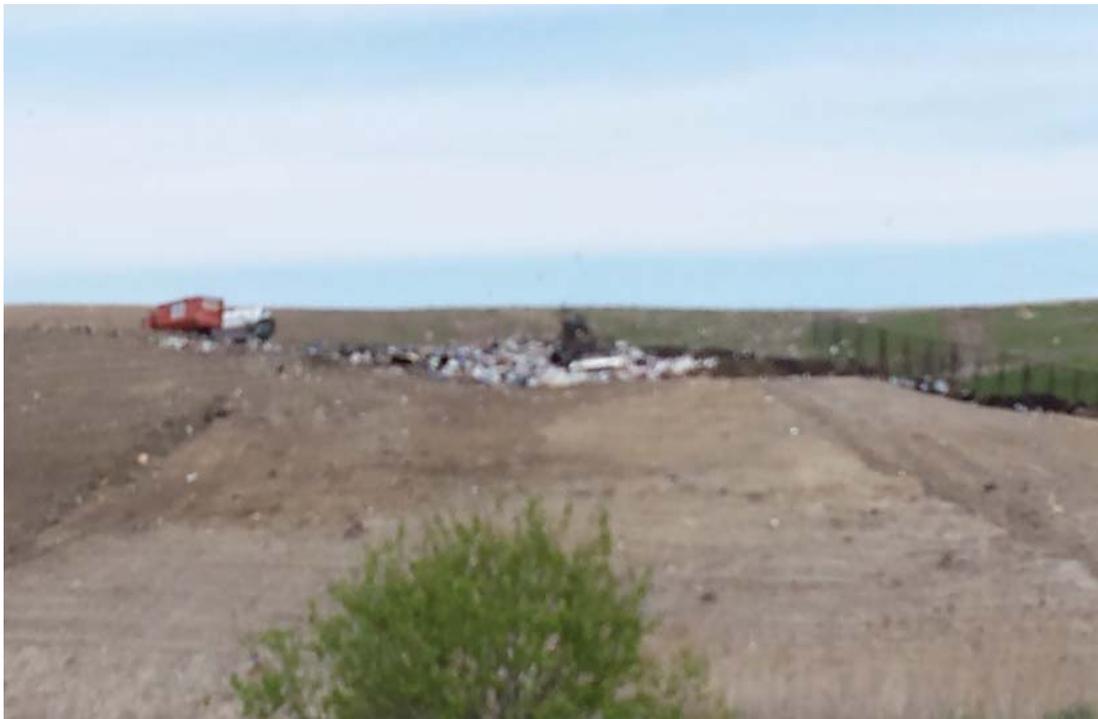
Working face in Southwest corner of Phase 7

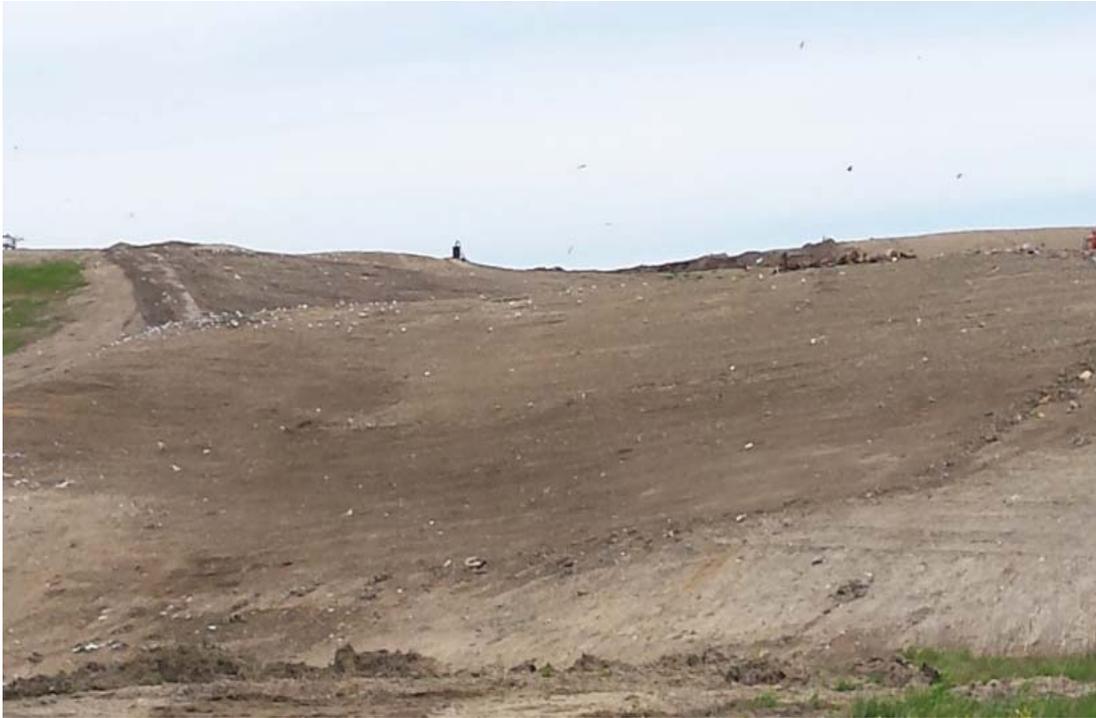
* Erosion repairs in excellent shape
Back dragging of these FB west slope occurred since last audit

West slope of Phase 7, back dragged and cover added.

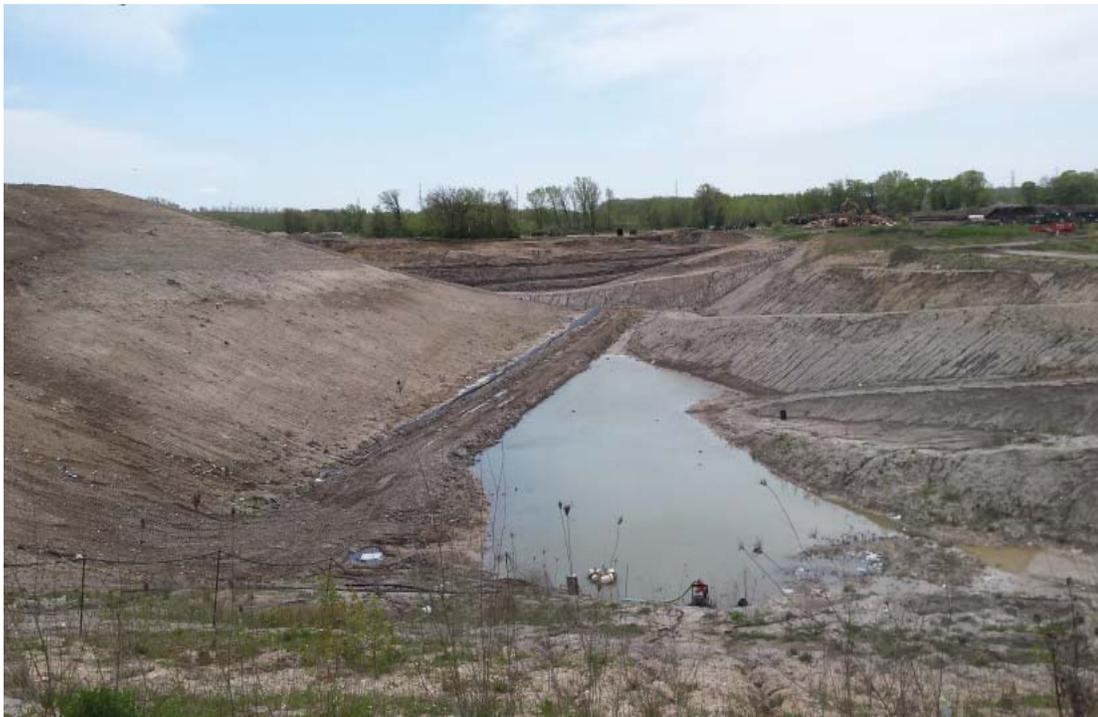
Temp sed basin

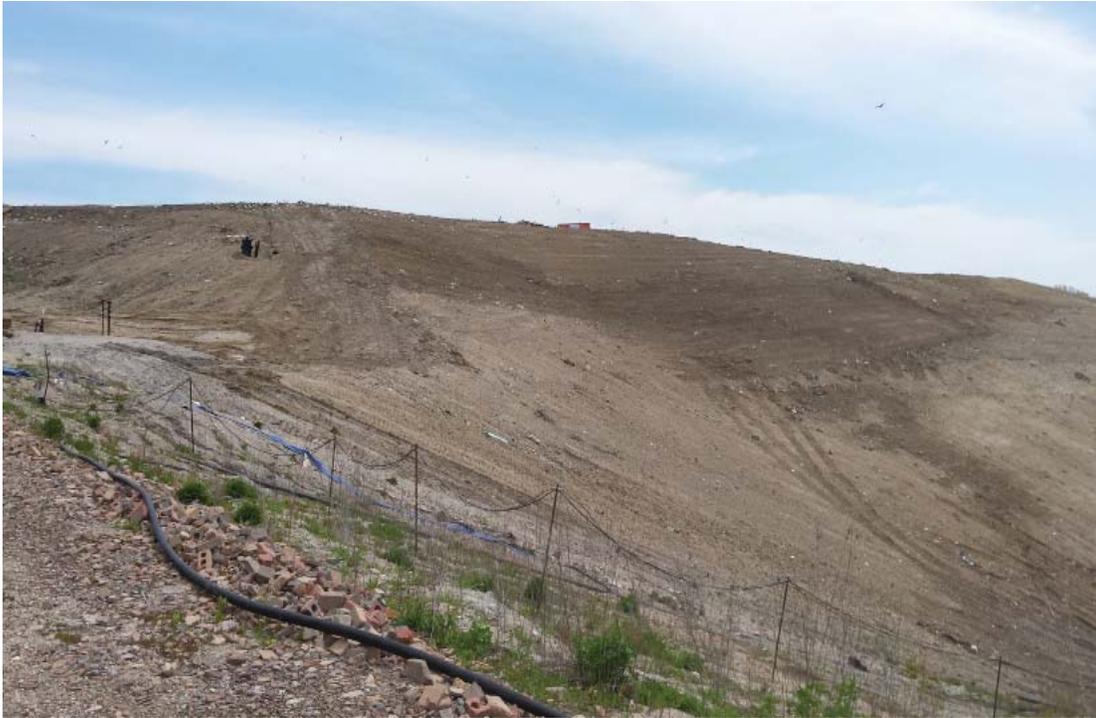
Western slope of Phase 7 and the junction with Phase 3 backdragged to improve cover
