### ADS Emerald Park Landfill Audit Summary

**To:** ADS Emerald Park Landfill Standing Committee, City of Muskego  
**FROM:** Faith Spear.  
**COPIES:** File  
**DATE:** 06/24/16  
**PROJECT NUMBER:** 1012.10030

Attached is the audit report for activities at the ADS Emerald Park Landfill for the week of May 22, 2016. The audit was performed at 3:37 PM on **May 25, 2016** by Jo Spear, Jr. in the presence of Brett Coogan, Operations Manager.

**ADVANCED DISPOSAL SERVICES  
EMERALD PARK LANDFILL / CITY OF MUSKEGO  
AUDIT PHOTOS**

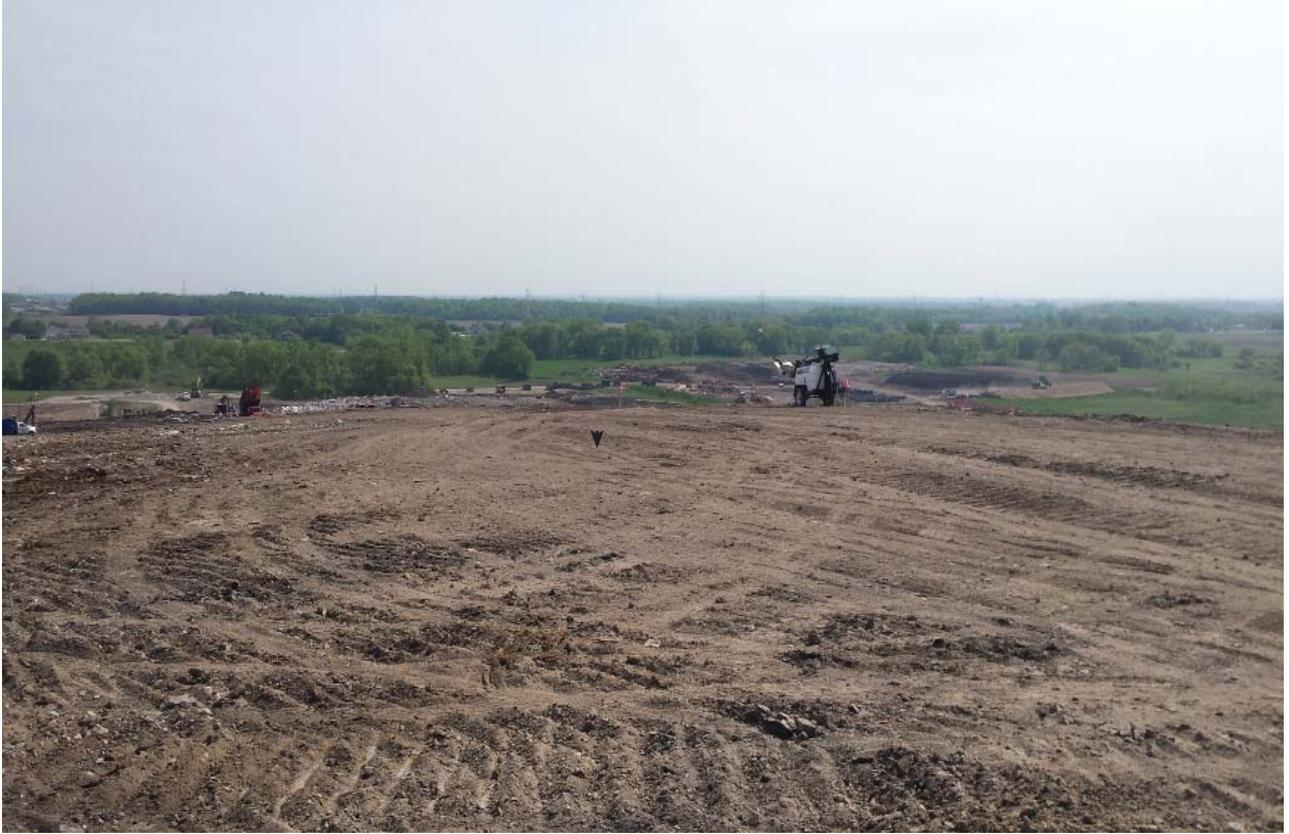
Phase 2 & 3, top dressed and graded

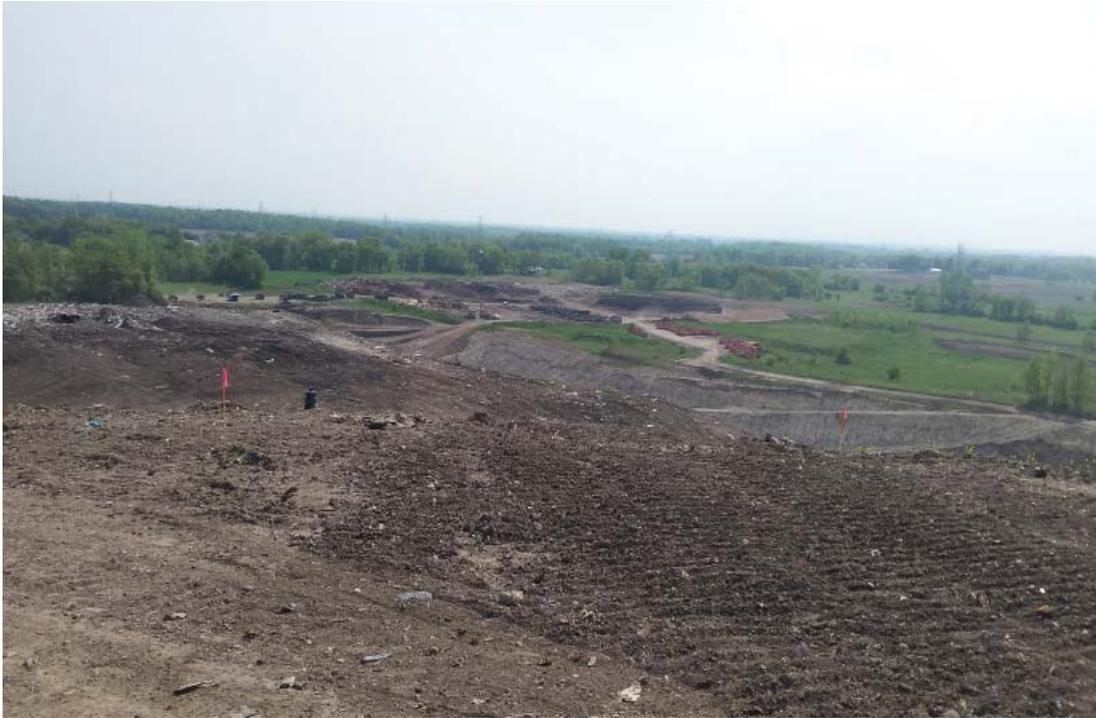
Overview of compost lot and stone stockpiling activities

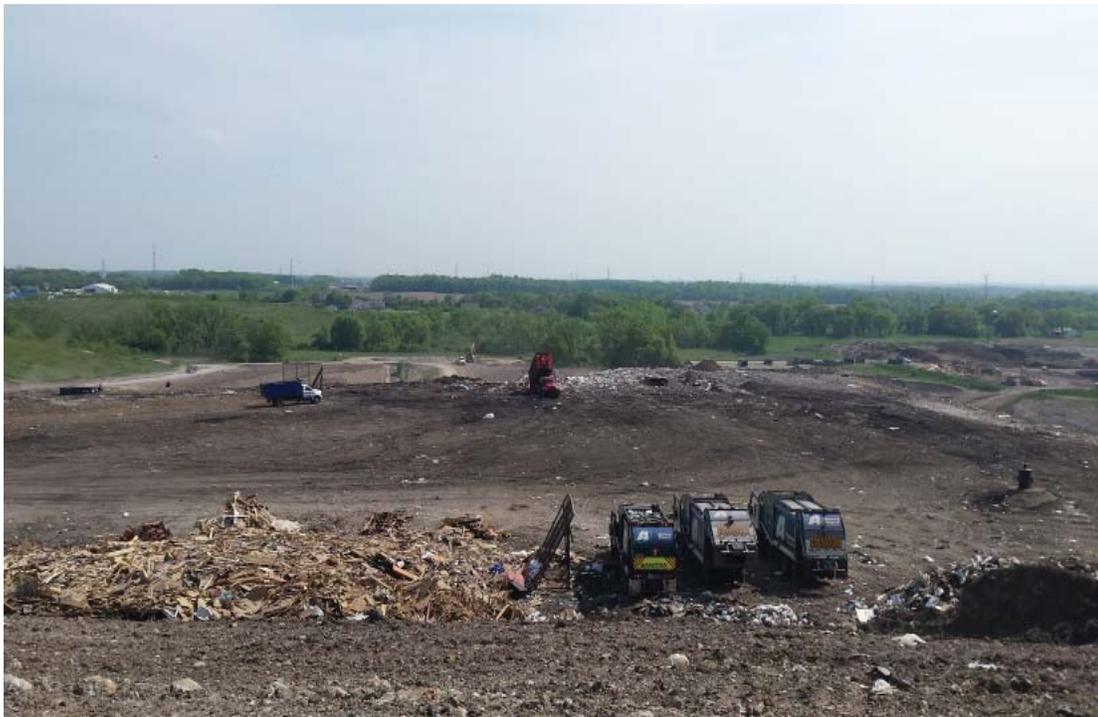
Active area viewed from North

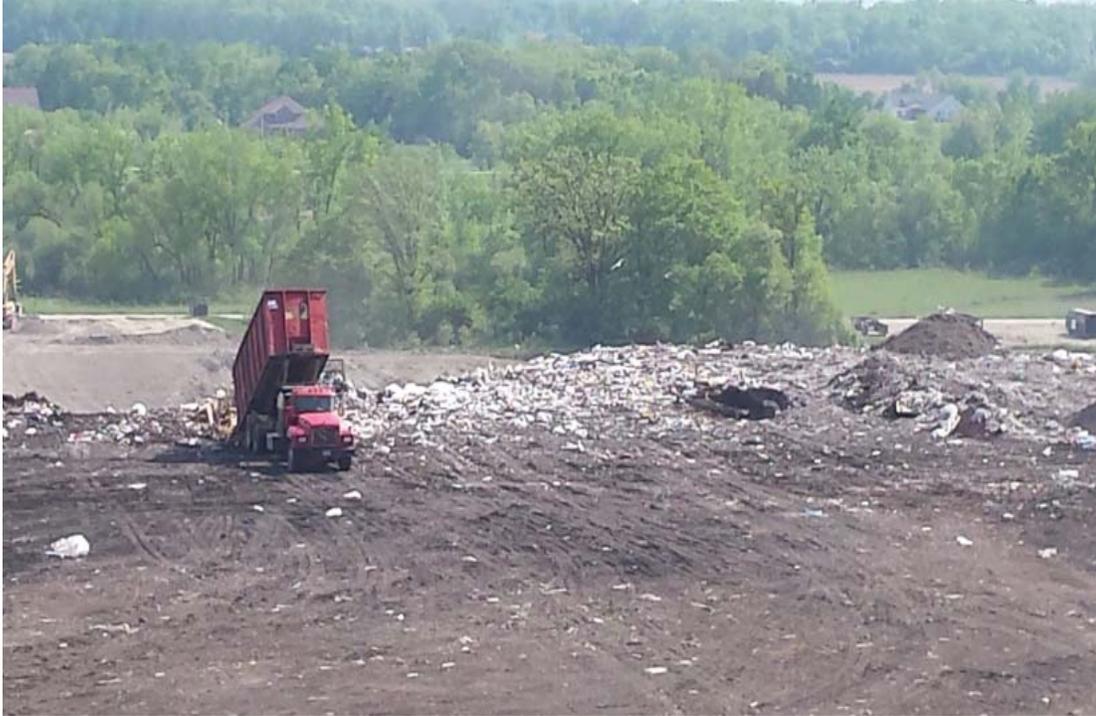
Working face viewed from North

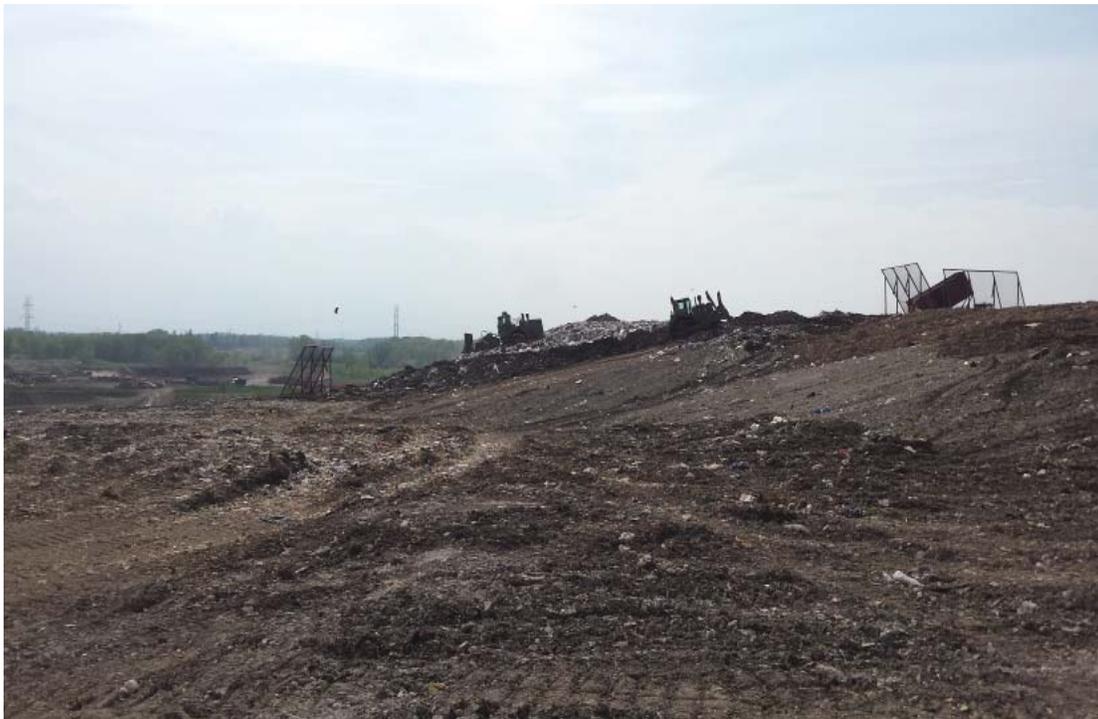
Working face viewed from East

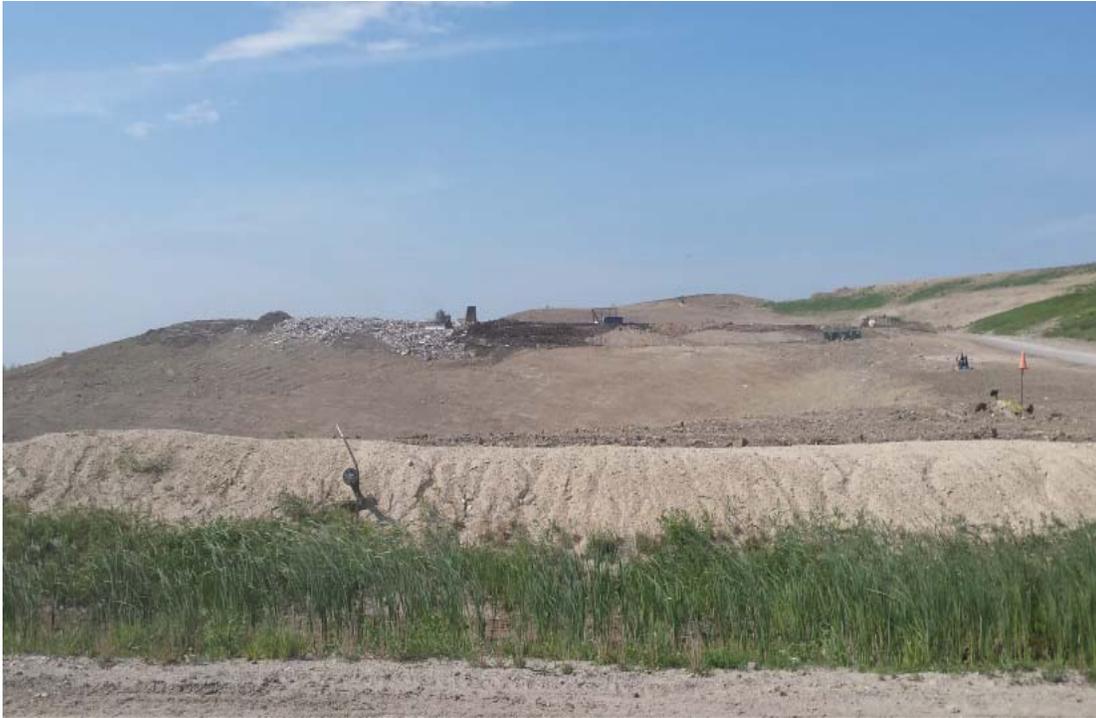
Working face viewed from the South

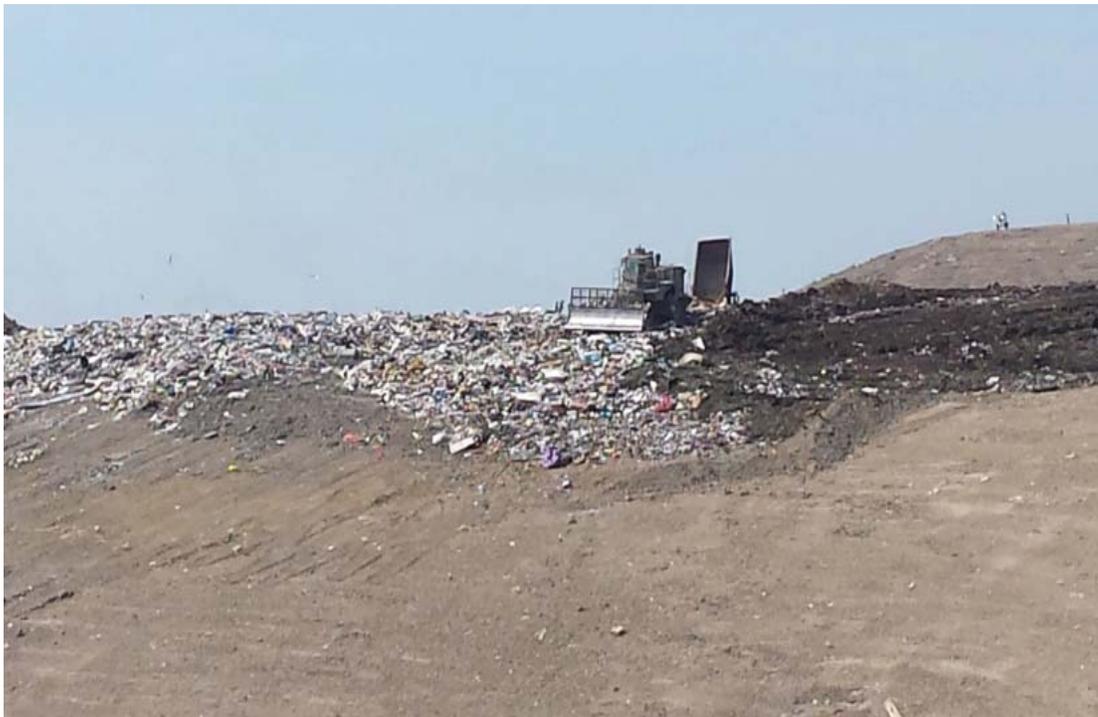
Working face on South slope of Phase 7B  
bringing the lift Eastward to bring  
Phase up to surrounding elevations  
No other working faces today

South slope of Phase 7B, working face

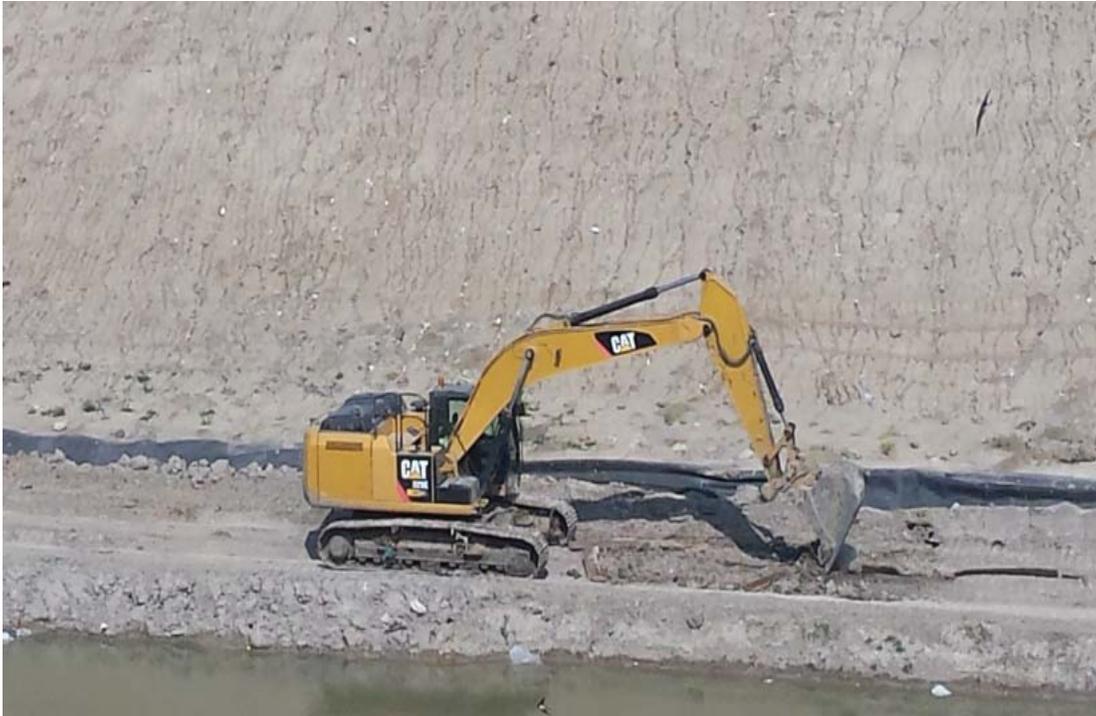
\* Small seep repair is Phase 7 at Northwest toe of slope above temp. Sed basin.

Excavator at toe of slope, West side fo Phase 7, to repair seep and clean up rain flap

- Small seep has been repaired
  - Phase 7 at Northwest toe of slope above temporary sediment basin
- Road has been expanded about base of Phase 7B
- Stockpiles in Future Parkland are well maintained; in good shape
  - Staff will be removing silt fence

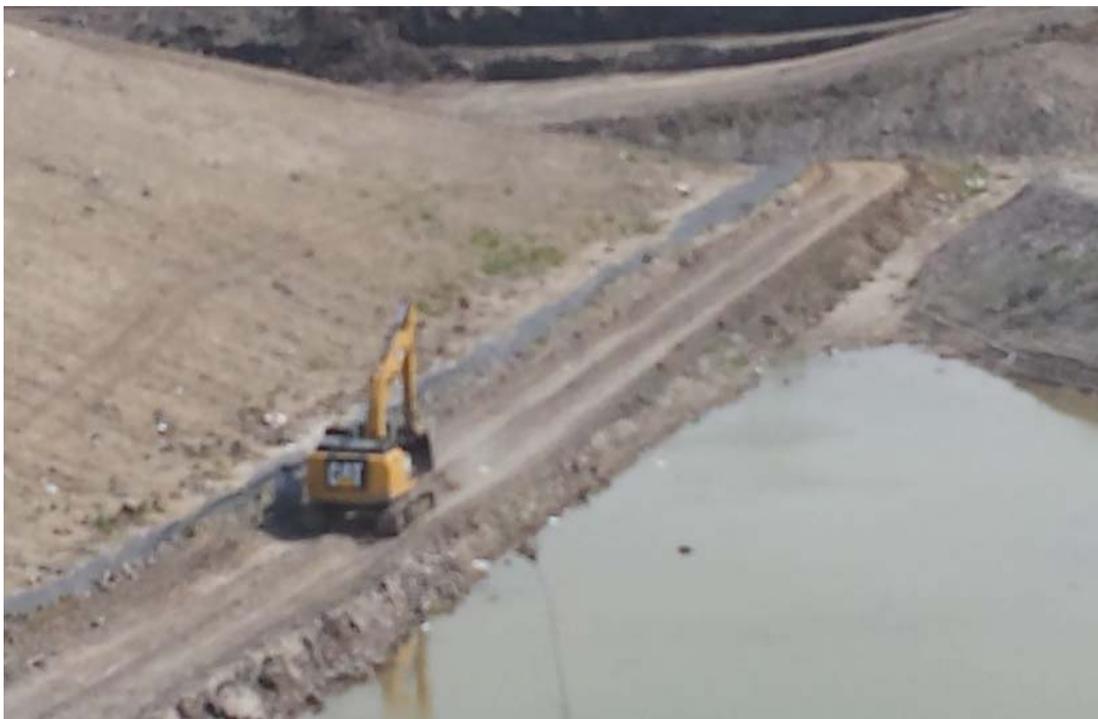
Excavator cleaning up rain flap and access way
