ADS Emerald Park Landfill Audit Summary

TO: ADS Emerald Park Landfill Standing Committee, City of Muskego
FROM: Faith Spear.
COPIES: File
DATE: 7/26/16
PROJECT NUMBER: 1012.10030

Attached is the audit report for activities at the ADS Emerald Park Landfill for the week of June 5, 2016. The audit was performed at 11:00 AM on **June 9, 2016** by Jo Spear, Jr. in the presence of Scott Croft, Landfill Gas Technician.

**ADVANCED DISPOSAL SERVICES
EMERALD PARK LANDFILL / CITY OF MUSKEGO
AUDIT PHOTOS**

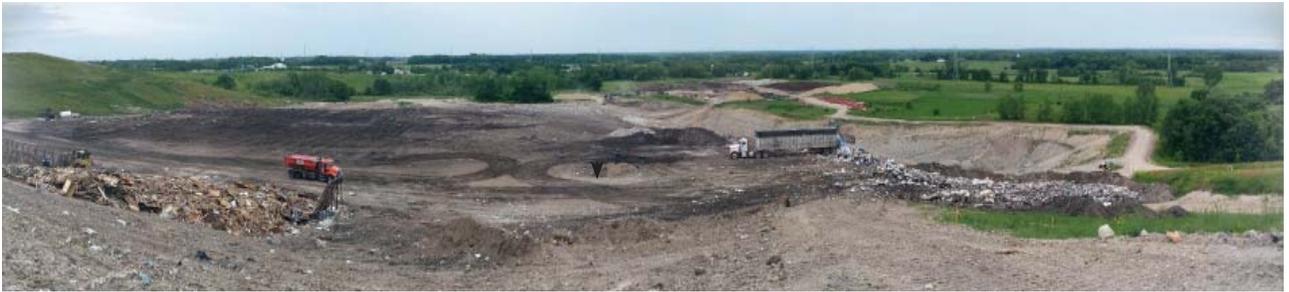
Panorama of Phase 7 viewed from the North

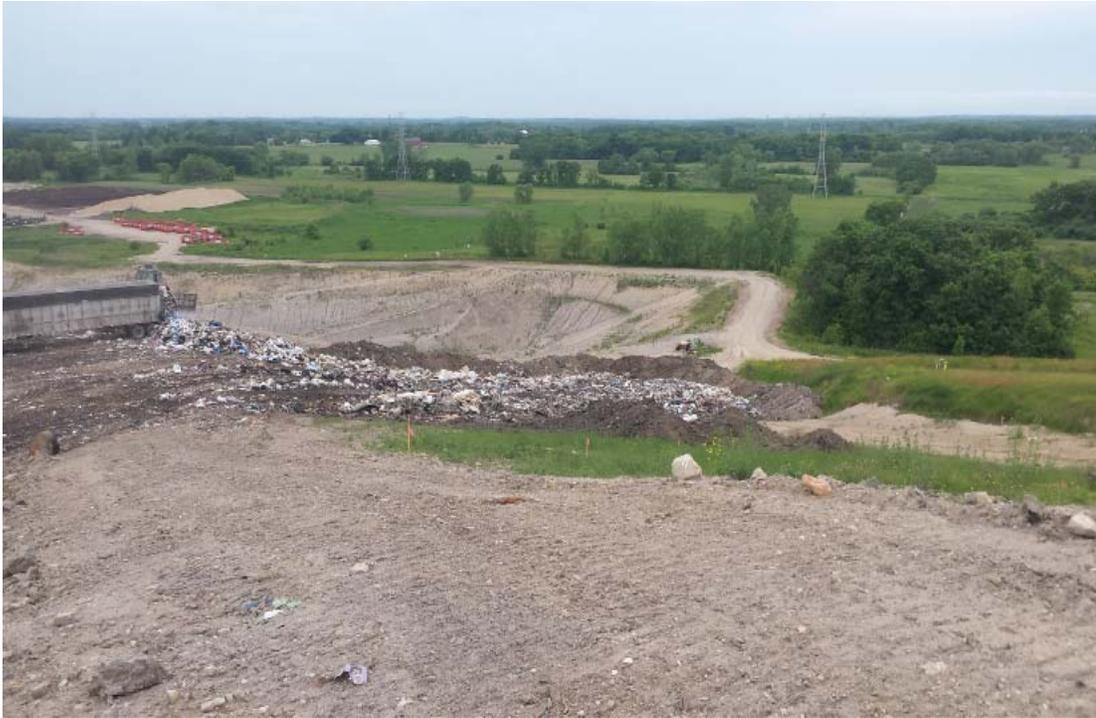
Working face viewed from North

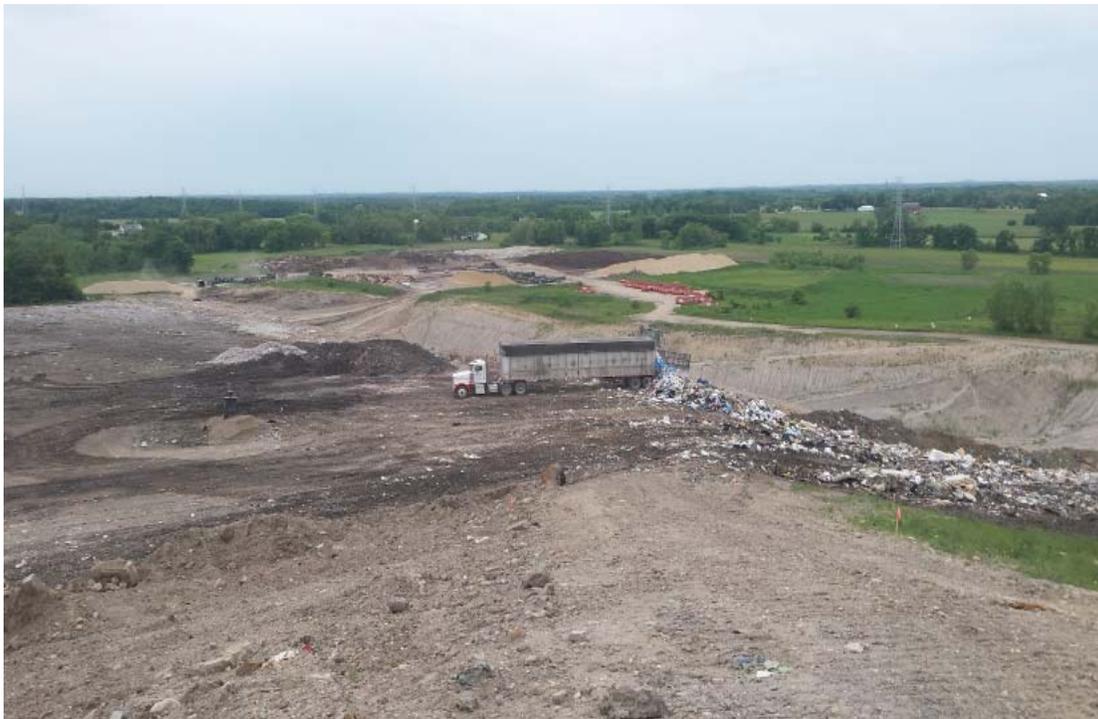
Working face viewed from North

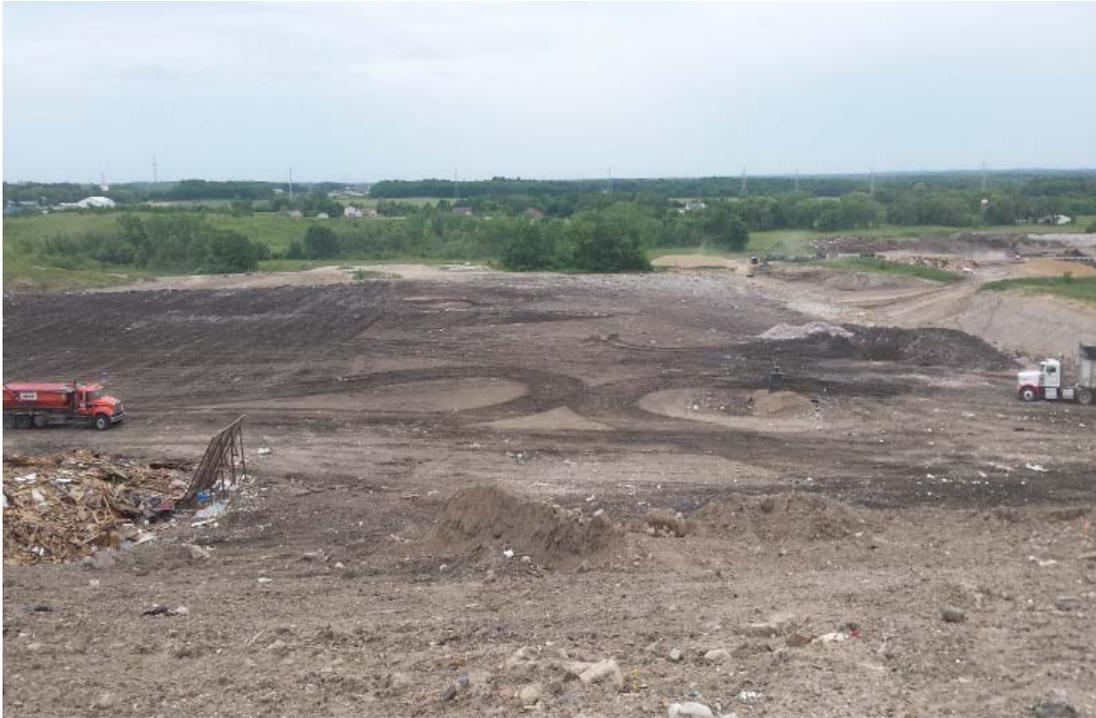
Active area viewed from the North

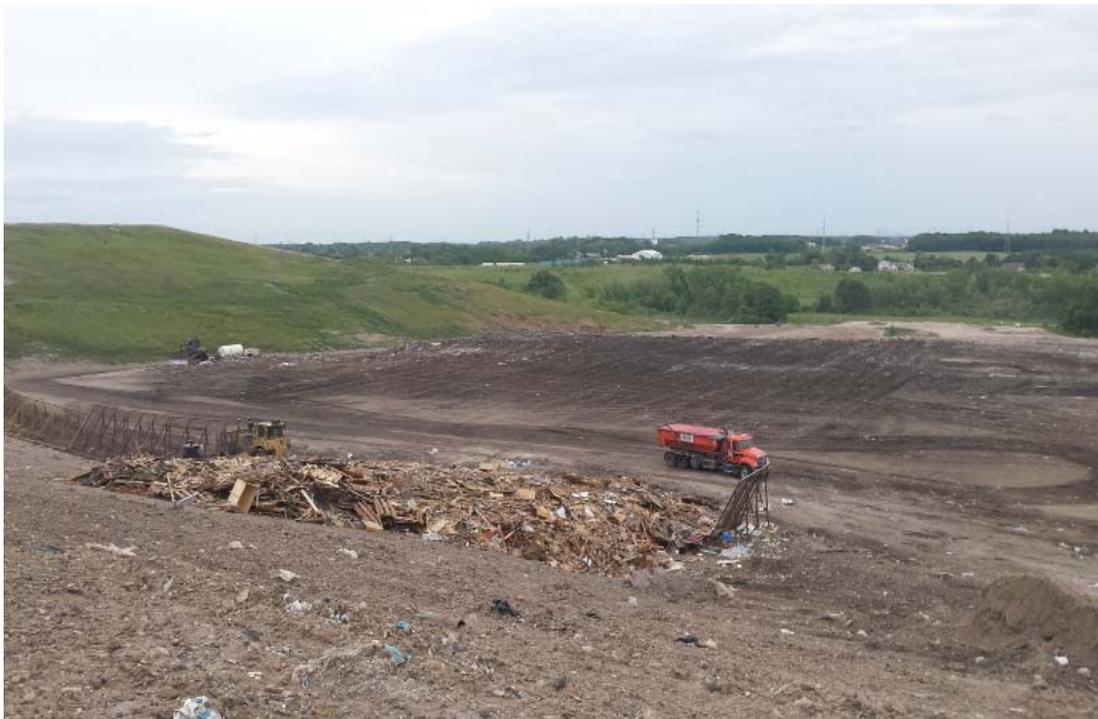
Active area viewed from the North

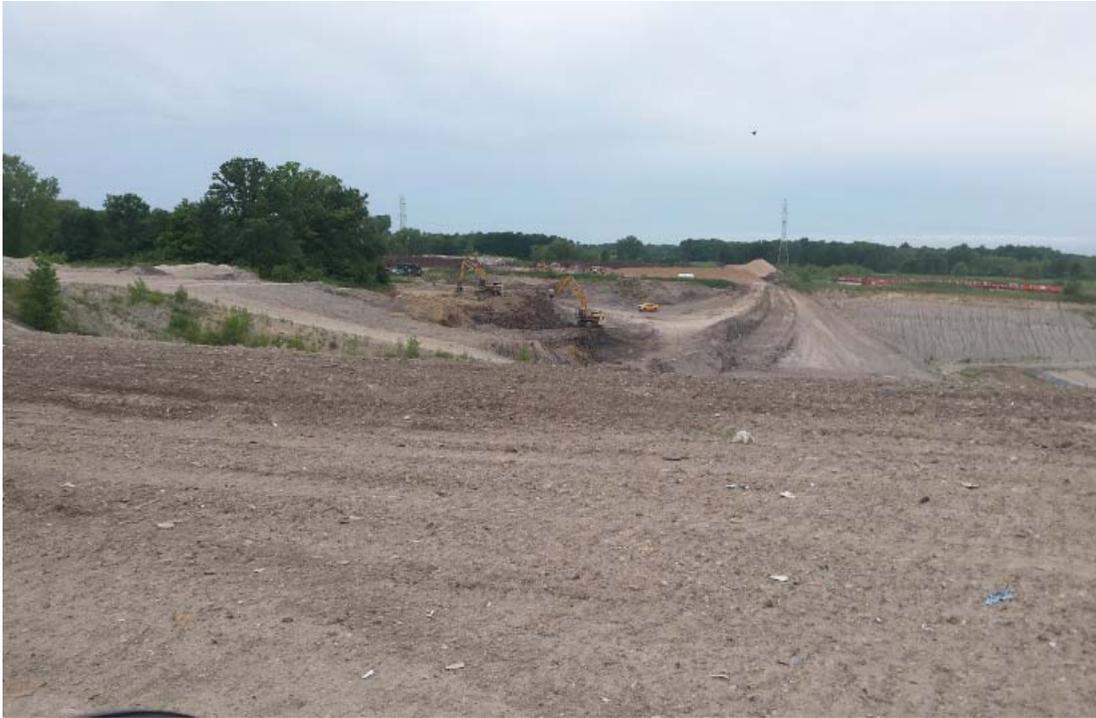
Excavation of remainder of Phase 7

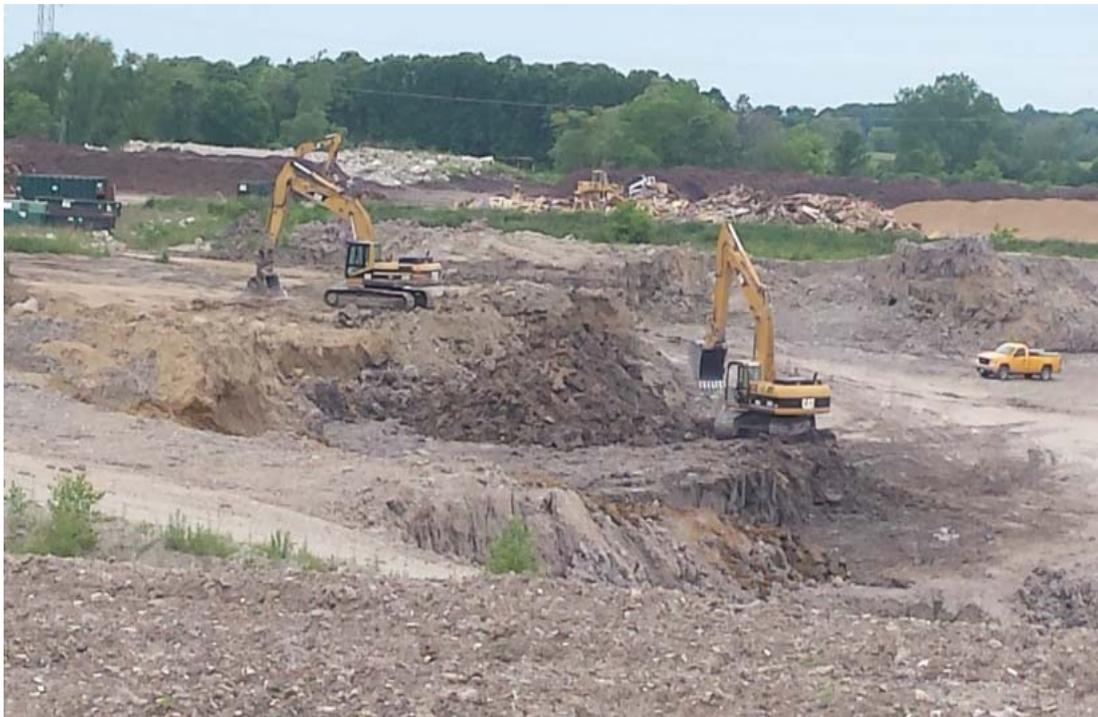
Contractor and site operator excavating for cover and back haul

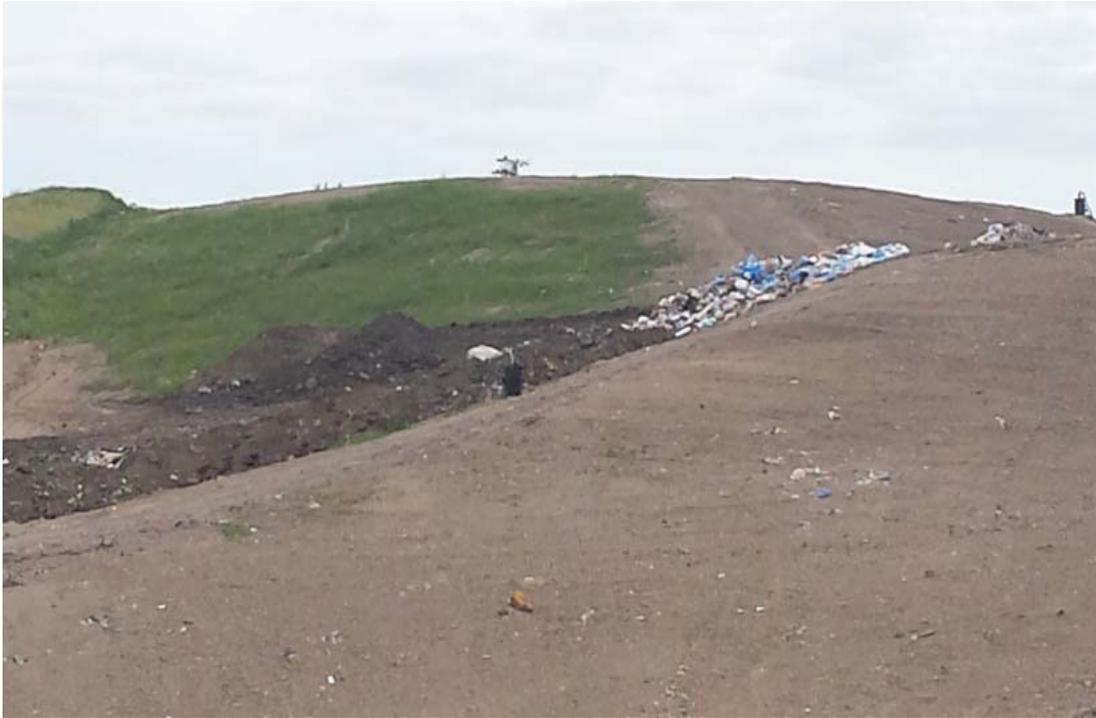
Working face at Phase 3/7 West most edge

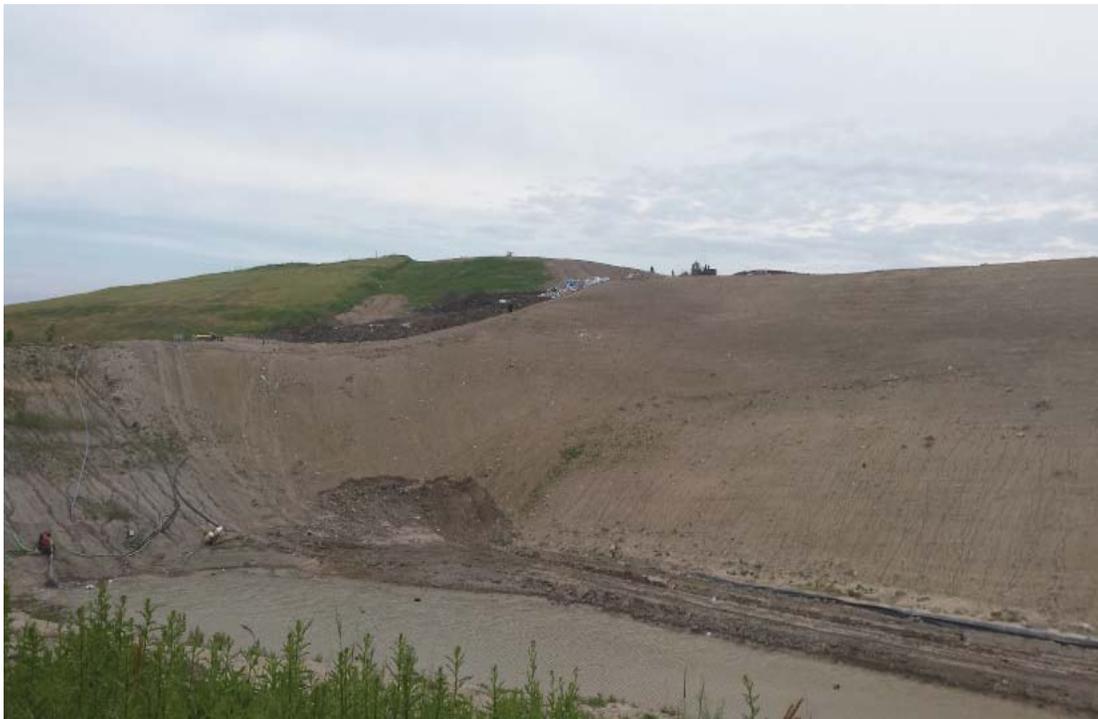
- Leachate seep In West slope of Phase 7 fully repaired

West slope of Phase 7

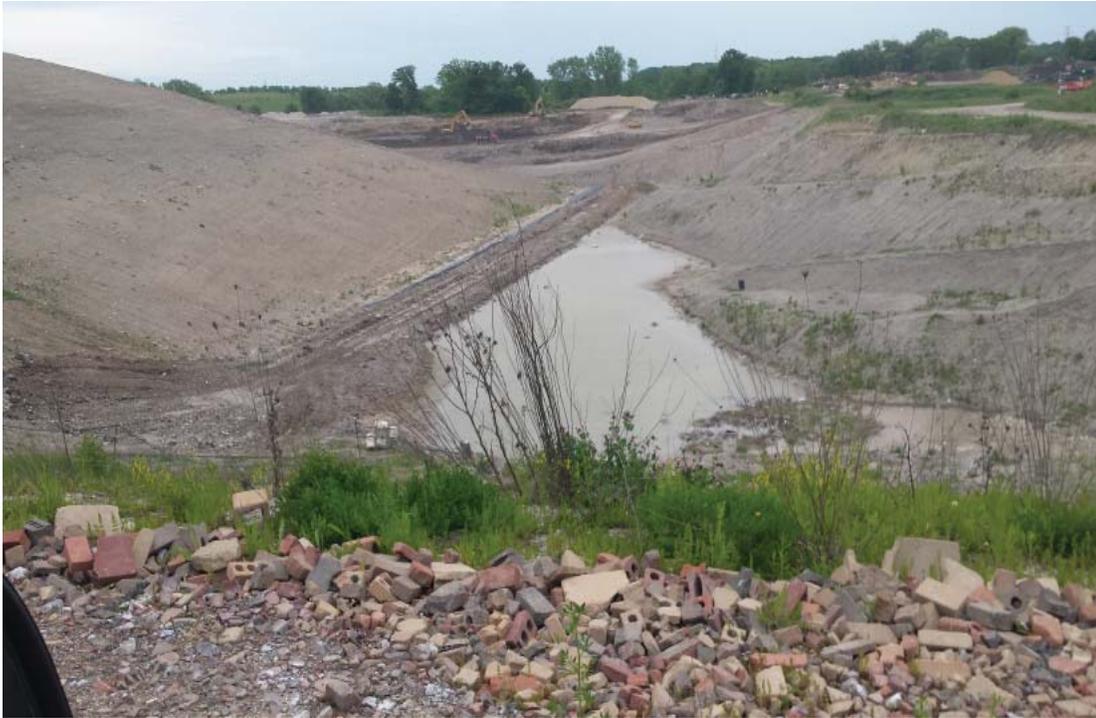
Basins Nearly dry, Temp Sed Basin
Erosion repairs greening up nicely

Temp sed basin at low levels

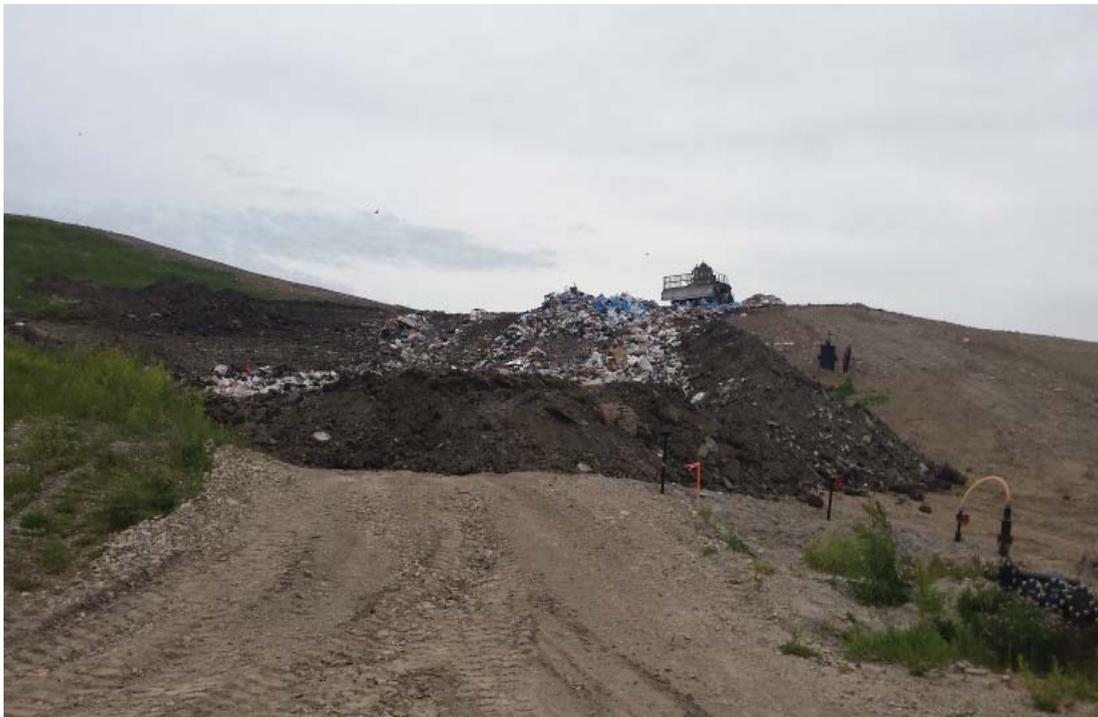
Working bringing Phase 3/7 junction up to grade
