ADS Emerald Park Landfill Audit Summary

TO: ADS Emerald Park Landfill Standing Committee, City of Muskego
FROM: Faith Spear.
COPIES: File
DATE: 10/07/14
PROJECT NUMBER: 1012.10030

ADVANCED DISPOSAL SERVICES EMERALD PARK LANDFILL
 LANDFILL OPERATIONS AUDIT FORM
 CITY OF MUSKEGO

**ADVANCED DISPOSAL SERVICES
EMERALD PARK LANDFILL / CITY OF MUSKEGO
AUDIT PHOTOS**

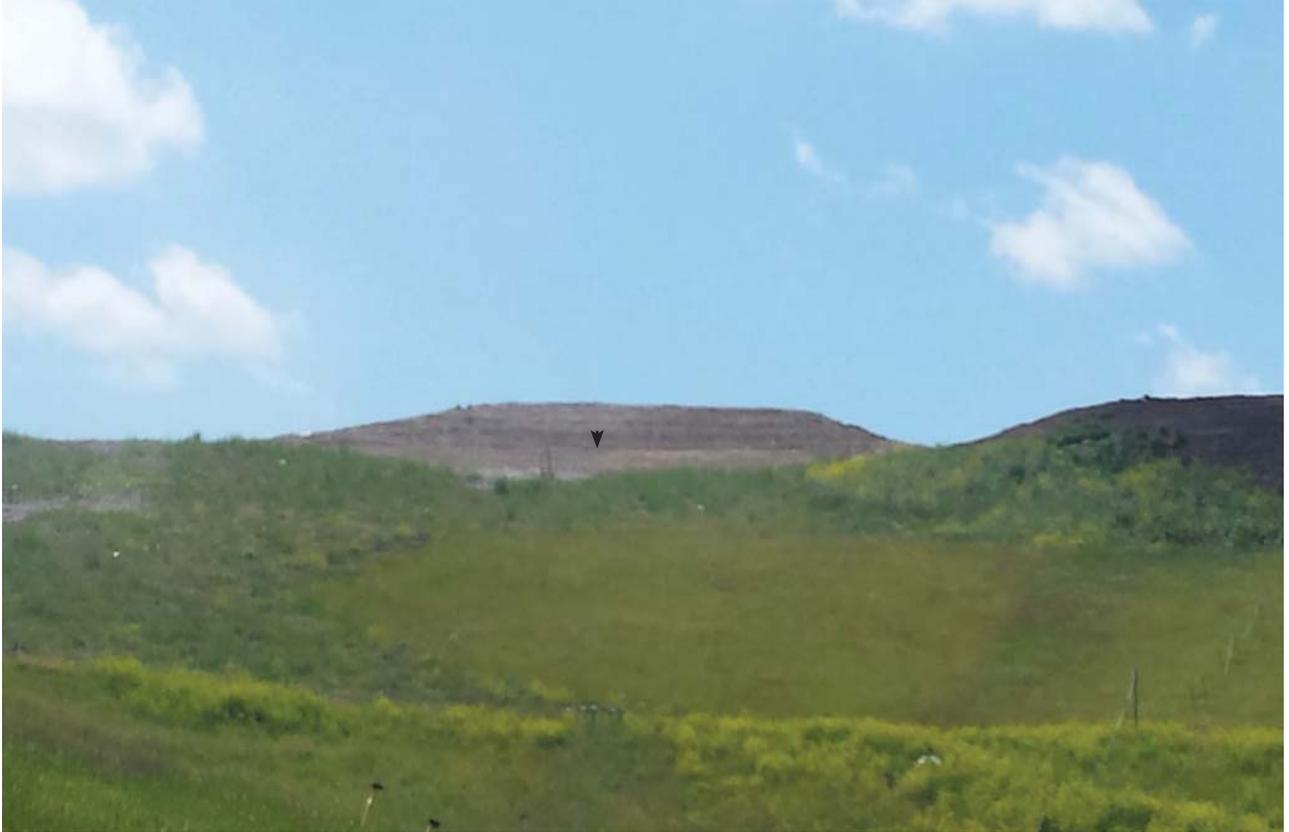
Phase 3/4/5 viewed from the East, stockpiled bio soils

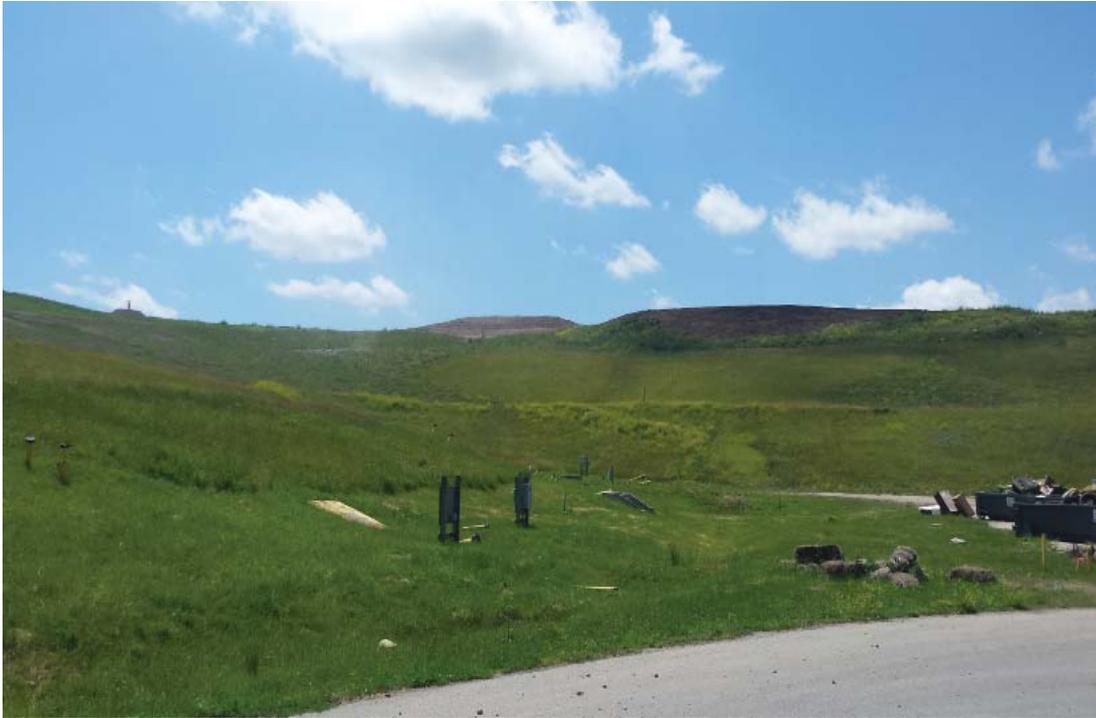
Phases 1 thru 4 viewed from the East

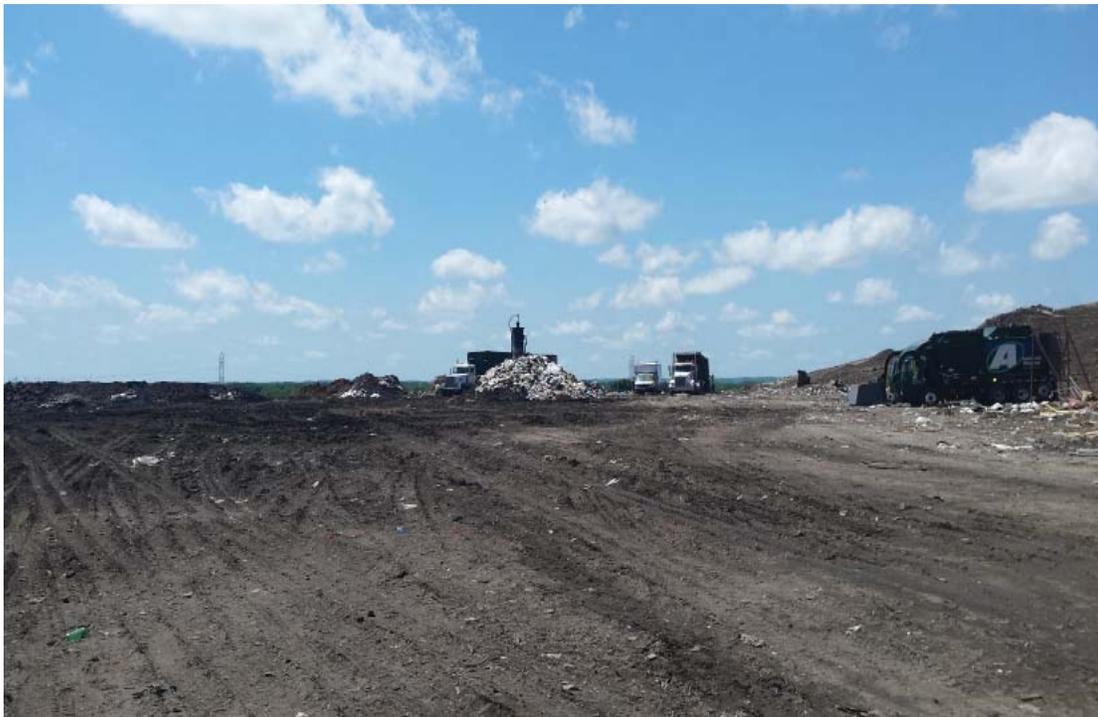
Working face across active area to West

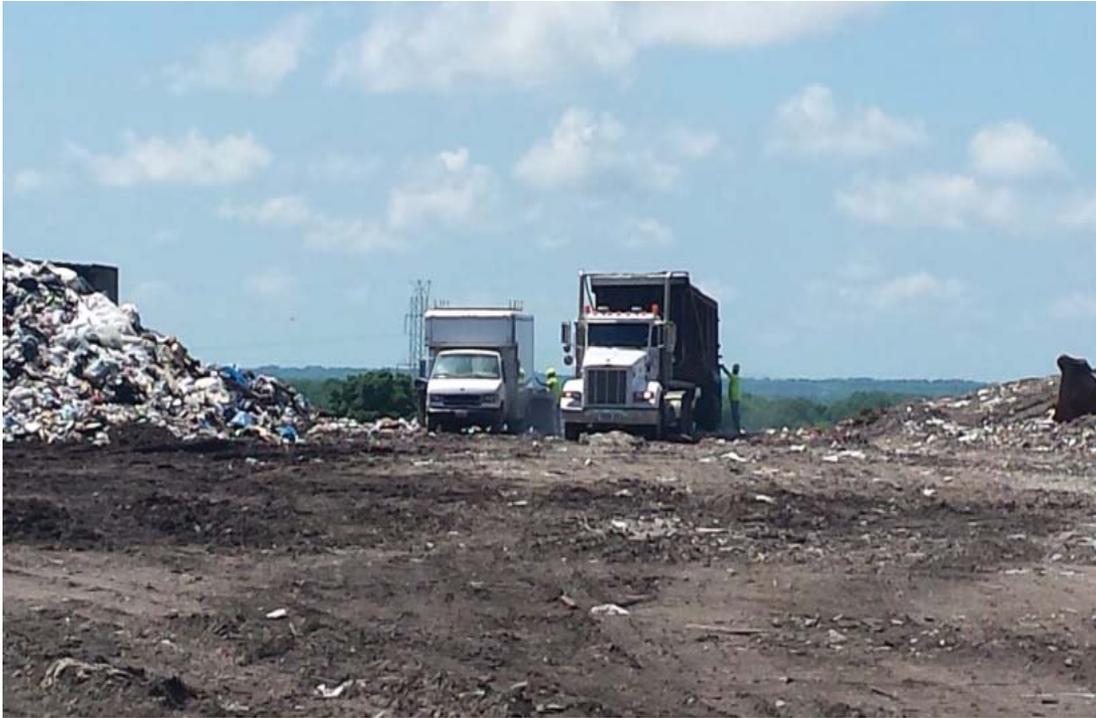
Trucks tipping in working face

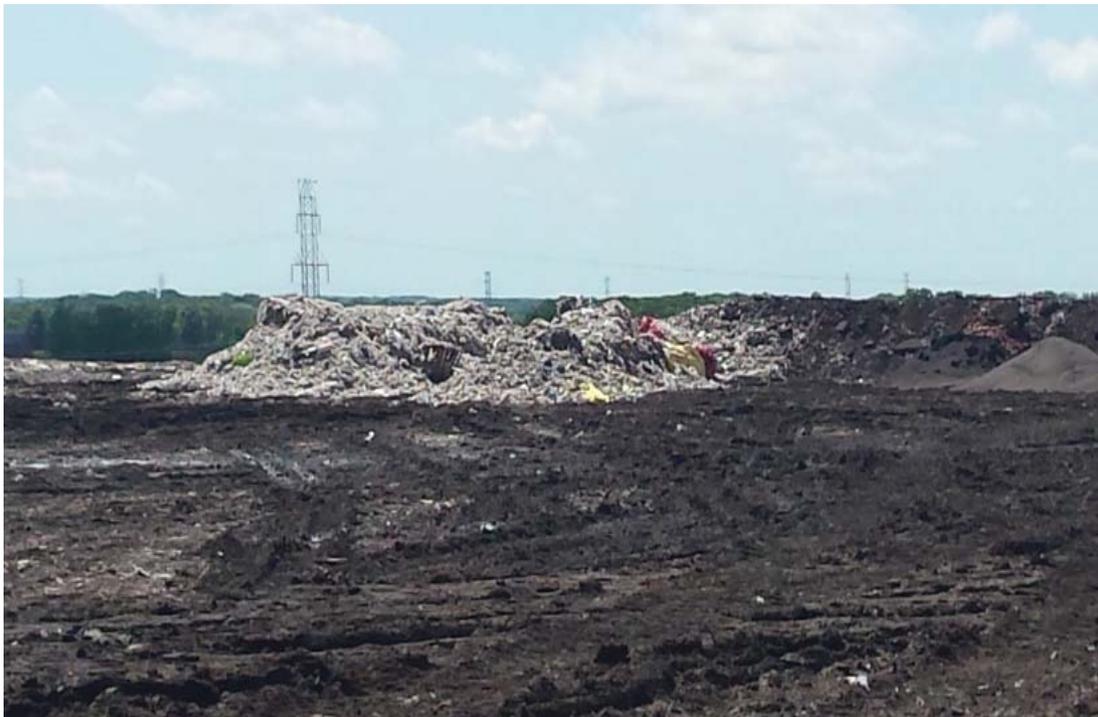
Fluff material for cover

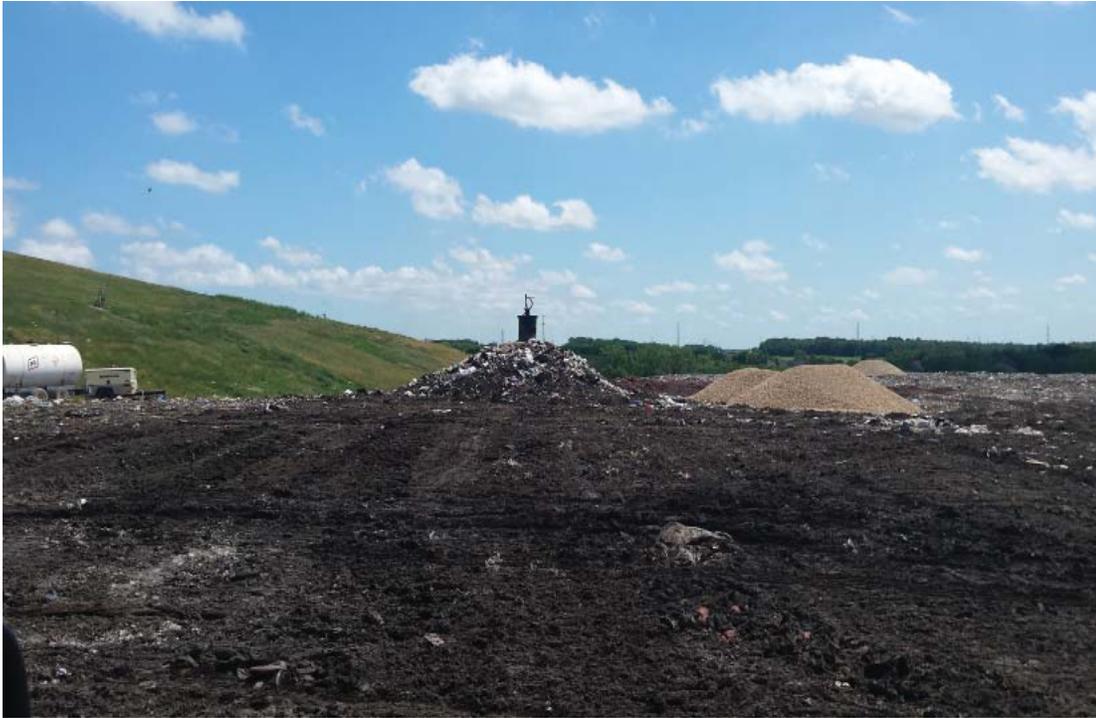
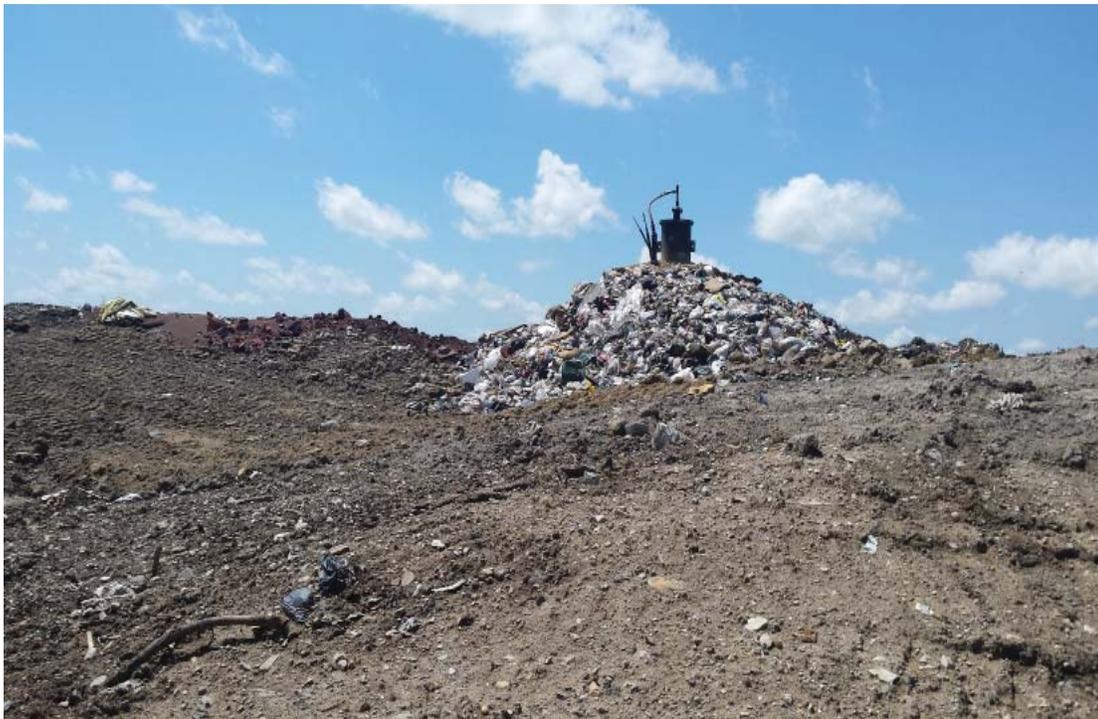
- * Contractor raising gas extraction wells in Active area to allow getting around the wells
- * Scale construction ongoing

Raised well wrapped in waste, awaiting cover

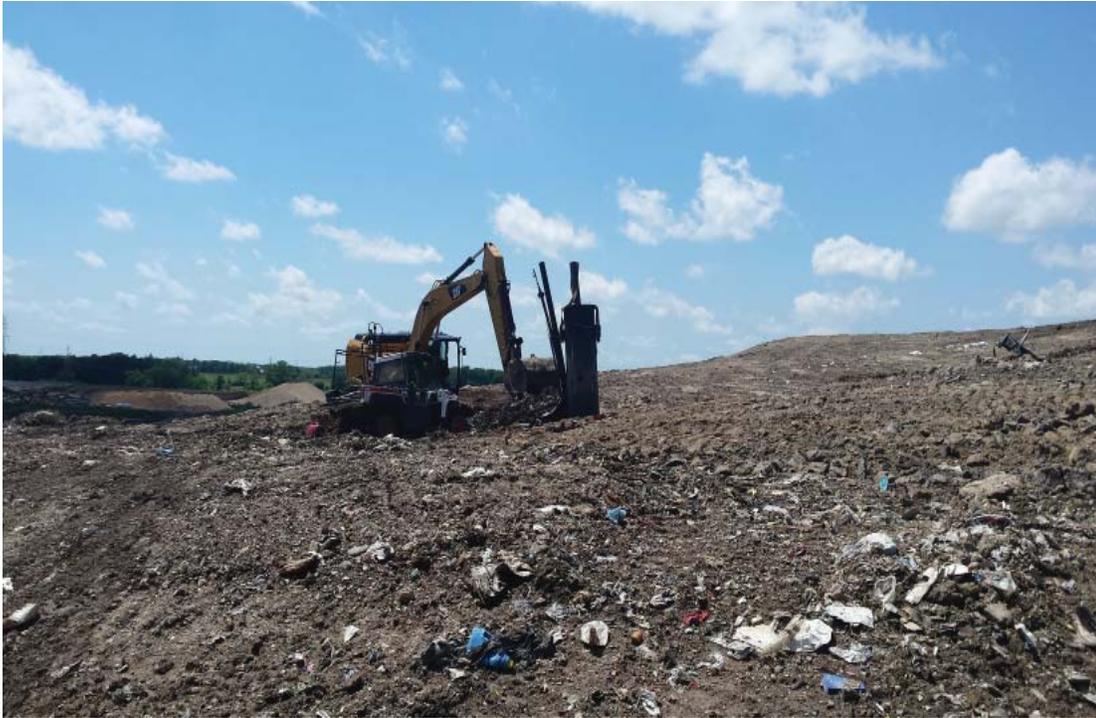
Contractor raising cason well

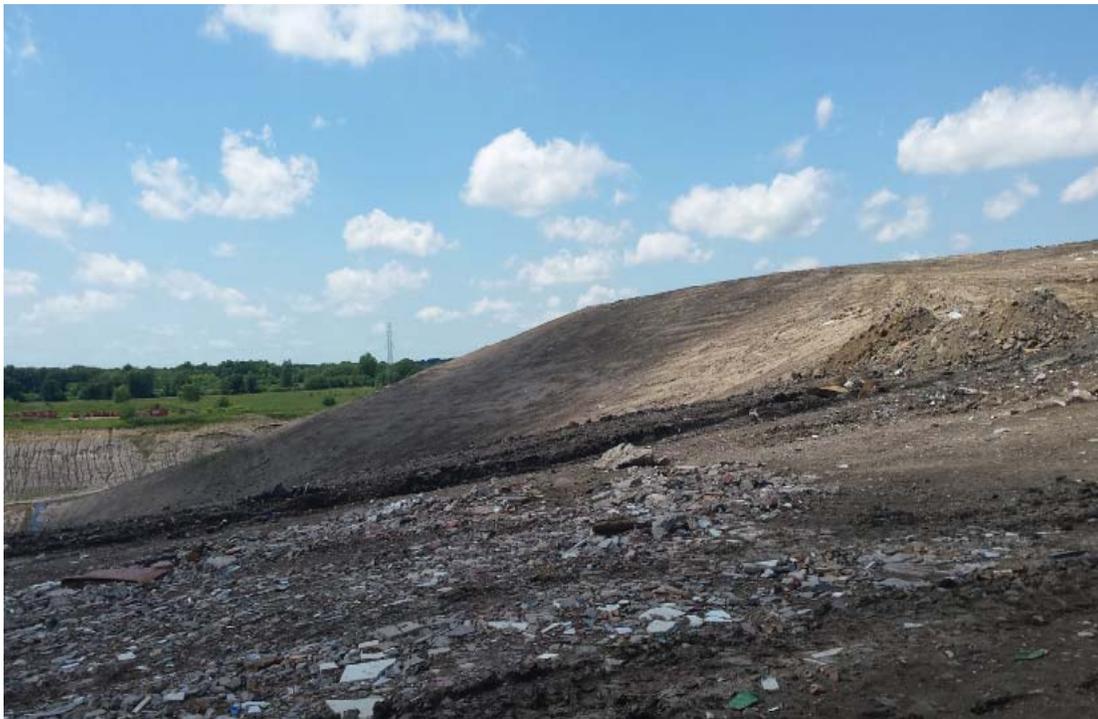
South slope of Phase 7
