## Memorandum

### ADS Emerald Park Landfill Audit Summary

**To:** ADS Emerald Park Landfill Standing Committee, City of Muskego  
**FROM:** Faith Spear.  
**COPIES:** File  
**DATE:** 8/15/2016  
**PROJECT NUMBER:** 1012.10030

**ADVANCED DISPOSAL SERVICES  
EMERALD PARK LANDFILL / CITY OF MUSKEGO  
AUDIT PHOTOS**

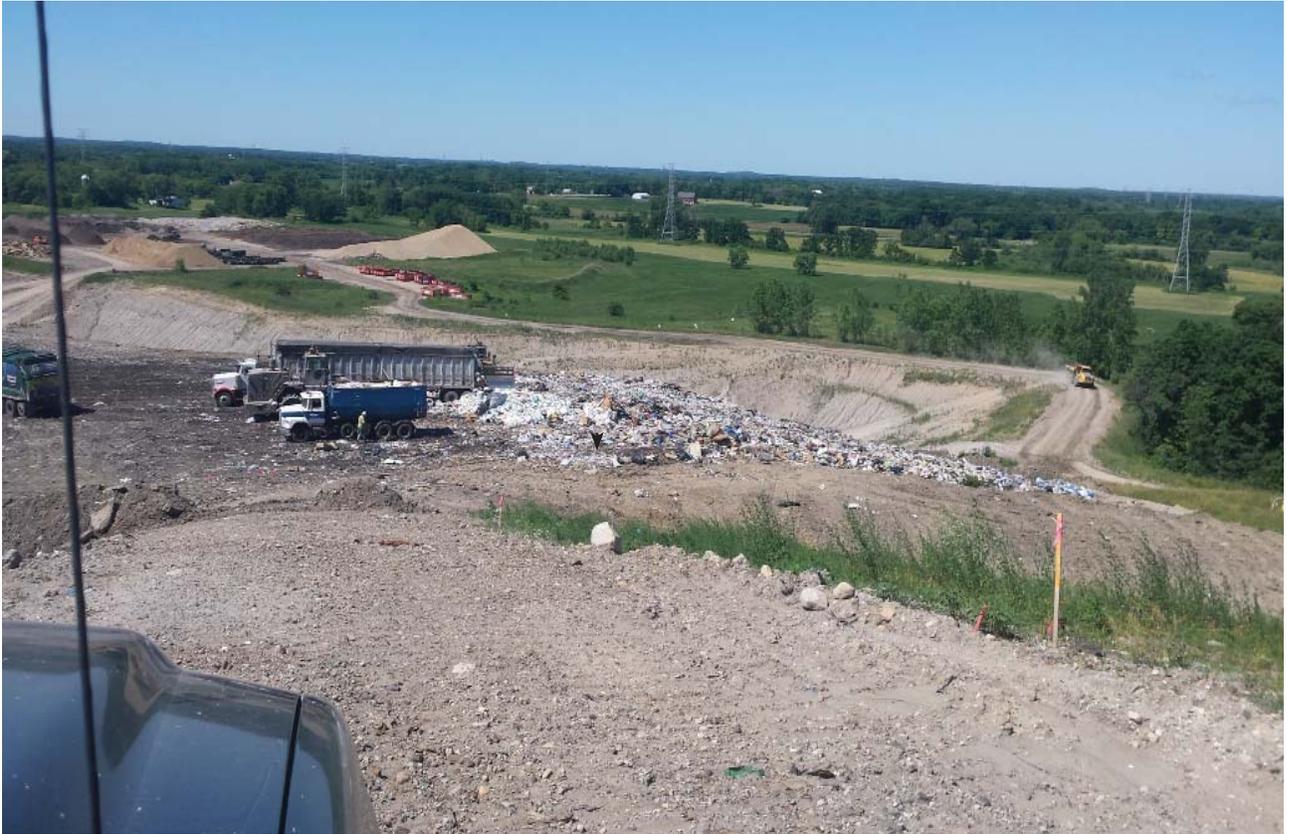
Working face in Northwestern most corner of Phase 7

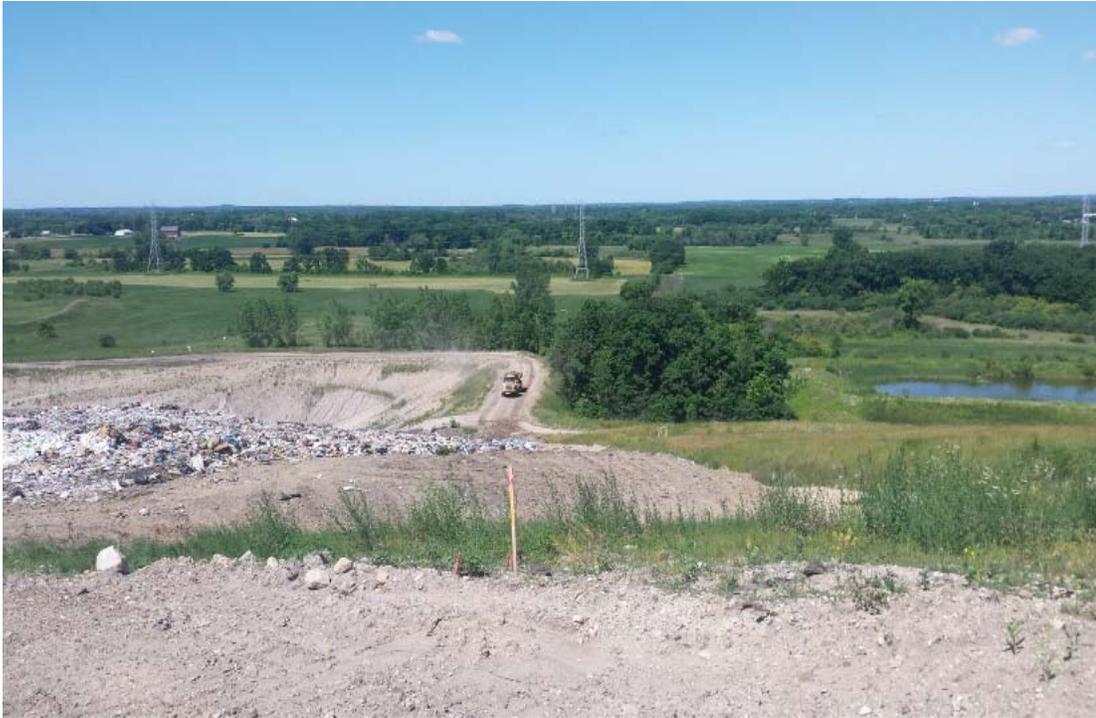
Working face viewed from the East

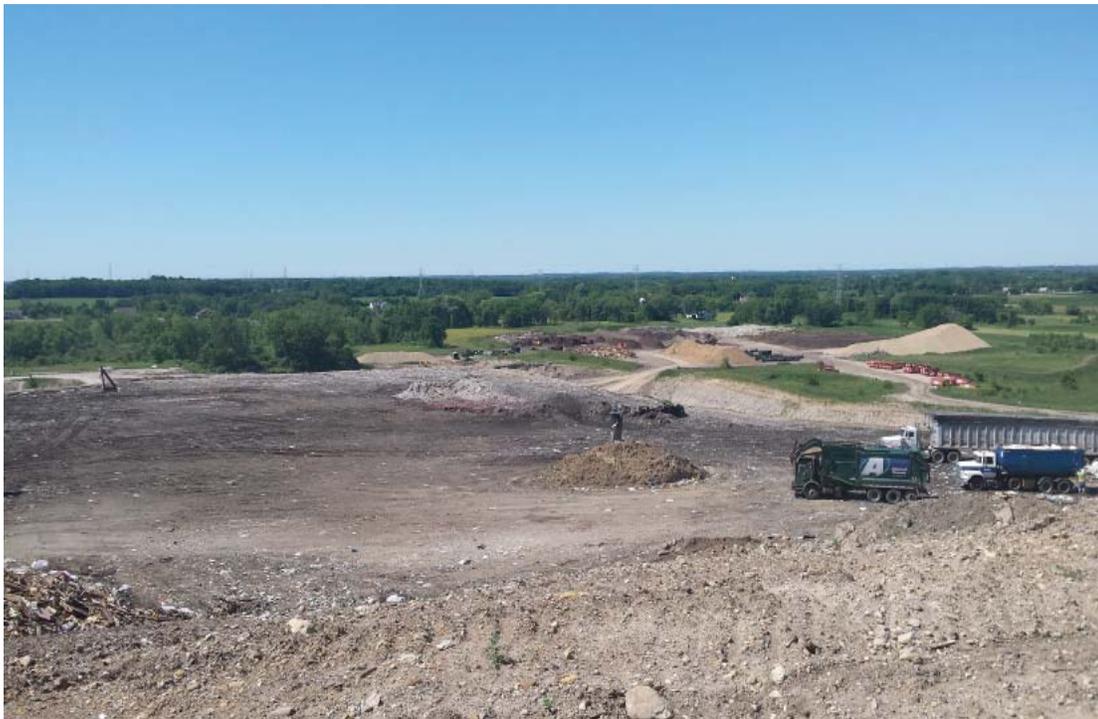
Western section of Active area

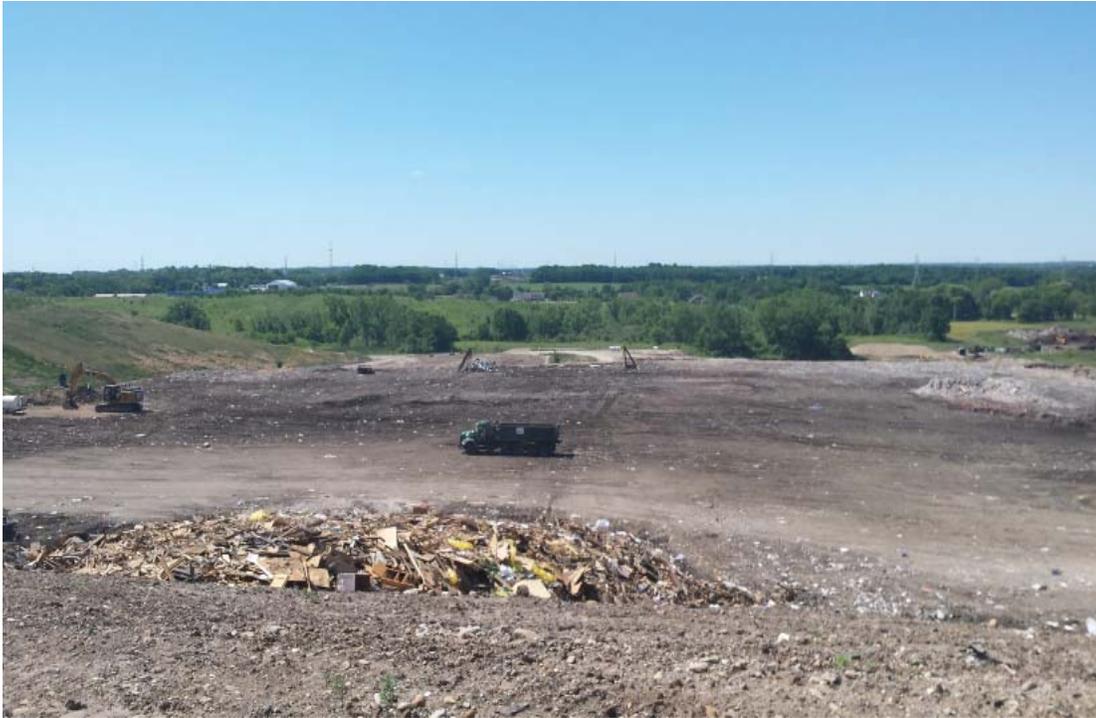
Active area viewed from the North

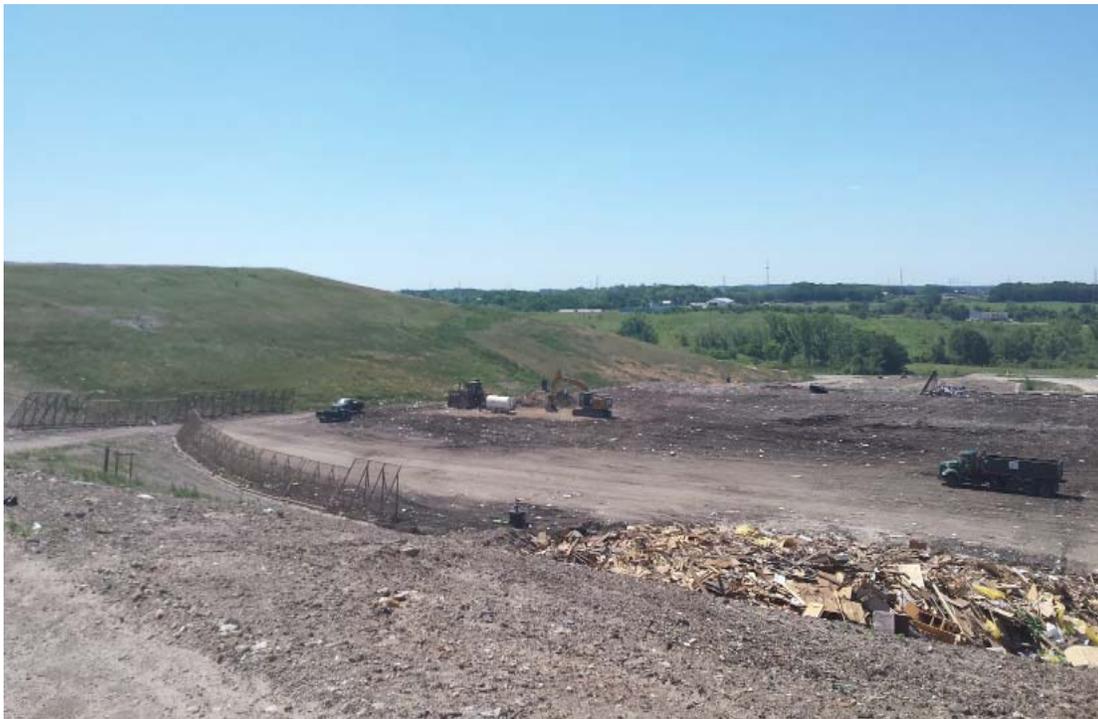
Eastern portion of active area

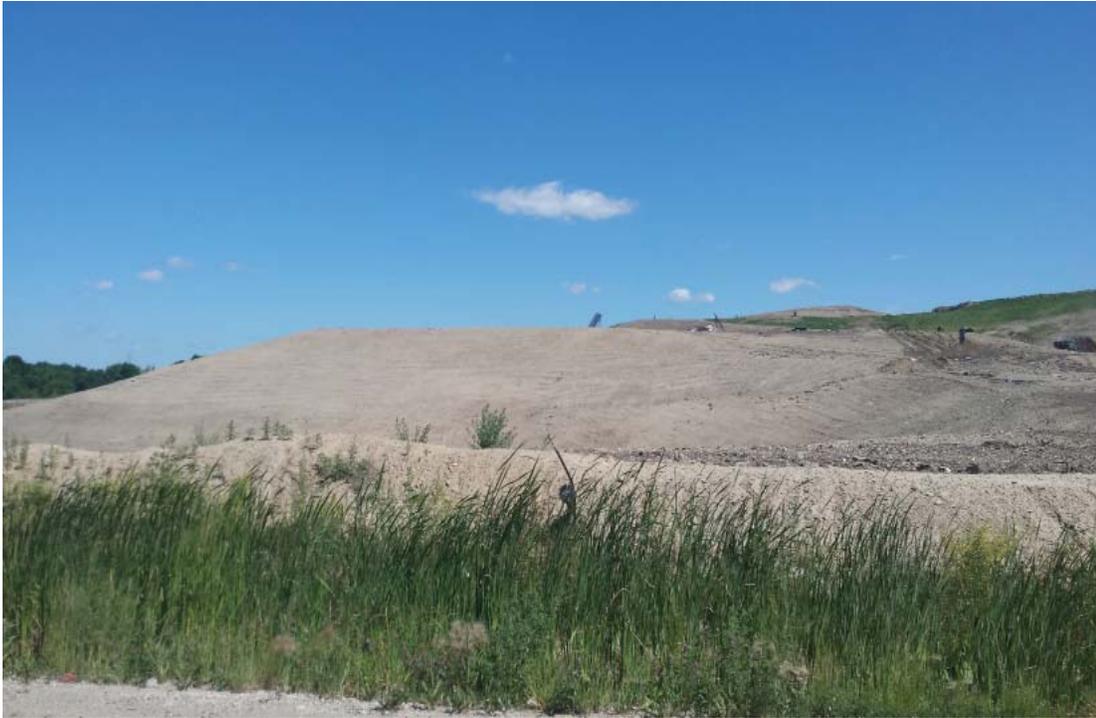
South slope of Phase 7

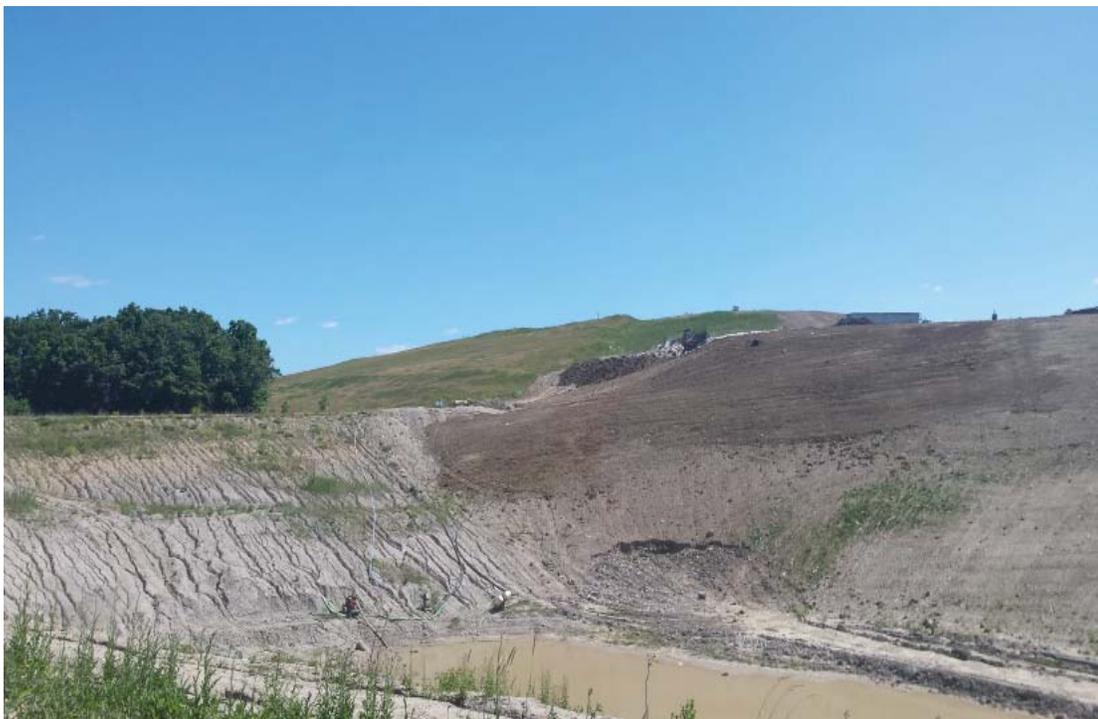
West slope of Phase 3 & 7, slope backdragged and regraded intermediate cover

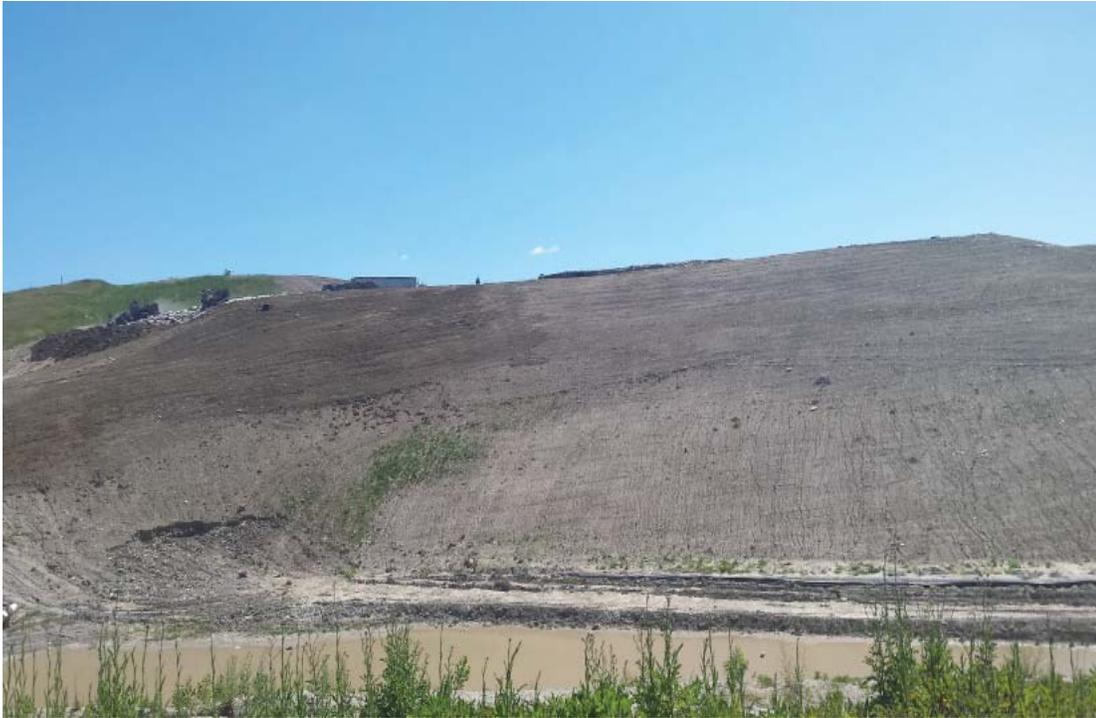
West slope of Phase 7

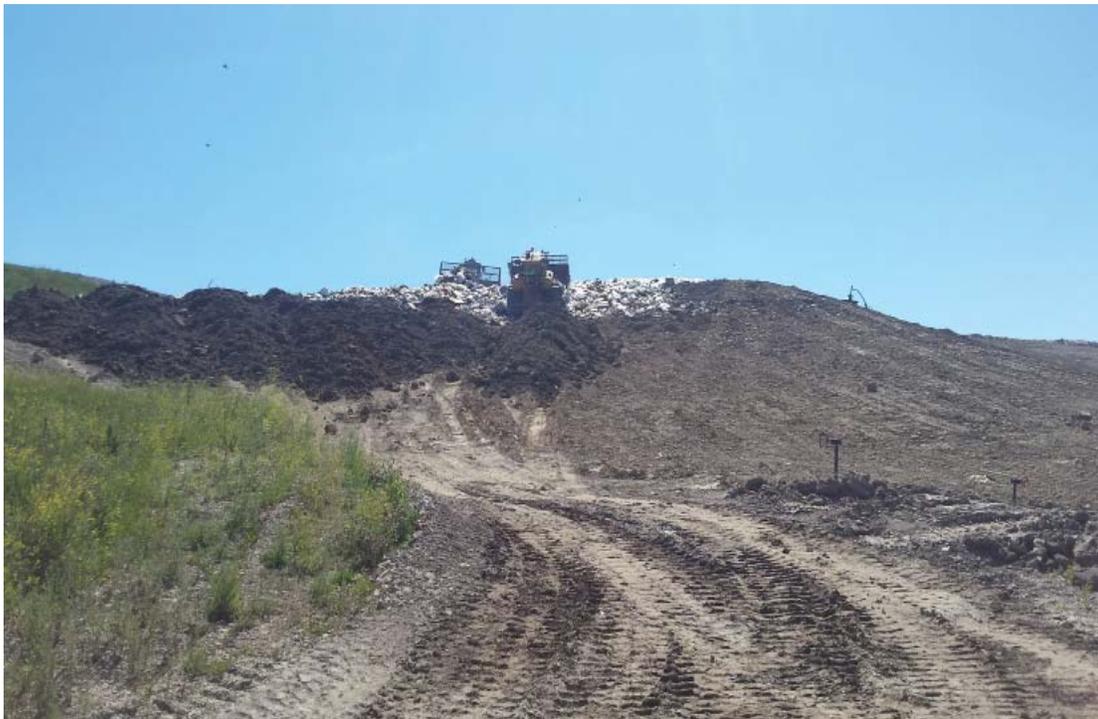
Working face in Northwest corner of Phase 7, viewed from West
