### ADS Emerald Park Landfill Audit Summary

**To:** ADS Emerald Park Landfill Standing Committee, City of Muskego  
**FROM:** Faith Spear.  
**COPIES:** File  
**DATE:** 8/29/16  
**PROJECT NUMBER:** 1012.10030

**ADVANCED DISPOSAL SERVICES  
EMERALD PARK LANDFILL / CITY OF MUSKEGO  
AUDIT PHOTOS**

PROJECT NO. 1012.10030

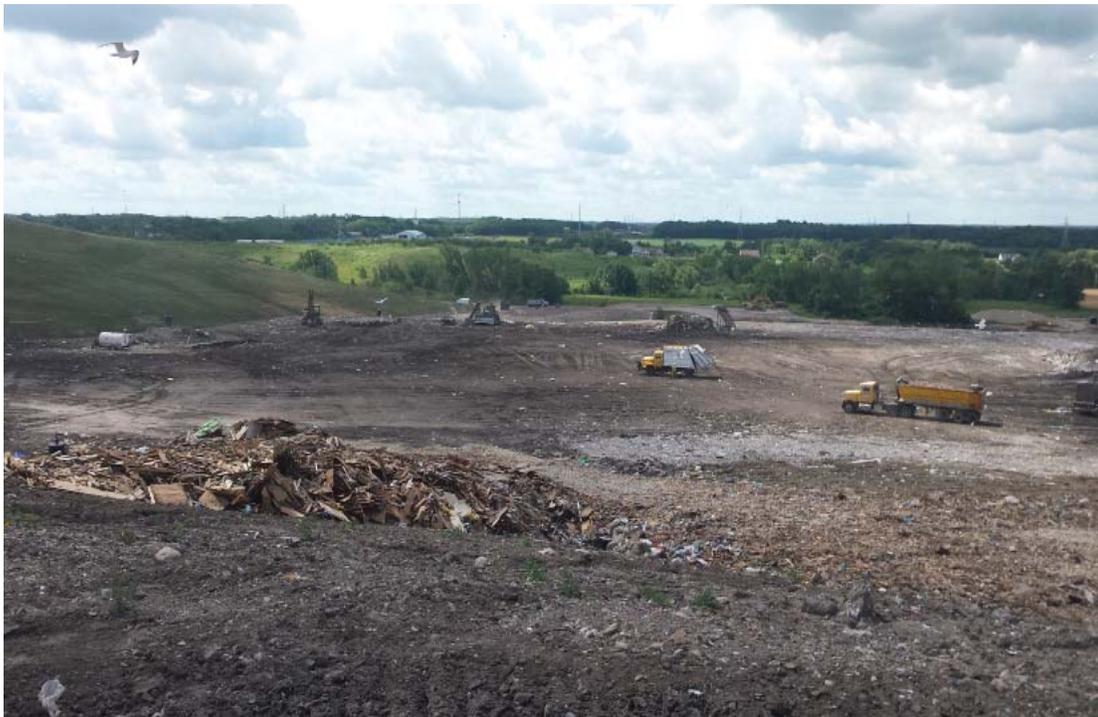
Western section of Active area

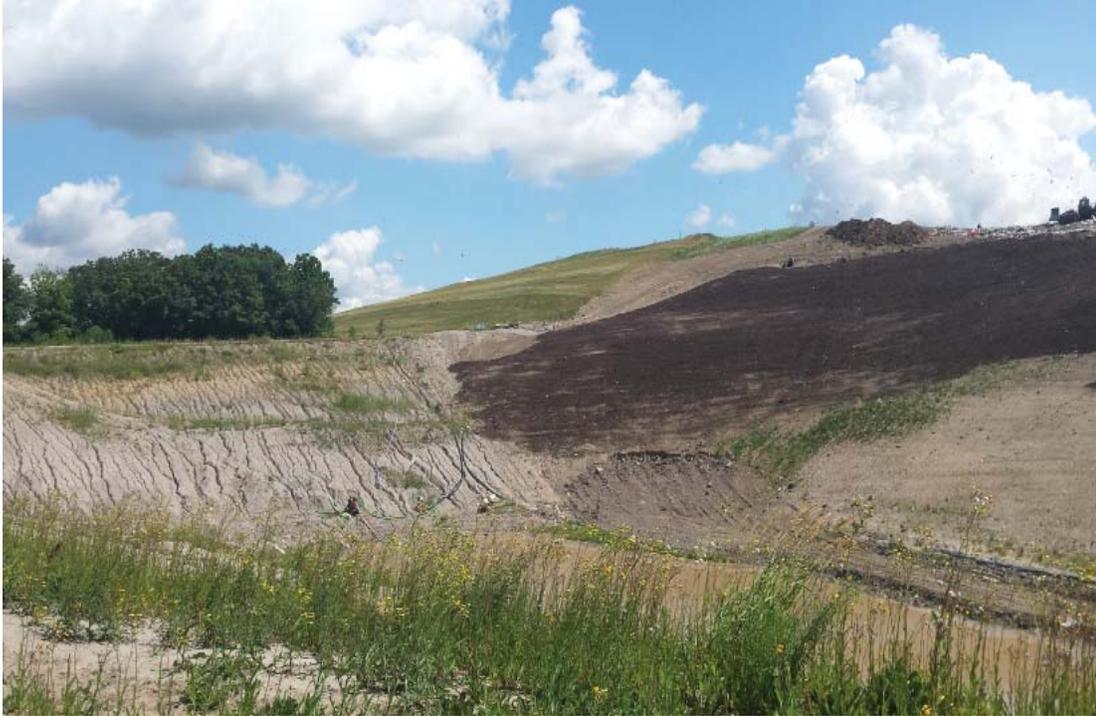
Phase 3 and 7 junction

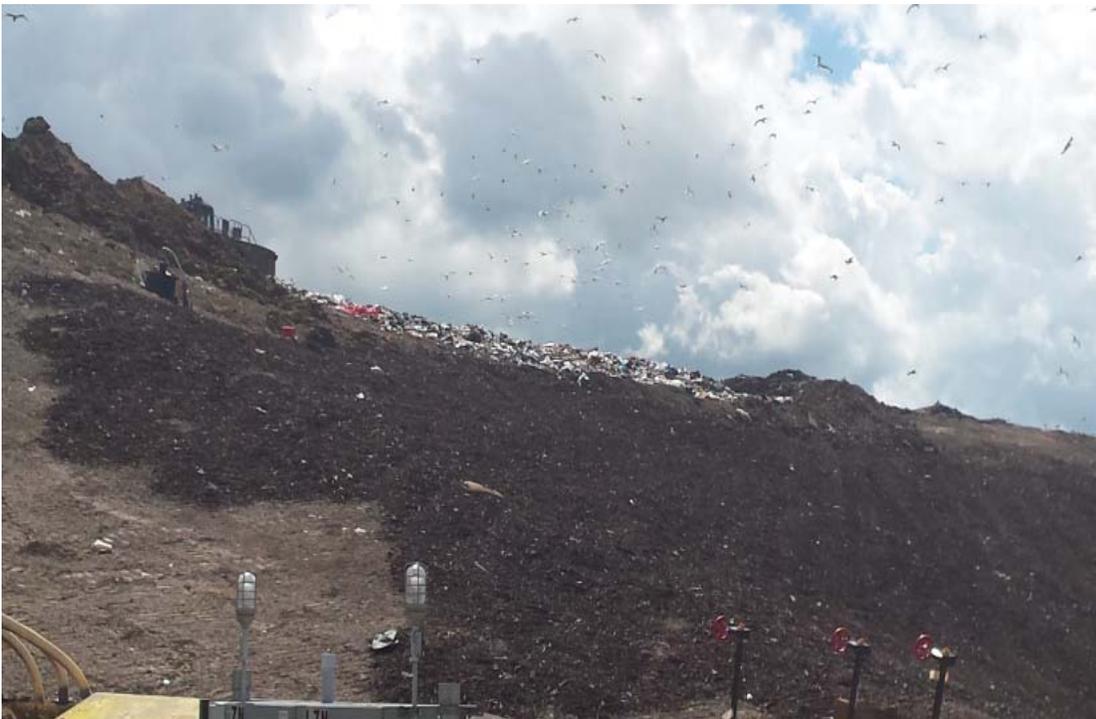
Working face viewed from West and below Phase 7
