ADS Emerald Park Landfill Audit Summary

To: ADS Emerald Park Landfill Standing Committee, City of Muskego
FROM: Faith Spear.
COPIES: File
DATE: 8/29/16
PROJECT NUMBER: 1012.10030

Attached is the audit report for activities at the ADS Emerald Park Landfill for the week of July 3, 2016. The audit was performed at 10:32 AM on **July 8, 2016** by Jo Spear, Jr. in the presence of Scott Croft, Landfill Technician.

**ADVANCED DISPOSAL SERVICES
EMERALD PARK LANDFILL / CITY OF MUSKEGO
AUDIT PHOTOS**

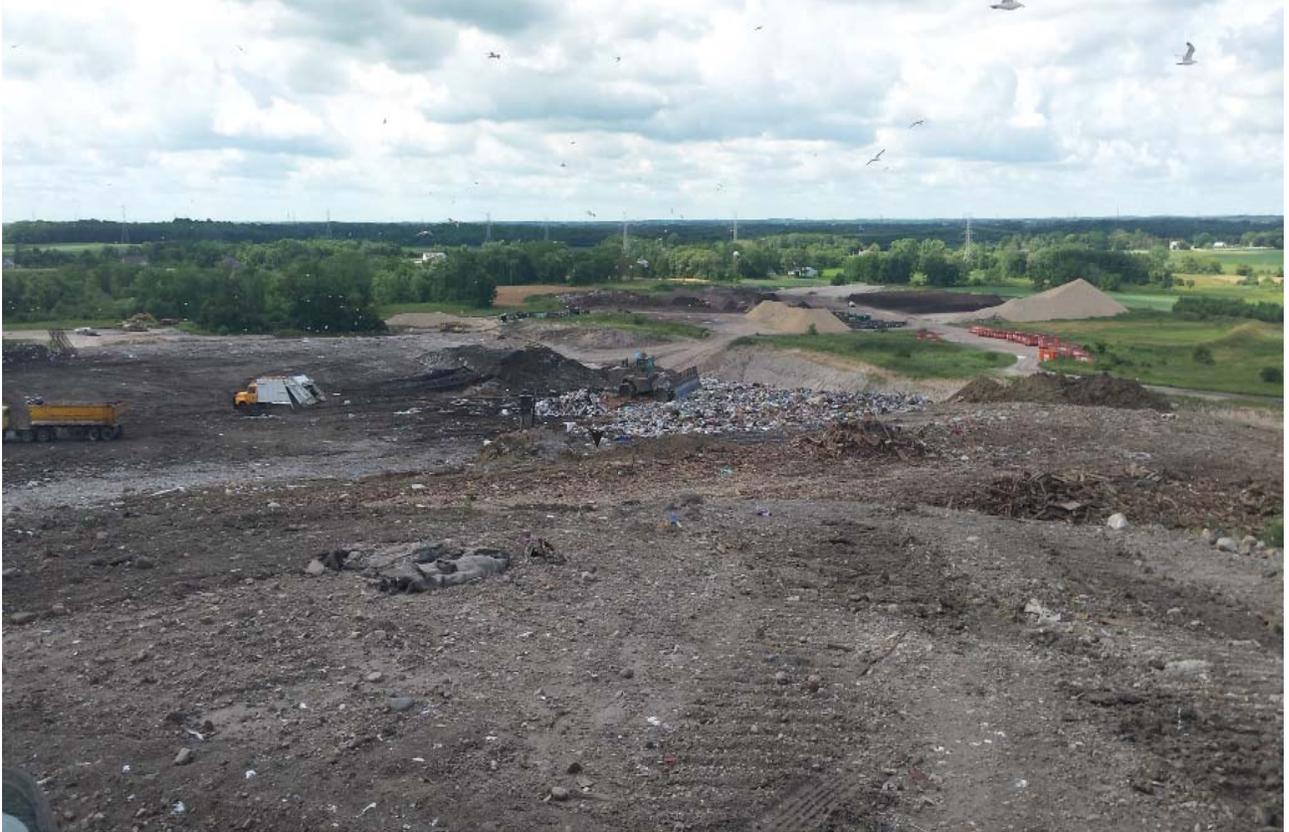
Working face in Northwestern most corner of Phase 7

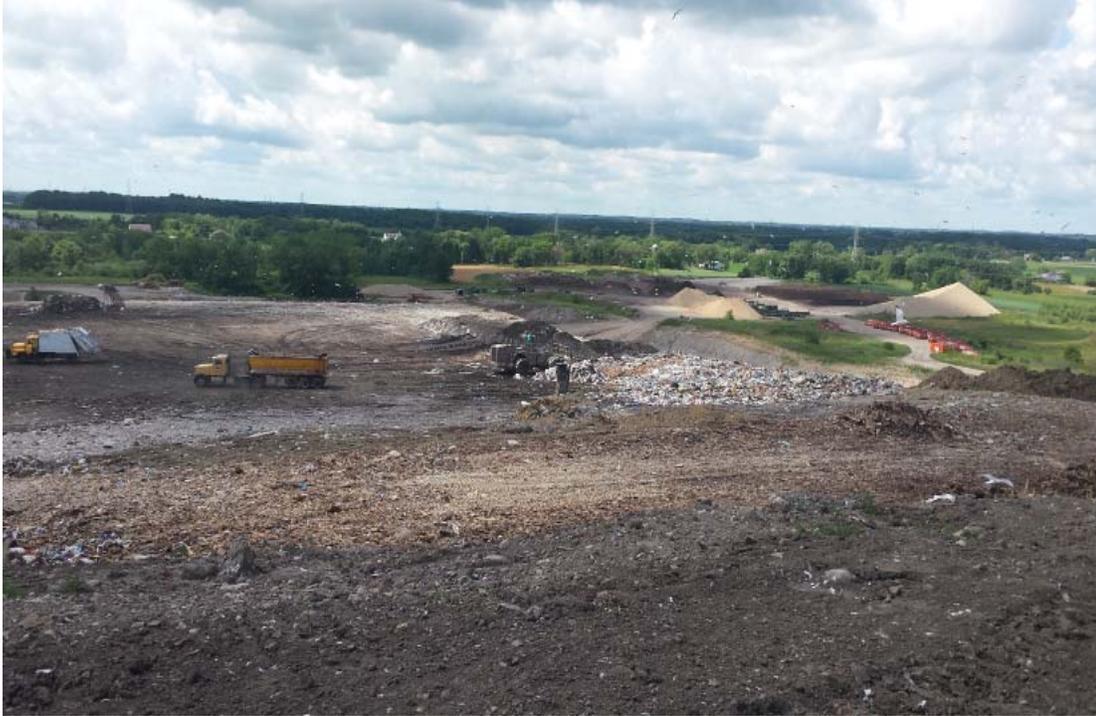
Working face viewed from the North

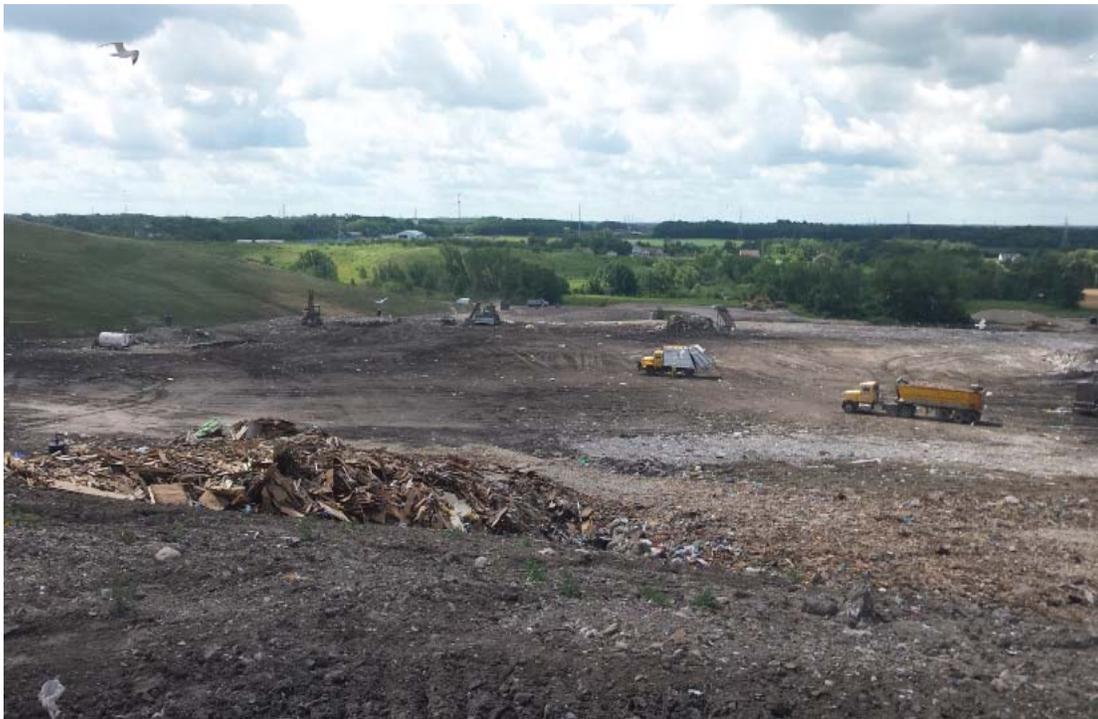
Western section of Active area

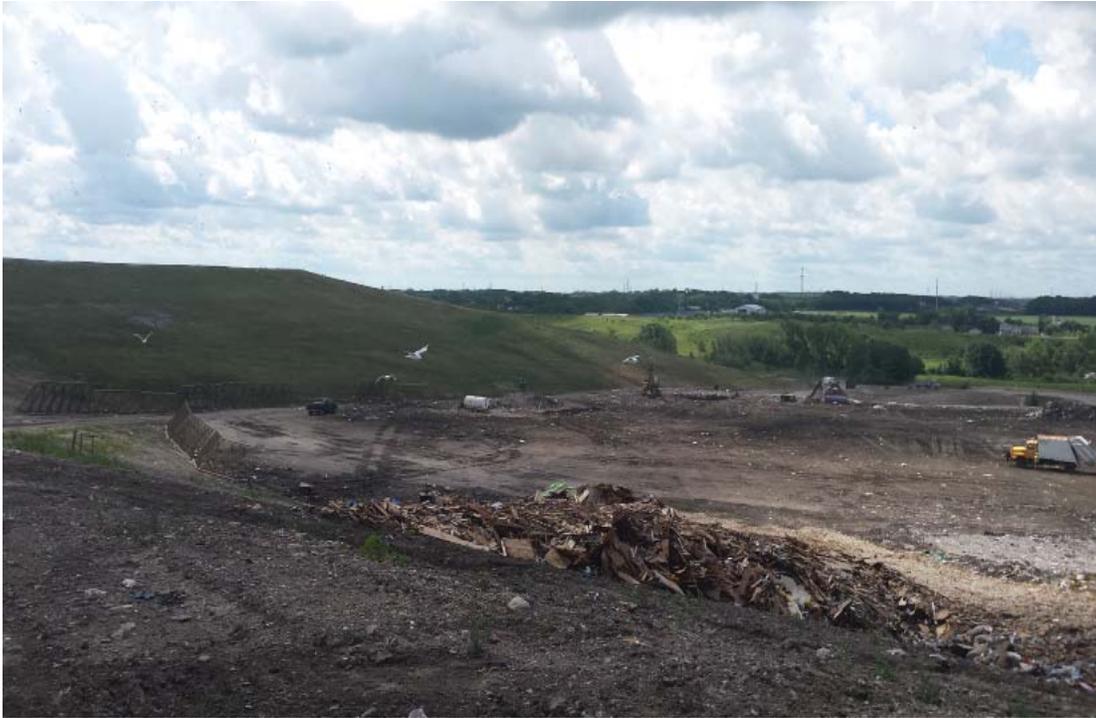
Active area viewed from the North

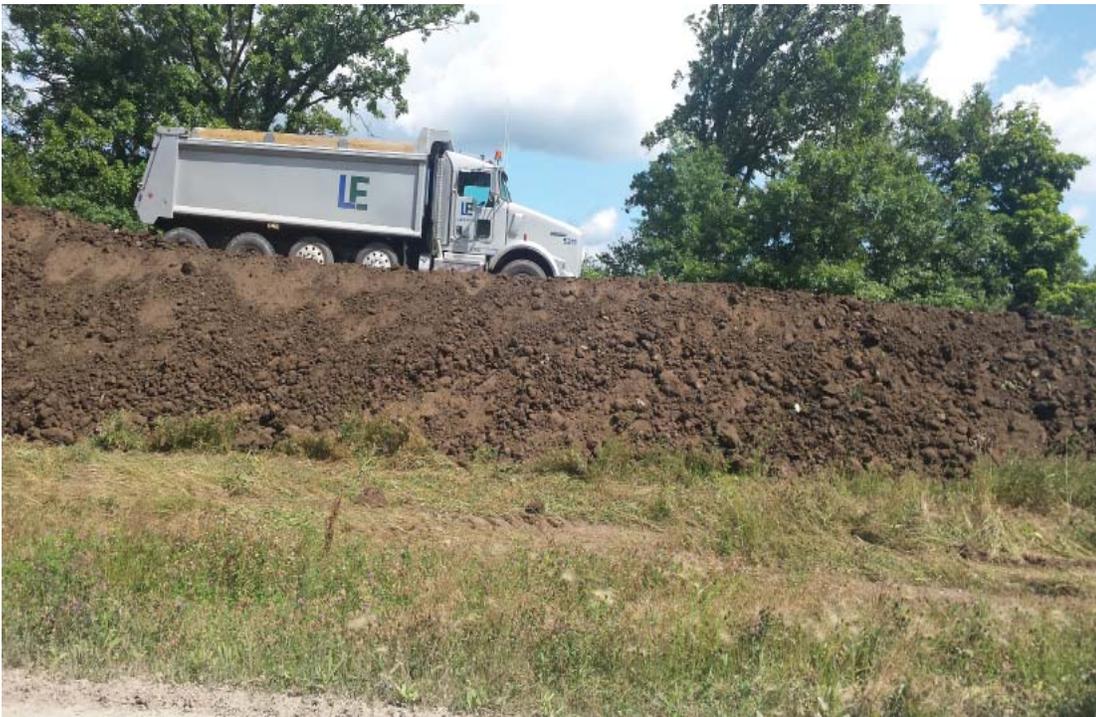
- Site staff stockpiling soil loads suitable for use as topsoil
 - Soil stockpiles North of access road to Compost Operations

Top soil stockpiled South of Phase 7 and East of Yard Waste Area

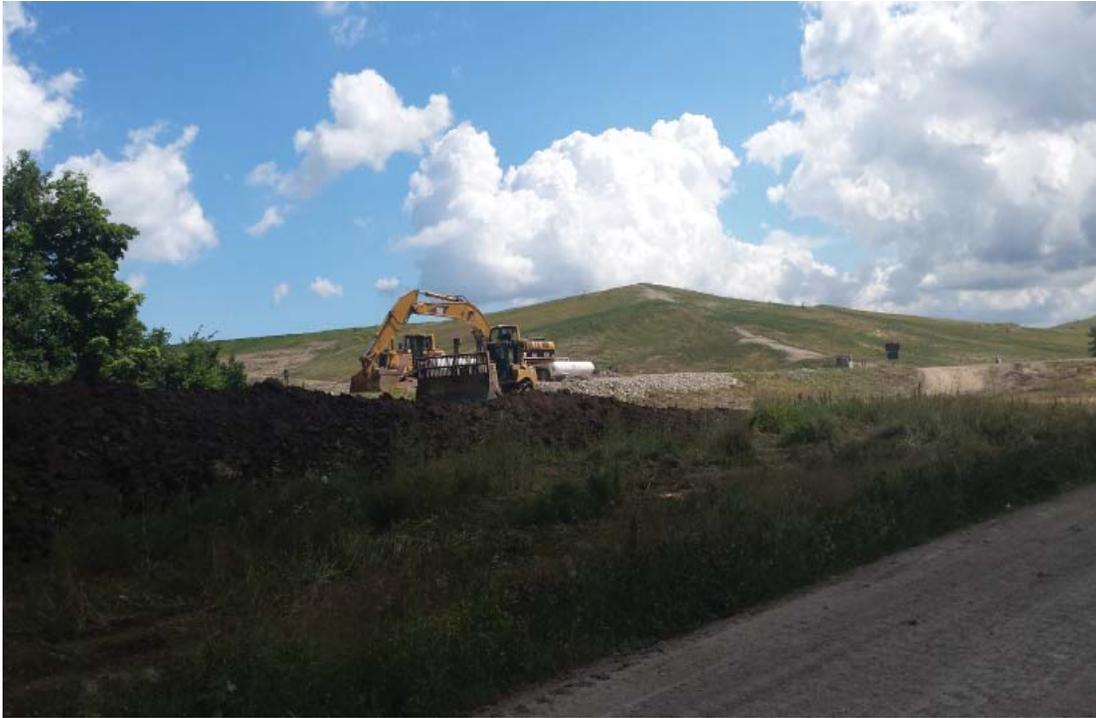
Excavation area

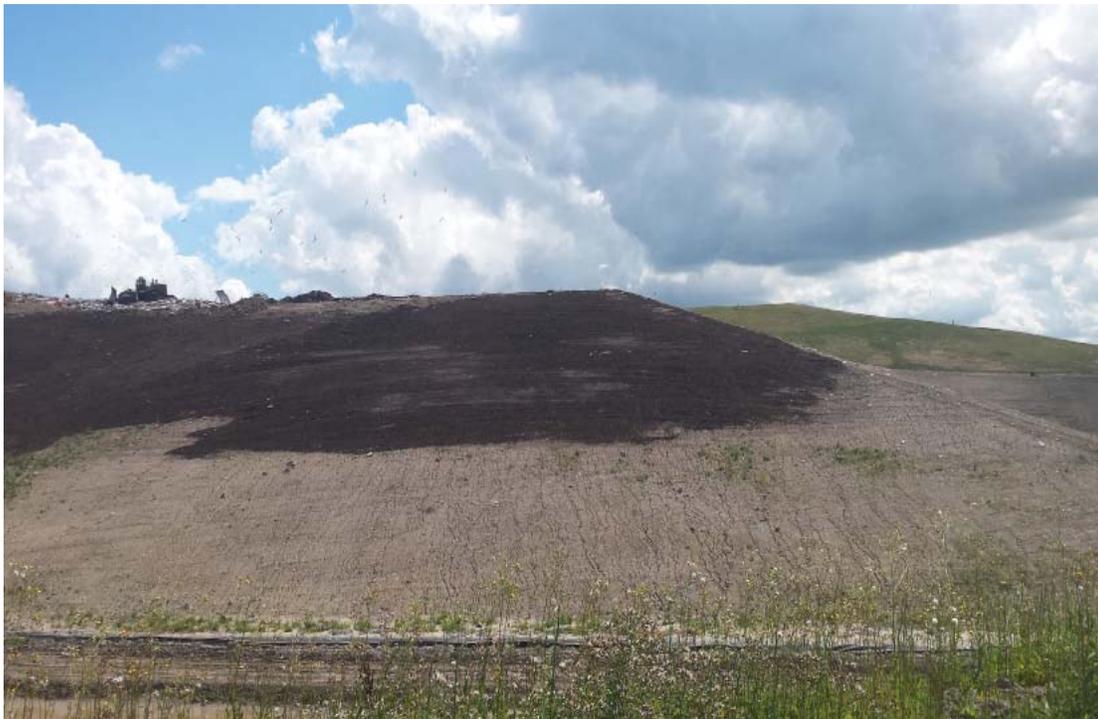
- Additional compost has been placed on West slope of Phase 7

- Erosion repairs are now covered with vegetation

West slope of Phase 7

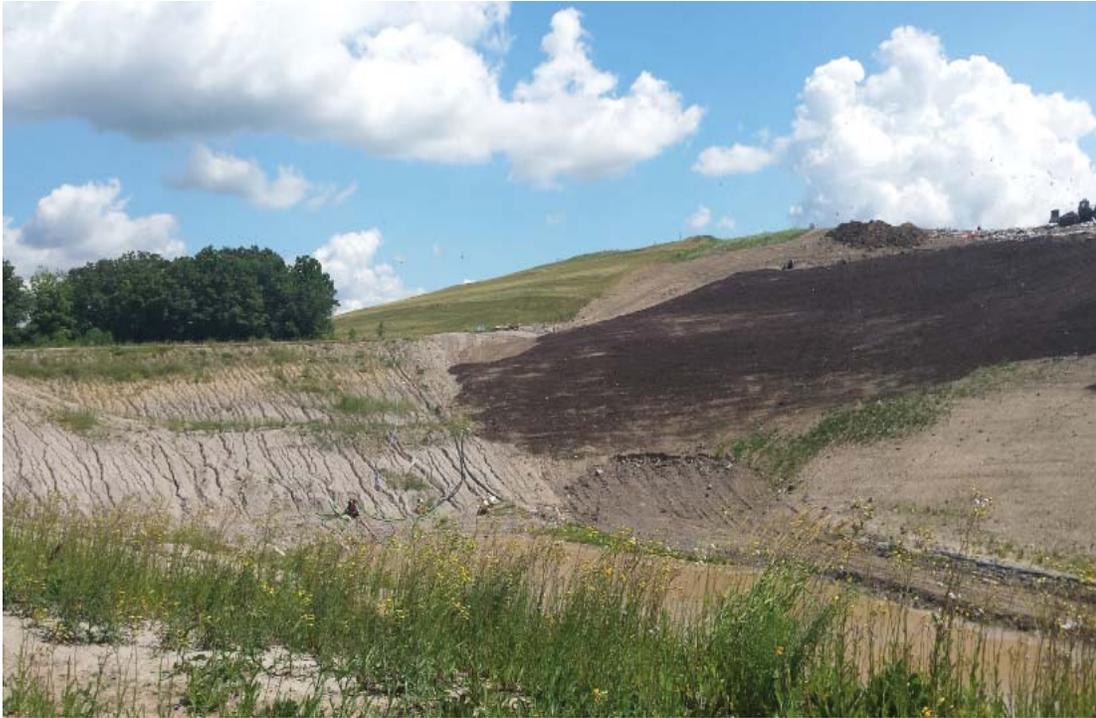
Phase 3 and 7 junction

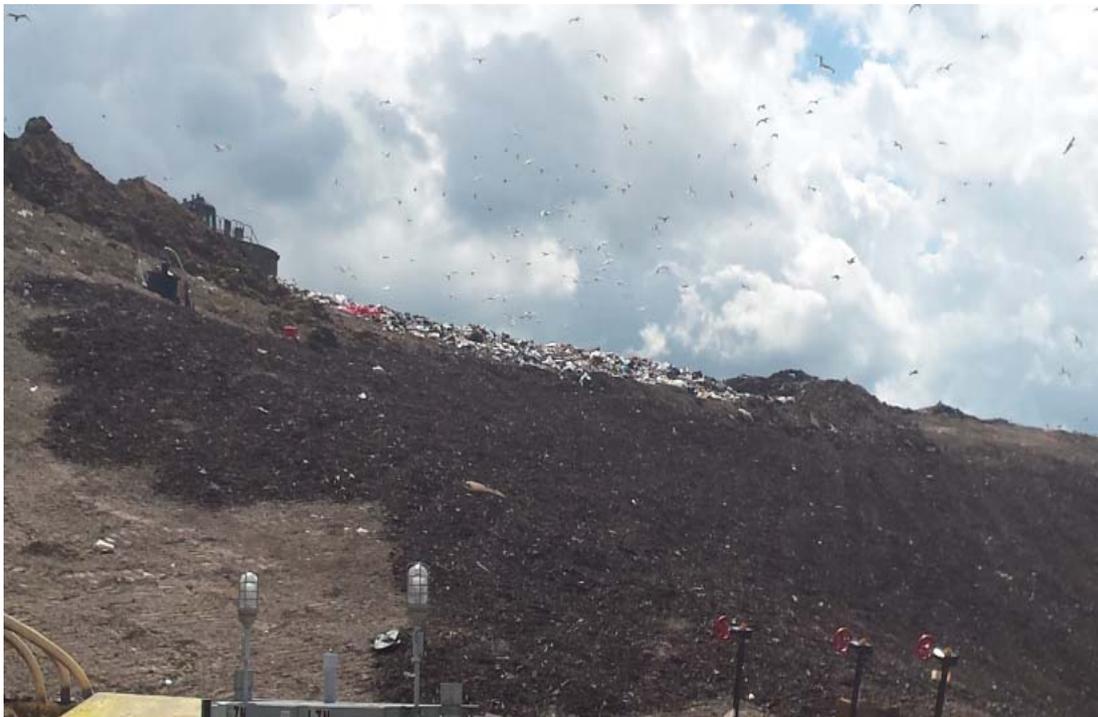
Working face viewed from West and below Phase 7
