### ADS Emerald Park Landfill Audit Summary

**TO:** ADS Emerald Park Landfill Standing Committee, City of Muskego  
**FROM:** Faith Spear.  
**COPIES:** File  
**DATE:** 8/15/16  
**PROJECT NUMBER:** 1012.10030

**ADVANCED DISPOSAL SERVICES  
EMERALD PARK LANDFILL / CITY OF MUSKEGO  
AUDIT PHOTOS**

PROJECT NO. 1012.10030

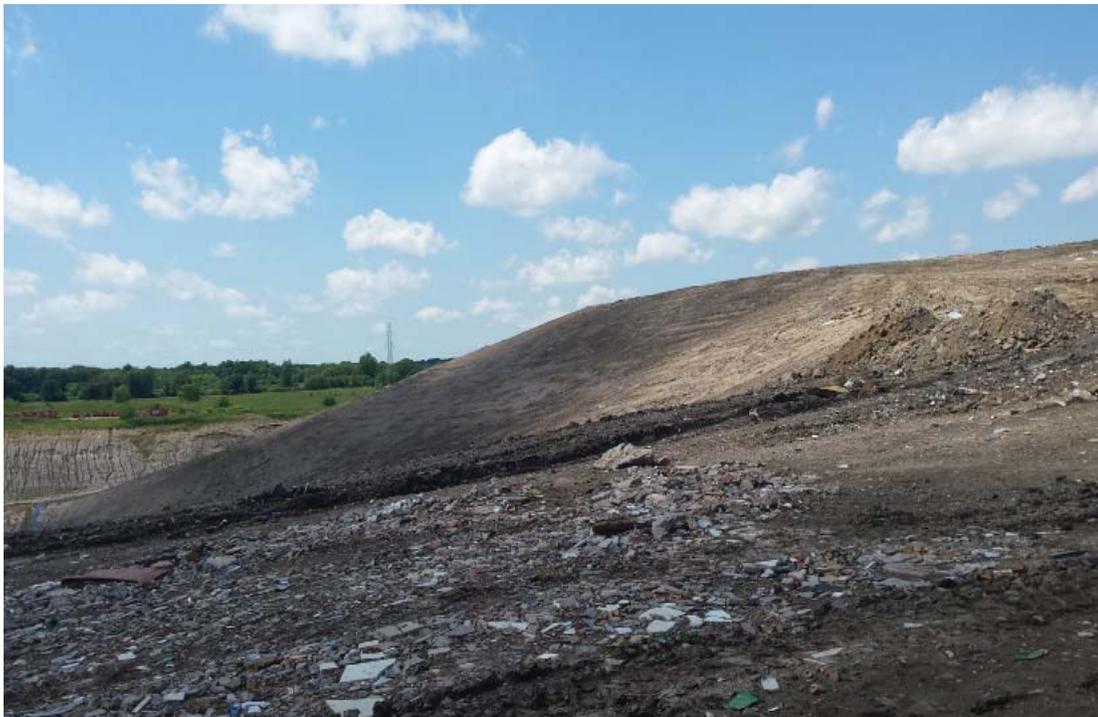
South slope of Phase 7
