Memorandum

ADS Emerald Park Landfill Audit Summary

To: ADS Emerald Park Landfill Standing Committee, City of Muskego
FROM: Faith Spear.
COPIES: File
DATE: 9/15/16
PROJECT NUMBER: 1012.10030

**ADVANCED DISPOSAL SERVICES
EMERALD PARK LANDFILL / CITY OF MUSKEGO
AUDIT PHOTOS**

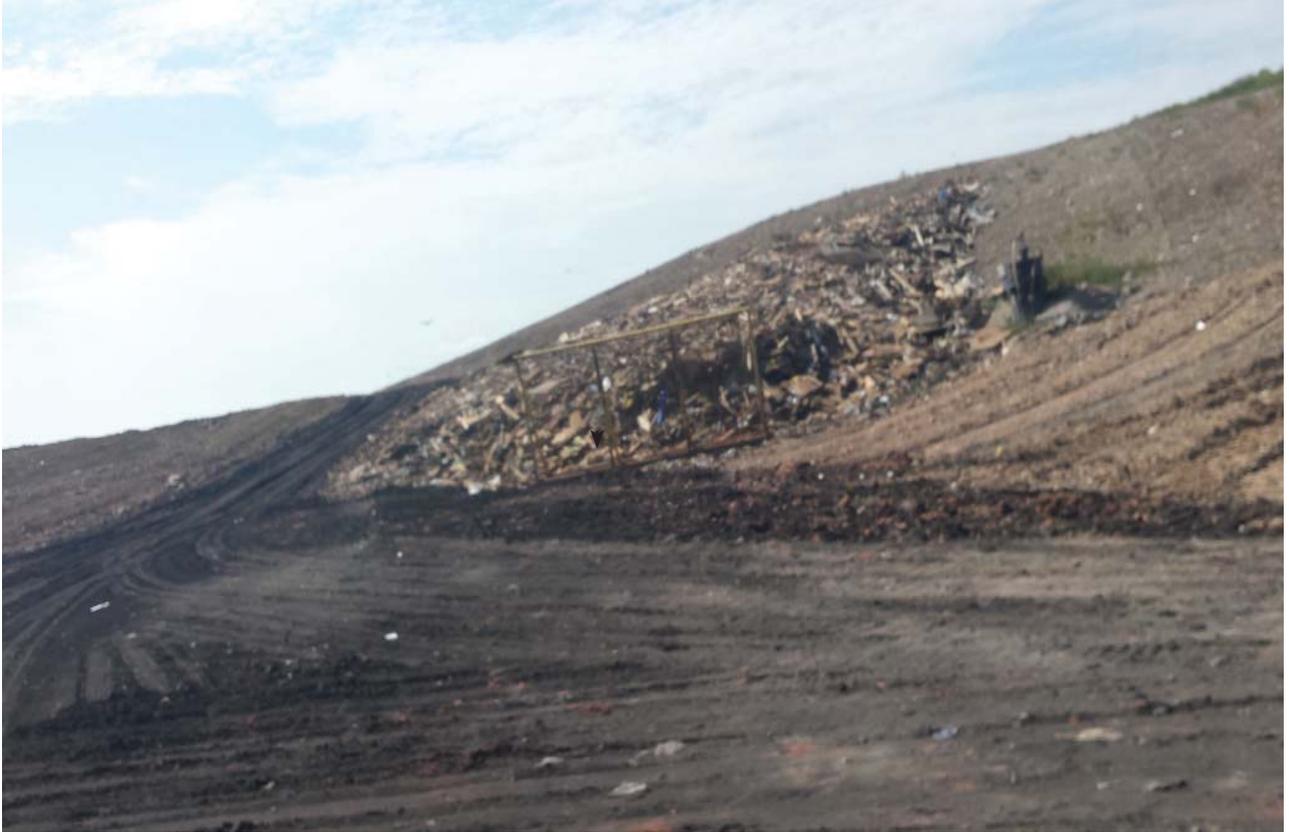
Wood stockpiled on the slope between Phases 3 and 7 for creating travel ways

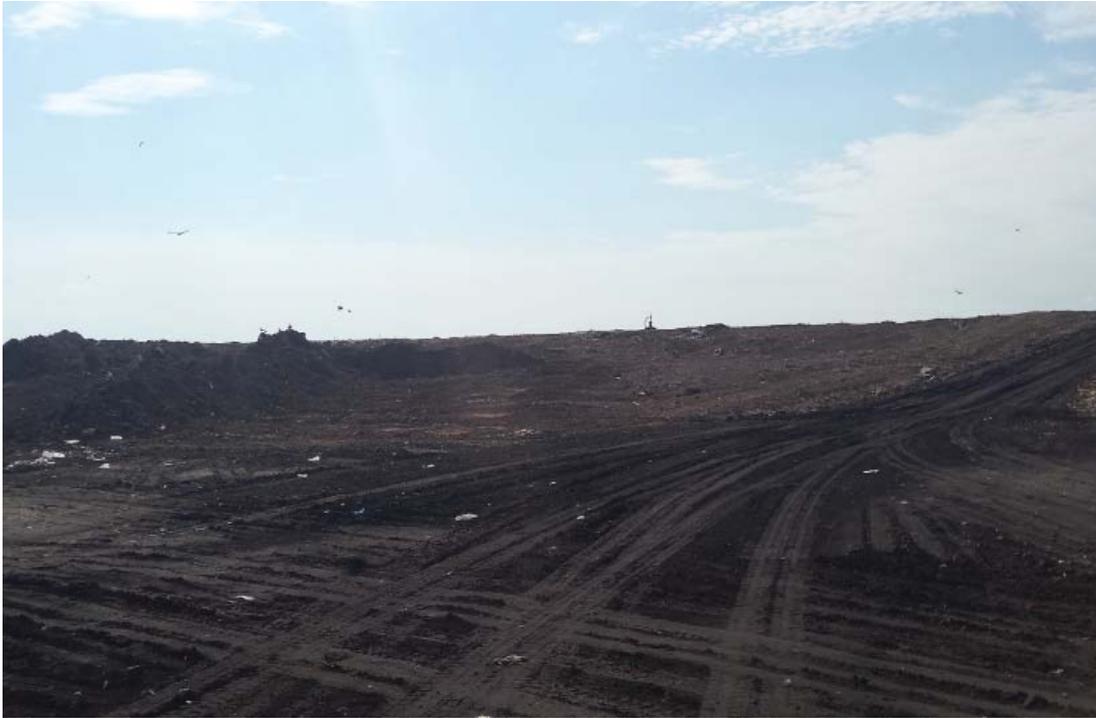
Active area of Phase 7

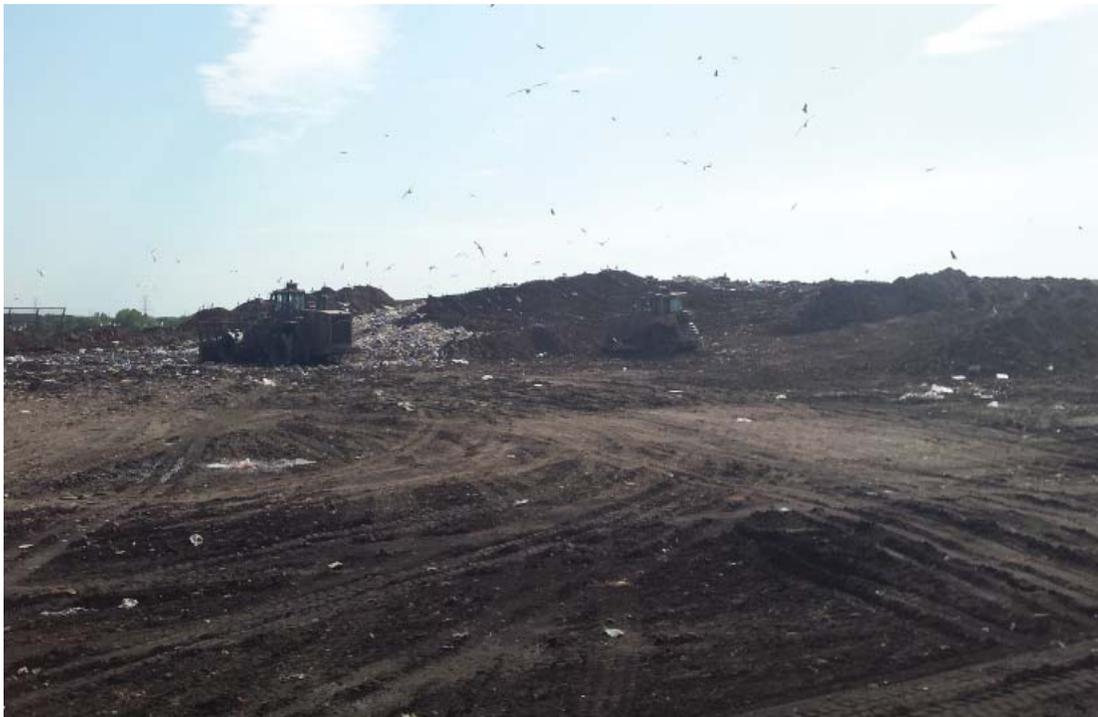
Working face in Southwest corner of Phase 7

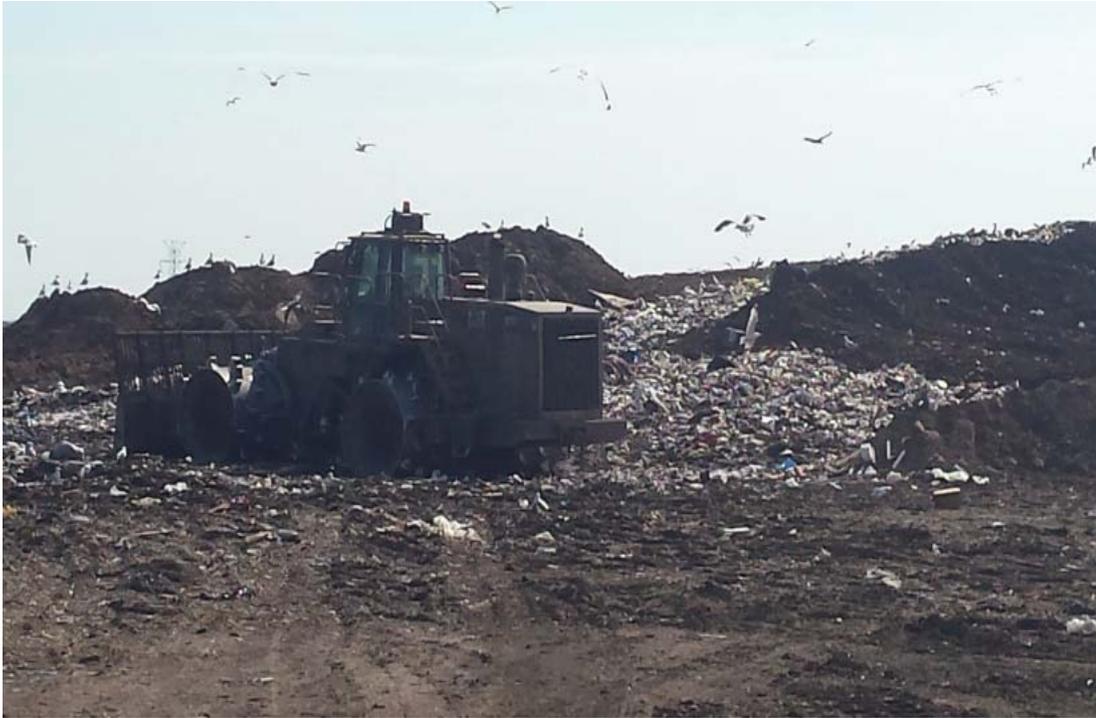
Compactor cleaning up working face prior to cover

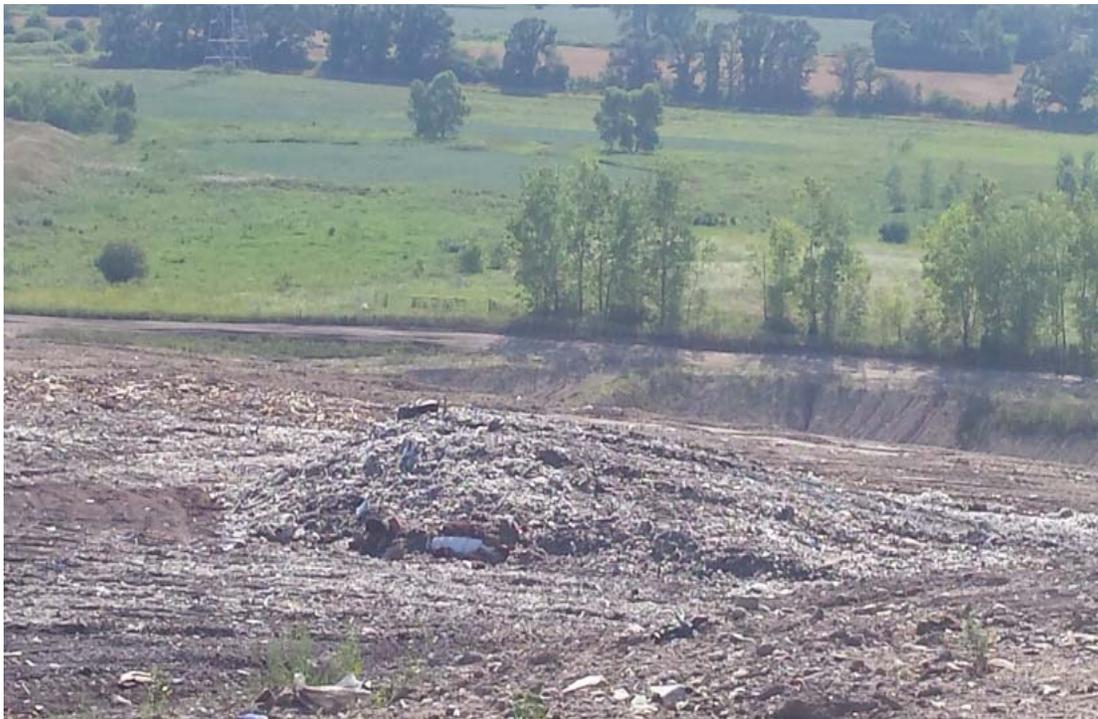
Poly-fluff or MRF screenings stockpiled for cover

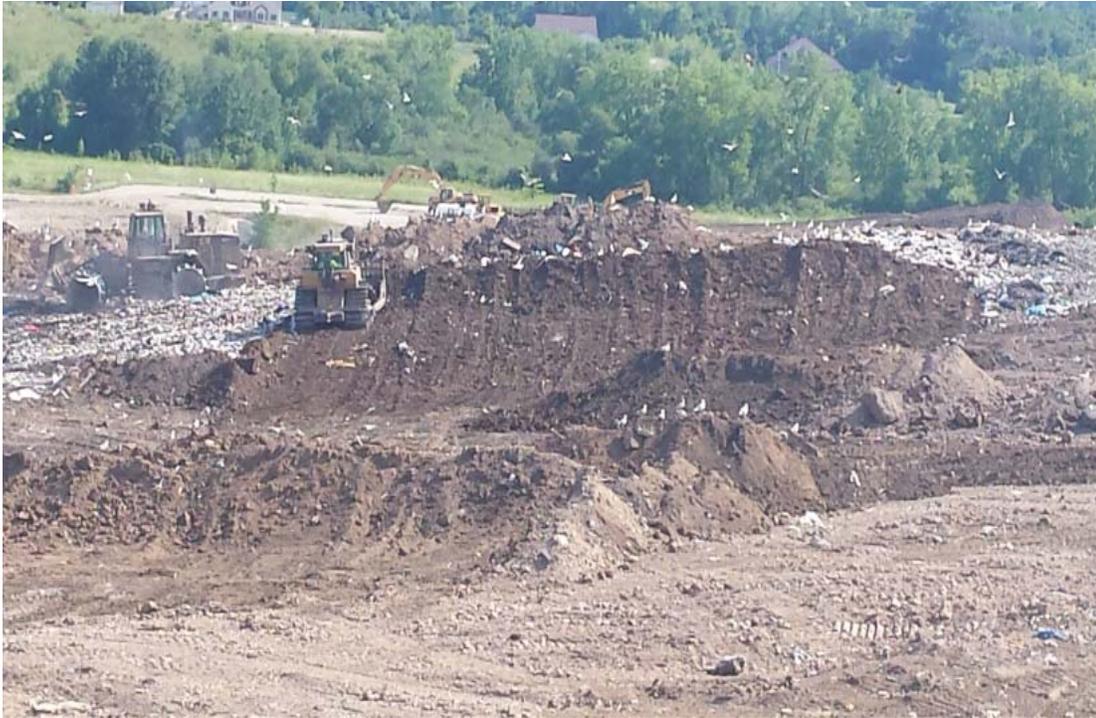
Working face, soils being used for daily cover

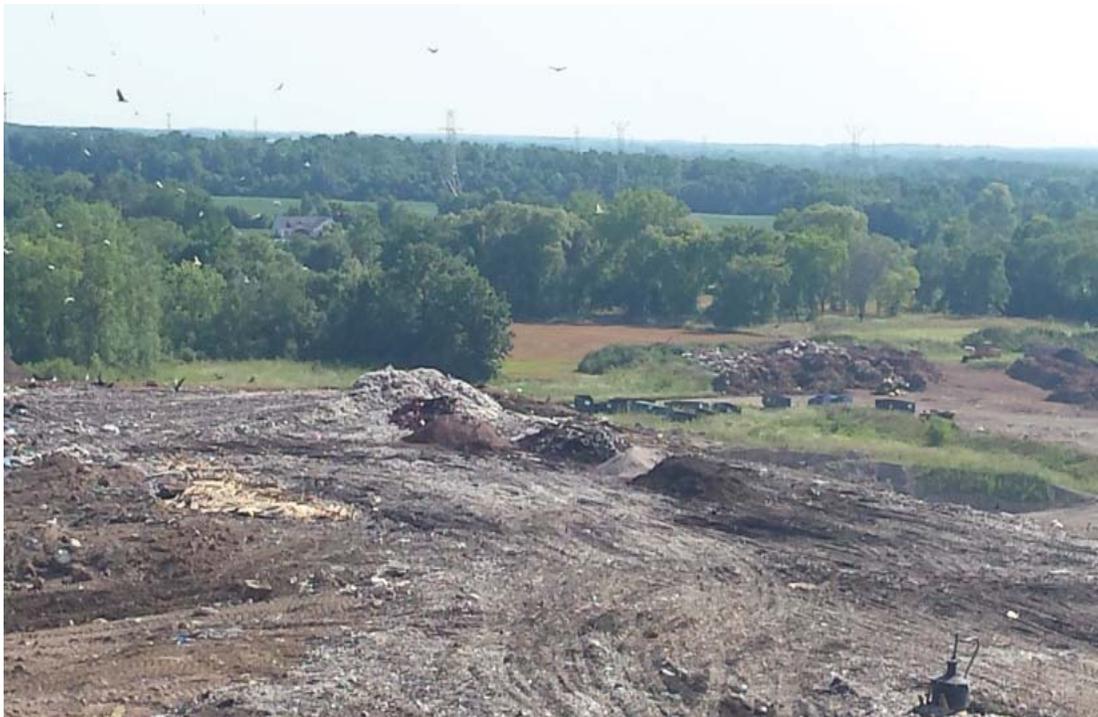
West slope of Phase 7 with daily cover types stockpiled

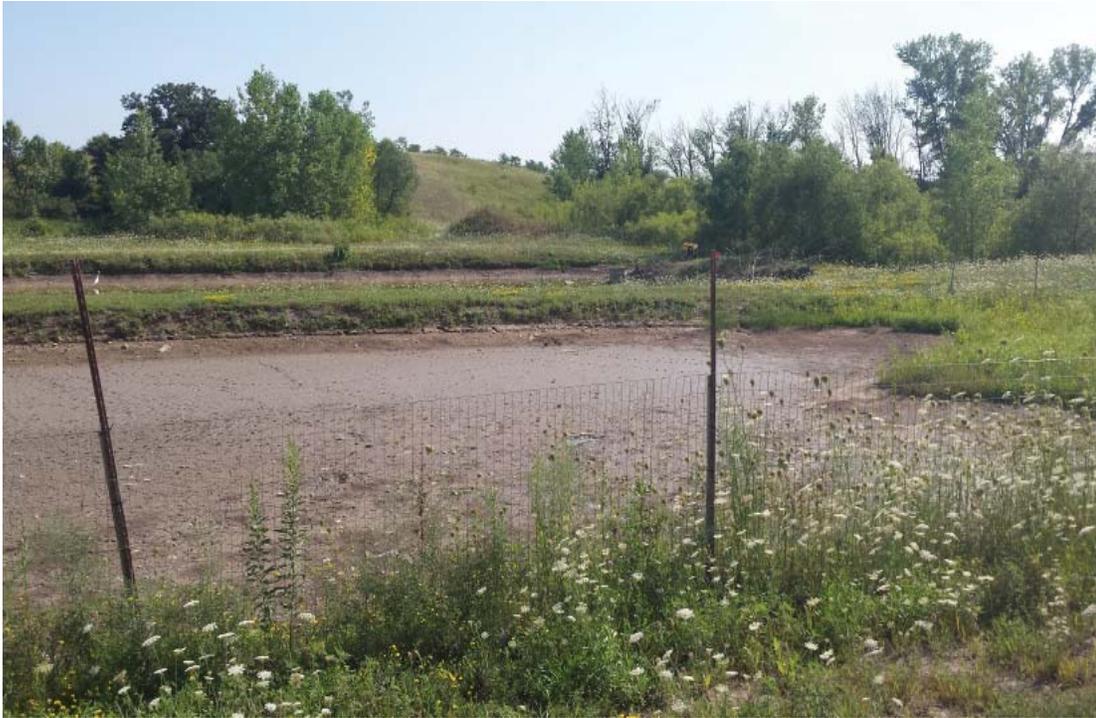
- Basin #2 has been drained in prep for cleaning
 - Cleaning will begin next week, weather permitting
 - Basin outfall will also be cleaned
- Perimeter drainage system being upgraded by addition of check dams

Basin #2, partially cleaned

* Basin #2 Drained and will be cleaned, starting next week weather permitting
Basin outfall will also be cleaned

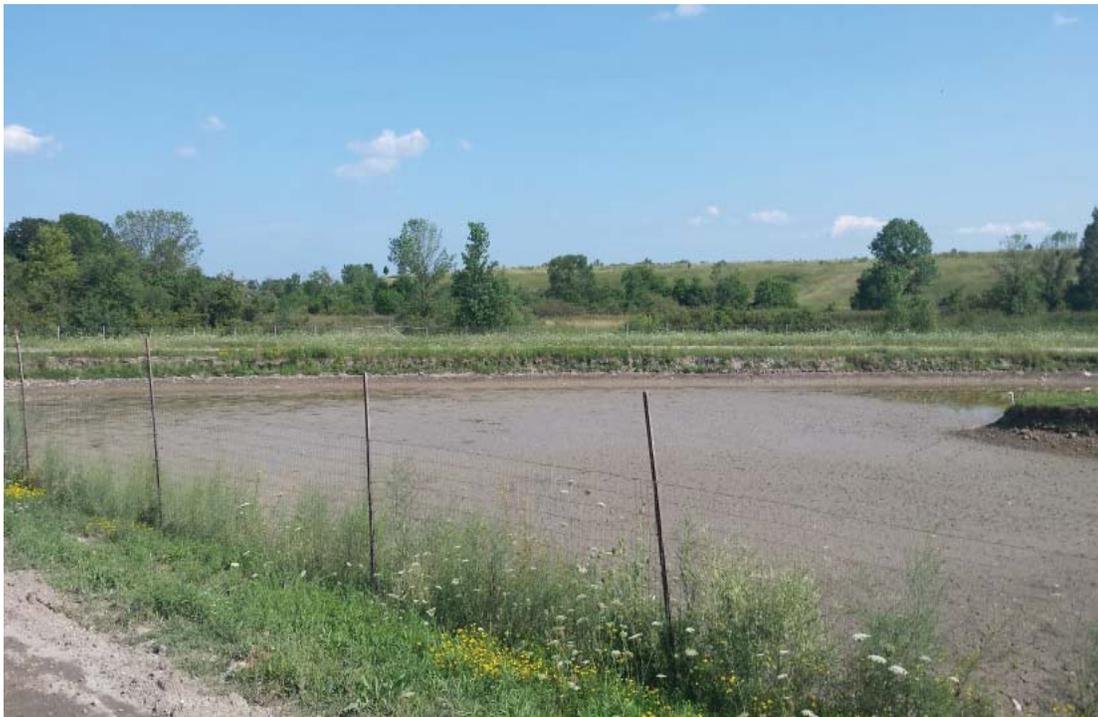
Minor storm event on S/S
Basin #2 drained

Basin #2, flooded from rain events and control structure is still clogged
