ADS Emerald Park Landfill Audit Summary

TO: ADS Emerald Park Landfill Standing Committee, City of Muskego
FROM: Faith Spear.
COPIES: File
DATE: 9/16/16
PROJECT NUMBER: 1012.10030

Attached is the audit report for activities at the ADS Emerald Park Landfill for the week of August 14, 2016. The audit was performed at 1:18 PM on **August 19, 2016** by Jo Spear, Jr. in the presence of Brett Coogan, District Manager.

**ADVANCED DISPOSAL SERVICES
EMERALD PARK LANDFILL / CITY OF MUSKEGO
AUDIT PHOTOS**

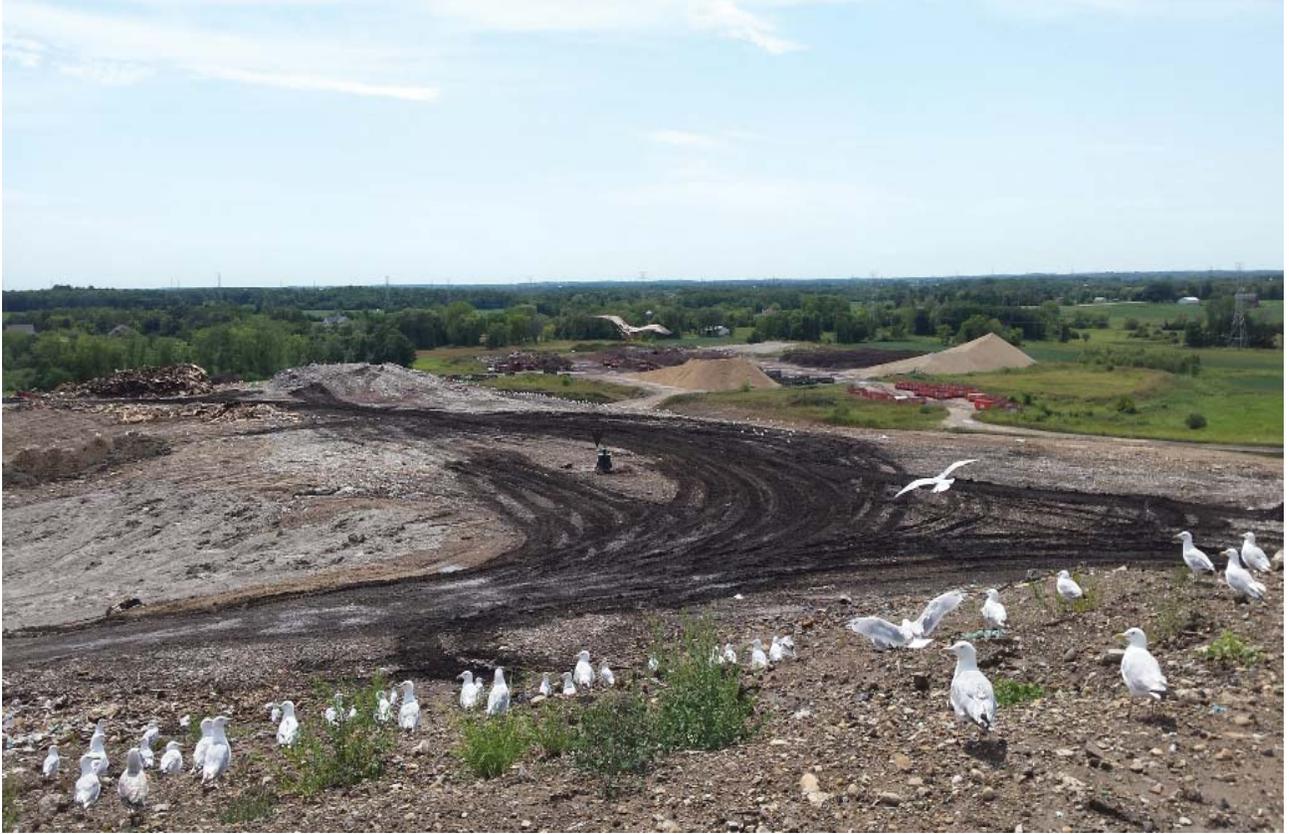
View across Phase 7 from Phase 3

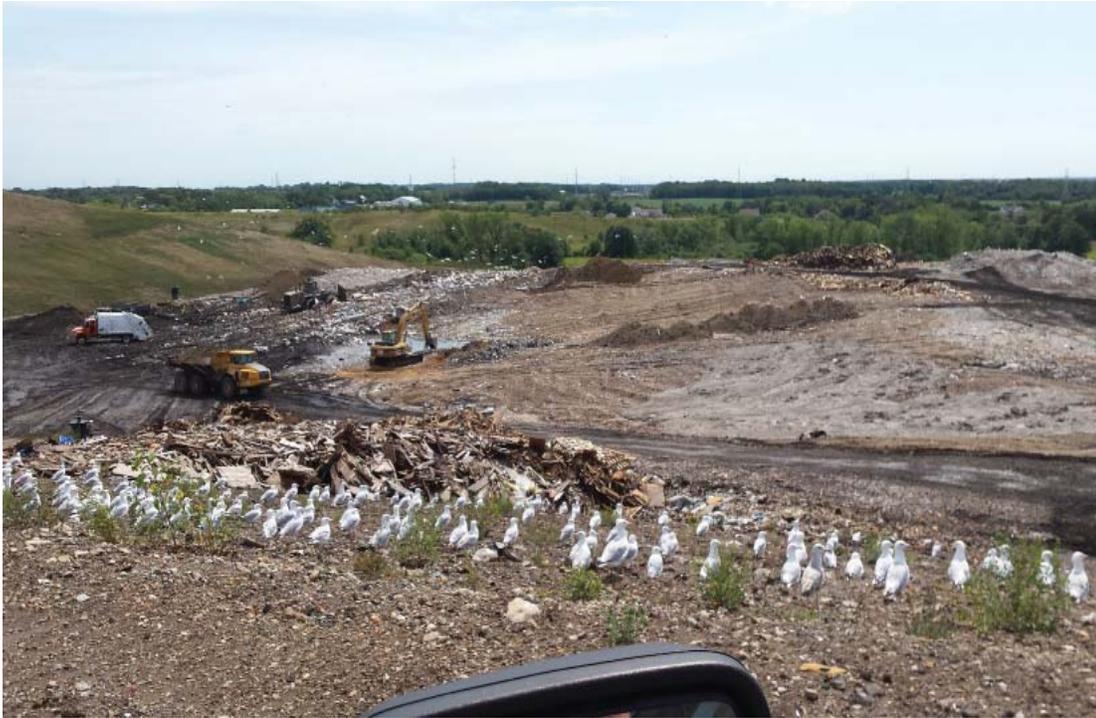
Active area viewed from the North

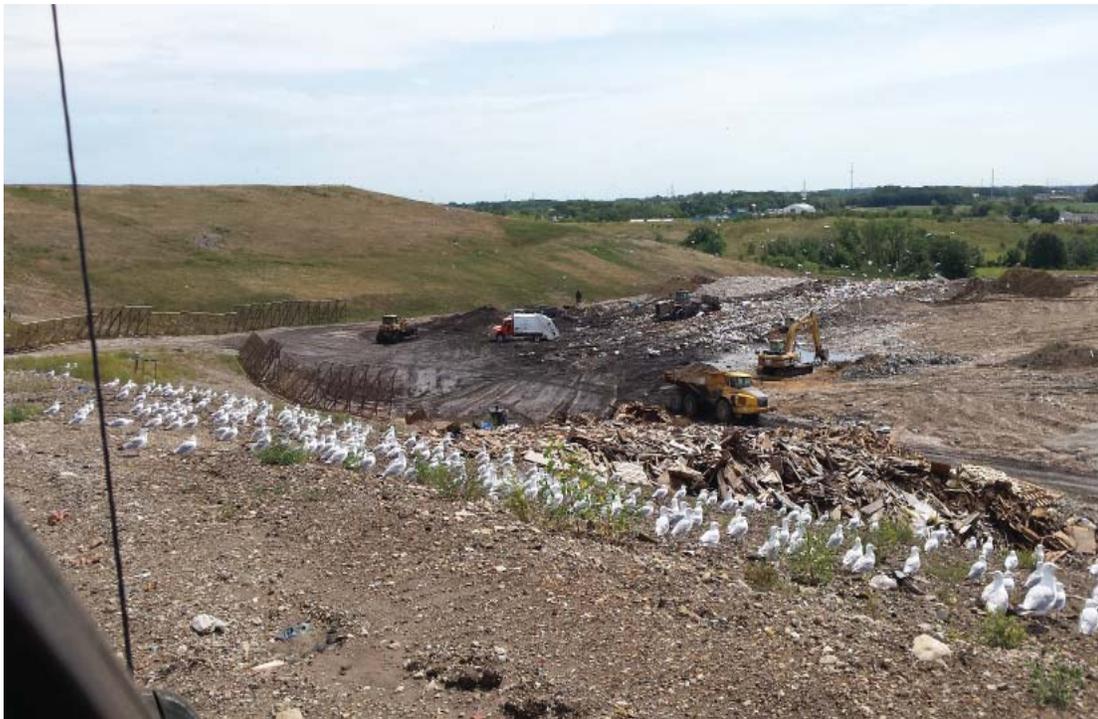
Working face viewed from the North

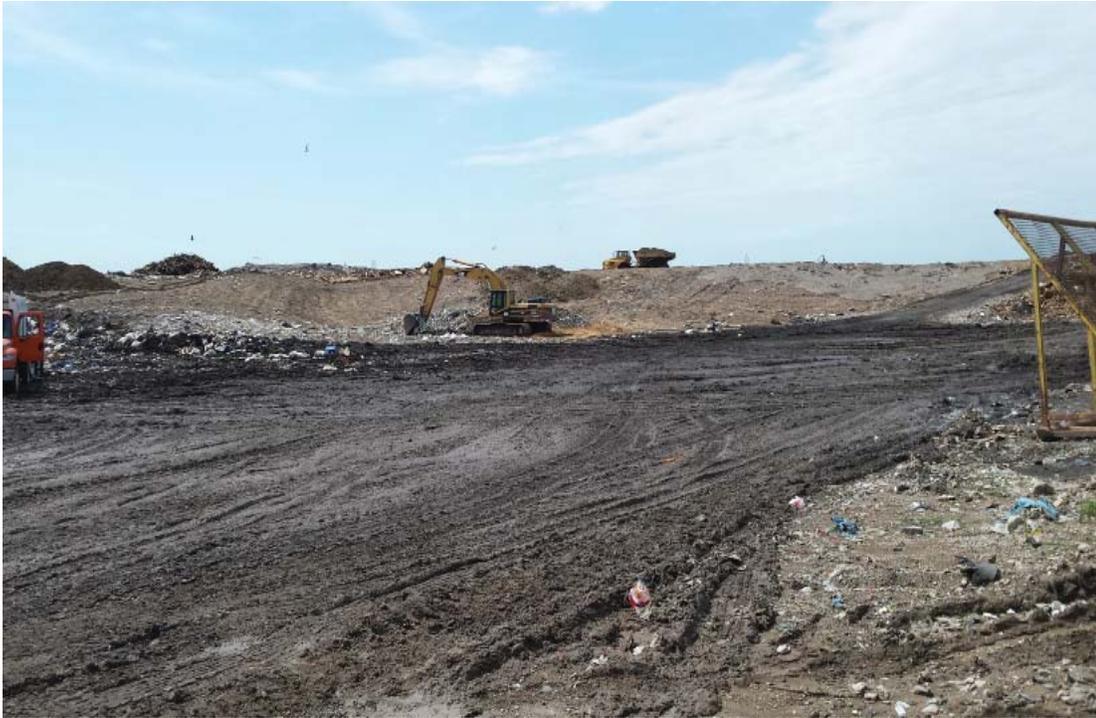
Active area viewed from the East, haul truck stockpiling soil for cover in background

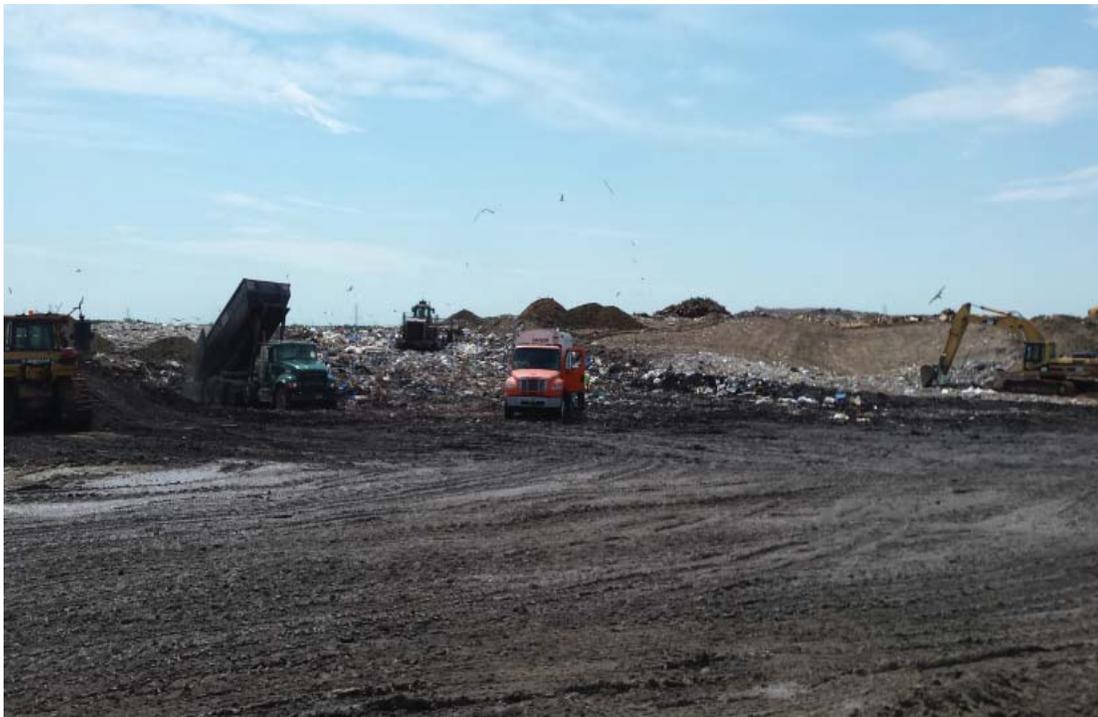
Working face

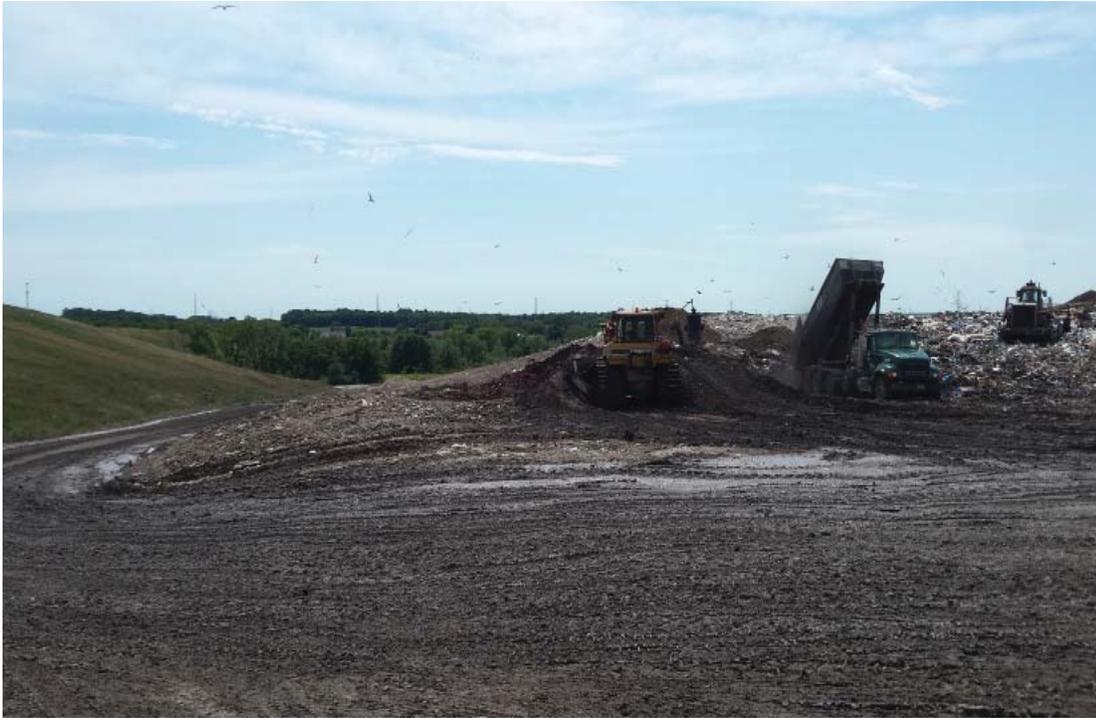
Working face at top of access ramp in Phase 7

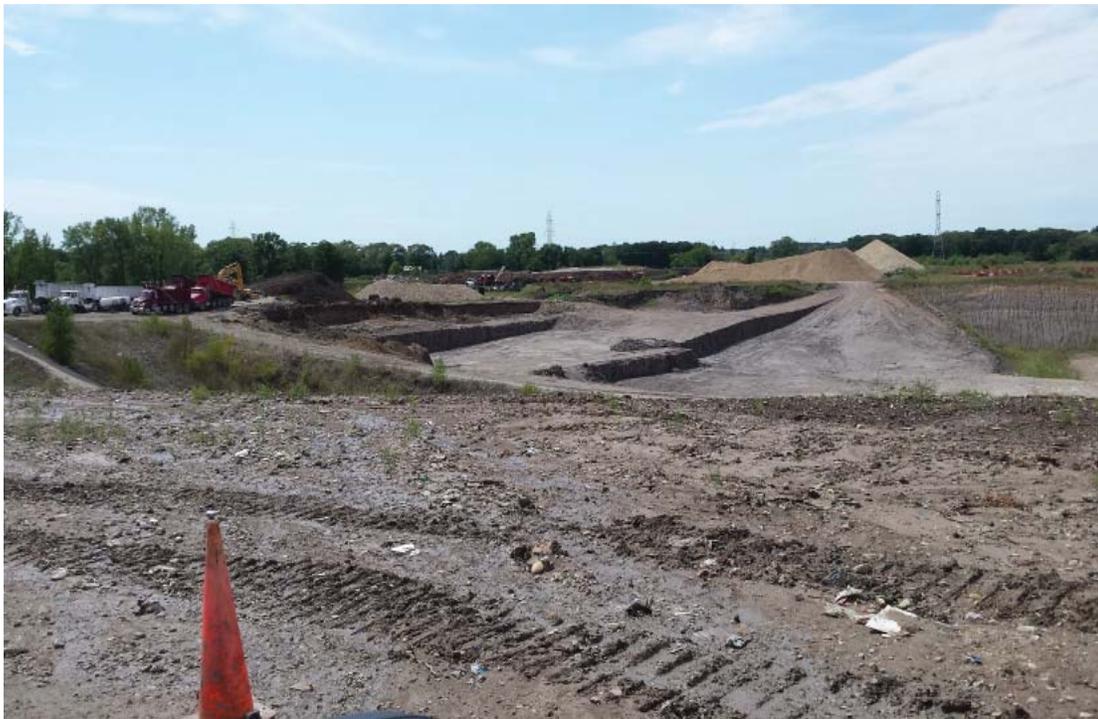
Excavation area viewed over Phase 7 staging area

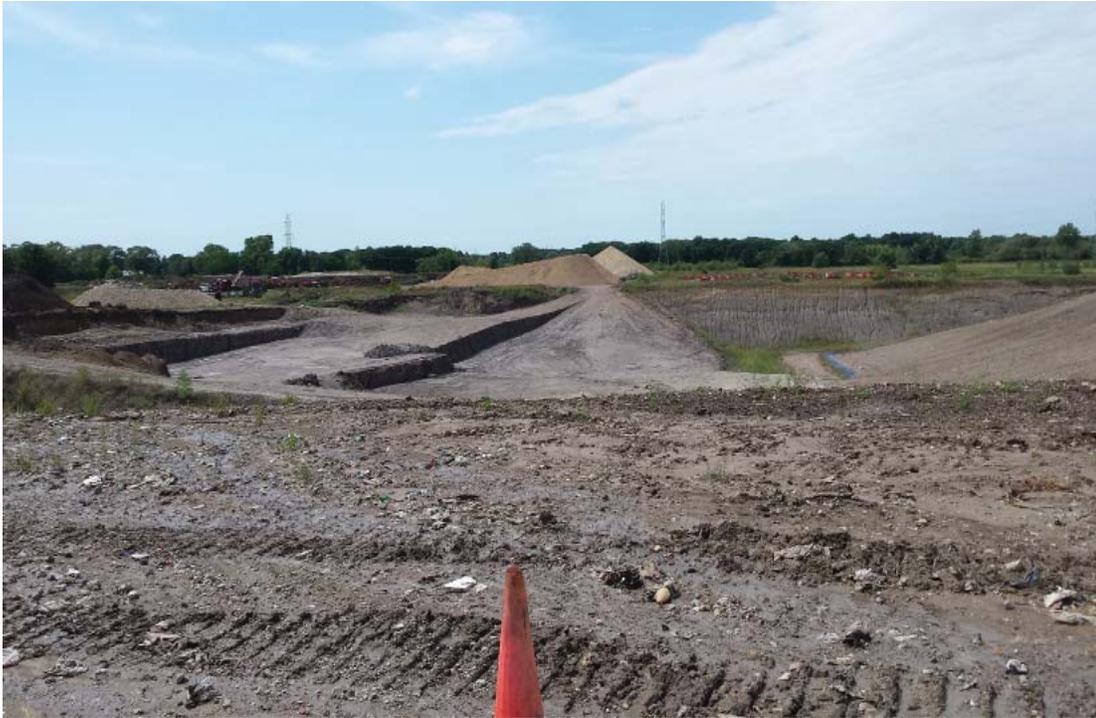
Excavation area and staging area for Phase 7
