Memorandum

ADS Emerald Park Landfill Audit Summary

To: ADS Emerald Park Landfill Standing Committee, City of Muskego
FROM: Faith Spear.
COPIES: File
DATE: 9/22/16
PROJECT NUMBER: 1012.10030

**ADVANCED DISPOSAL SERVICES
EMERALD PARK LANDFILL / CITY OF MUSKEGO
AUDIT PHOTOS**

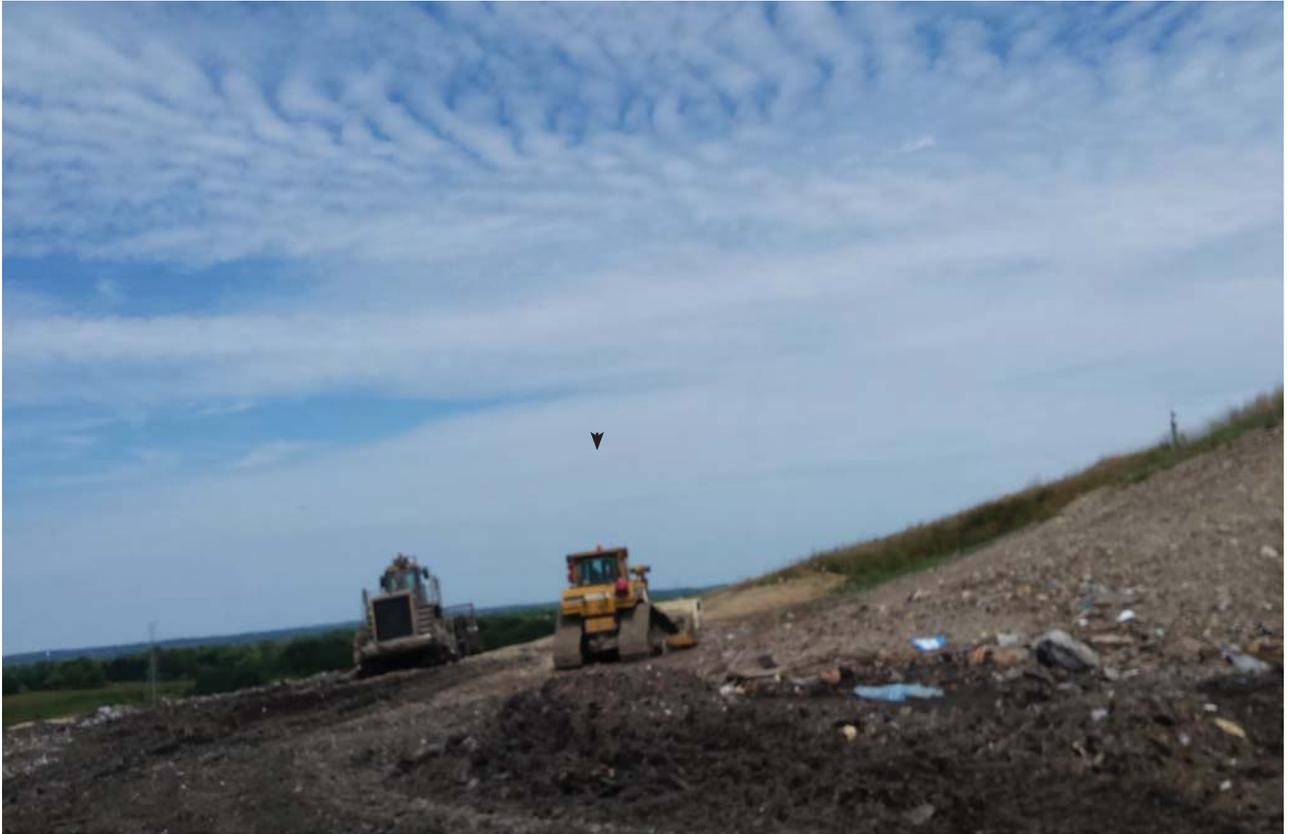
Equipment down for lunch breaks

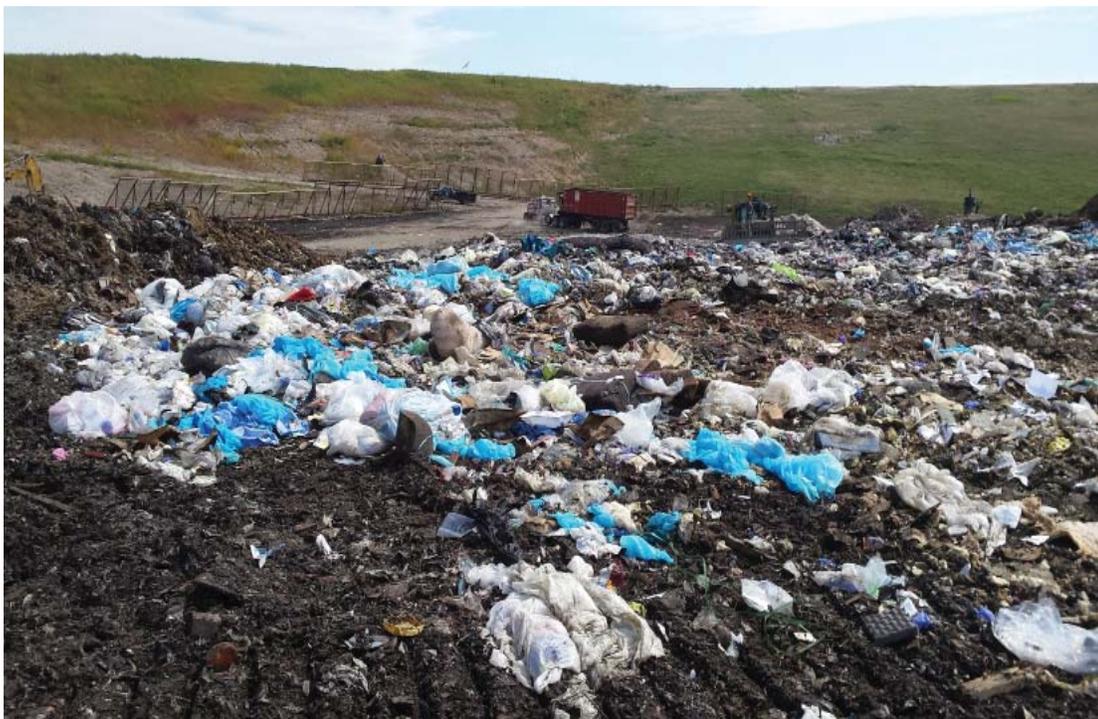
View from above/West of working face in Phase 7

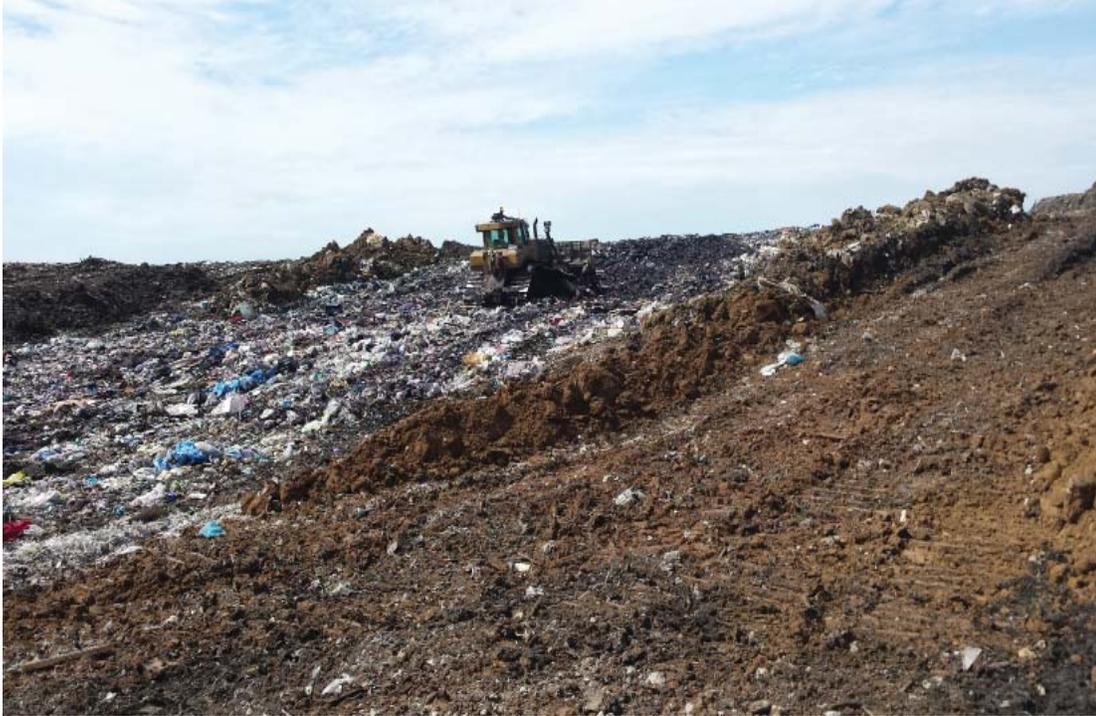
Working face with soil stockpiled about for cover

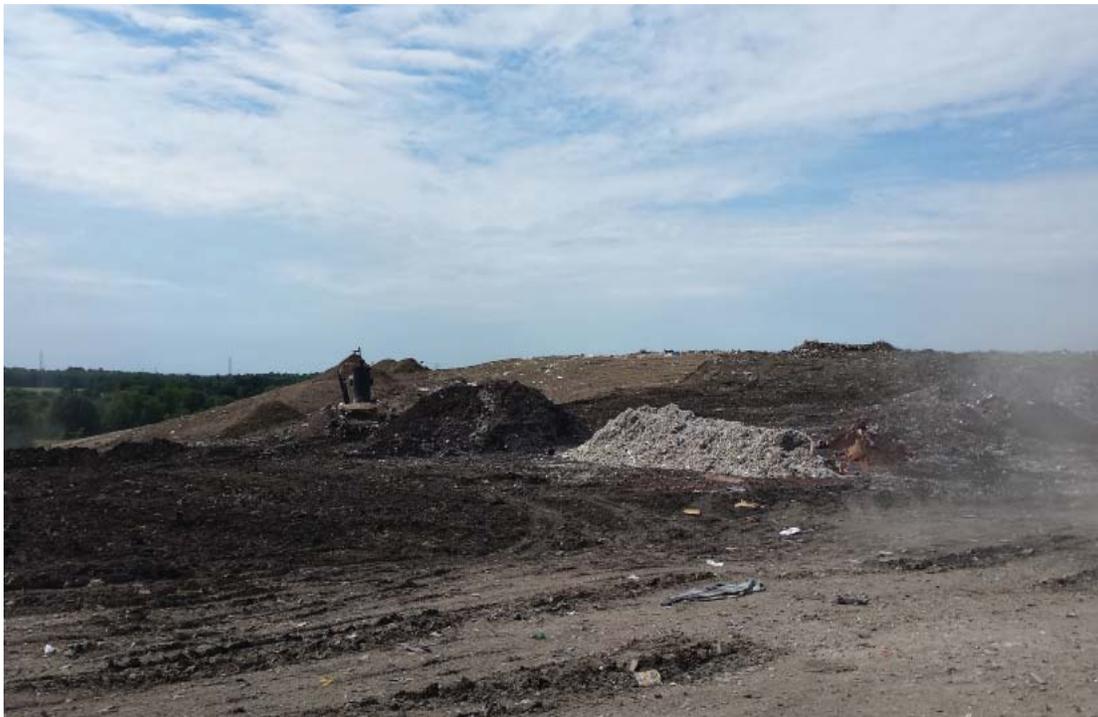
Working face in rough middle of Phase 7

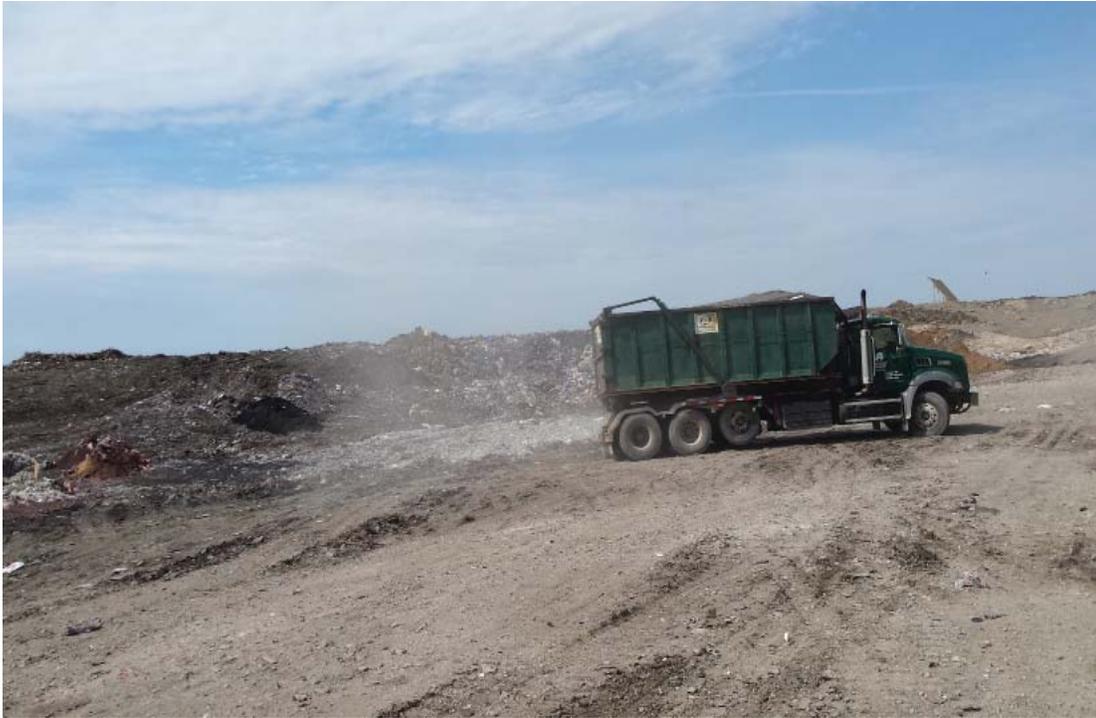
Working face

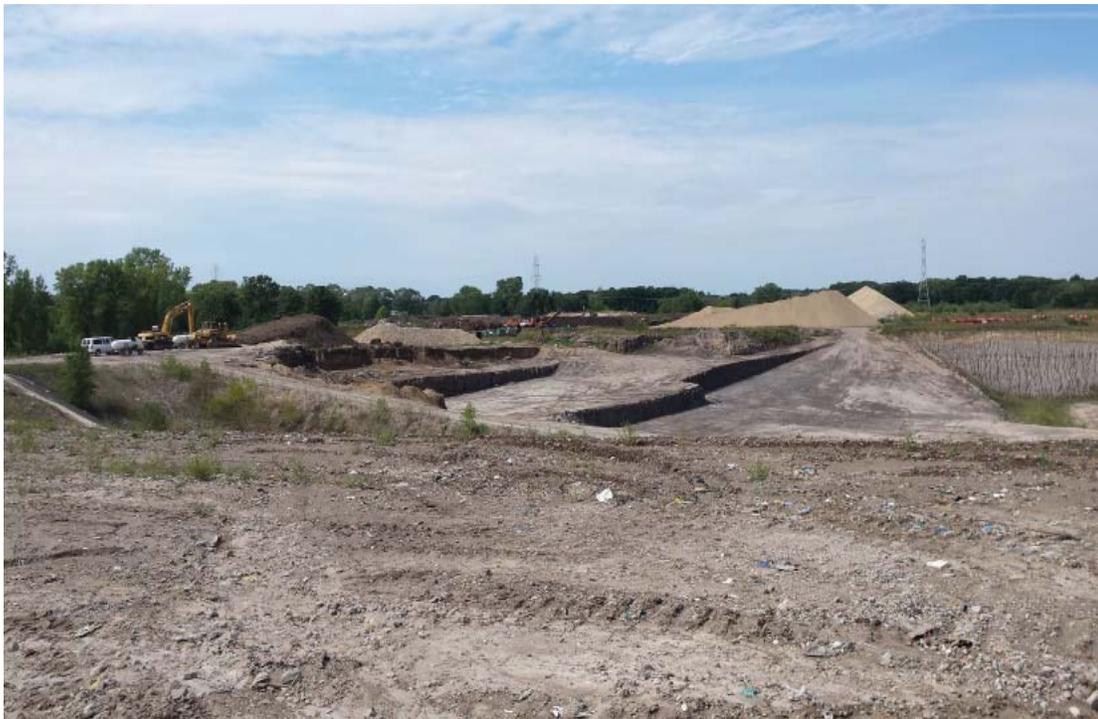
Staging area of Phase 7, excavation area, and stockpile stone and sand for future construction in the background

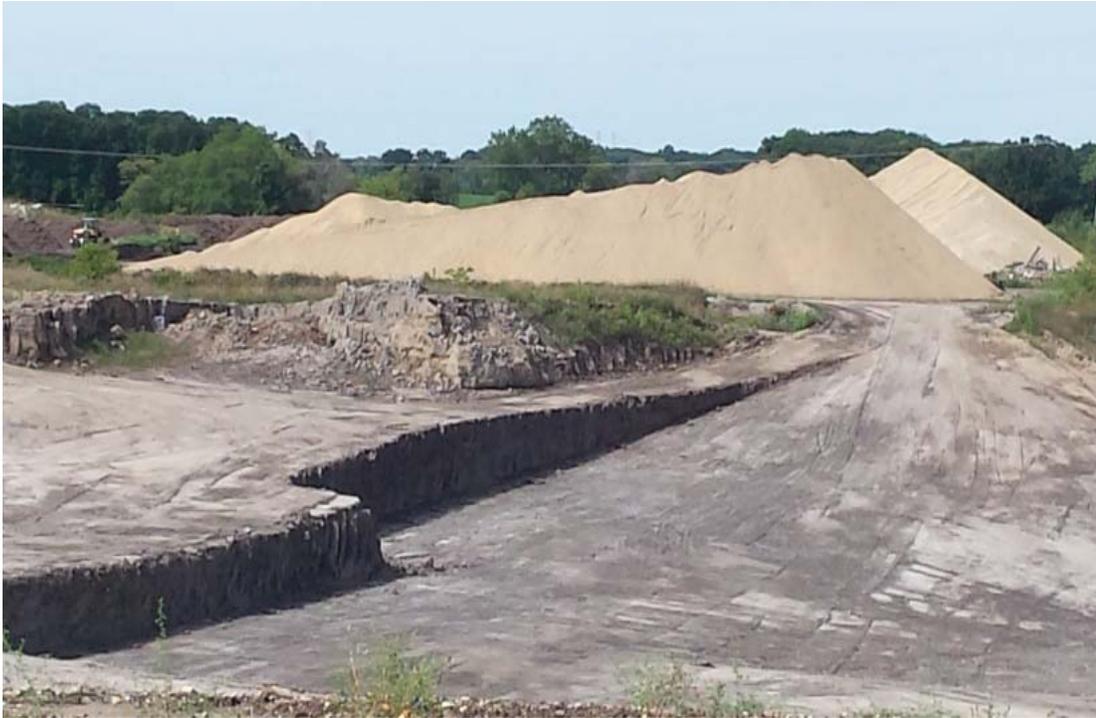
Excavation area, reaching final depth at Northern end
