ADS Emerald Park Landfill Audit Summary

To: ADS Emerald Park Landfill Standing Committee, City of Muskego
FROM: Faith Spear.
COPIES: File
DATE: 9/26/16
PROJECT NUMBER: 1012.10030

**ADVANCED DISPOSAL SERVICES
EMERALD PARK LANDFILL / CITY OF MUSKEGO
AUDIT PHOTOS**

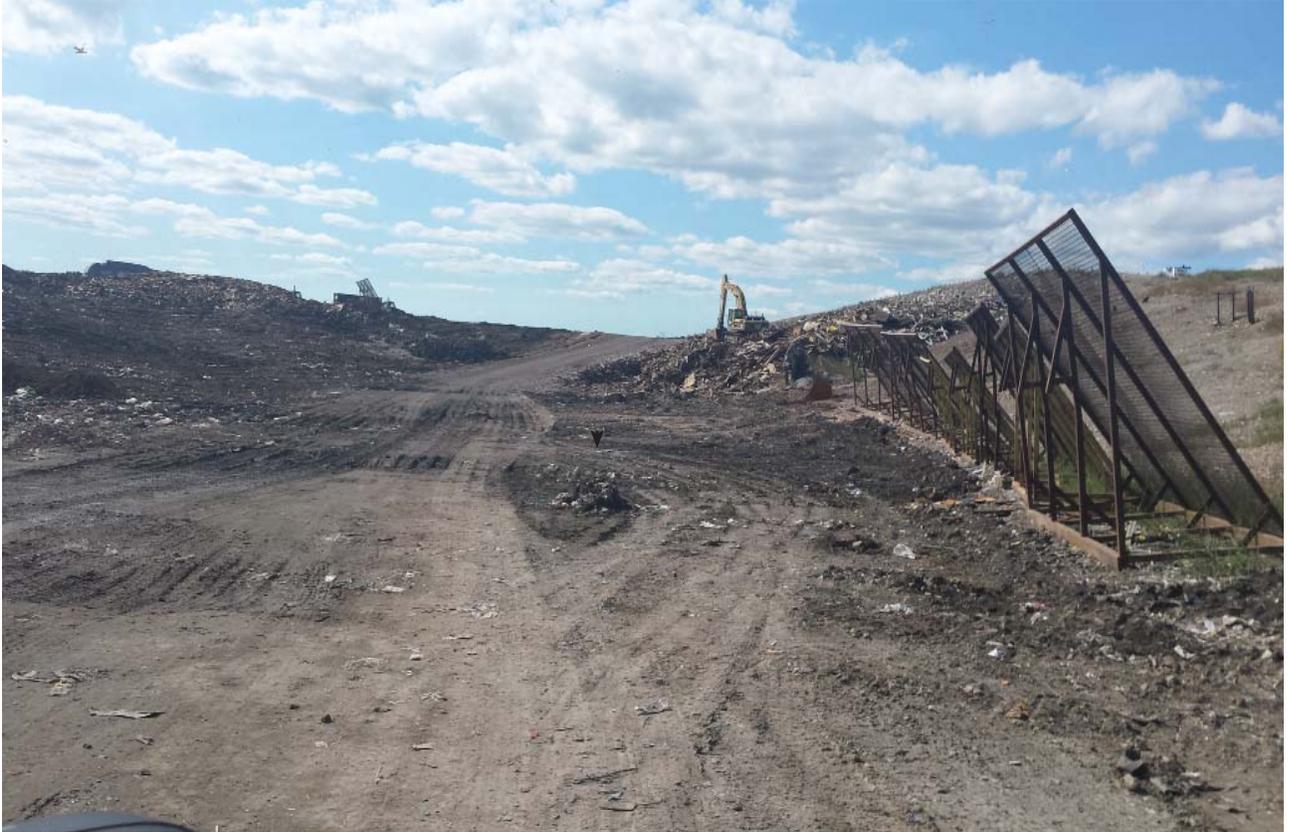
Entrance to Phase 7

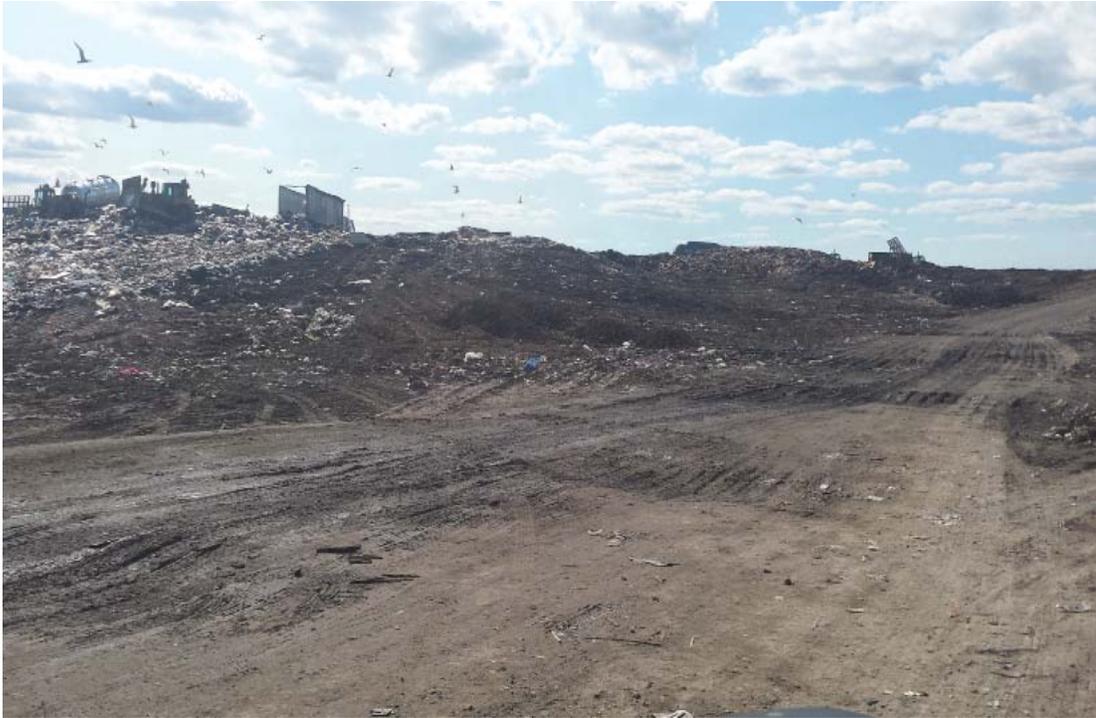
Working face in Southeastern corner, east of Access road to Phase 7. Working face wrapping about top of slope of Phase 7 leaving low area in center of Phase 7
No other working face

Lift wrapping about the outer (West and South) edge of Phase 7

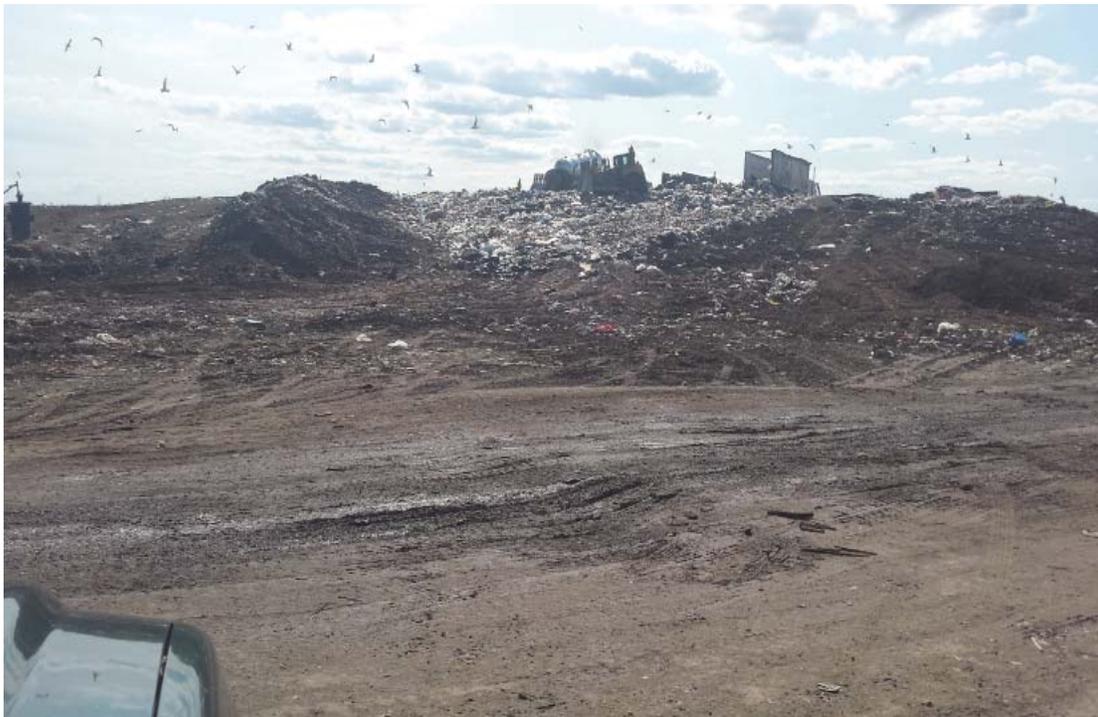
Working face

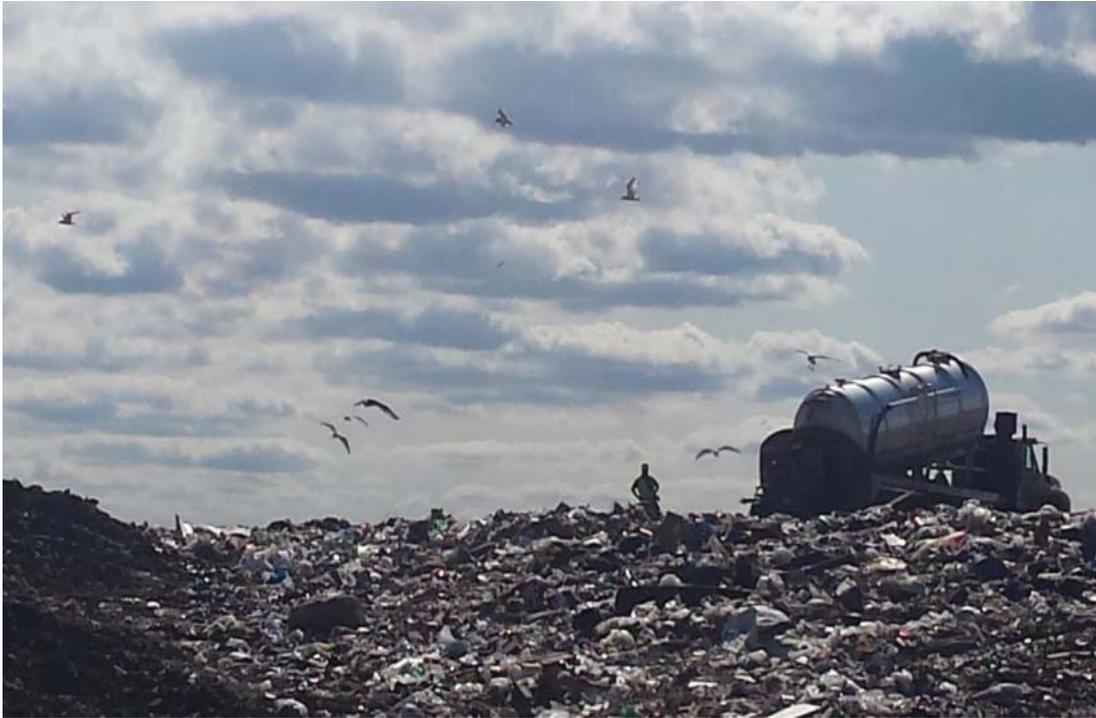
Periodic in Phase 7 active area
one during audit

Liquid load tipping in working face under supervision of site manager

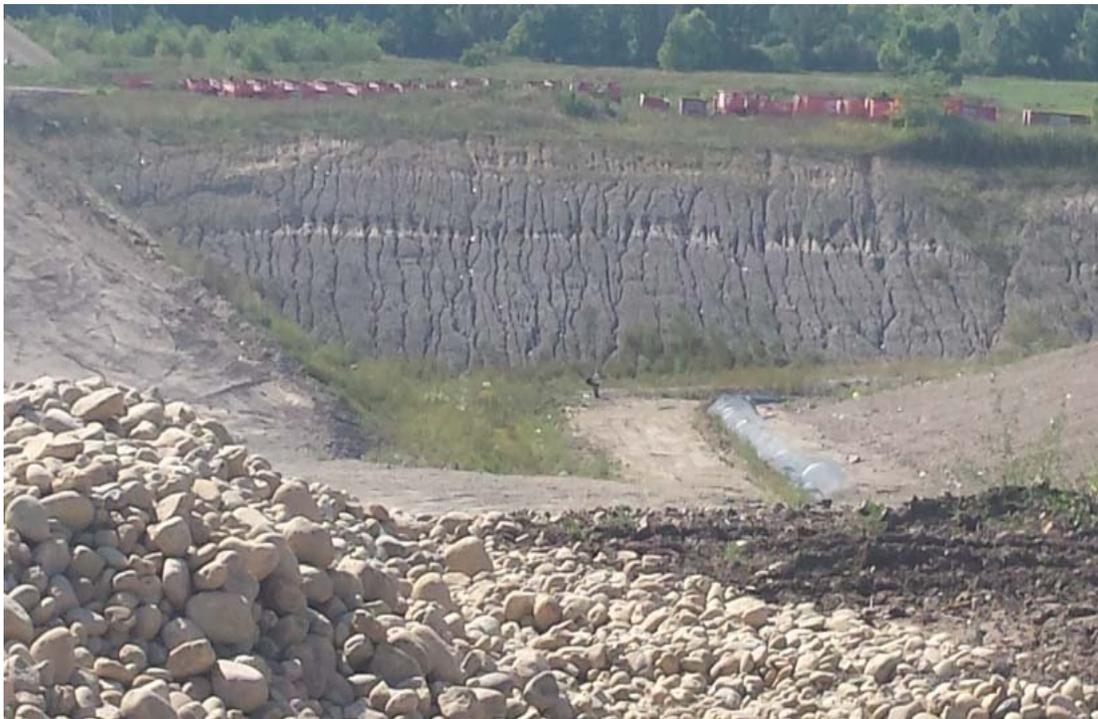
Litter controlled, picker active about temp
 SD Basin during audit

Picker at South end fo Temp. Sed. Basin

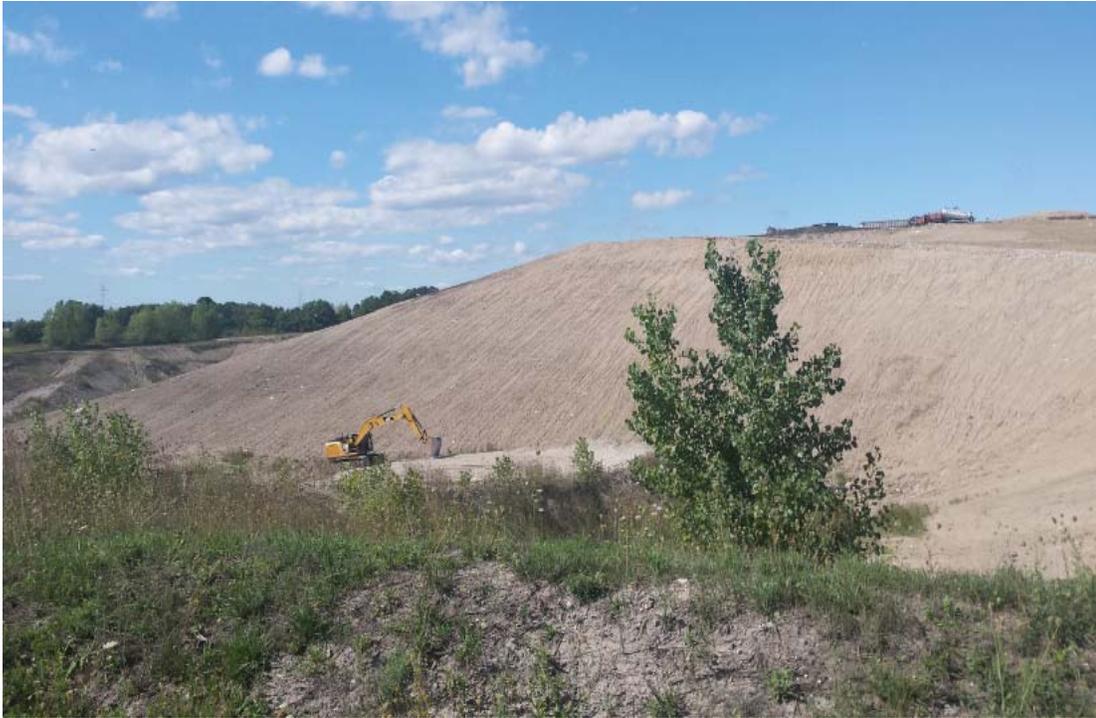
South slope of Phase 7

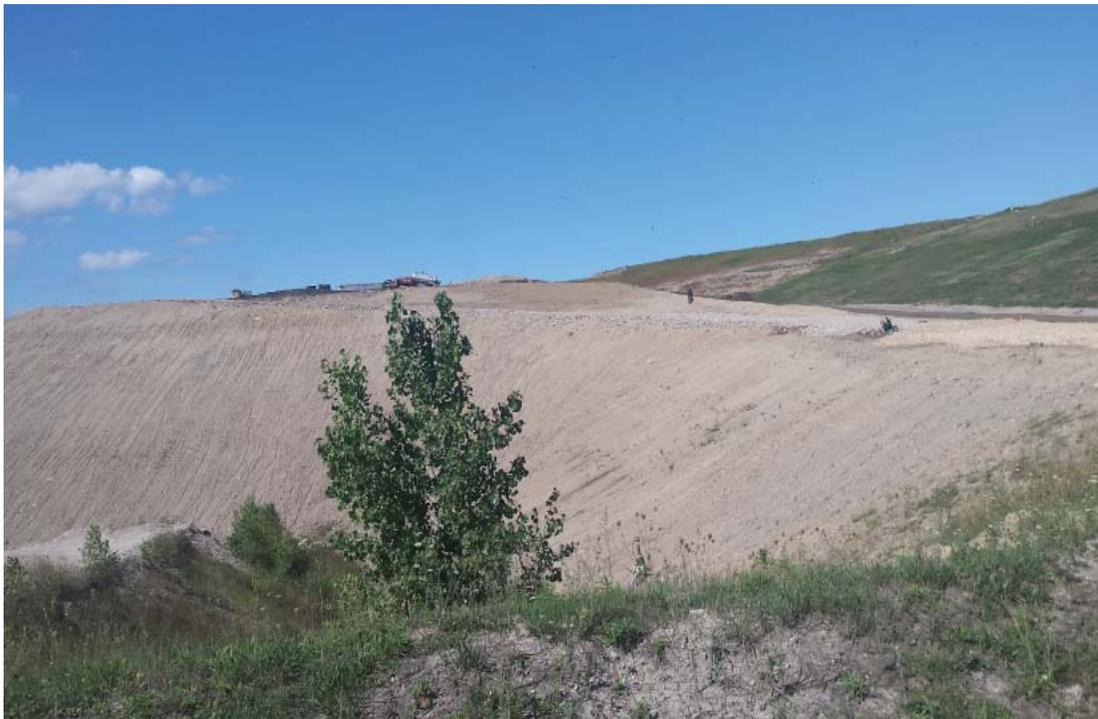
Southeast corner of Phase 7, viewed from the South
