ADS Emerald Park Landfill Audit Summary

TO: ADS Emerald Park Landfill Standing Committee, City of Muskego
FROM: Faith Spear.
COPIES: File
DATE: 10/14/16
PROJECT NUMBER: 1012.10030

Attached is the audit report for activities at the ADS Emerald Park Landfill for the week of September 15, 2016. The audit was performed at 11:55 AM on **September 20, 2016** by Jo Spear, Jr. in the presence of Brett Coogan, Operations Manager.

**ADVANCED DISPOSAL SERVICES
EMERALD PARK LANDFILL / CITY OF MUSKEGO
AUDIT PHOTOS**

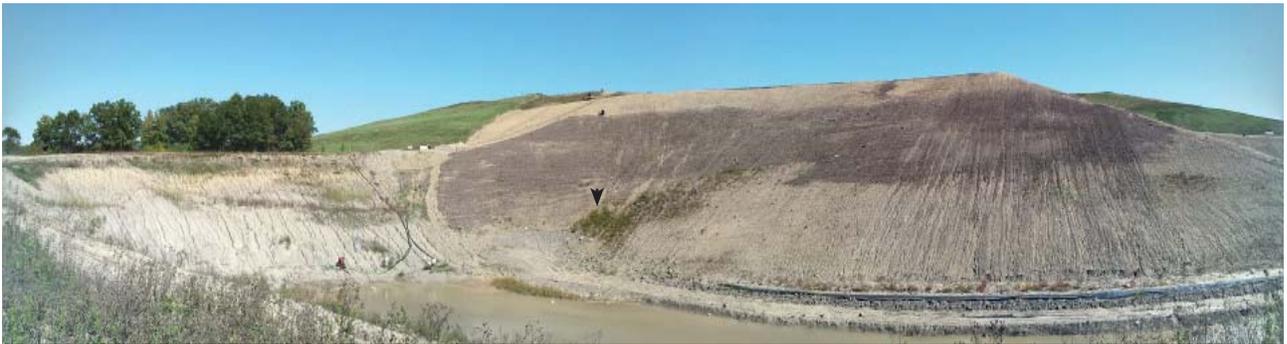
Phase 7 West slope and Temp Sed Basin

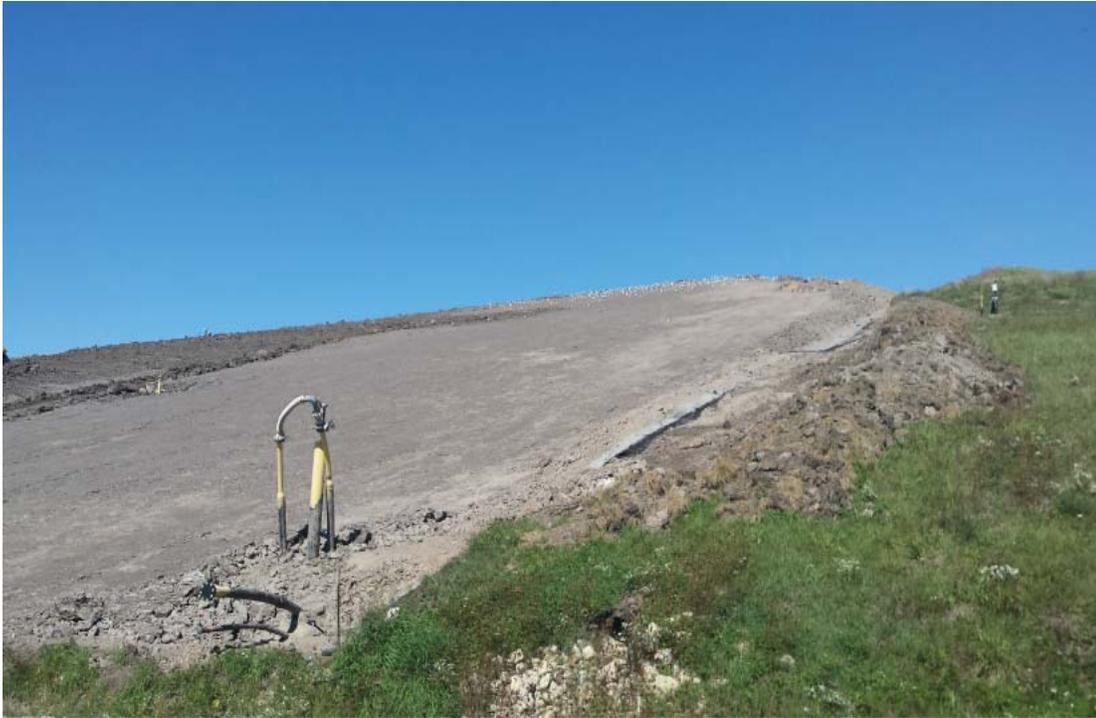
Closure Area III & IV interface

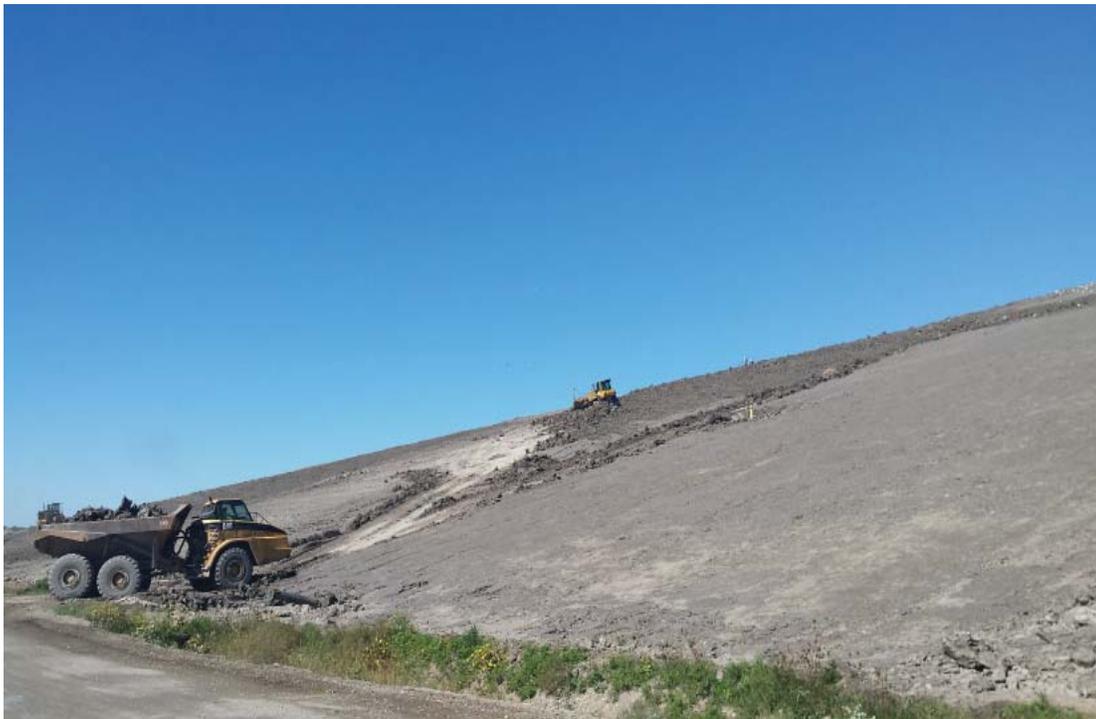
Closure Area IV

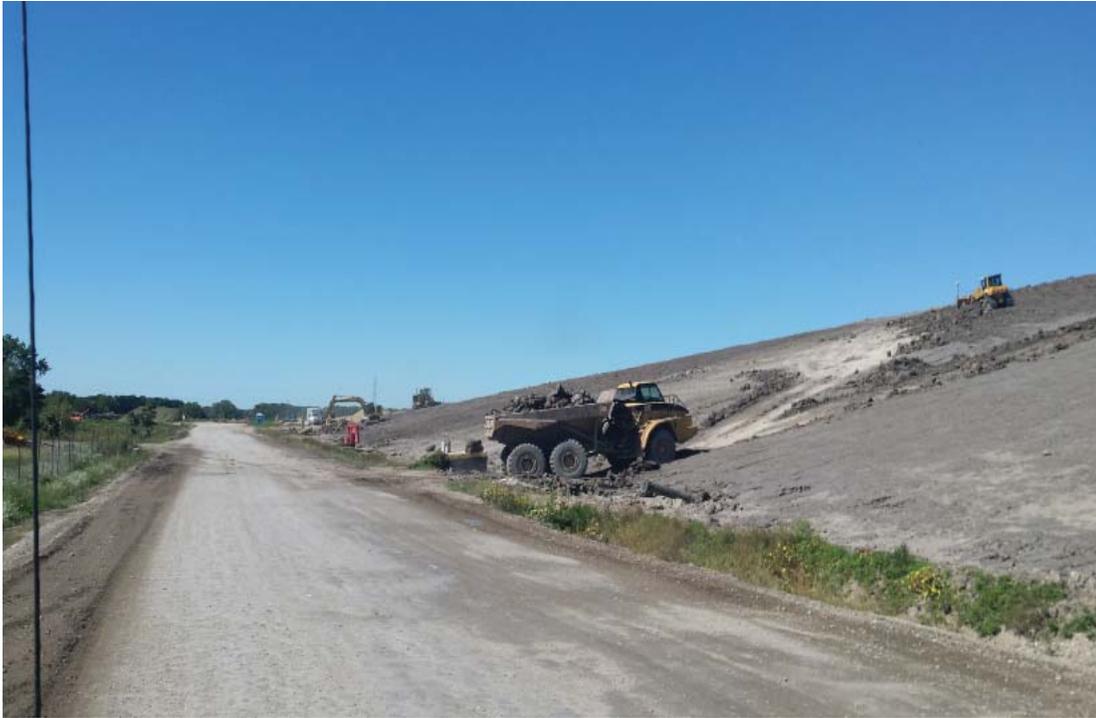
Closure Area IV receiving additional clay

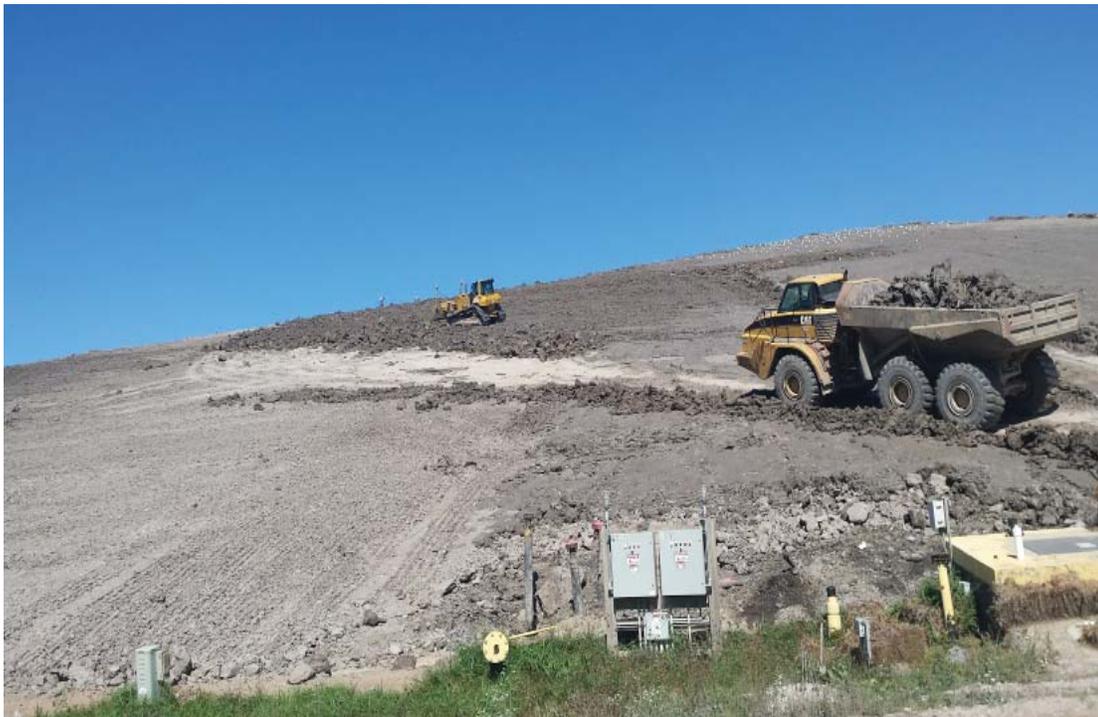
Second lift of clay being placed and graded on Closure Area IV

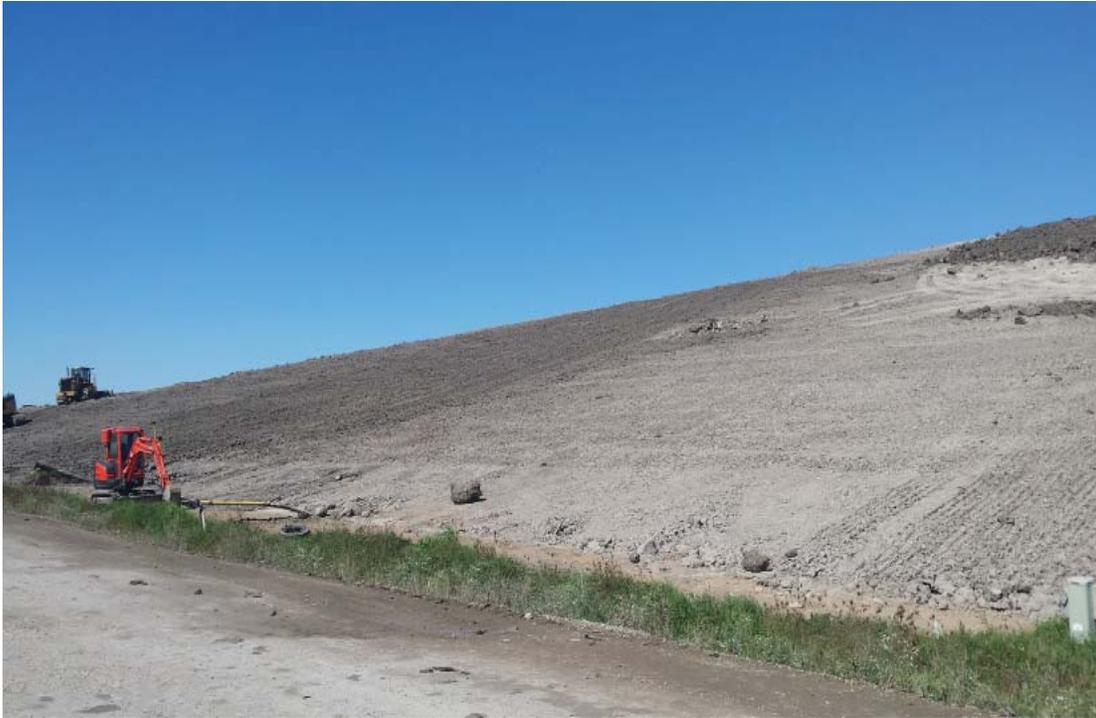
Closure Area IV

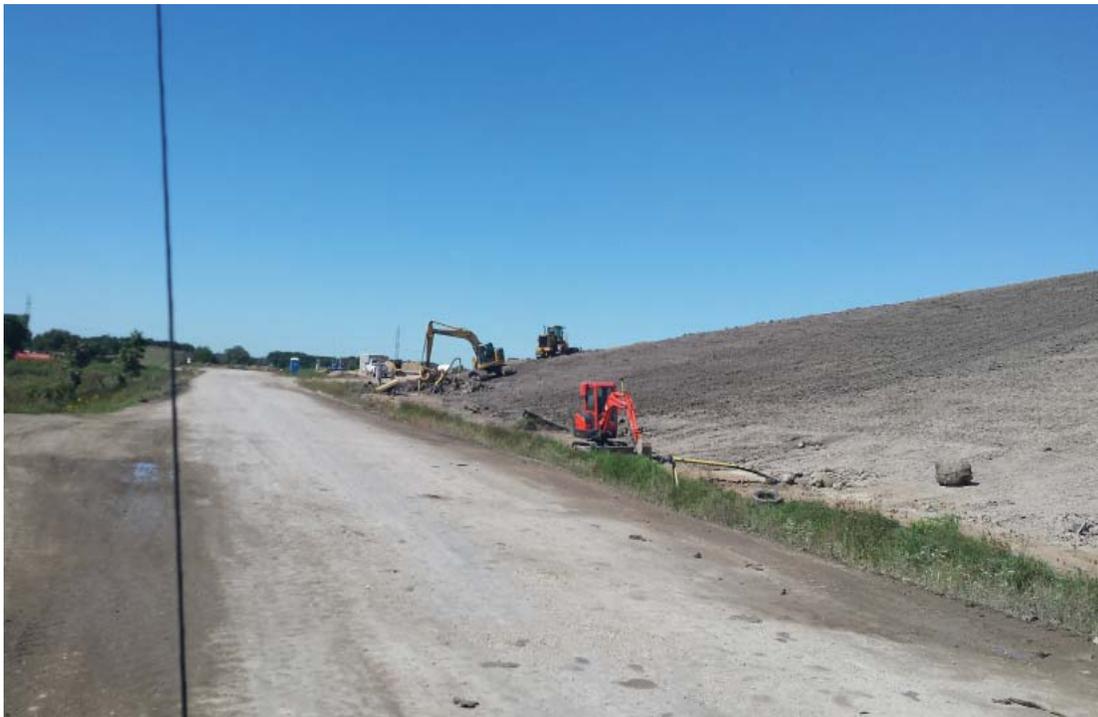
Second lift initiated on Closure Area IV

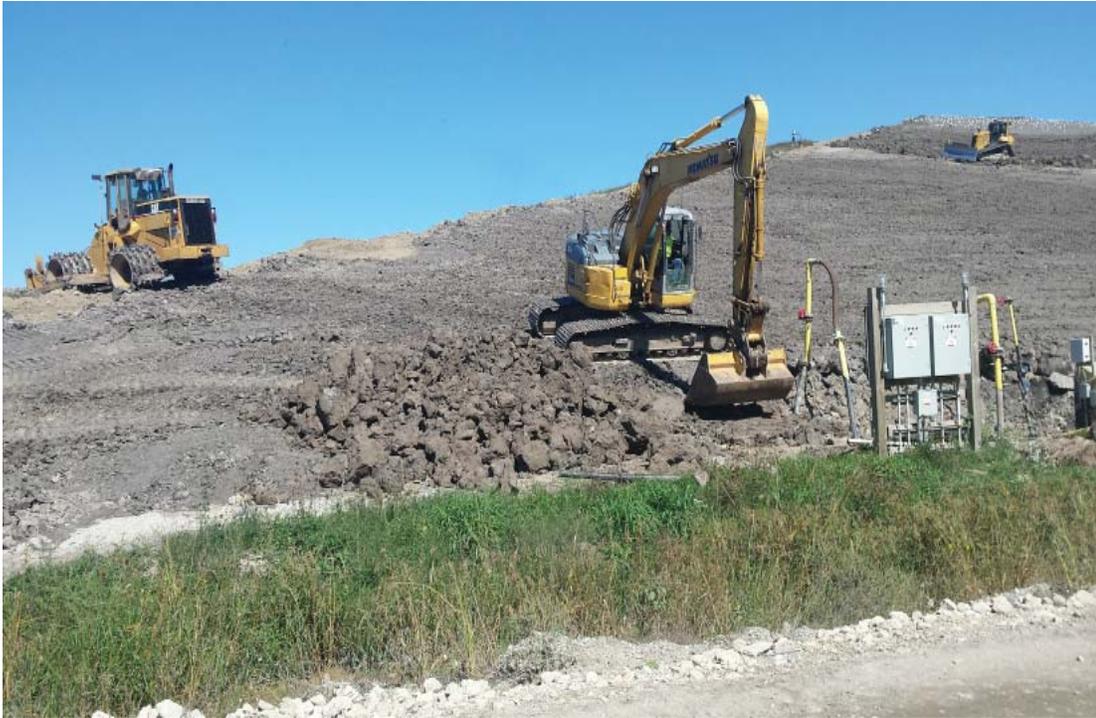
Clay being compacted about leachate vault for construction of Closure Area IV

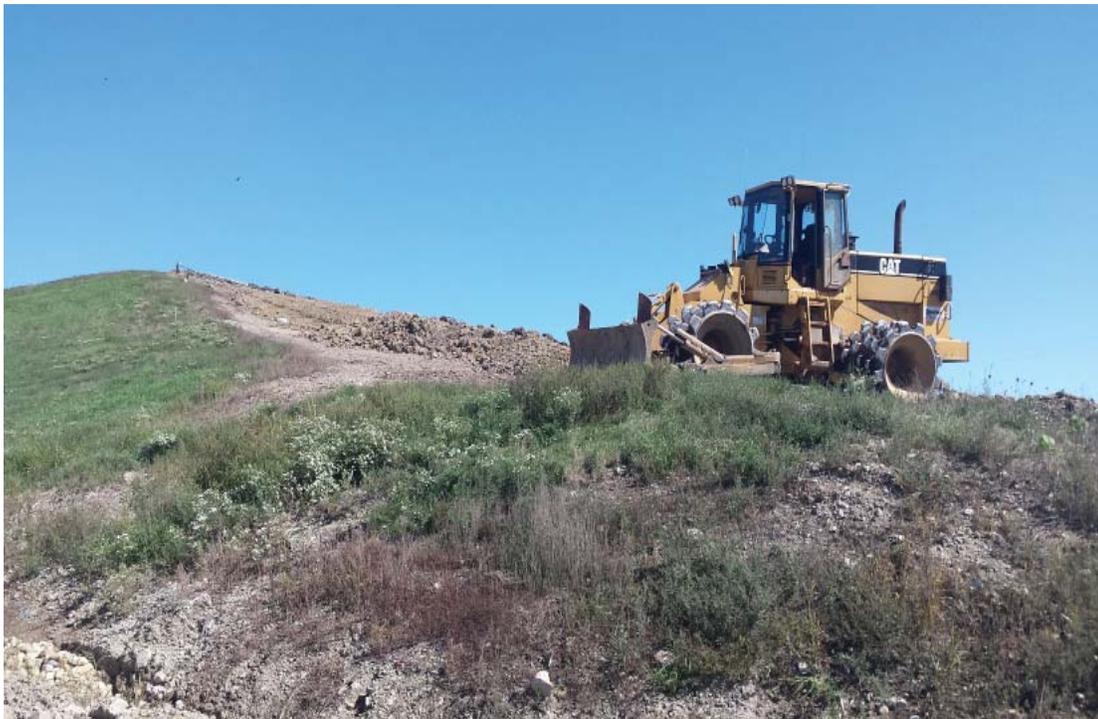
Southeast corner of Phase 6 and Closure Area IV

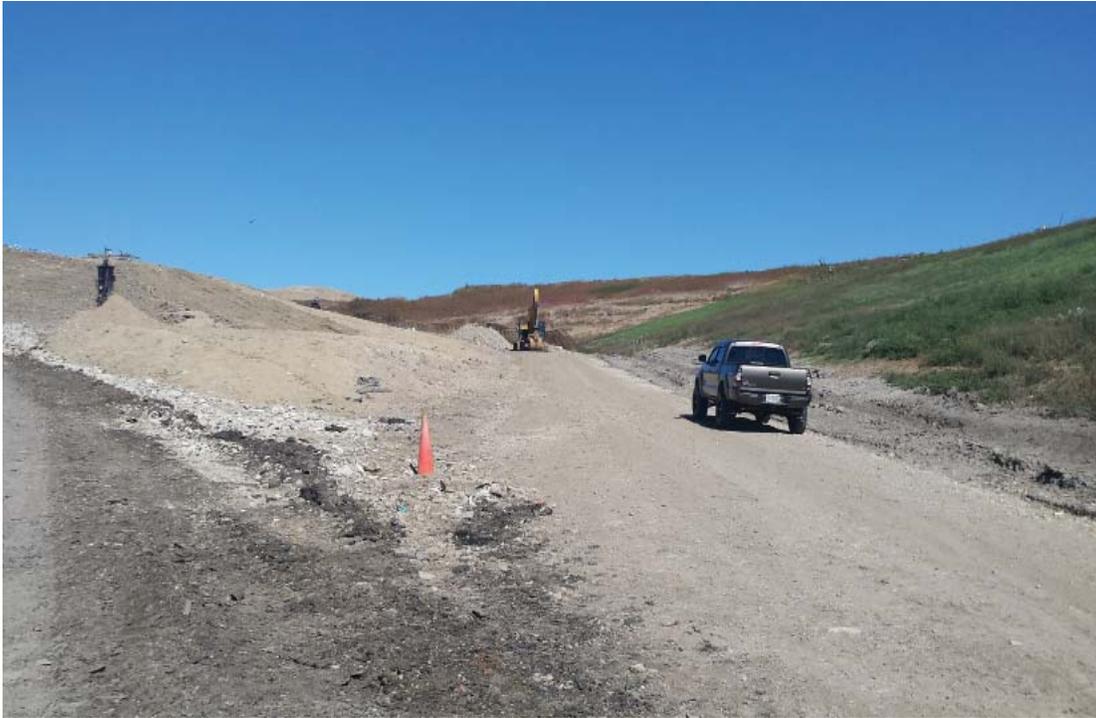
Previously used access road to top of Phases 1 thru 3 being deconstructed prior to placement of waste

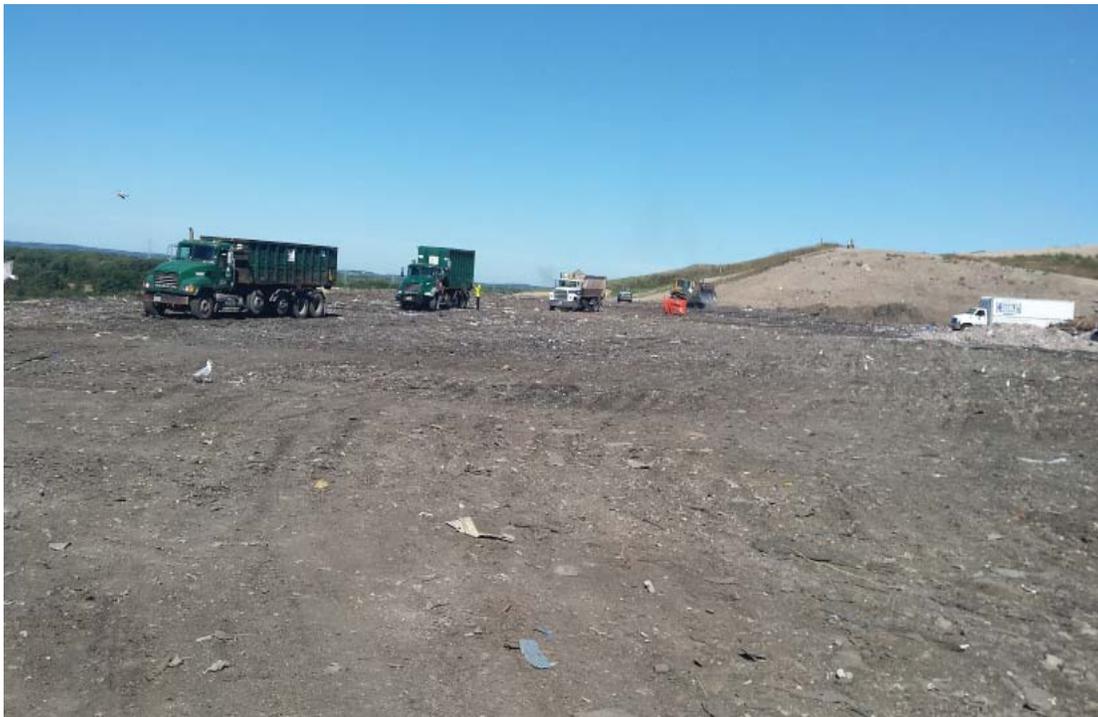
Trucks staged out for cleaning and exit

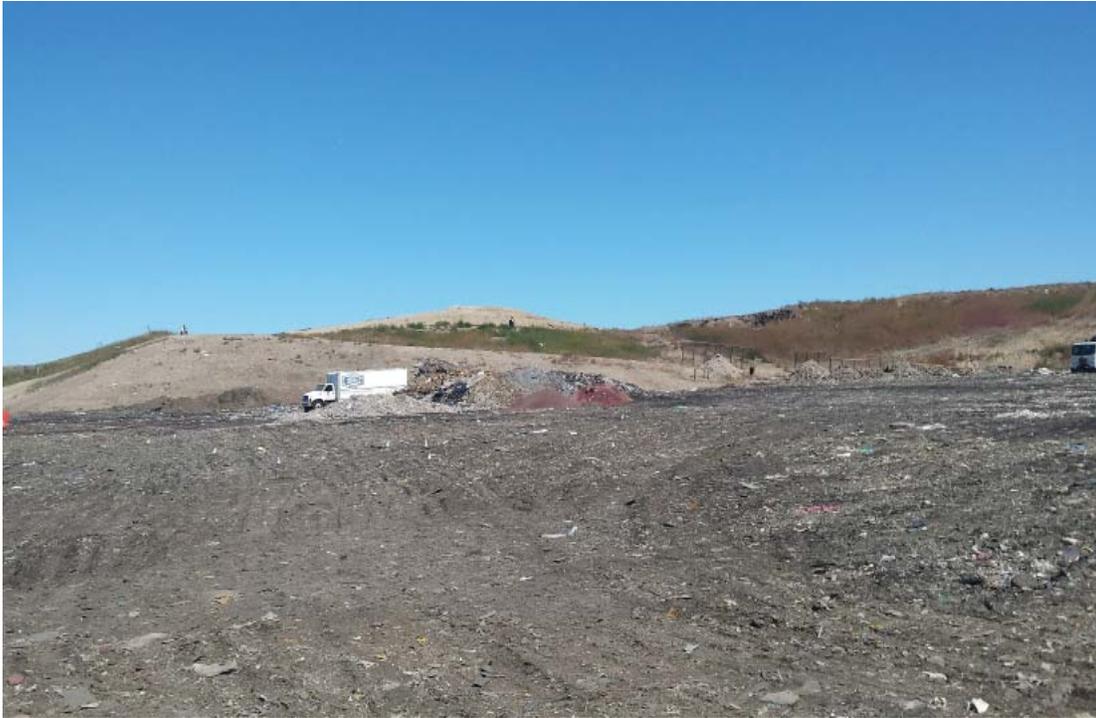
ADC stockpile and tipping hand truck

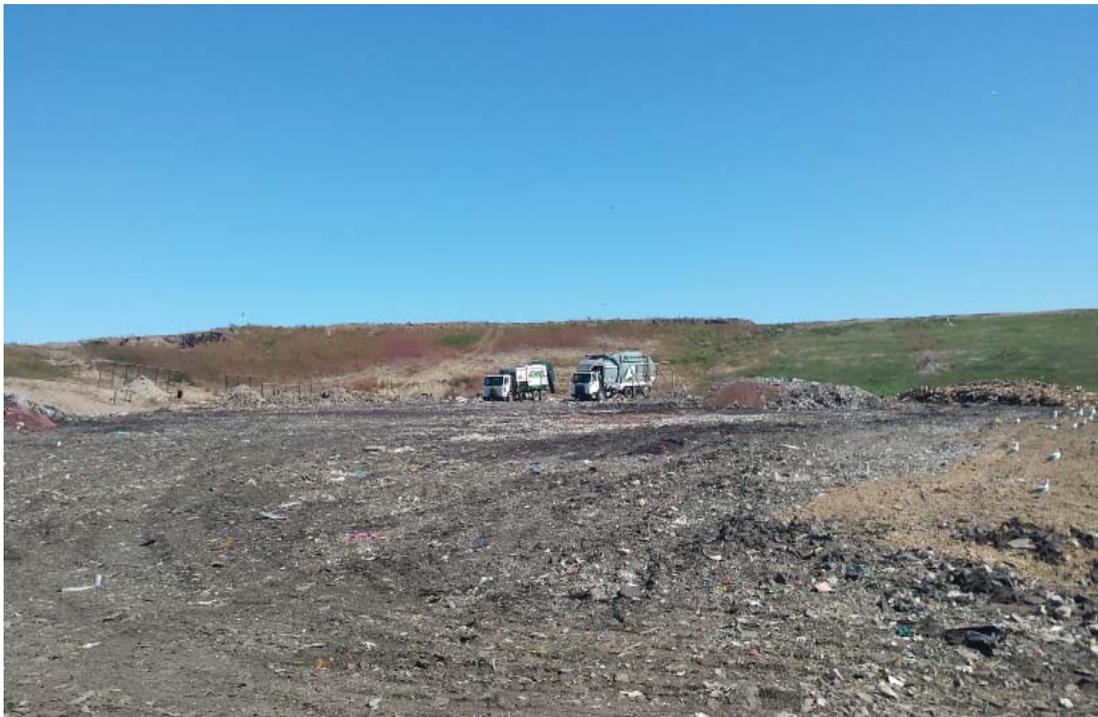
Tipping in working face

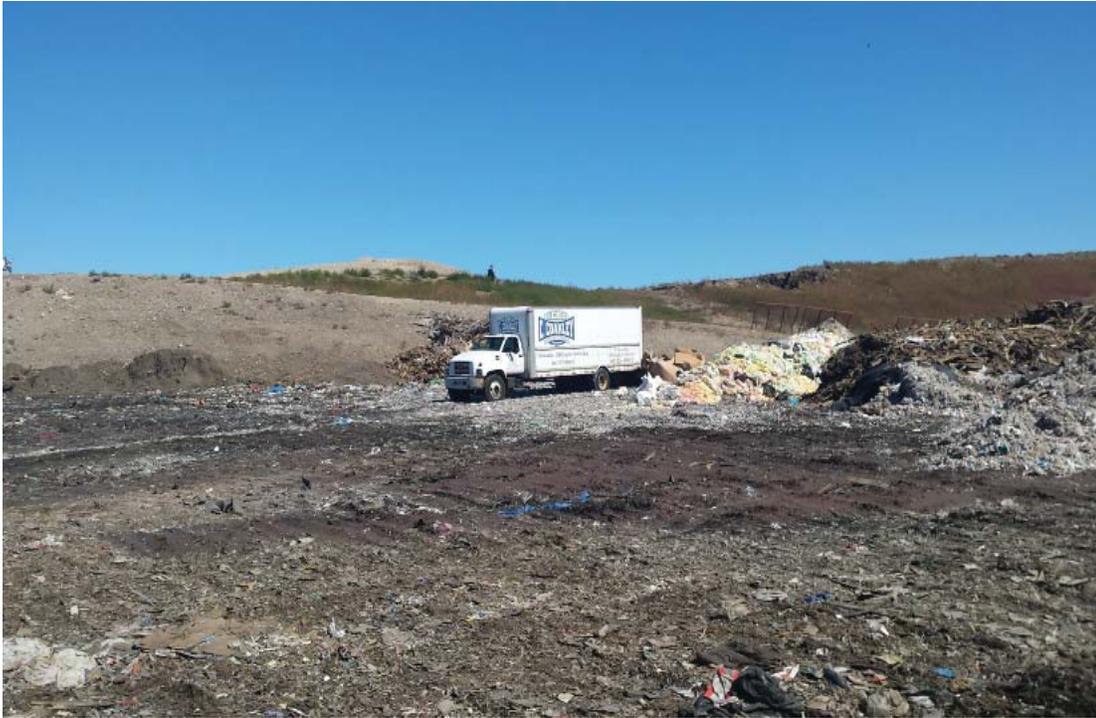
Truck being unloaded by hand away from tipping vehicles

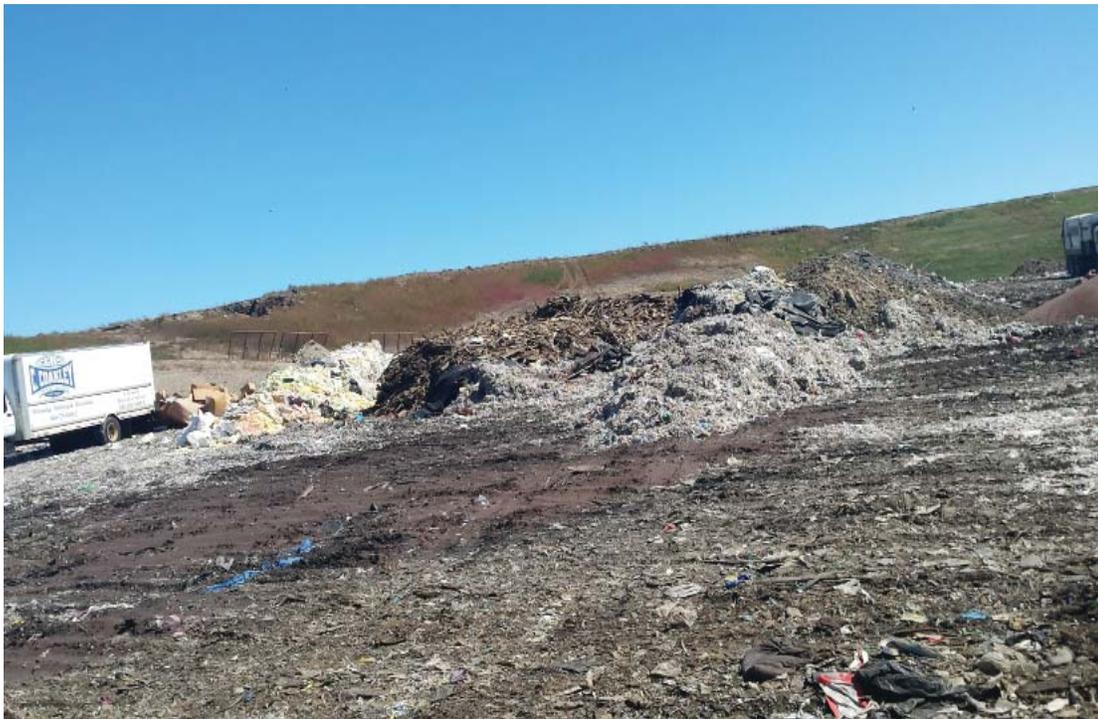
Various ADC stockpiled for cover

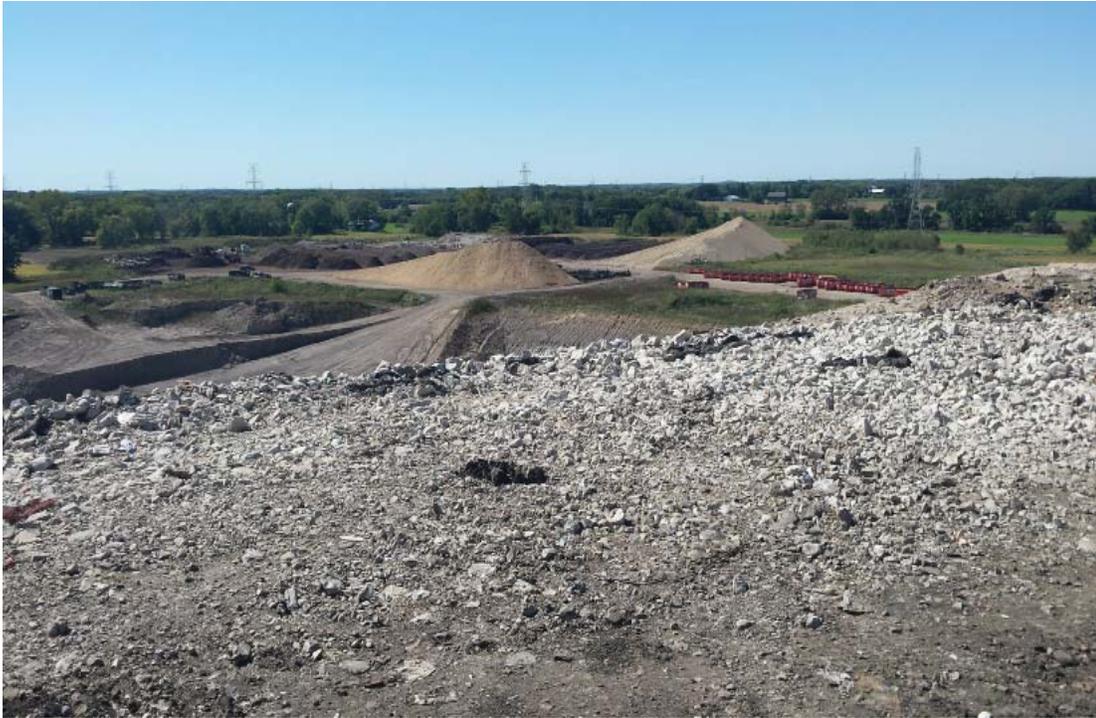
Compost area and stockpiling for construction

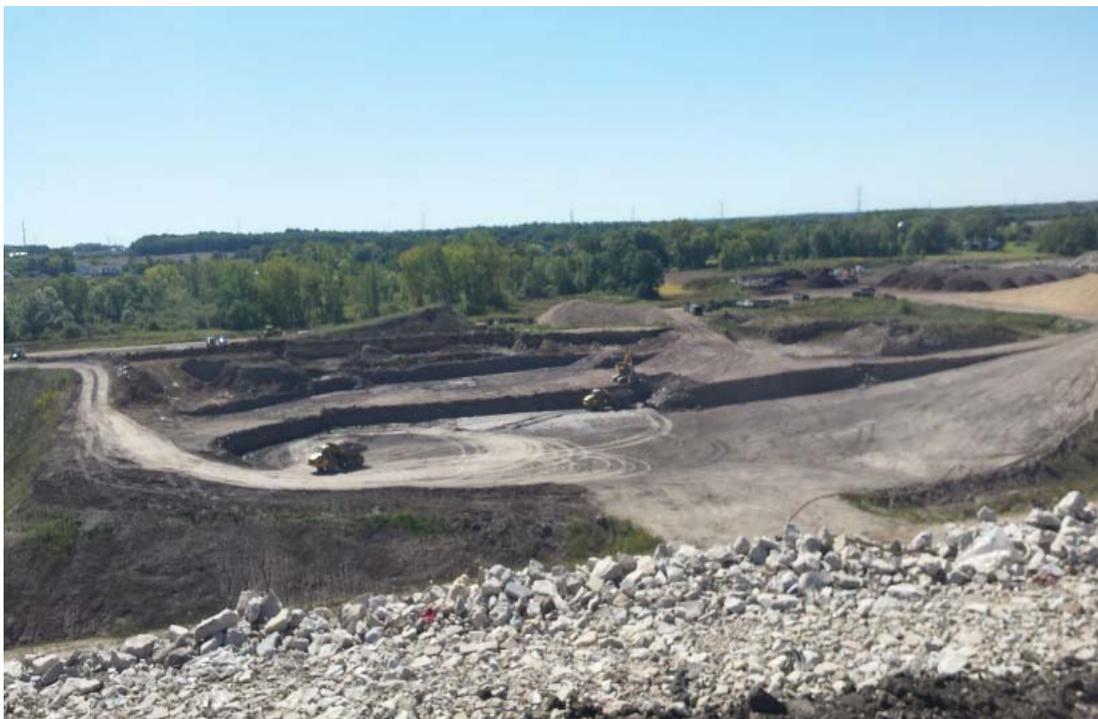
Excavation of future Phase 7&8, excavation being used for Closure Area IV

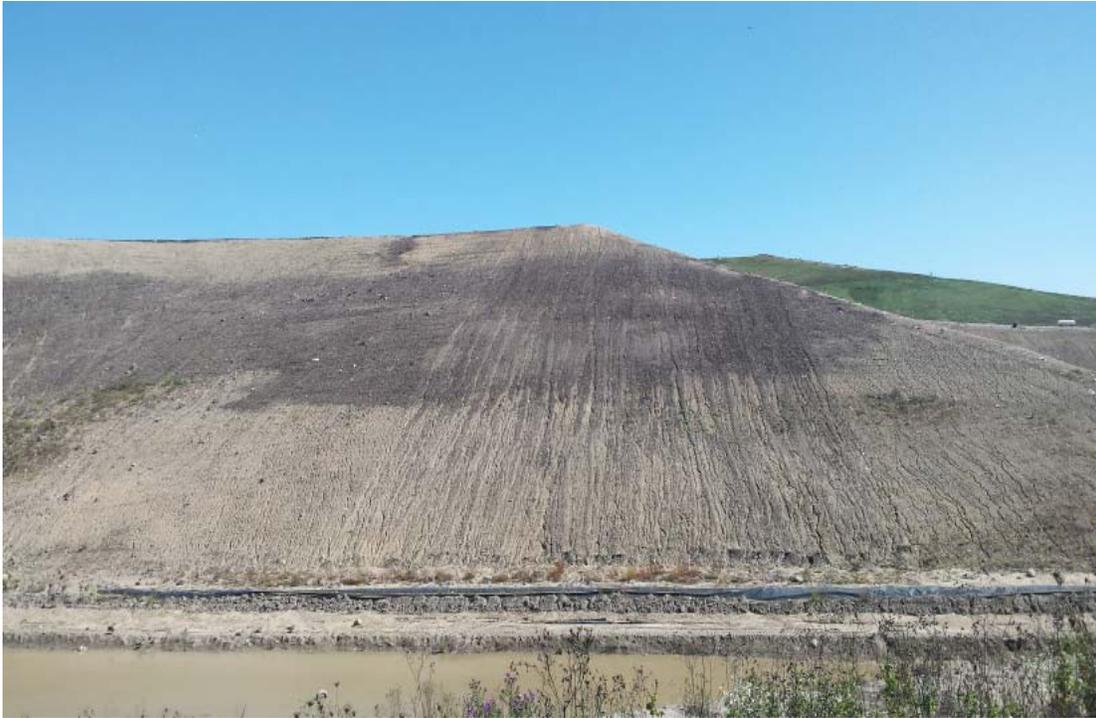
West slope of Phase 7, minor rills and compost

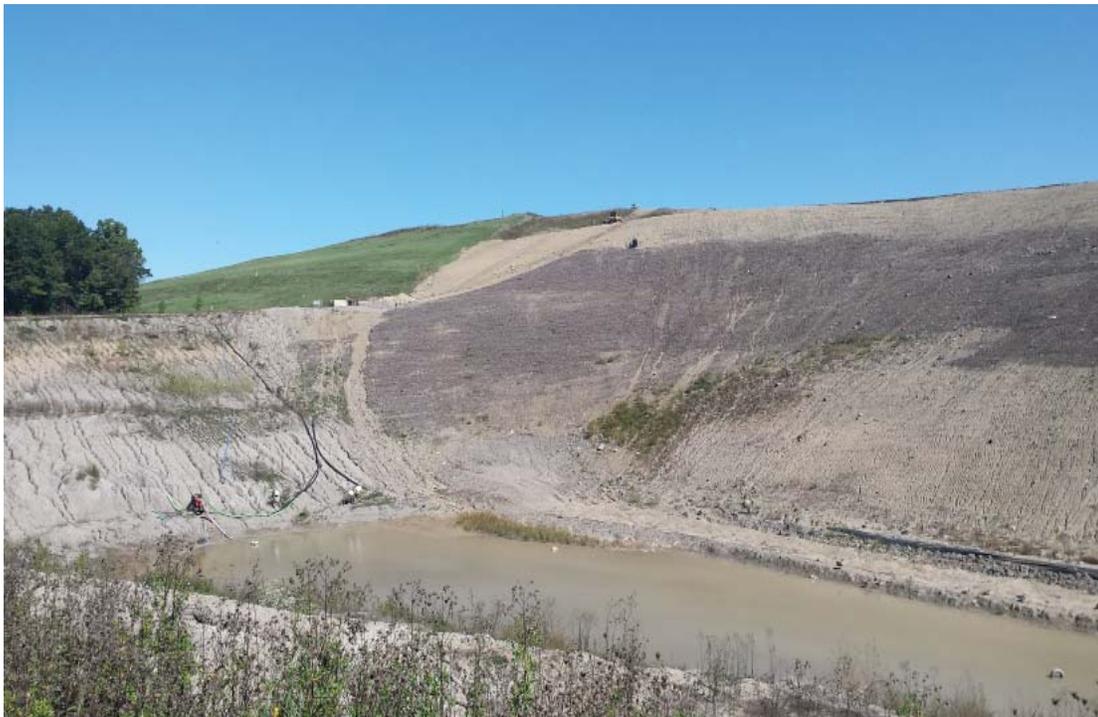
- One small storm on 9/19/16; about 1"
 - More rain expected this week
- Basins very low; temporary sediment basin low, too

Temp Sed Basin below Phase 7

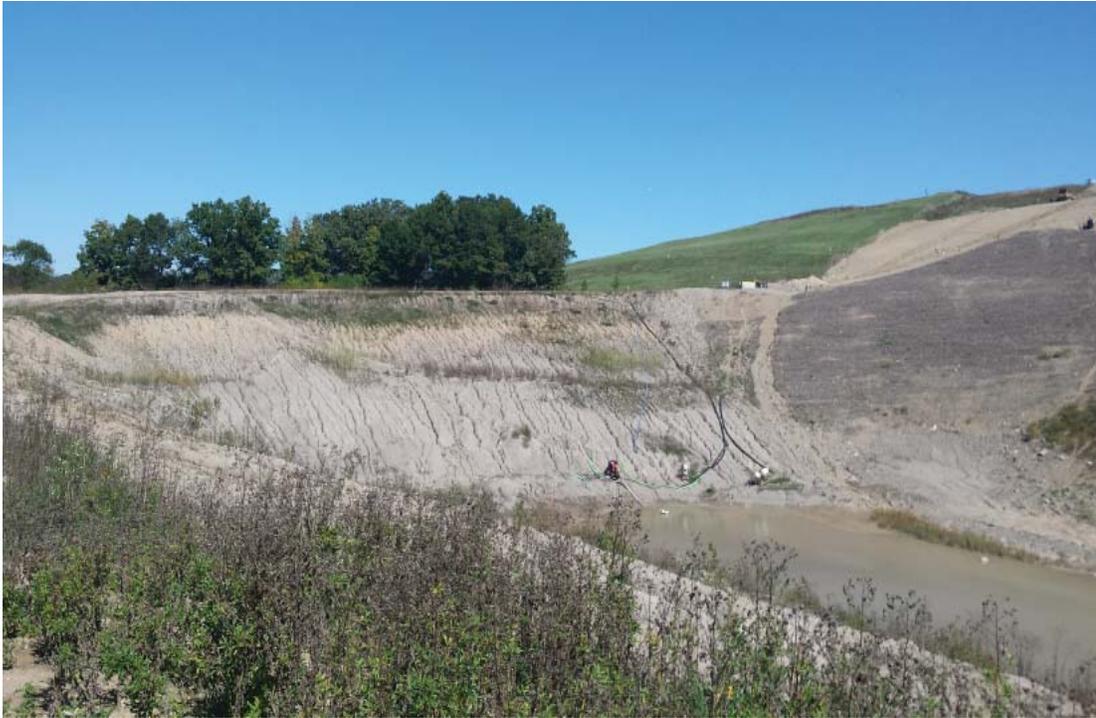
North slope of excavation above Temp Sed Basin
